WHOI-91-34

## ESOM I and II Final Report

November, 1991

### Technical Report

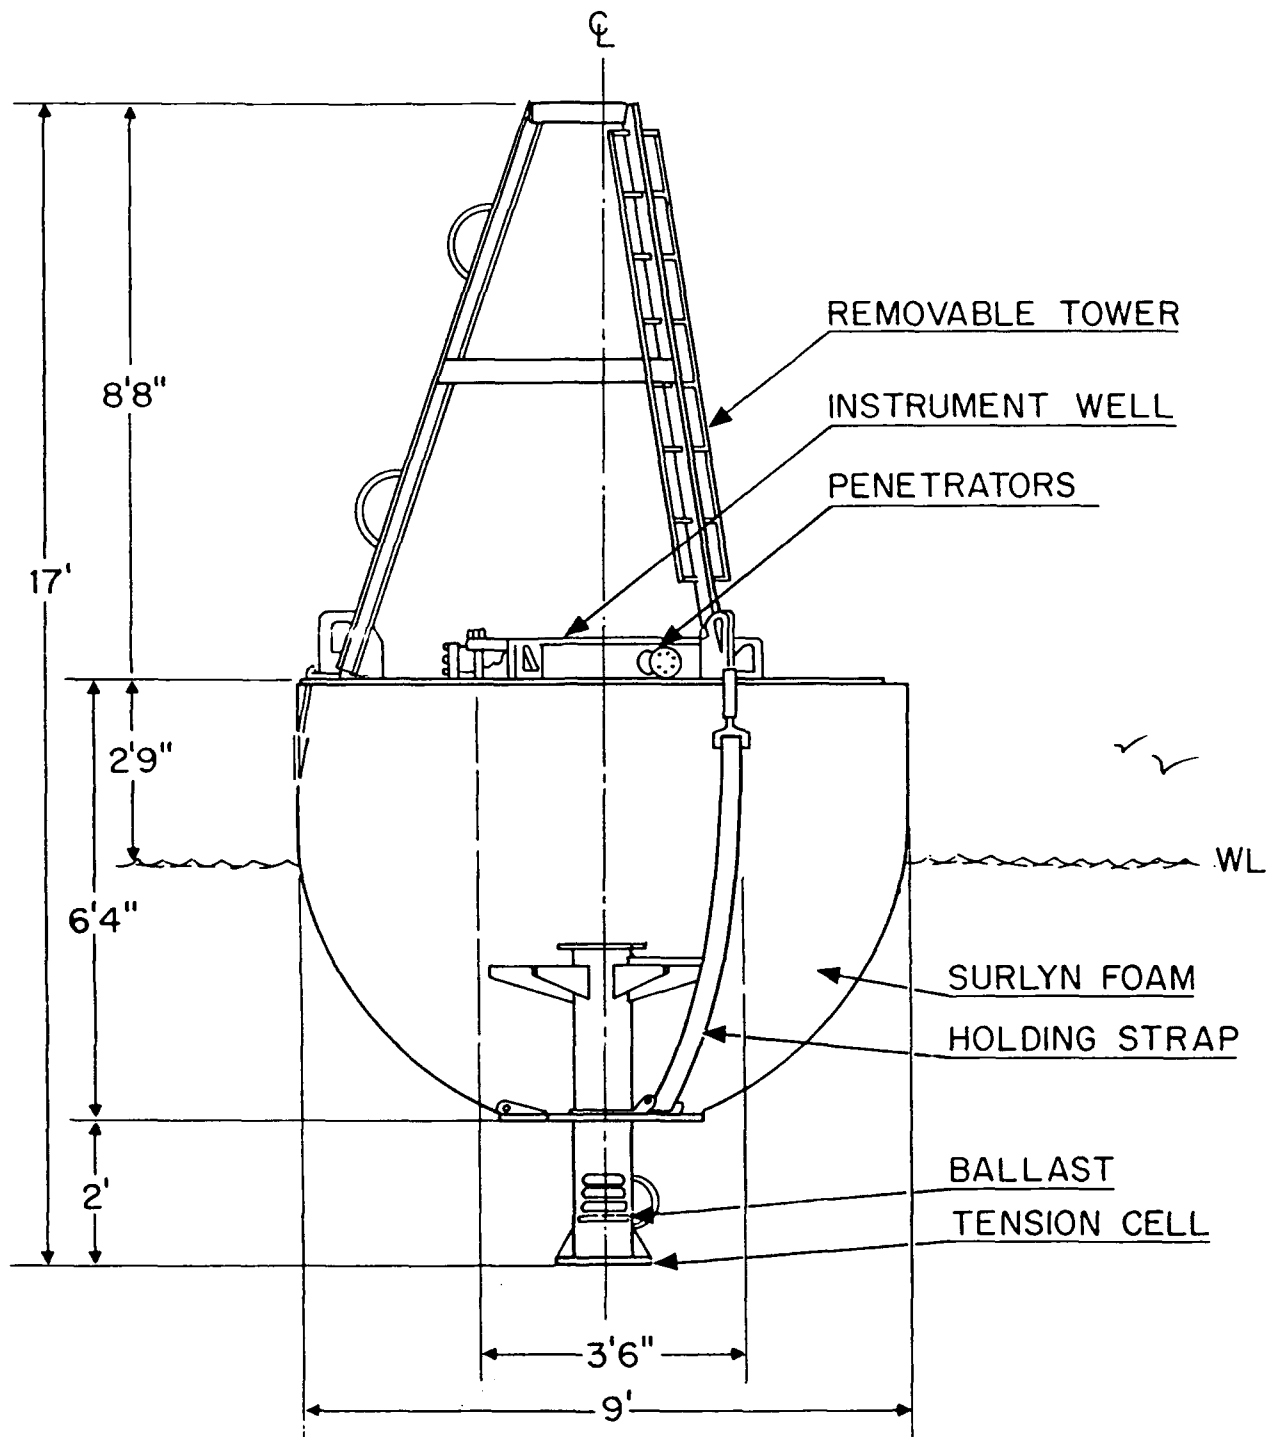
FIGURE 3: ESOM buoy

A preliminary inspection showed no signs of material degradation due to environmental agents. No discoloration due to UV action was noticed on the SURLYN foam. No cracks, abrasion or punctures were found on the hardened skin of the foam body. Light biofouling (algae) and some goose barnacles were growing on the immersed section of the hull, which had been coated with antifouling paint. The nylon straps (stitching and hardware) appeared to be in good condition. Overall, the buoy retained its hemispherical shape with no evidence of permanent deformation or bumps.

The aluminum (6061-T6) structure, including the instrument well, deck, tower and point of attachment, was inspected and found to be in

good condition. The buoy keel, also made of aluminum (5086-H34) was covered with biofouling, but when cleaned, no evidence was found of corrosion or welding cracks. The tension cell was removed from it, and the hardware, including the electrical harness, appeared to be intact. The instrument well was found completely dry with no sign of water infiltration or moisture accumulation. The electronics and batteries were removed from the well; the meteorological sensors, antennae and electrical harness were stripped off the tower. All these components were then shipped to WHOI on the R/V Oceanus.

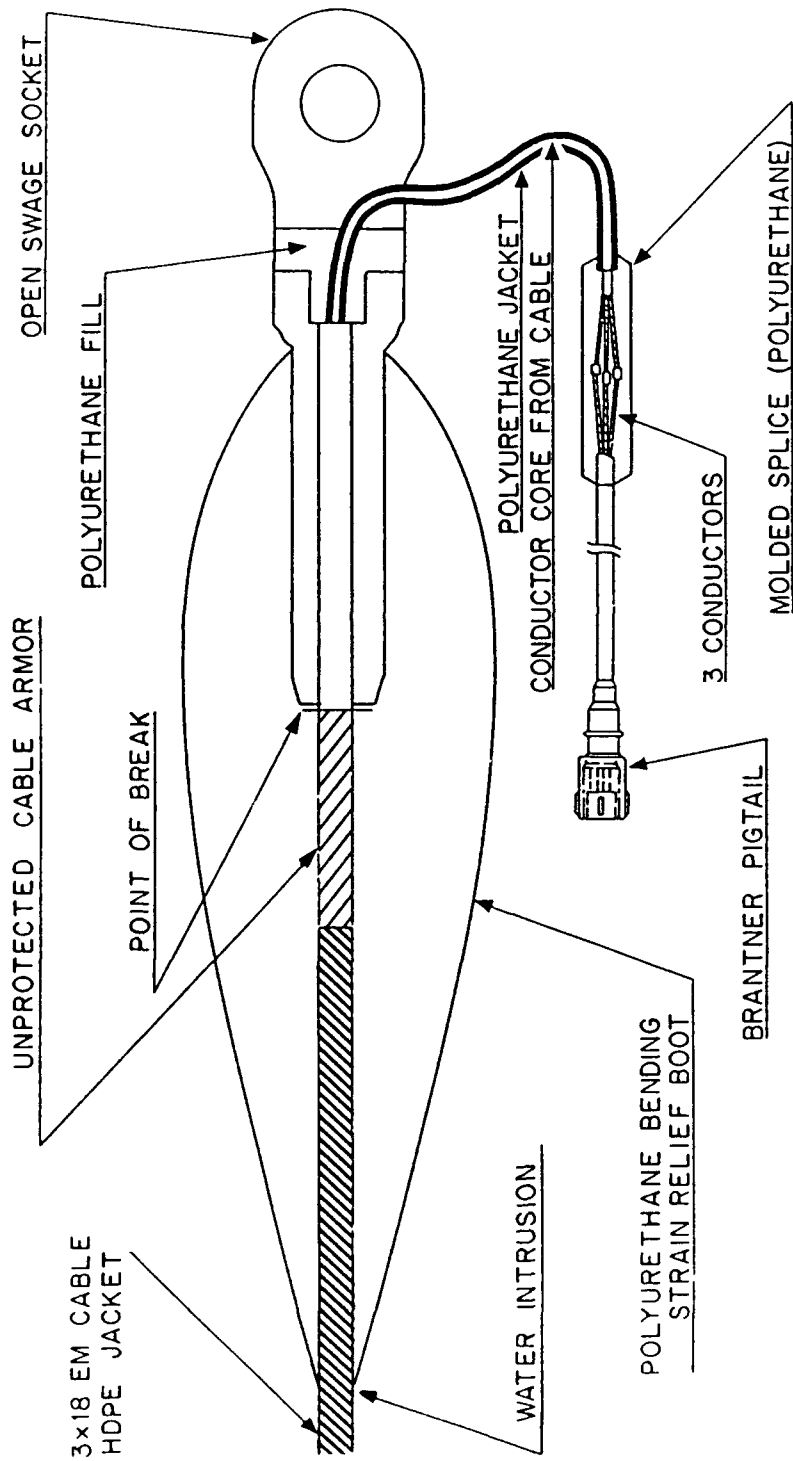
FIGURE 6: Swage socket termination

Two types of EM cable terminations, both designed and built at WHOI, were tested during the ESOM experiment. The "in house" epoxy termination (Fig. 5) for 3x19 EM cables had been previously during the six month STEM experiment with excellent results [9]. The new swage socket termination for the 3x18 EM cables (Fig. 6) was deployed at sea for the first time.

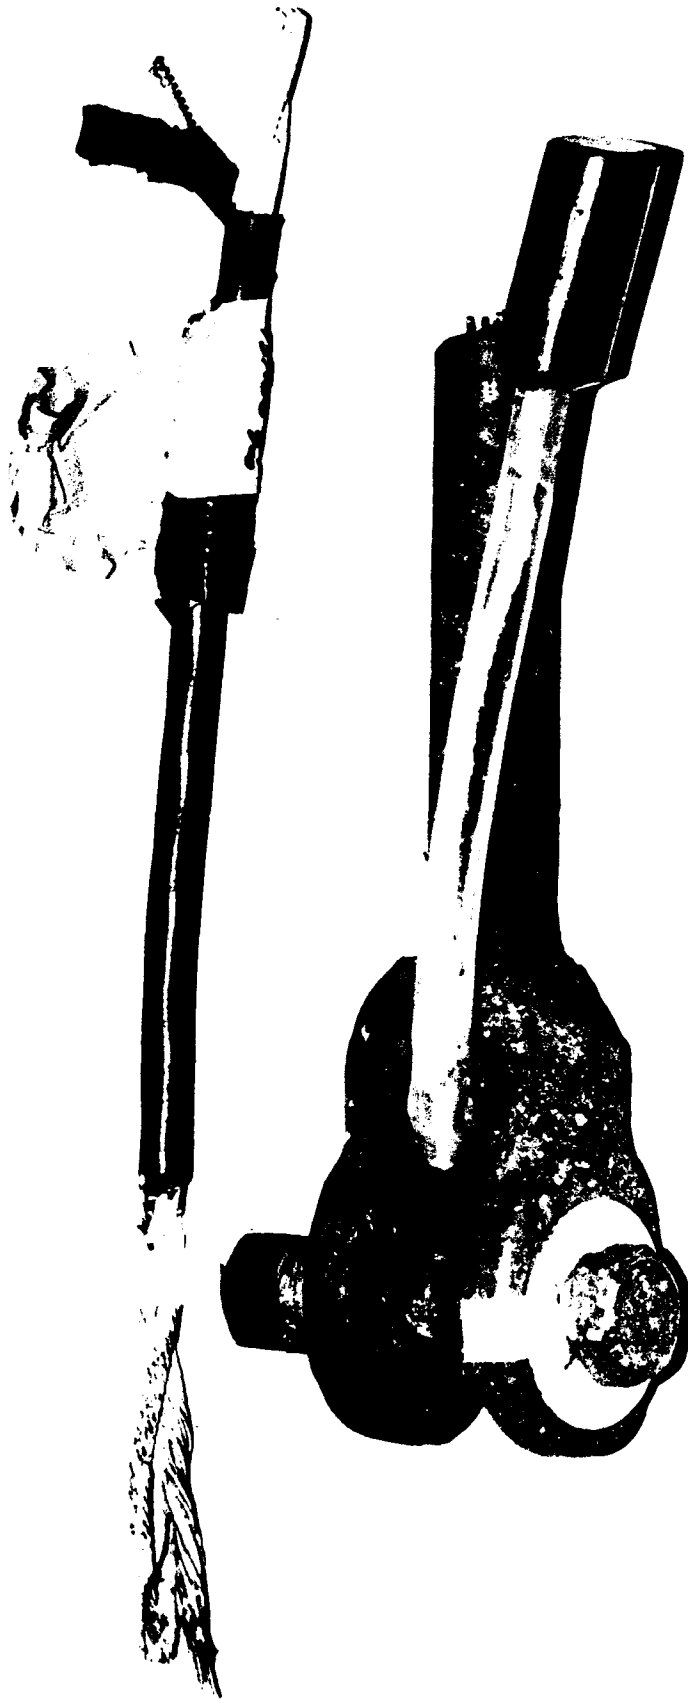
FIGURE 7: Failed swage socket termination

Six months after redeployment, the ESOM II mooring failed due to a mechanical break of the 3x18-7/16" EM cable section (Item 16, Fig.2) This section was carefully examined at WHOI and then sent to Al Lucht, Wire Rope Industry Consultant for microscopic examination and analysis [10]. His conclusions on the modes and causes of cable failure were:

- the cable did break at the end of the swaged fitting shank (Fig.6-7)
- the mode of cable failure was corrosion fatigue
- swaging resulted in initial indentation, or cracks at the surface of the armor wires; the termination mechanical design permitted the wires to flex and twist thus creating the mechanism for crack propagation
- deterioration due to fatigue was accelerated by corrosion resulting from 1) infiltration of sea water over the bare,unjacketed wires inside the boot, and 2) electro-chemical corrosion resulting from rupture in the insulation of the hot electrical wires in a salt environment; the insulation may have been damaged by swaging or by handling during the recovery and redeployment.

The report recommended that future terminations include the following changes:

- Avoid swaging, instead use epoxy filled socket
- Prevent flexing by using stronger, harder stress relief boot
- Provide watertightness and isolate the armor wires from sea water.
