# Delivery Order 9 Enhanced Preliminary Assessment

FORT BENJAMIN HARRISON, INDIANA

February 1992

Roy F. Weston, Inc.  
West Chester,  
Pennsylvania 19380

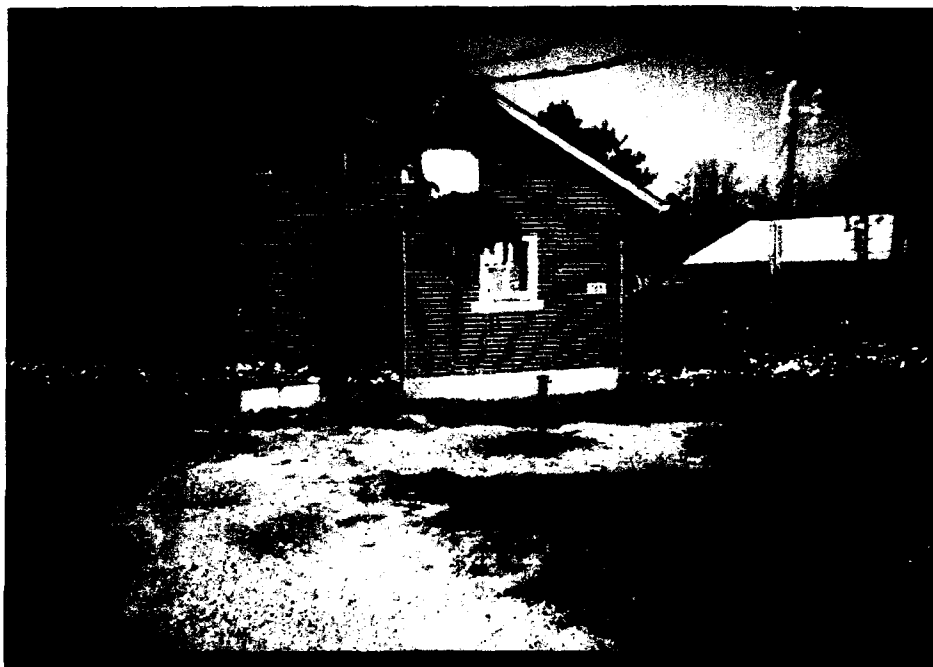
**7. STAINING AT WASTE OIL TANK, AUTO CRAFT SHOP  
(BUILDING 705)**

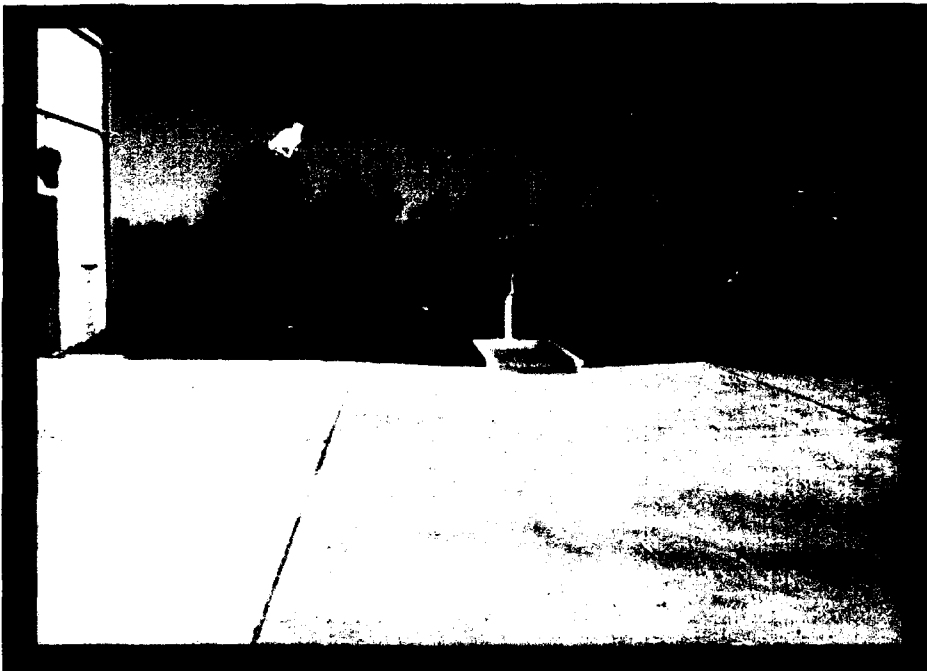
**16. SPILL CONTAINMENT AREA, DRMO HAZARDOUS WASTE STORAGE  
(BUILDING 125)**

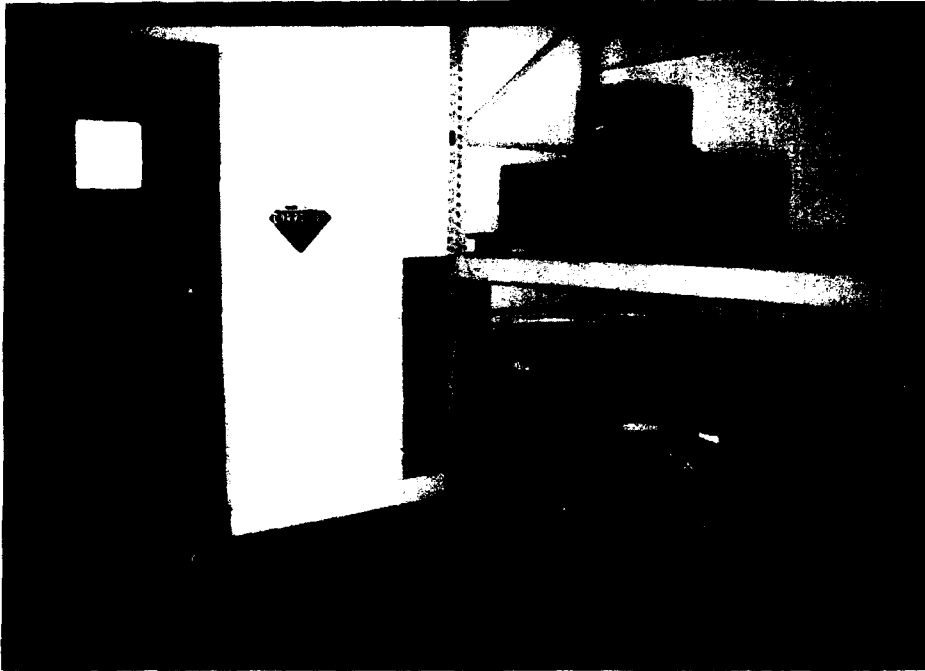
**17. RCRA-PERMITTED STORAGE FACILITY, DRMO  
(BUILDING 125)**

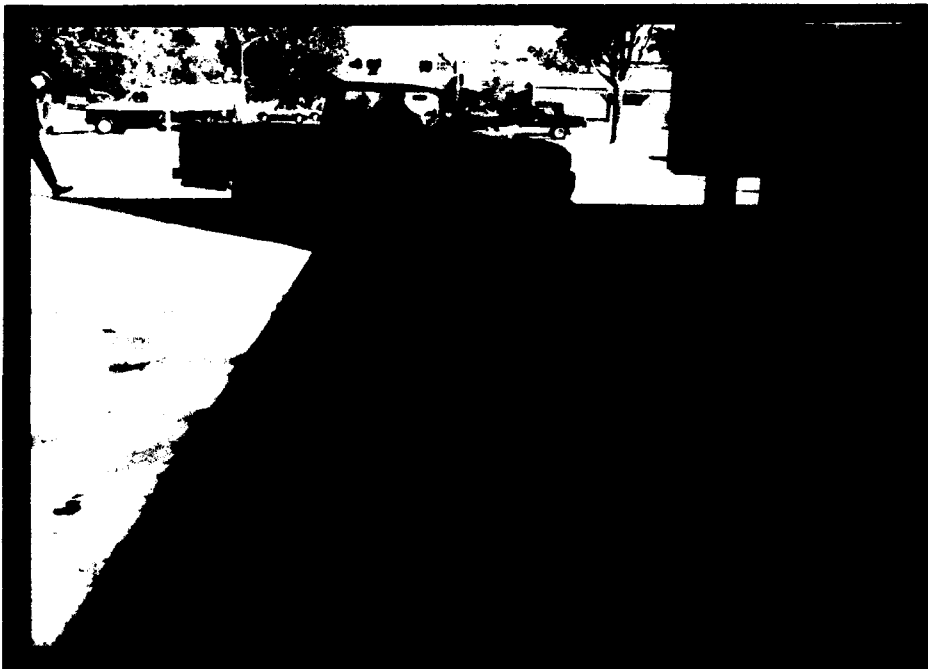
**20. STAINING NEAR WASTE OIL UST, AAFES STATION  
(BUILDING 33)**

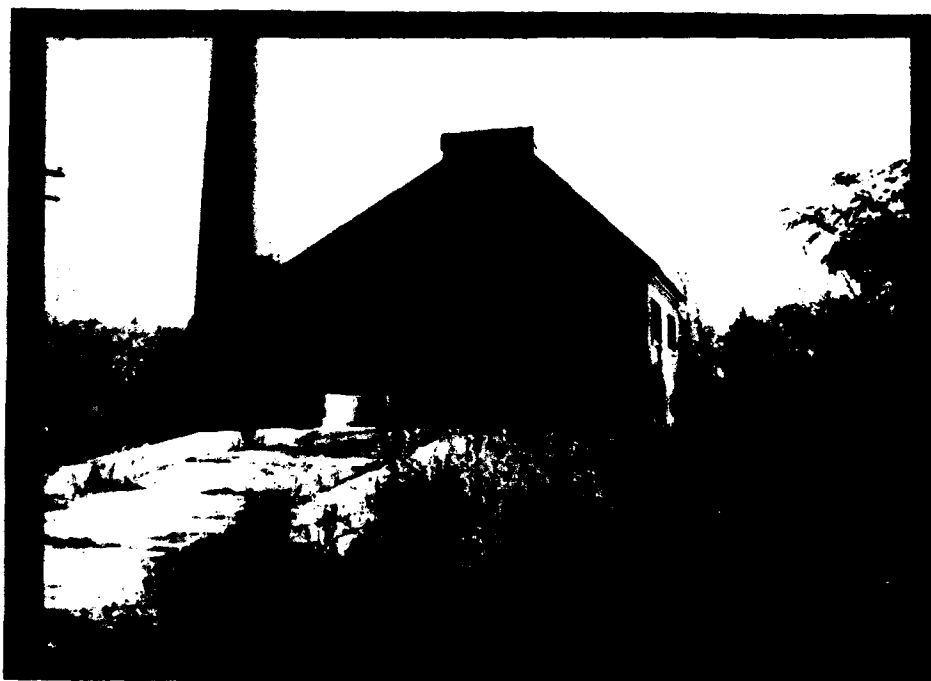
**24. FORMER INCINERATOR  
(BUILDING 518)**
