Performance of Insulated Pavements at Newton Field, Jackman, Maine

Maureen A. Kestler and Richard L. Berg

May 1992

Prepared for
FEDERAL AVIATION ADMINISTRATION
DOT/FAA/RD-92/8

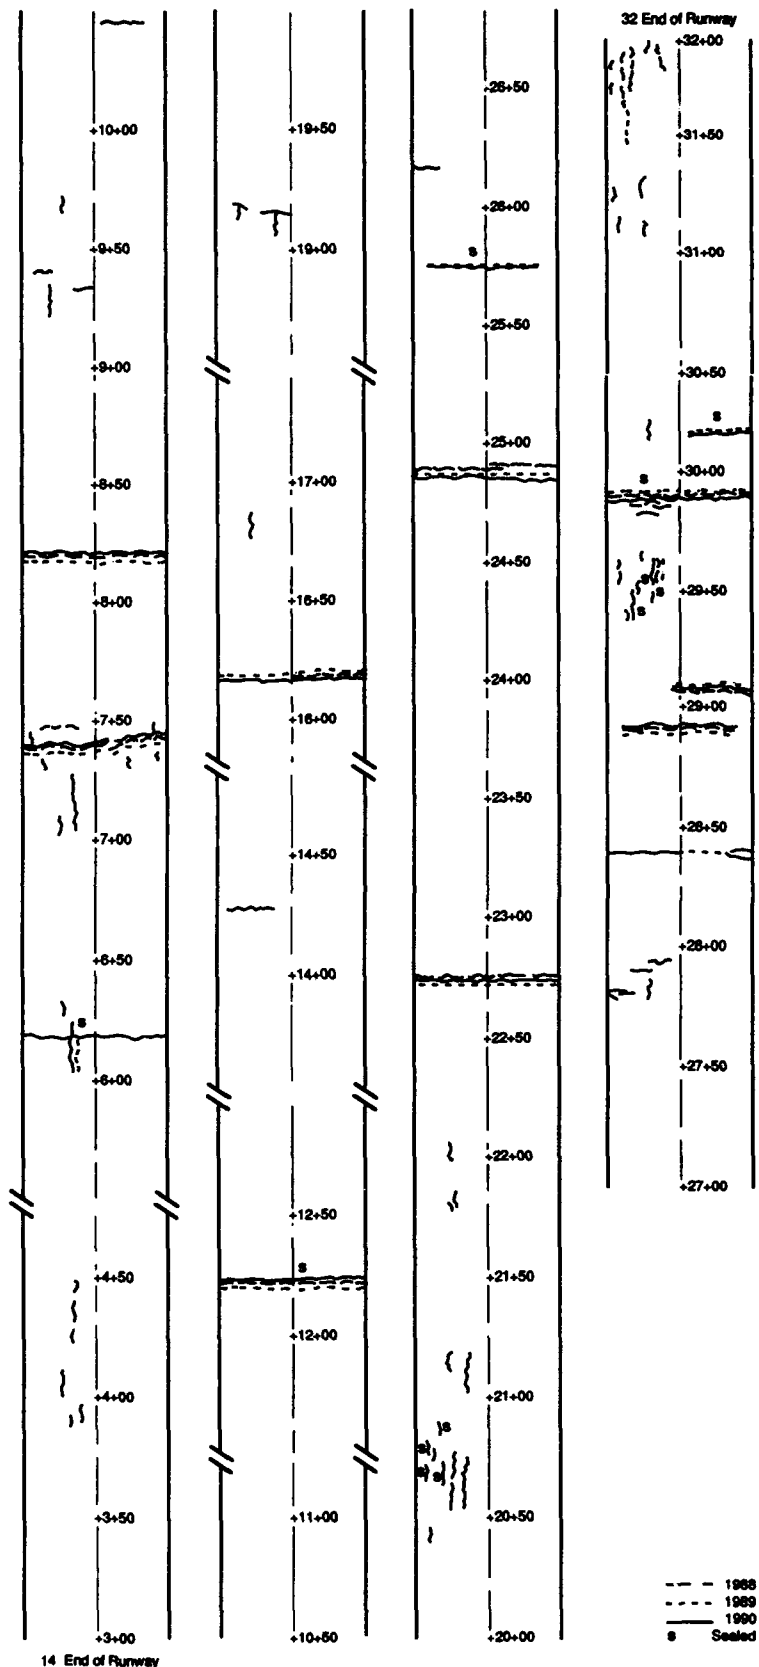
Figure 9. Newton Field pavement crack map.

The progression of crack development following placement of the final 1 1/4-in. asphalt concrete lift in 1987 is shown in Figure 9. Although the cracks had been sealed in September 1989 with a rubberized crack sealer and polyfiber, nearly all cracks have since reopened. In all instances, the failure occurred due to a loss of adhesion between the asphalt pavement and the sealing agent. The crack shown in Figure 10a was unsuccessfully sealed with silicone shortly before being resealed with the rubberized crack sealer.

Generally, the cracks have manifested themselves in two varieties: small longitudinal cracks typically occurring in localized groups, and individual long, wide, transverse cracks. Elev-

en transverse cracks extend across, or nearly across, the entire runway, and two transverse cracks extend across the taxiway. Crack density is particularly high at the southeast (32) end of the runway; elsewhere, cracks are fairly evenly distributed.

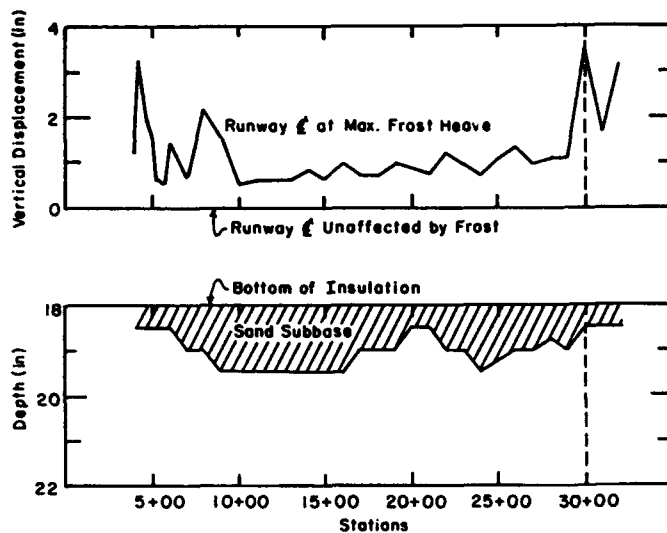
Figure 11. Profile of frost-heaved centerline and corresponding depth of sand subbase, March 1990.

insulated pavement at Nichols Road was approximately 1 in. While the maximum frost heave along most of the runway was only slightly greater than that observed at the test sections, substantial frost heave occurred in three localized areas: station 4+00 to station 6+00 exhibited approximately 3 in. of frost heave; stations 8+00 to 9+00, approximately 2 in.; and stations 30+00 to

32+00, approximately 3 in. Figure 11 shows both the March 1990 centerline profile and the depth of sand subbase along the length of the runway. The areas that experienced appreciable frost heave generally correspond to the two ends of the runway that were excavated to a lesser depth. In addition, both ends of the runway were particularly spongy during construction.
