# DETERIORATED CONCRETE FROM LINER OF WIPP WASTE SHAFT

L. D. Wakeley, T. S. Poole, J. P. Burkes

June 1992  
Final Report

Prepared for Sandia National Laboratories  
Albuquerque, New Mexico 87185

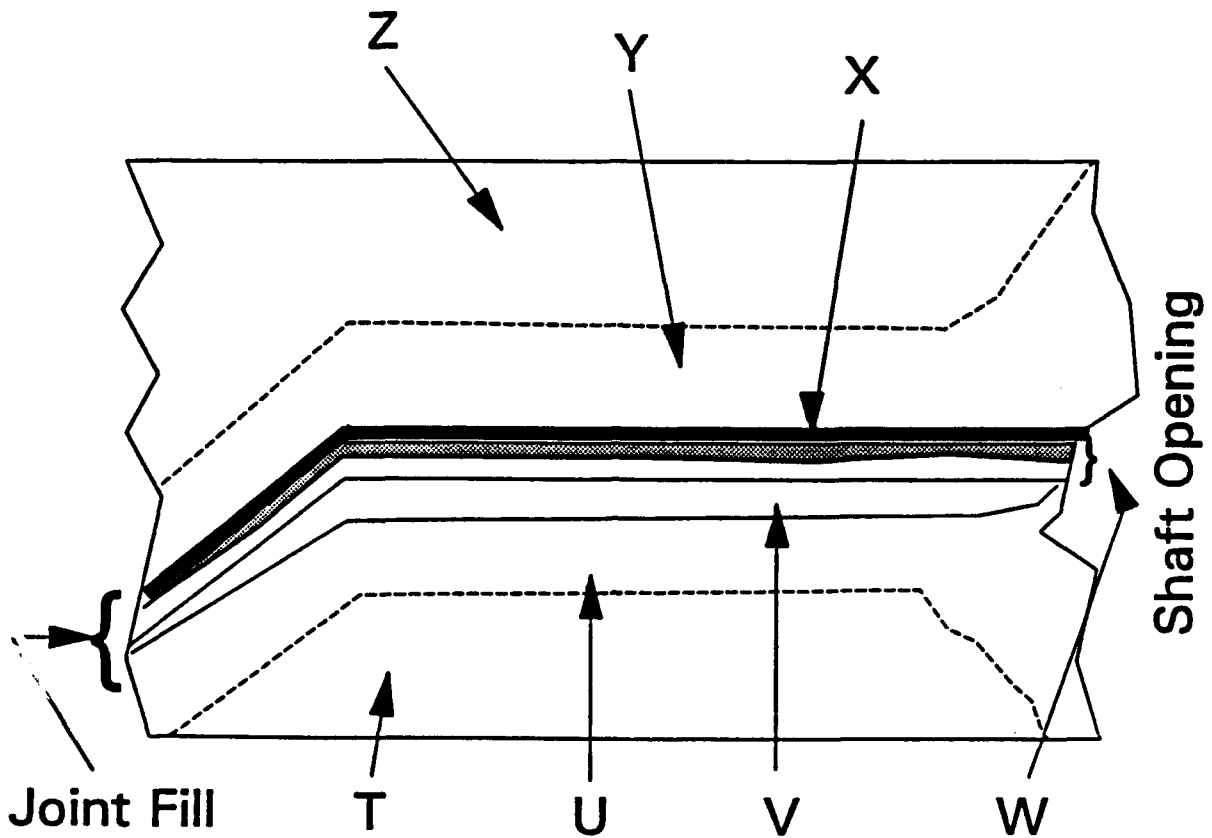
54. The deteriorated layers were almost exactly parallel to the joint and thicker in the lift below the joint (up to 50 mm thick vs. 20 mm or less for the upper concrete). The shaft-opening end of each core segment also was discolored and apparently deteriorated, which was taken to indicate deterioration by interaction between moving brine and concrete components. Both cement paste and aggregates were affected, indicating multiple mechanisms of degradation. The greater thickness and severity of damage below the joint was attributed to a difference in the original concrete; or a simple effect of gravity causing the brine to penetrate the concrete more, downward; or both.

60. Individual coarse aggregates straddled the boundary between discolored and "good" concrete (between U and T on Figure 2). These aggregates tended to break along this boundary when probed with a dental pick, rather than break out of the paste. In fact, each individual aggregate broke along the line where the discoloration stopped, and fractured into many parallel pieces above this interface (the portion that was within U). That portion of each aggregate that was within the "good" paste (T) remained intact and bonded to the paste. Recall that this boundary is not from casting, but is apparently a front representing the extent of chemical alteration. Their fracturing showed that the aggregates, too, were softened by chemical attack.

- Z, sound concrete
- Y, partially deteriorated concrete
- X, black material (local)
- W, chemical grout + crystalline material
- V, sanded grout
- U, deteriorated concrete
- T, sound concrete

Figure 2. Lateral view of external features of 834-1 and 834-2. Cores are approximately 15 cm long

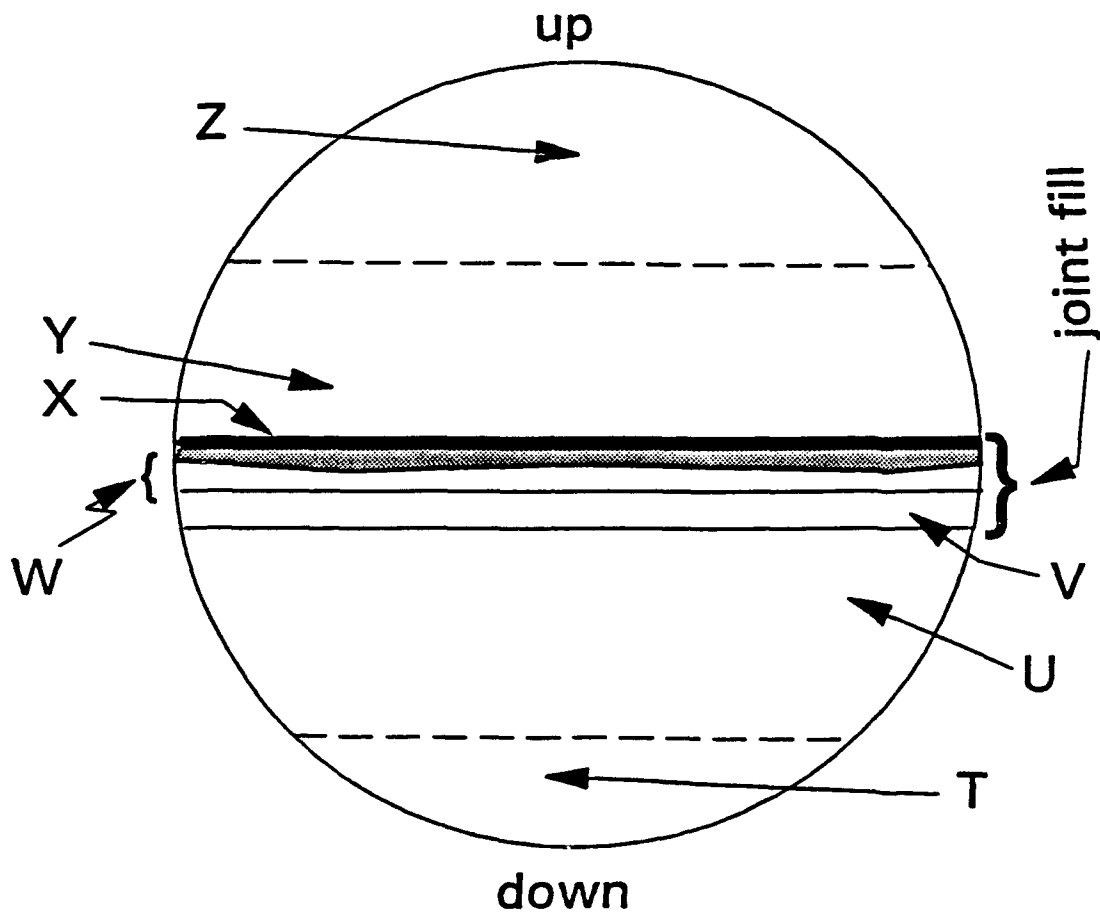
Figure 3. Cross section of 834-1 and 834-2.  
Cores are 7.5 cm across

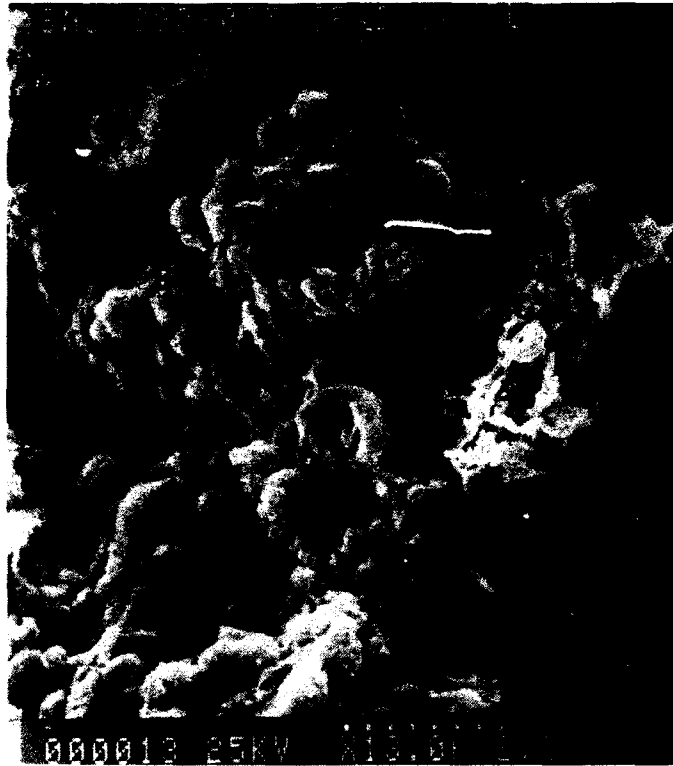
Figure C17. Grab sample 890-085 (WIPP-2 SM-6).  
Aggregate surface that was exposed to brine
