CONTRACT REPORT EL-92-2

STABILIZATION OF DAKOTA SANDSTONE
SURFACE OF THE FARIS CAVE PETROGLYPHS
KANOPOLIS LAKE PROJECT, KANSAS

David A. Grisafe

Kansas Geological Survey
University of Kansas
Lawrence, Kansas 66044

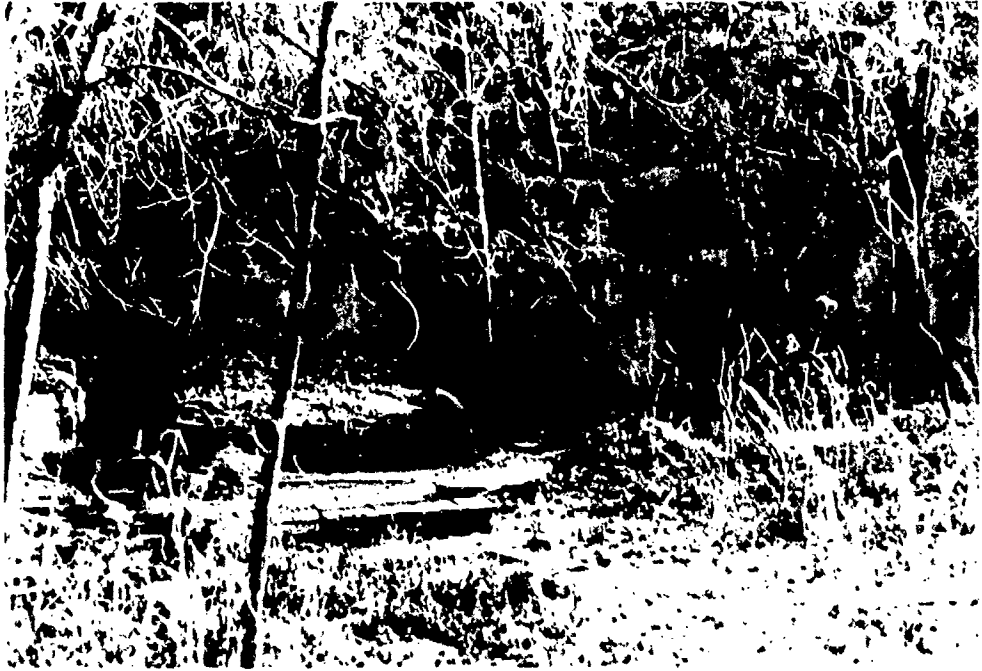
Figure 2. Approach to Faris Cave Site, showing the three doorways to the late-19th century man-made caves or rooms at the base of the cliff. The northernmost room (extreme left) still contains an active spring

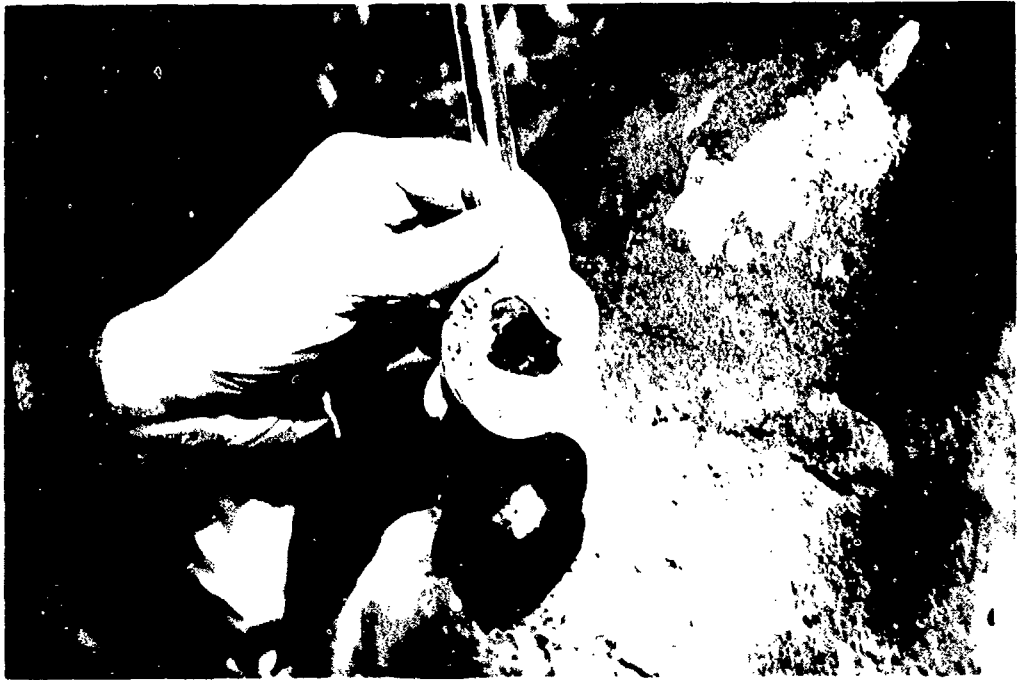
absorbed. Some difficulty was experienced in obtaining a good seal because of the very friable nature of the stone and biological growth at some locations (Figures 8 and 9).

Figure 8. Biological growth often made it impossible to form a watertight seal (note residue on ring of mastic) between the base of the capillary tube and the sandstone

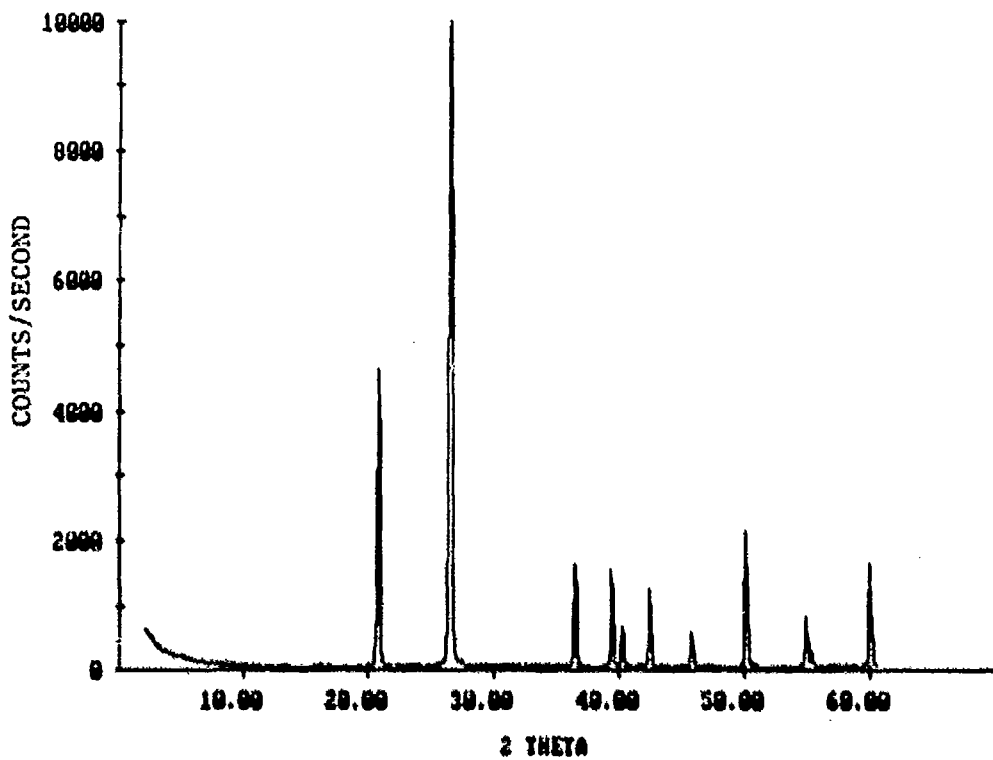
29. A summary of the chemical analyses for seven samples is shown in Table 2. In general, the stone consists of over 96 percent silica and about 1.5 percent iron oxide. The remainder is divided between the loss on ignition at 1,000 °C and several oxides. The low alumina content indicates the absence of any significant amounts of clay or feldspar minerals. This is in agreement with optical microscopy. Optically, one observes quartz grains, many with a thin, fine-grained buff coating, and occasional grains of opaque mineral(s) and muscovite mica. Based on these observations, this sandstone would be classified as an arenite or arenaceous sandstone. The x-ray diffraction patterns showed only the presence of quartz (Figure 10). Since the iron oxide content is low and iron minerals and iron-bearing clay minerals are often poorly crystallized, the absence of any iron minerals in the diffraction patterns is not surprising. The color under the microscope suggested that some of the iron may be present in traces of clay or as limonite. A piece of sandstone higher on the cliff face that possessed a higher iron content did show traces of goethite in the x-ray diffraction pattern.

Figure 10. X-ray diffraction pattern (2 theta versus counts per second) for a sample of the Dakota Formation sandstone at the Faris Cave Site. All seven samples collected at the site yielded the same pattern with all diffraction peaks due to quartz

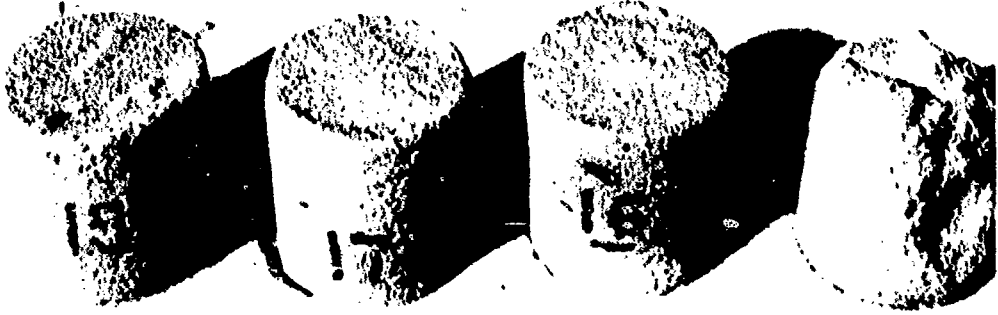
33. Table 6 shows the percent weight loss for each set of cores after 25, 50, 75, and 100 cycles. The data show an increased resistance to freeze-thaw cycling (lower weight loss) with increasing numbers of treatments. Two of the untreated cores failed completely (disintegrated completely to sand grains) during the first 25 cycles, while the third core in the set failed completely on the 33rd cycle. By contrast, none of the treated cores failed completely during the 100 cycles, including those given only a single 2-min capillary absorption treatment (Figure 11). However, the latter cores were friable, suggesting that more than one consolidation treatment is necessary for this type of stone.

34. As expected, small weight losses occurred by sanding (the removal of grains from the exterior surface). With increasing numbers of treatments, the increased bonding minimized the amount of grains removed in this manner. A few of the treated cores showed areas of swelling and cracking during the first 25 cycles, but no complete failure occurred after 100 cycles. The cause of this swelling is unknown but was never observed at the site.

Figure 11. Results after 25 freeze-thaw cycles. The three cores on the left had received one 2-min capillary absorption treatment with Conservare OH stone strengthener. These cores show no damage. By contrast, the core on the right is all that remains from a set of three untreated cores. The other two cores completely disintegrated
