AEROSPACE REPORT NO.
TR-0091(6935-03)-1

Space Environmental Effects on Silvered Teflon Thermal Control Surfaces

15 September 1991

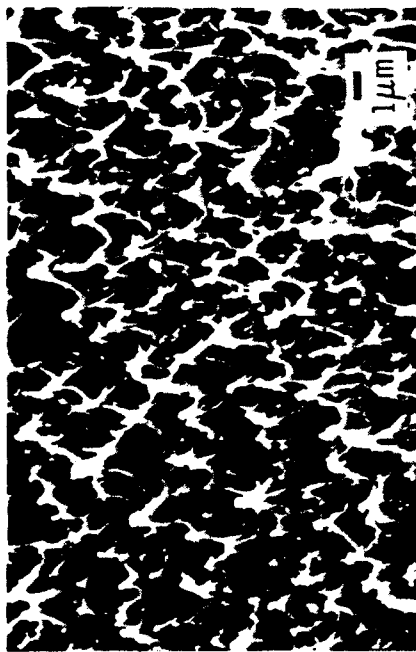
LDEF TRAY C11 EXPOSED TEFLON

The leading edge samples were uniform in appearance from rows 7 through 11. Typical results of analyses with SEM and XPS are shown in Figure 3. The control surface, which is a non-flight FEP surface, is featureless in the SEM while the flight sample shows a typical erosion pattern in FEP for high velocity atomic oxygen erosion. The XPS data for the control surface shows carbon and fluorine only. The XPS analysis of the exposed surface shows that the surface composition of the FEP remaining after the erosion is indistinguishable in carbon and fluorine composition from the control, with trace amounts of some contaminants (Si, N, S, and Cl) and measurable oxygen present. This oxygen could be from the atomic oxygen interaction or from water adsorption from the atmosphere after retrieval. Water adsorption could be enhanced on the erosion-roughened surfaces, which have much higher surface area than the control surfaces. Some variations in the erosion pattern on leading edges were observed as shown in Figure 4.

Figure 3. Leading edge sample of Ag/FEP compared to control sample. Typical results of analyses with SEM and XPS.

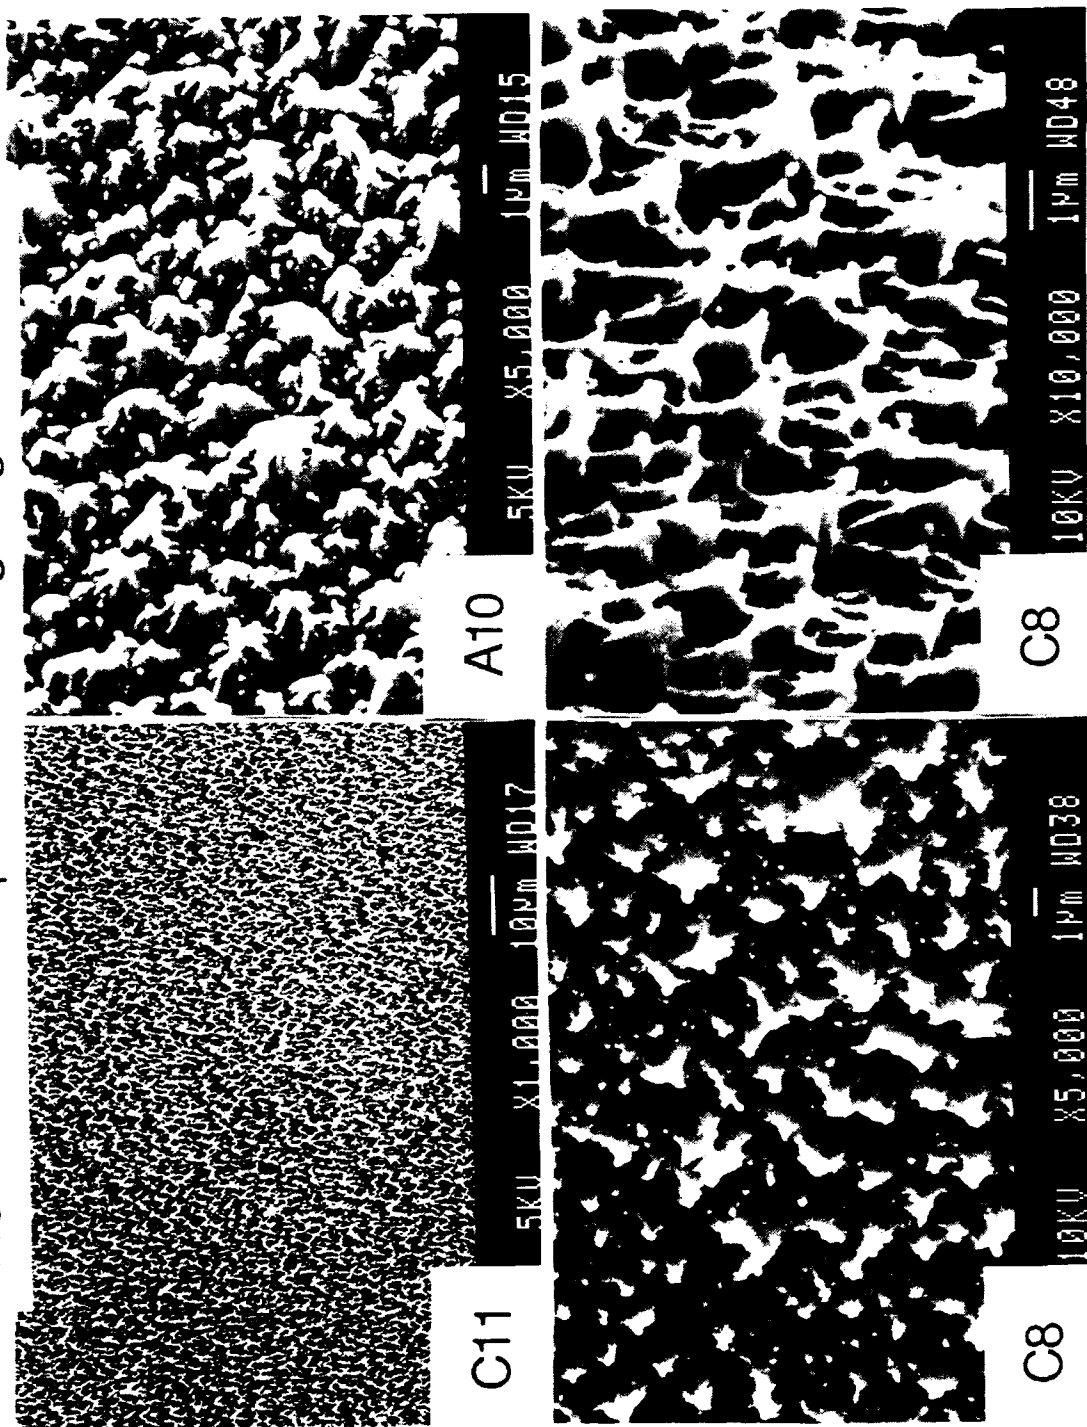
AO Erosion of Exposed Leading Edge Surfaces

Figure 4. Some variations in the erosion pattern on leading edge samples of Ag/FEP.

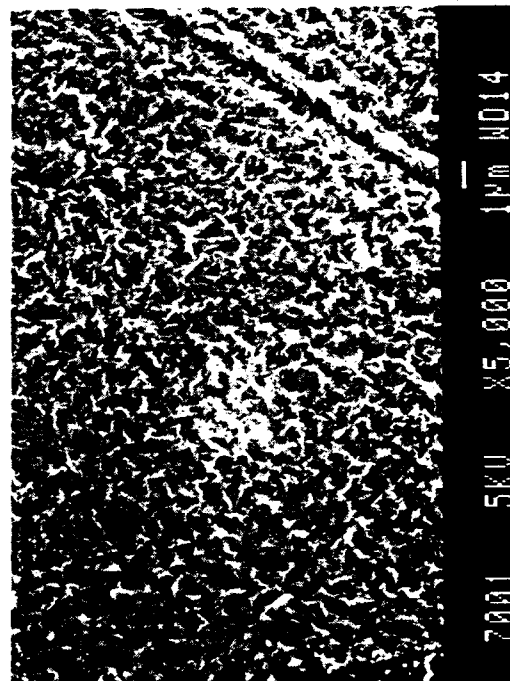
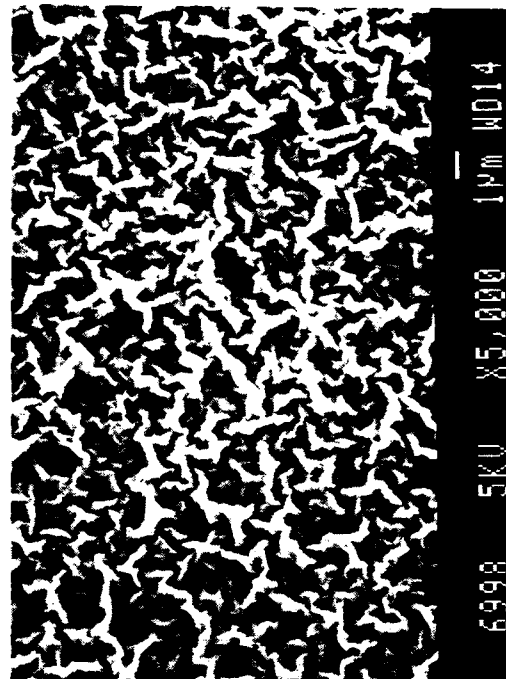
F2: Exposed Trailing Edge Surface

Exposed trailing edge samples were found to have developed a wide variety of surface morphologies, very distinct in appearance from the featureless control surface and the atomic oxygen eroded surfaces. The blanket surface areas that appear fogged or cloudy on the trailing edge have become sufficiently diffuse to change visibly. Many of the clear, visibly unaffected areas, however, also have morphology changes, as seen in Figure 5. Within short distances on some trailing edge samples both the surface morphology and surface contamination levels were observed to change dramatically. This is shown in Figure 6. Silicon, detected as SiO_2 , is one of the most significant contaminants on trailing edge Ag/FEP surfaces. It is currently not clear if any causal relationship exists between observed morphology type and surface contamination build-up. It is possible that some morphologies will have a higher probability of trapping or adsorbing outgassed or backscattered species, thereby leading to greater surface contamination buildup. Some additional morphology types observed on exposed trailing edge FEP surfaces are seen in Figures 7 and 8. Figure 7 shows a series of closely spaced bands on a section of the thermal blanket from bay A of row 2 (A2). Figure 8 shows that some trailing edge surfaces are still relatively smooth; this was most typical of samples at larger angles to the trailing edge, e.g. rows 1, 5 and 6. EDS analysis showed the bright spots to be relatively high in Si concentration.

Figure 5. Exposed trailing edge surface from F2 showing morphology changes by SEM in adjacent clear and diffuse areas of Teflon.

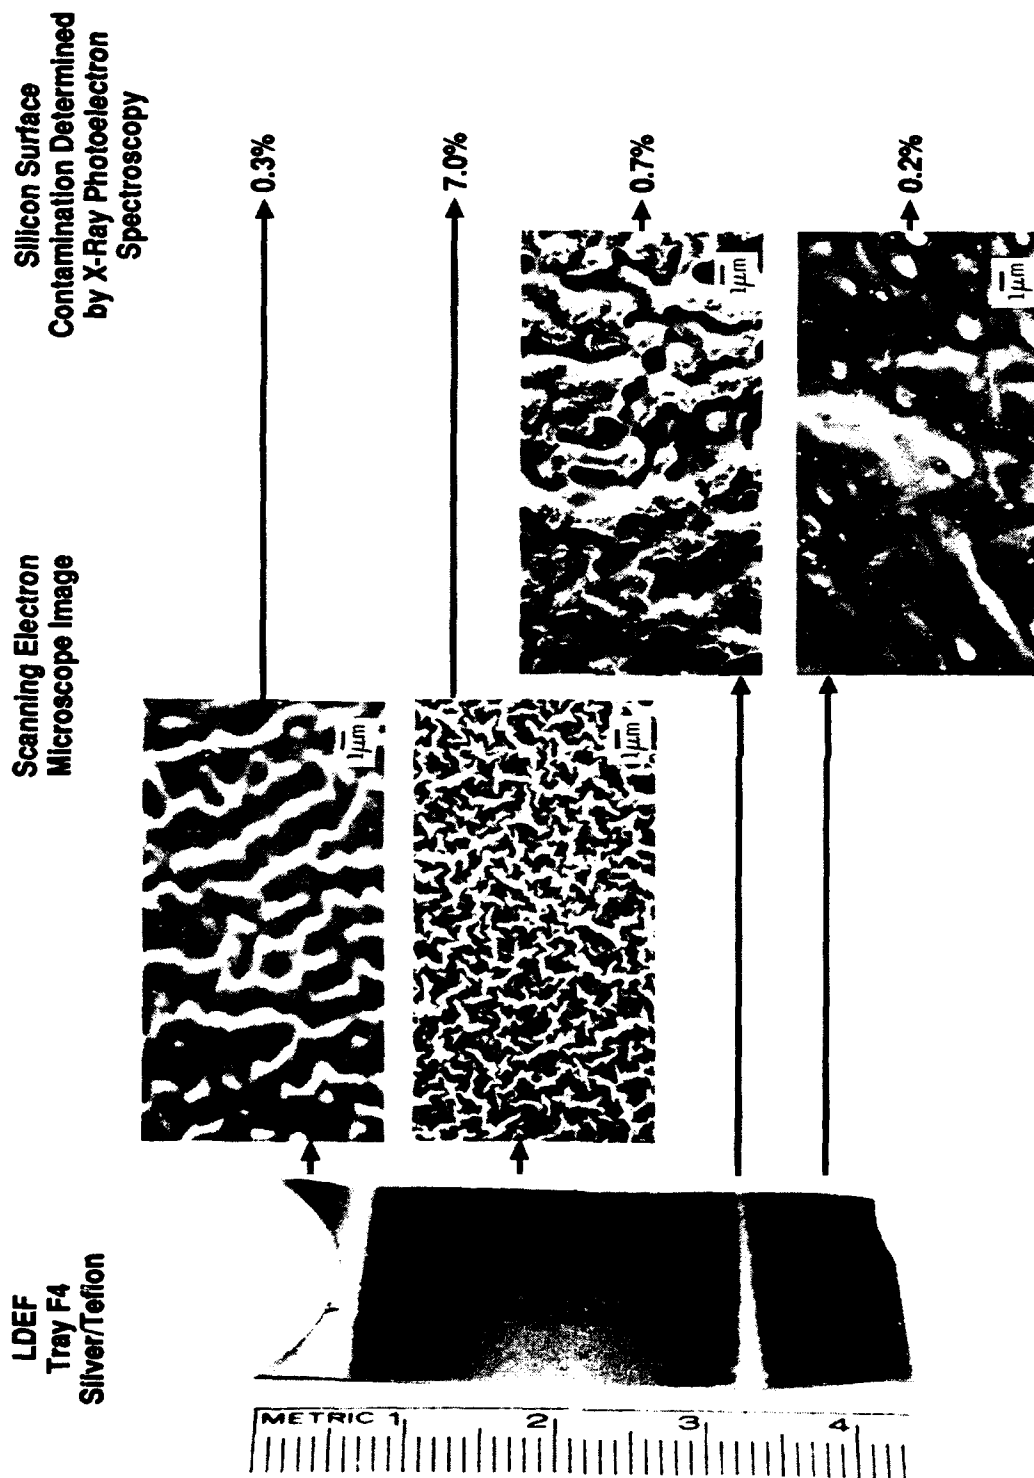
Figure 6. Changes in Teflon surface morphology and surface contamination level, as represented by Si concentration, for a series of adjacent bands on an exposed trailing edge surface from F4.

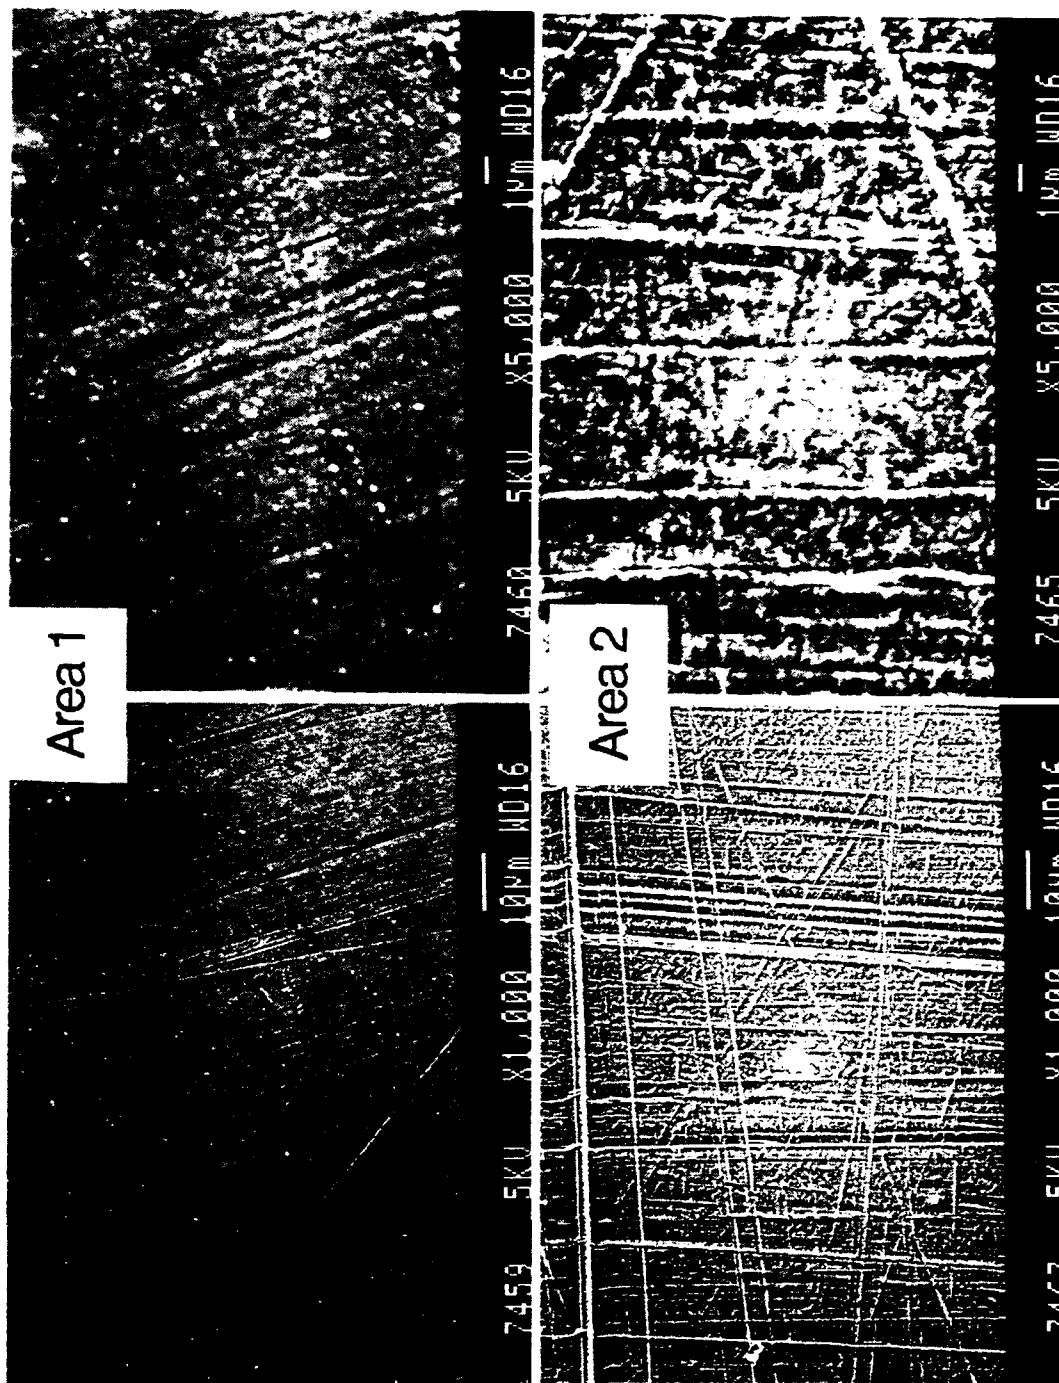
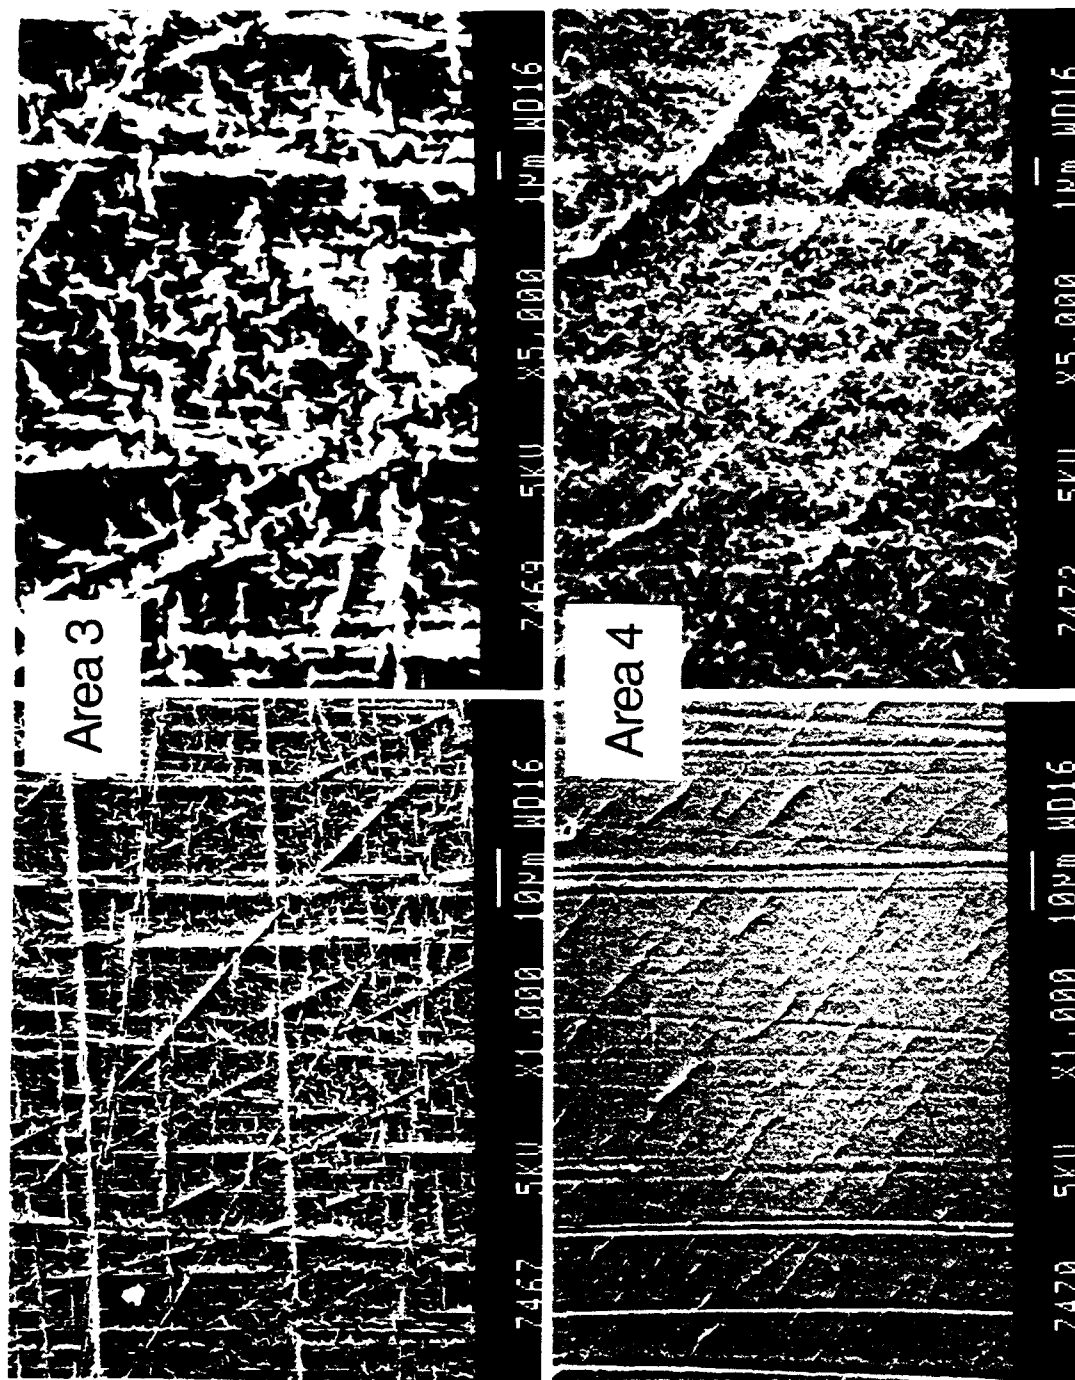
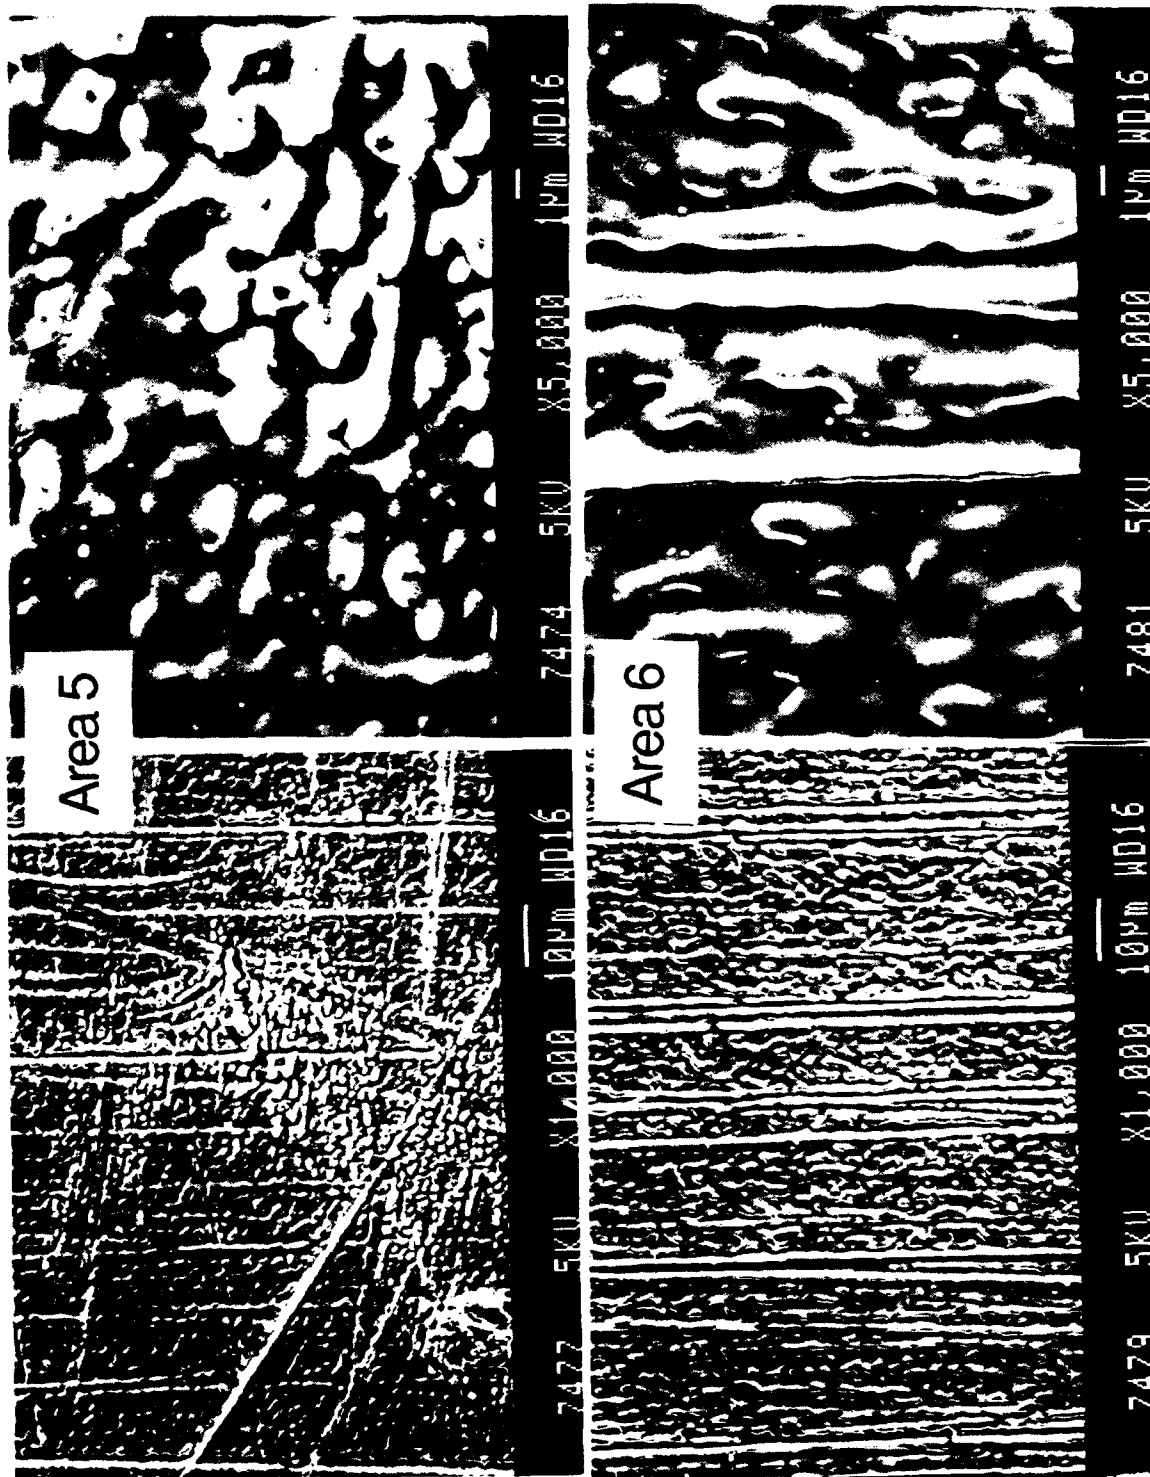
Figure 7 (Areas 1 and 2) Figure 7. SEM images of morphologies in a series of 6 closely spaced bands on a section of exposed Teflon from trailing edge A2.

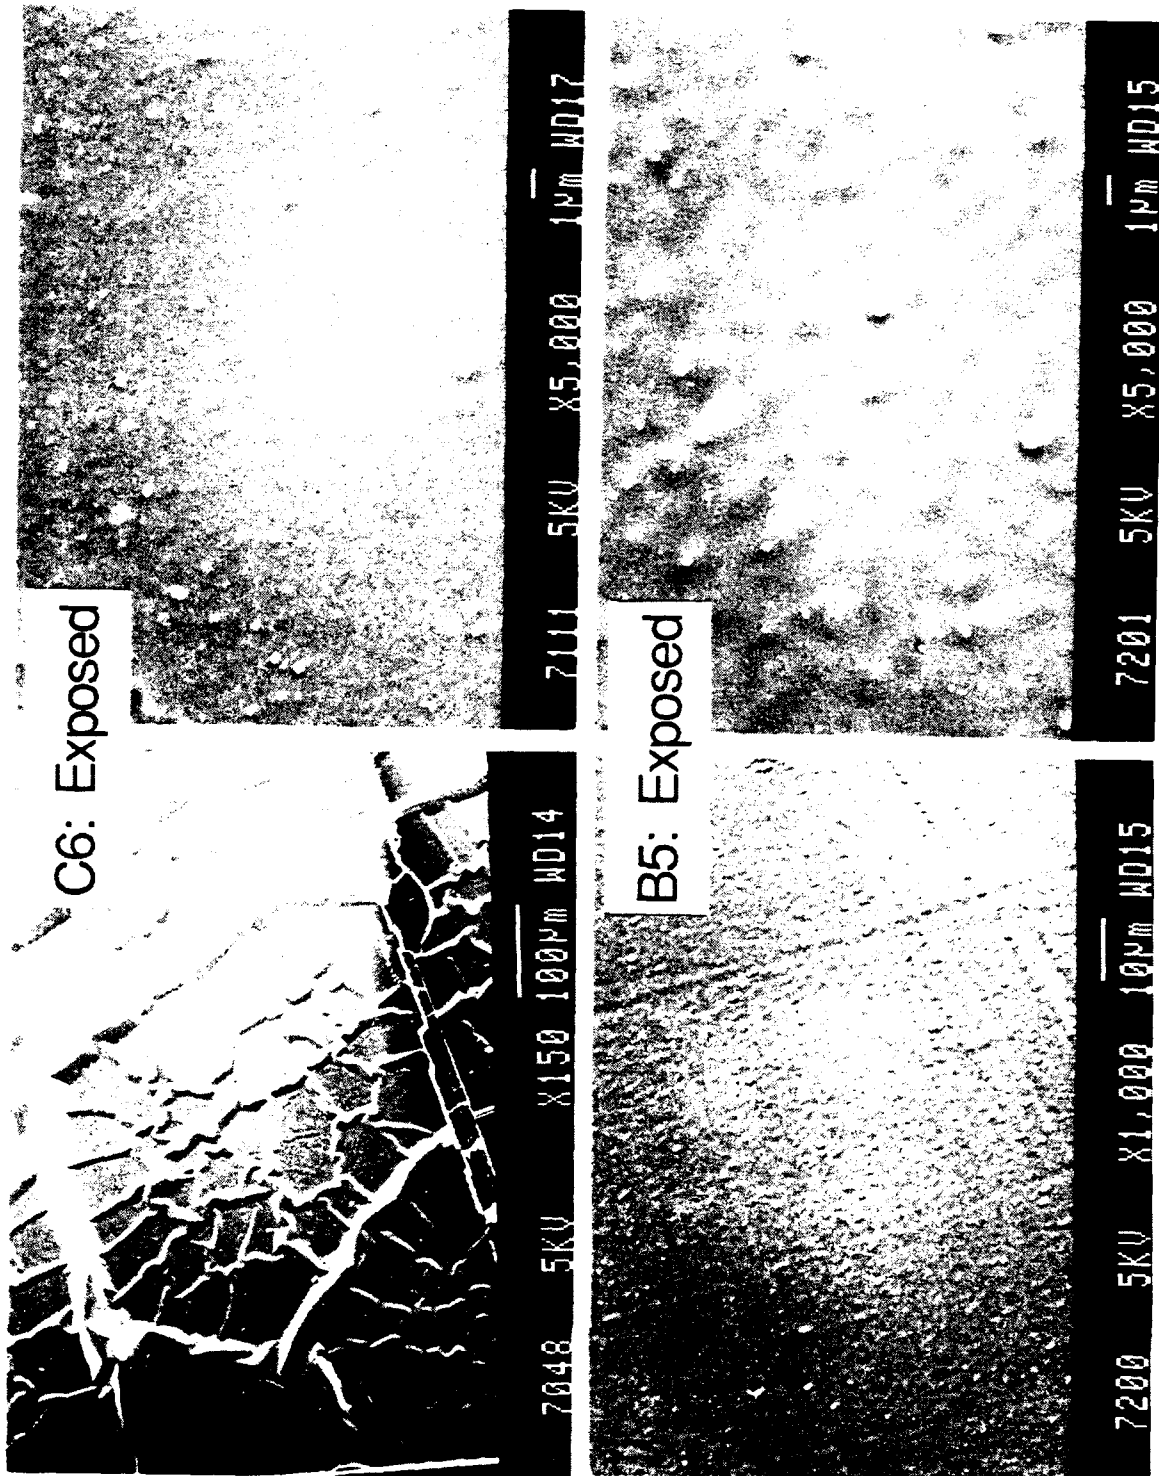
Figure 8. Exposed trailing edge surfaces that are still relatively smooth. Bright spots are relatively high in Si concentration.

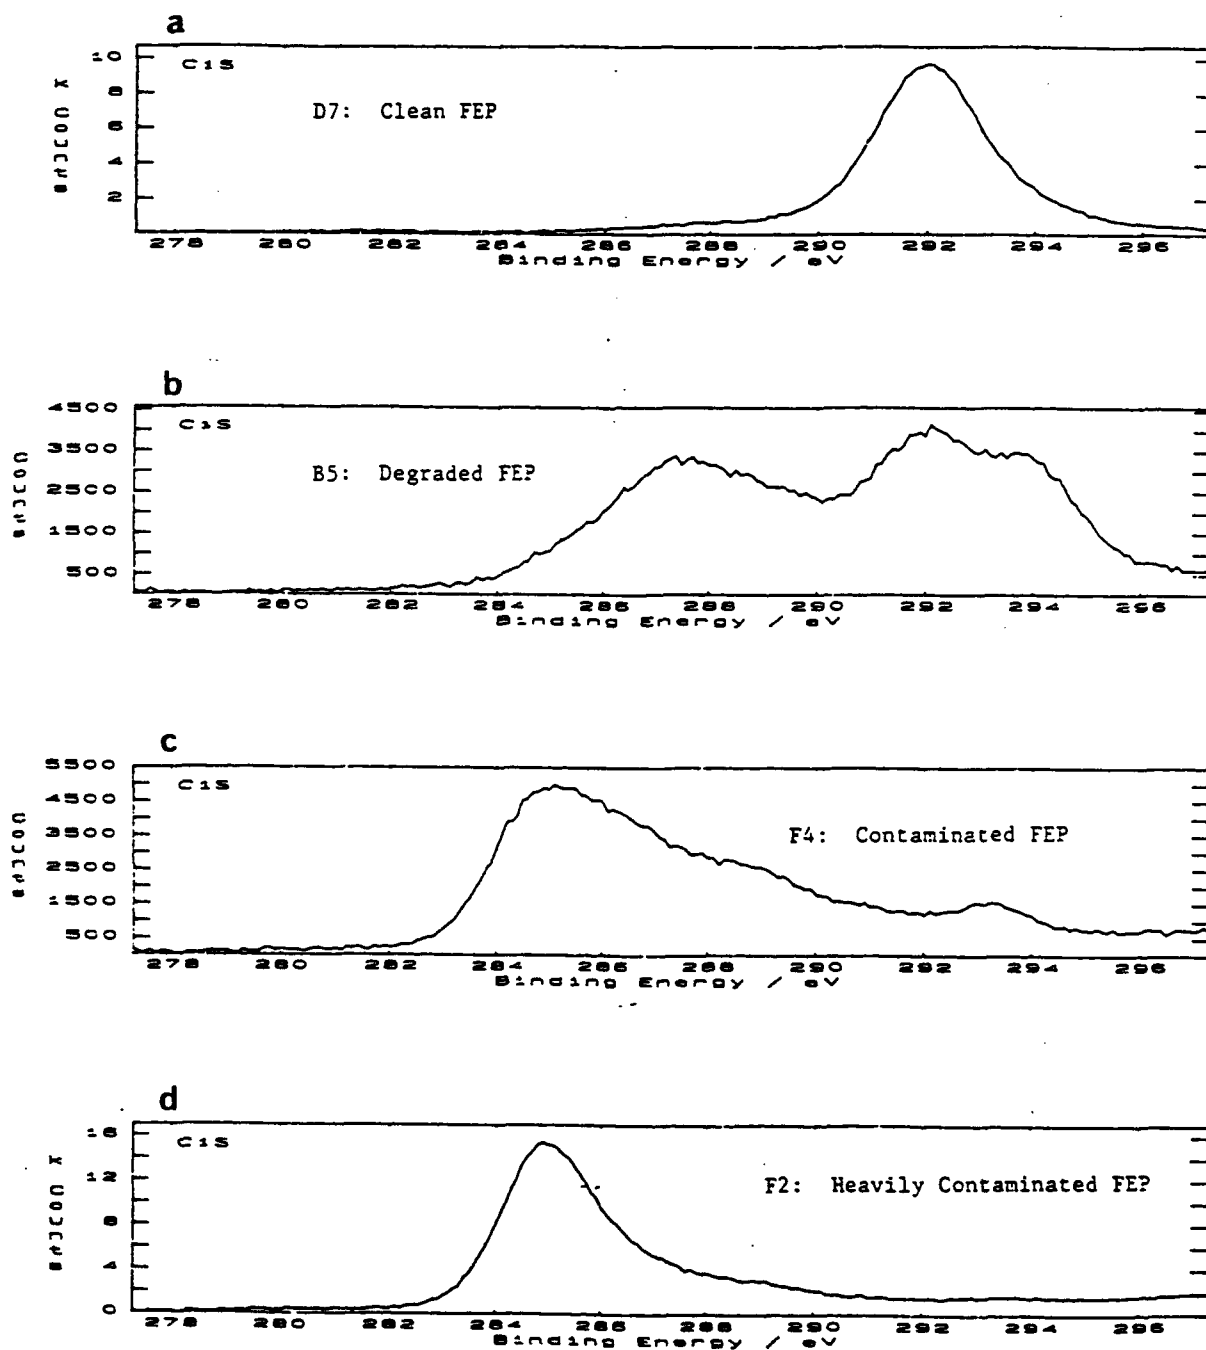
carbon 1s (C1s) XPS spectrum indistinguishable from the control material, the leading edge surfaces are characterized as clean FEP. The C1s spectrum from the D7 blanket surface is shown in Figure 9a. Curve-fitting reveals the major CF₂ peak at 292 eV and moderate CF and CF₃ peaks (approximately 10% each) at 289.5 eV and 294 eV respectively. This matches the spectrum predicted for FEP with an approximate ethylene/propylene comonomer blend of 90%/10%.

(Si, O, C, N, and S) and a C1s spectrum dominated by a peak at 285 eV, as seen in Figure 9c and d. The C1s peak at 285 eV is predominantly due to C-C bonds, and is thought to build up on the trailing edge surfaces from decomposition products of outgassed hydrocarbons and silicones.

The C1s spectrum in Figure 9b arises from degradation of the FEP surface. Curve-fitting shows that the decrease in intensity of the CF₂ peak at 292 eV is accompanied by major increases in intensity at 294 eV, 289.5 eV and 287 eV, assigned to CF₃, CF and C-(CF_n)₄, respectively. These changes are consistent with damage to the carbon backbone of the Teflon polymer causing molecular weight degradation, new chain terminations, branching, and crosslinking through free radical reactions. The solar ultraviolet (UV) radiation exposure of the LDEF surfaces is thought to have caused this FEP surface degradation. The FEP surfaces were also exposed to the stress of about 34,000 thermal cycles, but the maximum temperatures calculated for Ag/FEP blankets on LDEF are less than 0°C (Ref. 3) and not sufficient to break chemical bonds. Exposure of FEP to the XPS x-ray source for several hours induced similar shifts in the C1s spectrum; almost all of the FEP C1s spectra used for curve-fitting in this study were acquired during the first minute of sample exposure to the x-ray source to minimize surface degradation from the analysis itself. A recent study of the degradation of polytetrafluoroethylene (PTFE) Teflon by 3 keV electrons showed very similar XPS C1s spectra changes to those seen in Figure 9b as a function of electron irradiation and subsequent heating to drive off volatiles (Ref. 4). Degradation of the PTFE was attributed to the type of damage described above.

Figure 9. XPS spectra of the C1s region from Ag/FEP blanket surfaces.
a. D7 blanket surface. Characteristic of clean FEP.
b. B5 blanket surface. Characteristic of degraded FEP.
c. F4 blanket surface. Characteristic of contaminated, degraded FEP.
d. F2 blanket surface. Characteristic of heavily contaminated FEP.
