## Task Order 2 Enhanced Preliminary Assessment

KAPALAMA MILITARY RESERVATION  
HONOLULU, HAWAII

February 1990

USATHAMA Task Order 2  
ENHANCED PRELIMINARY ASSESSMENT REPORT

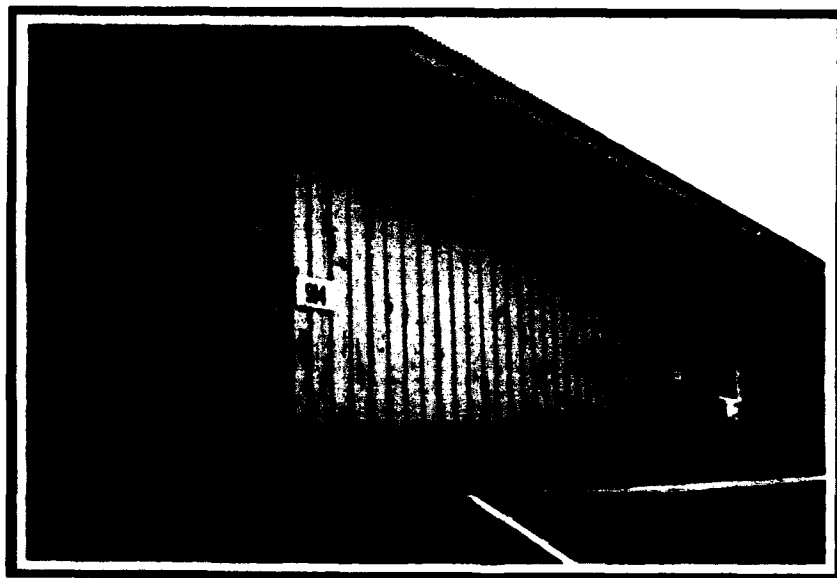
**GENERAL CONDITIONS OUTSIDE OF BUILDINGS (CONTINUED)**

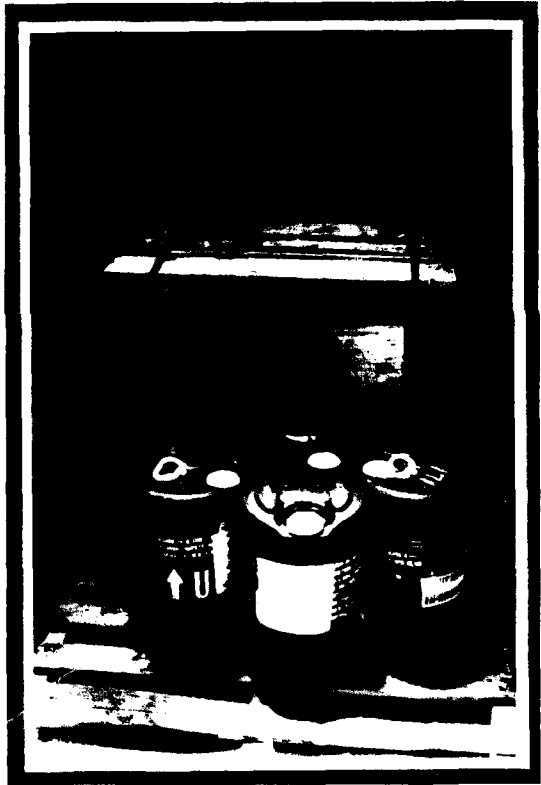
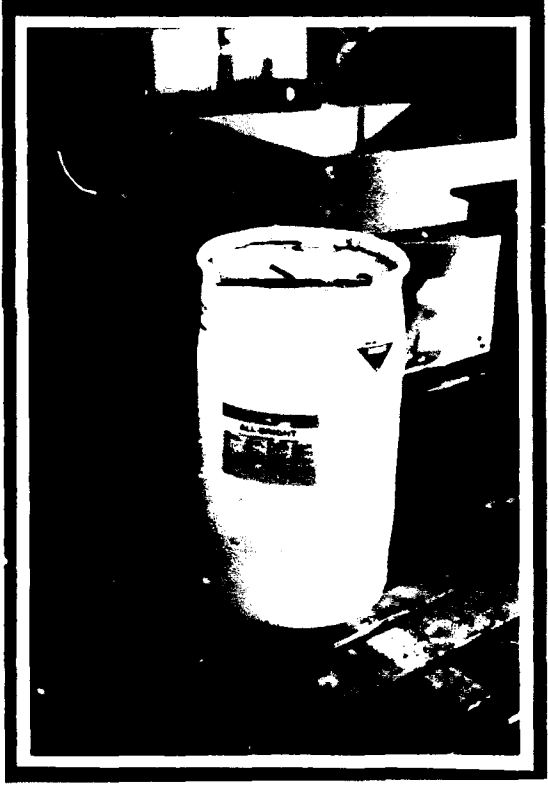
11. Battery Acid

12. Caustic Cleaner

CONTENTS OF BUILDING 917

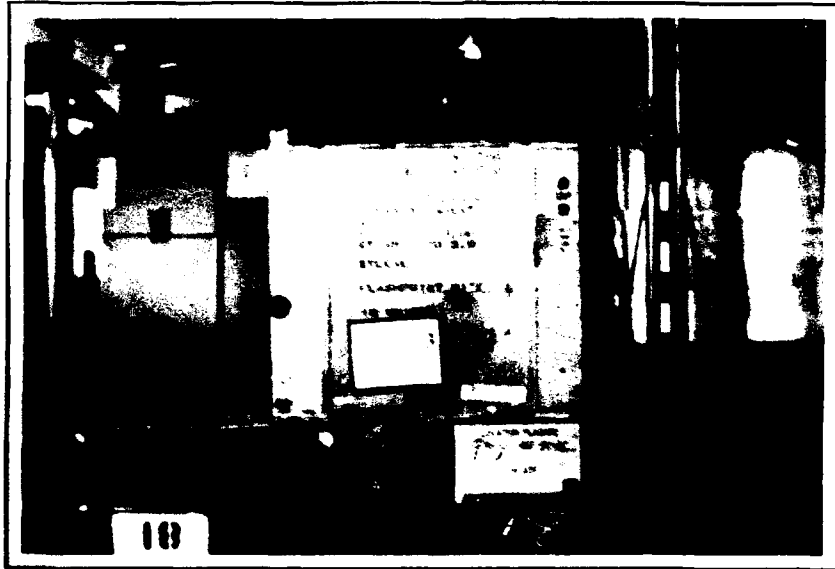
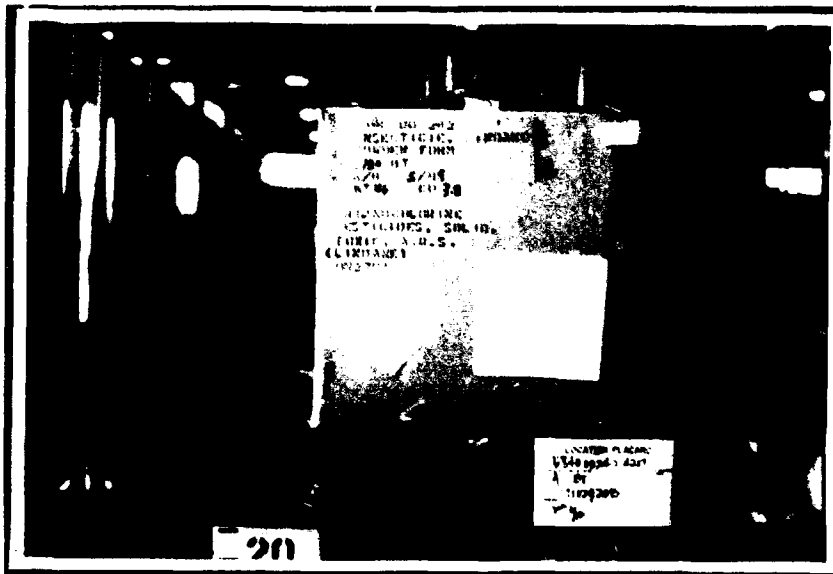
**13. Aromatic Solvents**

**14. Pesticides**

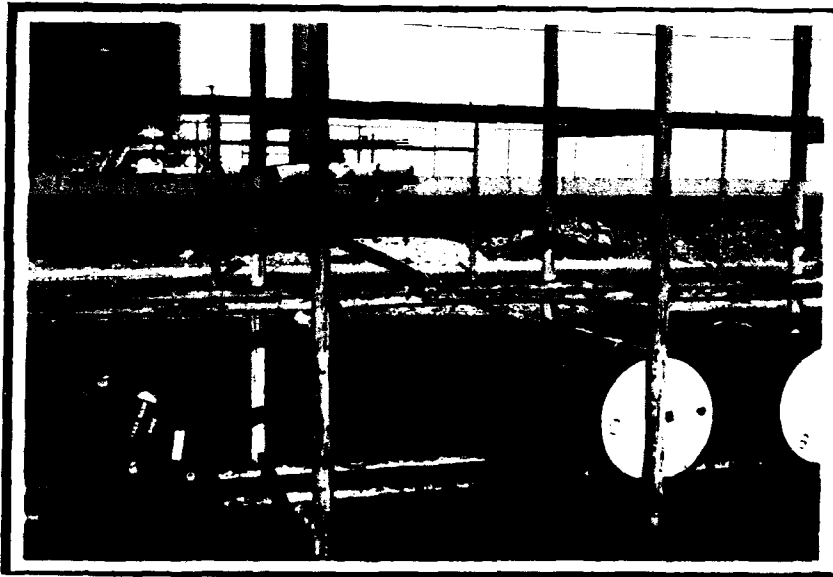
**DRUM STORAGE AREAS NEAR SAND ISLAND ROAD**

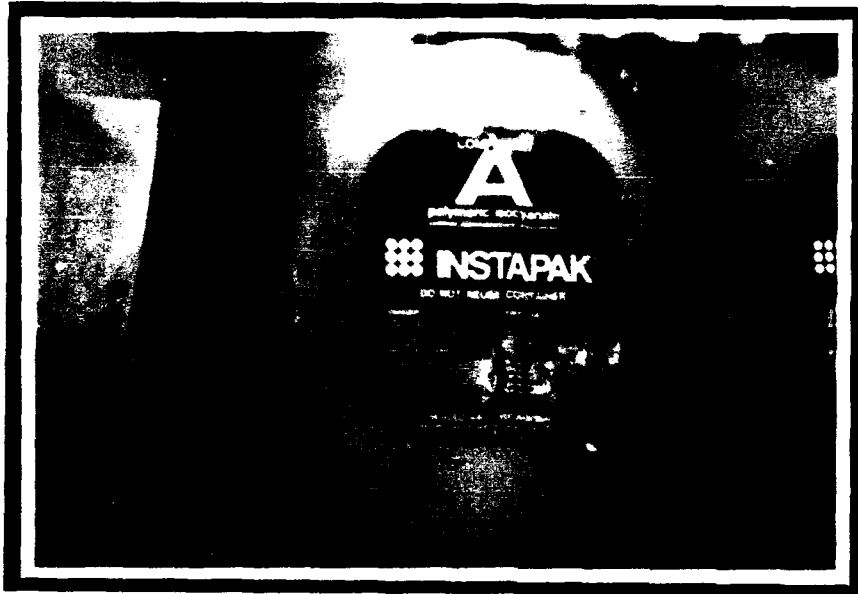
- Building 924 - Canvas Repair Area & Packaging Area - waterproofing with polymer-type water repellents; packaging with isocyanate foam; "waste oil" drums (apparently empty) on pallet outside building.

**FOAM PACKAGING AREA, BUILDING 924**

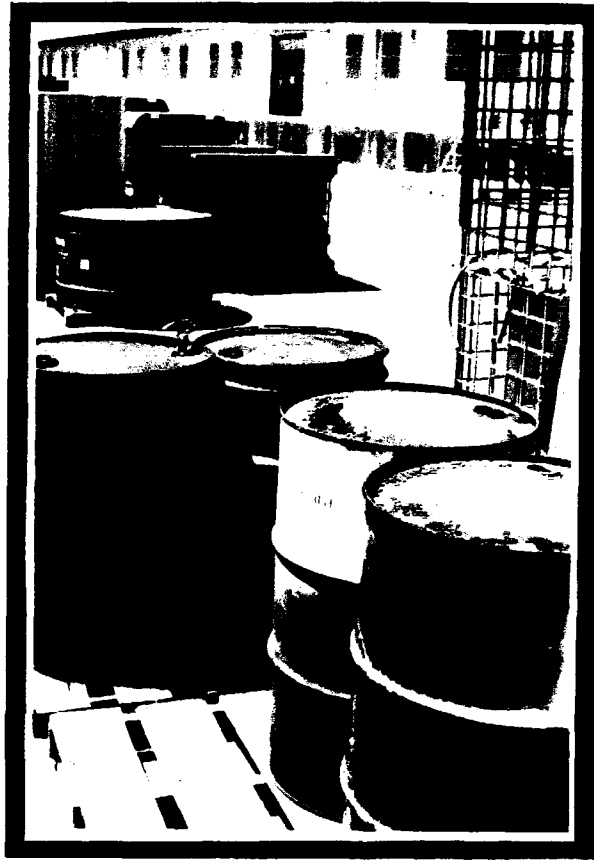
**29. RUSTED DRUMS OUTSIDE BUILDING 924**

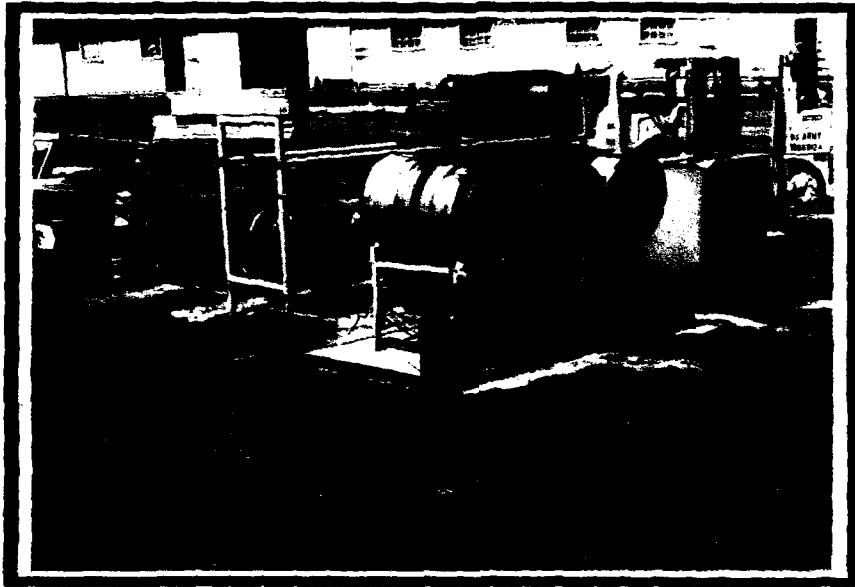
- Building 925 - Maintenance & Repair of Forklifts - oils, greases, solvents, and hydraulic fluids used in the repair and maintenance of forklifts in an area adjacent to the building.

**FORK LIFT MAINTENANCE AREA, BUILDING 925**

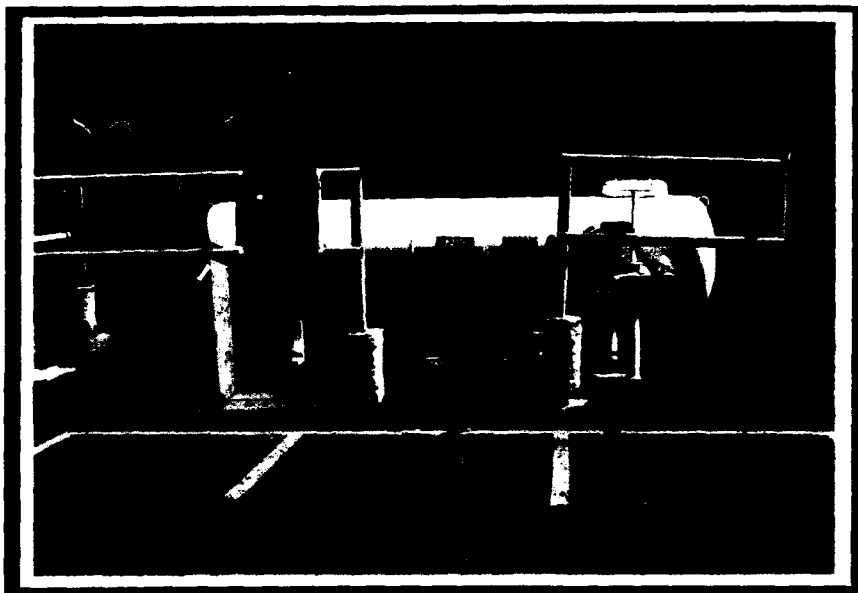
- approximately 300-gal kerosene tank adjacent to a grassy area.
  - 5,000-gal propane tank adjacent to Building 925.
  - 500-gal propane tank adjacent to Building 921 reported by personnel but not observed during site visit; 150-gal propane tank adjacent to Building 922.

**41. PROPANE STORAGE TANK NEAR BUILDING 925**

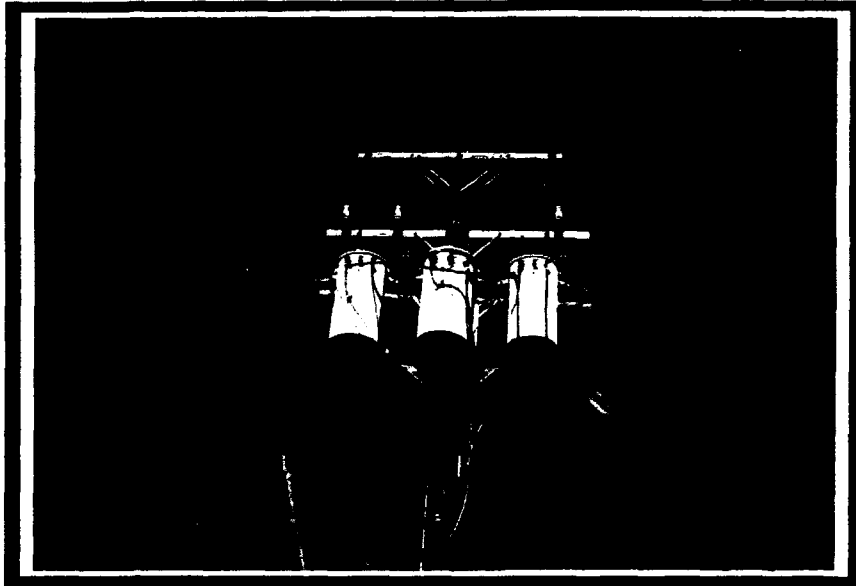
- Transformers - approximately 40 transformers, two pad mounted, the remainder pole mounted. Fluids have not been tested for polychlorinated biphenyls (PCBs) content. Two apparent minor leaks observed.

**TRANSFORMERS**

All transformers on the property potentially contain PCBs and two of them appear to have leaked in the past. An inventory should be made of all transformers remaining on the property (except Phase I), and each transformer should be sampled for PCBs.

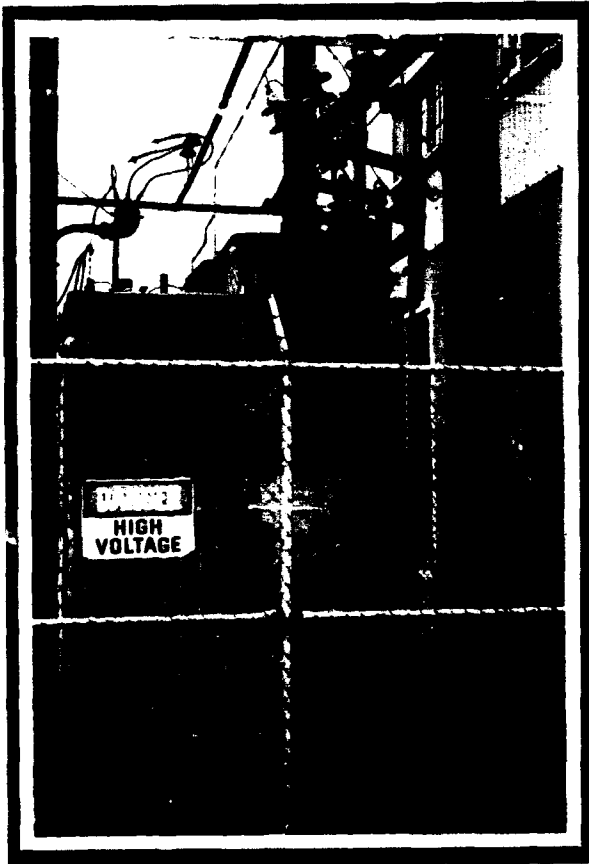
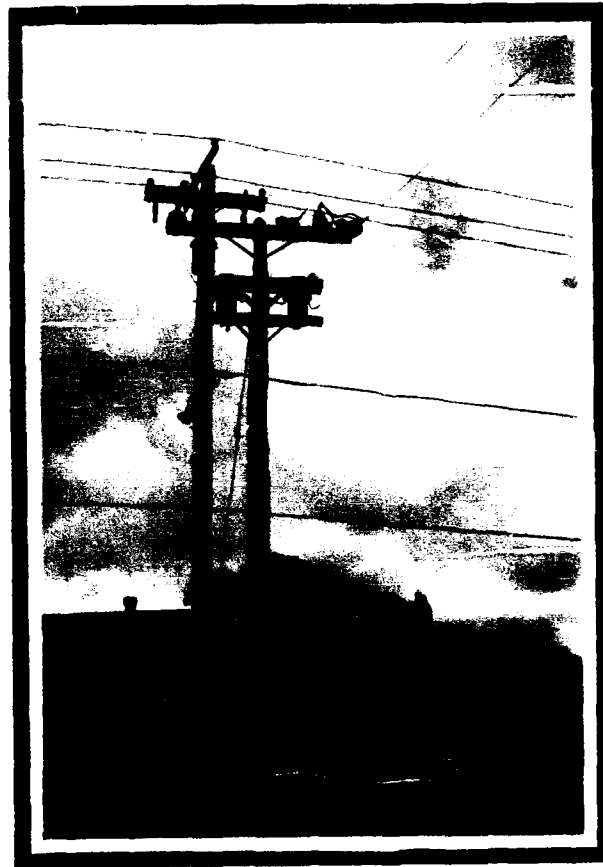
**TRANSFORMERS**
