MTL TR 92-39

FAILURE ANALYSIS OF THE MAIN ROTOR RETENTION NUT FROM THE AH-64 HELICOPTER

MILTON LEVY, PAUL BUCKLEY, JOHN BEATTY,
RICHARD BROWN, ROBERT HUIE
U.S. ARMY MATERIALS TECHNOLOGY LABORATORY
METALS RESEARCH BRANCH

June 1992

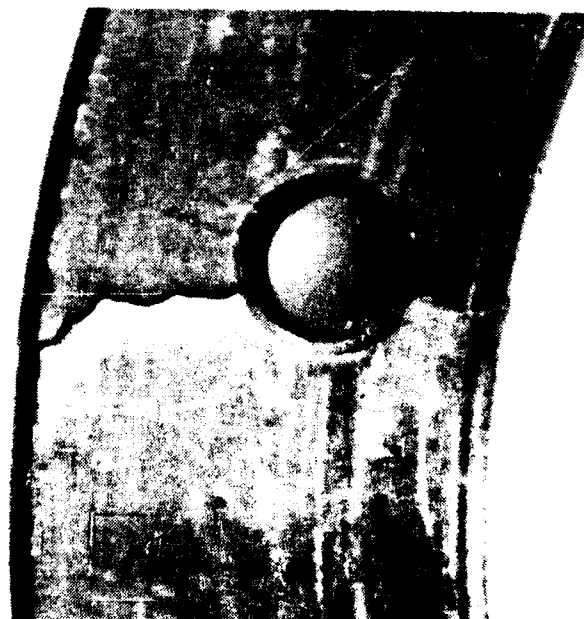
In the fall of 1989, upon inspection, one nut was found cracked, as shown in Figure 2a and 2b, (nut 0223). Subsequently, a Safety of Flight message was issued and a fleetwide inspection was carried out. A total of 10 nuts were reported as cracked, of which eight were confirmed. Two of these 10 nuts were found to be defect free upon re-examination in the laboratory. All the cracked nuts belonged to a *discrepant batch* heat 6644-A, Serial Nos. 0212 through 0226. These nuts were supplied to McDonnell-Douglas Helicopter Co. (MDHC) by FENN Manufacturing. The discrepant batch was forged by Teledyne Vasco. The drawing calls for a ring rolled microstructure. However, Teledyne Vasco reports indicated that ring rolling was not performed. The forged nuts were machined by McMellon Bros. Inc., and vacuum cadmium plated by Vacuum Deposited Coatings, Inc. per HP4-22. During the manufacture of the discrepant batch, hardness measurements (required for flight critical parts) were inadvertently omitted. Since this discovery was made after the cadmium plating operation, these nuts were sent to Westfield Electroplating for stripping of the cadmium by an ammonium-nitrate process. The cadmium stripping process renders the nuts prone to corrosion. The bare nuts were supposed to be protected with a corrosion prevention compound until they were replated. However, this operation was inadvertently left out for a few nuts, and verbal reports of isolated corrosion have been noted during the hardness measurements.

Figure 2. (b) Bottom view of main rotor retention nut 0223 showing crack transversing the thickness of the nut at a bolt hole. Note corrosion and wear evidence by the discolored regions.

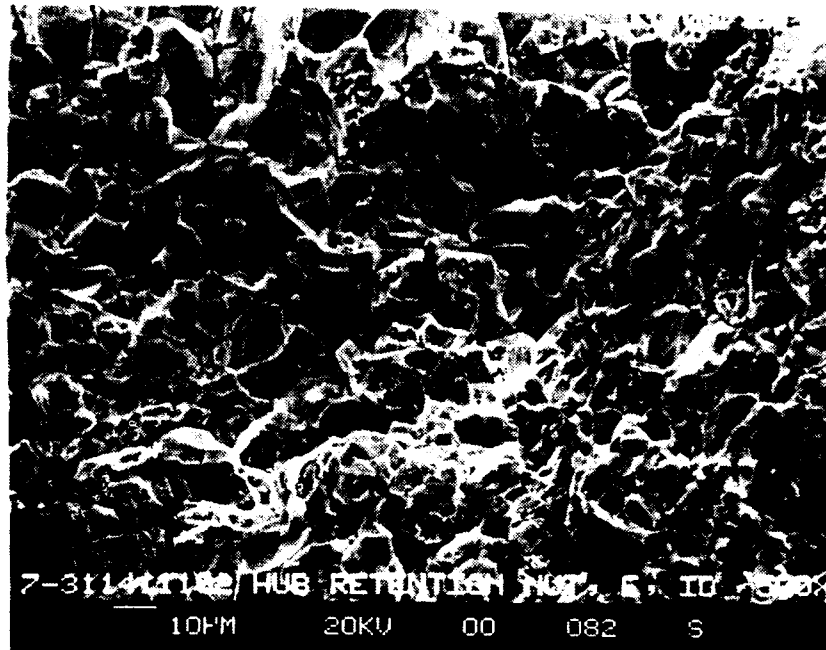
One of the cracked nuts (5TH-0223) was examined by MDHC and preliminary findings indicated the cause of failure to be hydrogen-assisted cracking as shown in Figure 3. The source of hydrogen was believed to be the result of a corrosion reaction in the field. MTL received the unused portion of this nut to perform a thorough failure analysis. During the course of investigation it became clear that additional factors were involved and efforts were directed towards determining if the problem was generic or isolated to a single batch. To that end, five additional nuts were received by MTL for examination and tests. Nuts 0223, 0257, and 0250 were from the discrepant batch. Nuts 0845, 0338, and 1202 were from other lots and showed no cracking.

Figure 3. McDonnell-Douglas SEM examination of fracture surface of nut 0223 indicating hydrogen-assisted cracking by the appearance of an intergranular crack path.

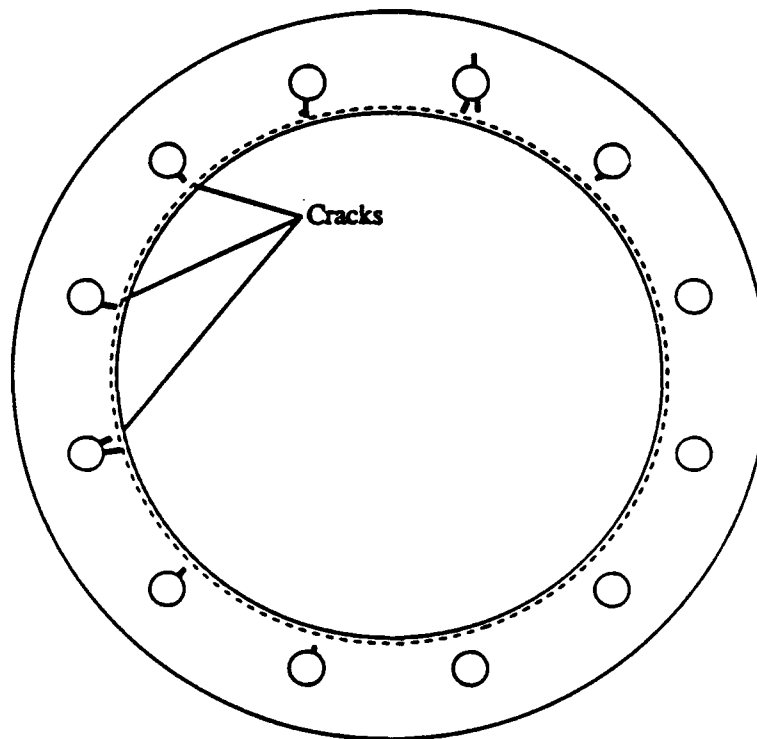
The retention nuts shipped to MTL were examined for irregularities and the presence of cracking. Nuts examined by MTL from heat 6644-A showed radial cracks emanating from one or more bolt holes. Figure 4 shows a schematic of nut 0257 and the locations of the radial cracks; additional typical cracks are shown in Figure 5. The radial direction of crack growth demonstrates that hoop stresses were the primary crack driving force. One nut examined, 0223, had experienced a complete fracture from the growth of one radial crack which, upon closer examination, showed the crack originated from the base of a thread root.

Figure 4. Schematic of main rotor hub retention nut 0257 with position of radial cracks emanating from bolt holes shown.

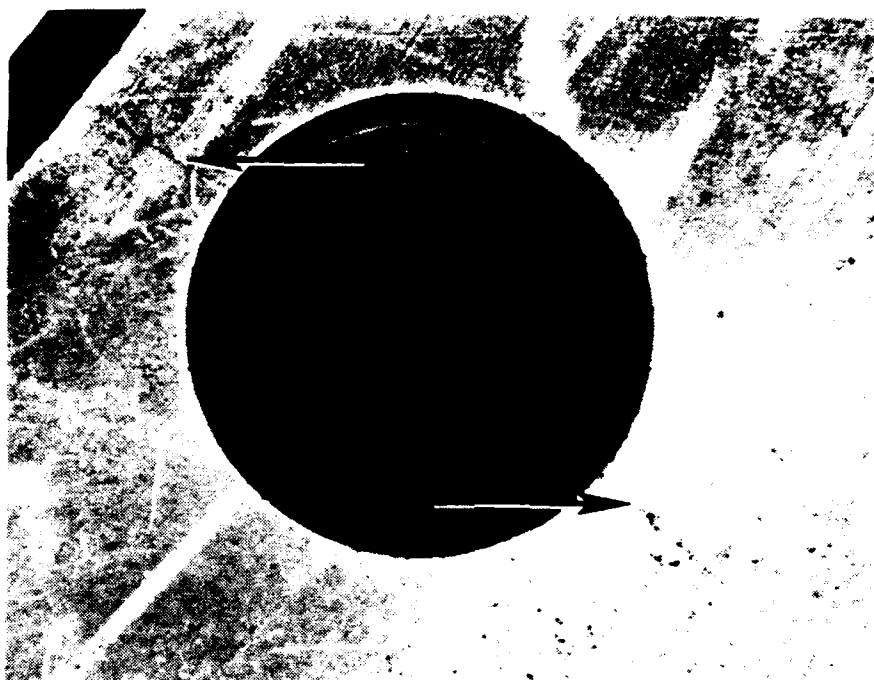
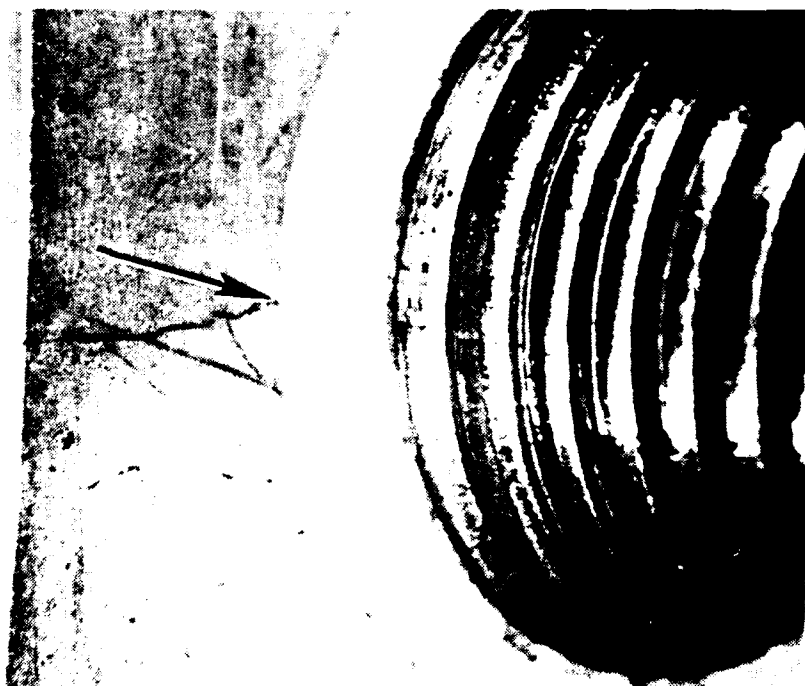
Figure 5. Optical micrographs of typical cracks emanating from bolt holes. Arrows denote location of cracks. (a) Mag. 7.5X., (b) Mag. 15X.

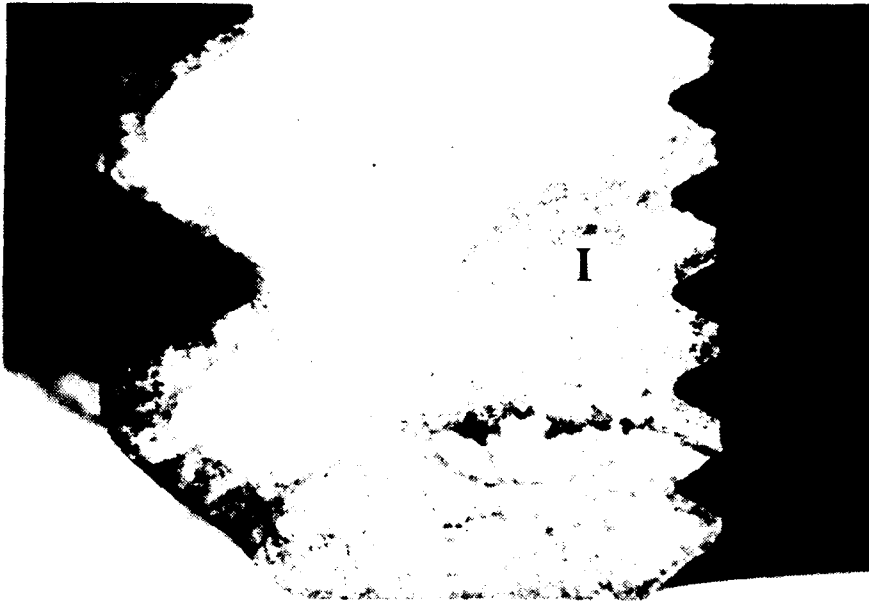
Optical and scanning electron microscopy (SEM) were utilized to examine the fracture surfaces of the radial cracks. Where necessary, samples were sectioned from the retention nuts and loaded in a three-point bend fixture to separate the crack faces for observation. Figure 6 shows an optical photograph of a typical crack from nut 0257 opened with the three-point bend apparatus.

Figure 6. Optical photograph of crack from nut 0257. The region marked "I" shows intergranular fracture. The rest of the fracture was subsequently formed by opening the crack with the three-point bend apparatus. Mag. 15X.

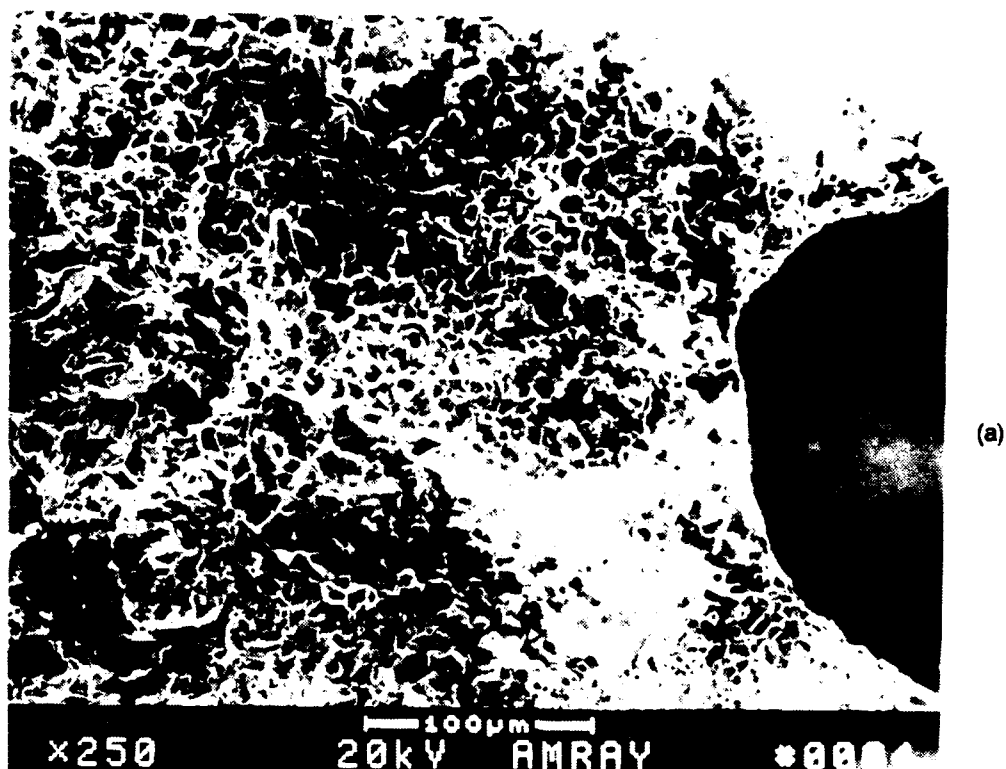
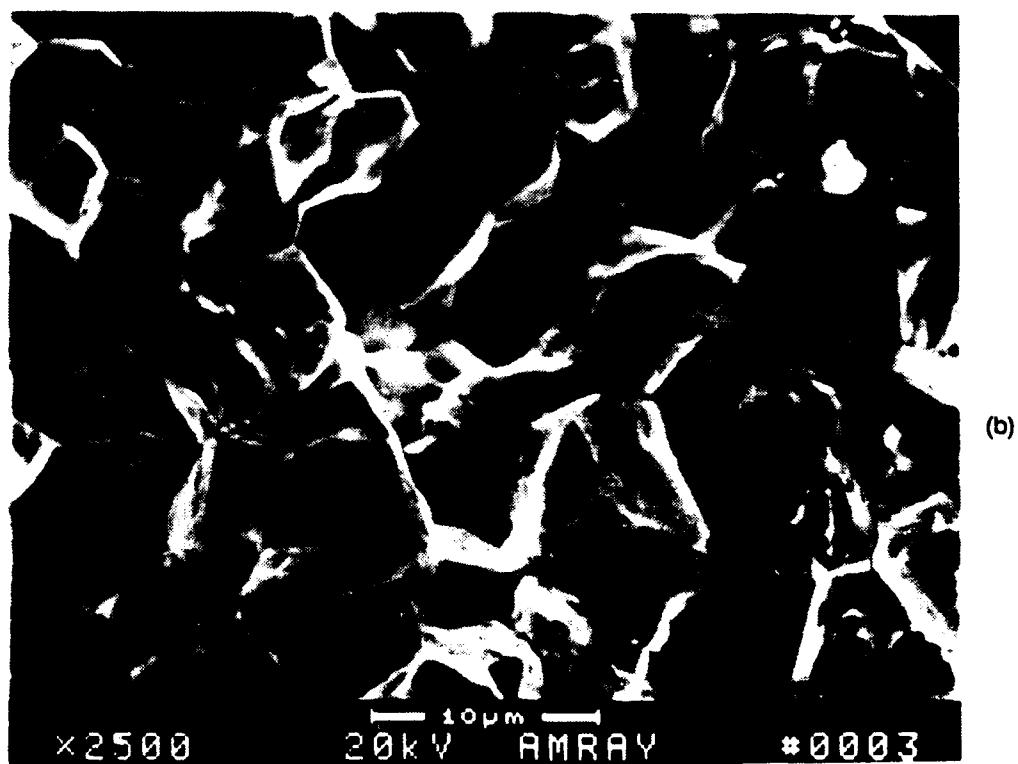
At higher magnification in the SEM two distinct regions of crack growth can be observed; near the origin the crack has a faceted, intergranular appearance signifying hydrogen embrittlement or hydrogen-assisted stress corrosion cracking, while farther away from the origin the final failure produced a dimpled appearance typical of ductile tensile failure though some cleavage areas were present. Small transition regions exist between these areas where the fracture appearance is mixed. The fracture appearance is the same as reported by McDonnell-Douglas in their analysis¹. The smaller, incomplete cracks (Figures 6 and 7) all showed intergranular fracture regions. The ductile dimple topology was due to the fast fracture subsequently induced by the three-point bending apparatus.

Figure 7. SEM micrographs showing origin of crack from Figure 4.
(a) Origin near thread root at Mag. 250X. (b) Close-up view of origin of crack depicting the intergranular nature of the crack.

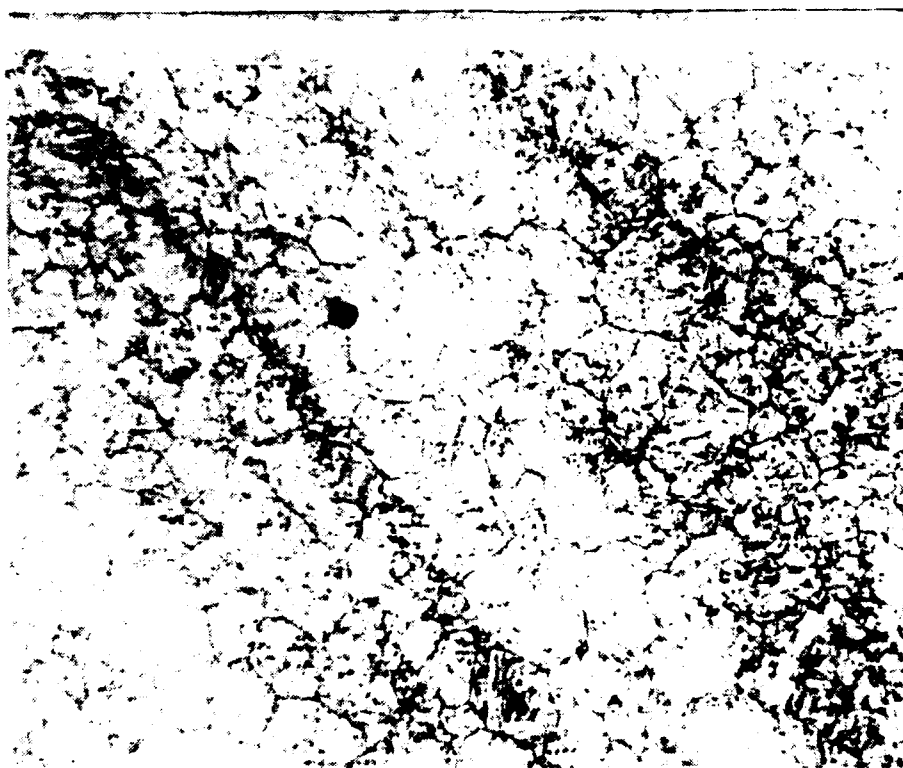
The microstructure of the C-250 steel used in the retention nuts is martensitic, as shown in Figure 9. The presence of *banding* was noted in several cases. Banding is caused by segregation of alloying elements, usually Ti and Mo in maraging steels, in the original ingot and is usually present to some extent in most commercial steels. Upon further working of the ingot the areas of segregation are deformed or compressed into thin bands. Etching reveals this microsegregation as alternate *bands* of light and dark areas. Figure 10 shows the micro-structure from nut 0250; appreciable banding can be seen. Banding was also detected to a lesser degree in nuts 1202 and 0845. These bands can produce variations in local mechanical properties most often detected by reduced values of elongation at tensile failure. The cadmium coating was also examined using standard metallographic techniques.

Figure 9. Micrograph showing the typical microstructure for the C-250. The structure consists of aged martensite, banding is apparent. Nital etch. Mag. 50X.

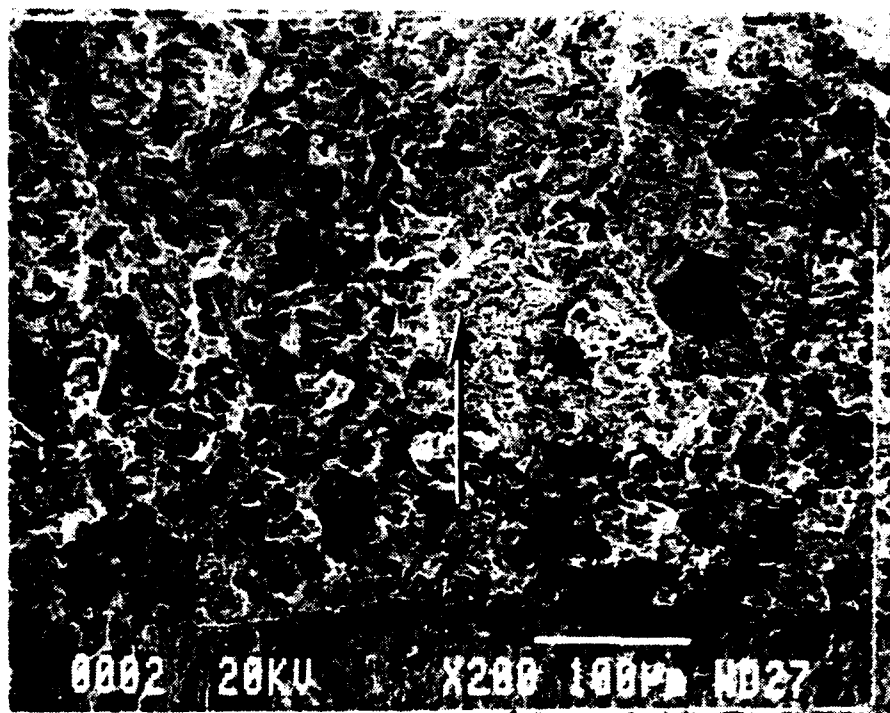
from the other nut. Figures 13 and 14 show fractographs from samples tested at -0.8 V that were made from nut 0250 (heat 6644-A) and nut 0845, respectively. Sample 0845-24 showed transgranular crack growth while sample 0250-CU2 from heat 6644-A showed a combination of intergranular crack growth and ductile crack growth. The intergranular regions occur in long *bands* in the direction of crack growth, alternating with ductile regions. The size and orientation of the intergranular/ductile regions matches the banding found metallographically. An attempt was made to determine the degree of alloy segregation in the bands using energy dispersive X-ray analysis in a SEM, but no measurable difference was apparent.

Figure 13. SEM micrographs of the fracture surface of K_{1SCC} specimen taken from nut 0250 and tested at -0.8 V versus SCE. Crack growth direction is noted. Alternating regions of intergranular and ductile crack growth can be seen. These regions match the size and orientation of the bands depicted in Figure 8. (a) Low Mag. (b) High Mag.

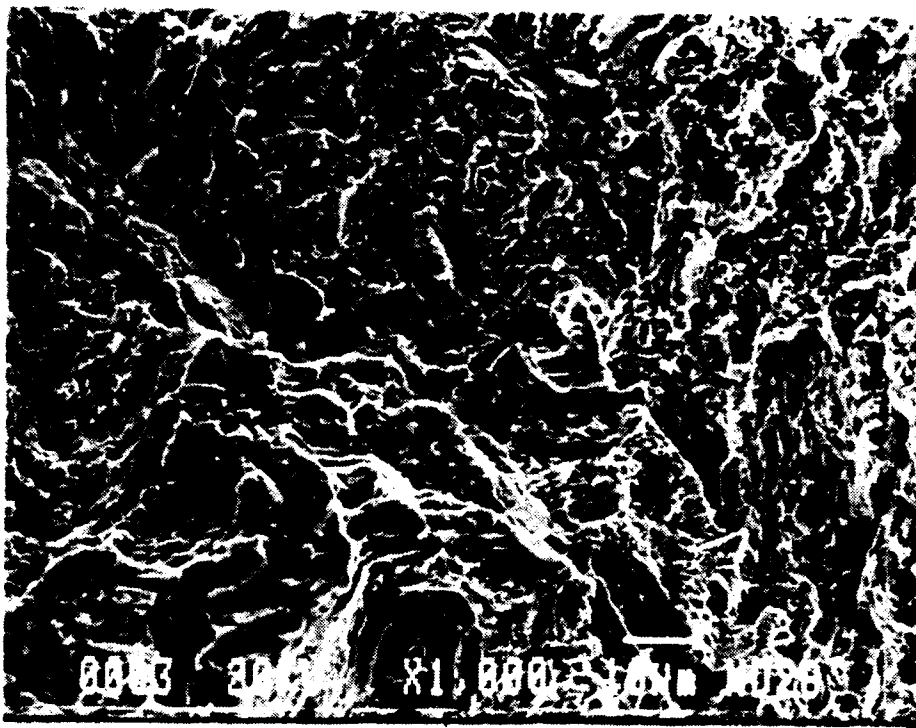
Figure 14. SEM micrographs of the fracture surface of K_{ISCC} specimen taken from nut 0845 and tested at -0.8 V versus SCE. Note transgranular crack growth.
