WL-TR-92-3069

ADD-ON DAMPING TREATMENT
FOR THE F-15 UPPER-OUTER
WING SKIN

JULY 1992

FINAL TECHNICAL REPORT FOR PERIOD 1 JANUARY 1989 TO 28 FEBRUARY 1991

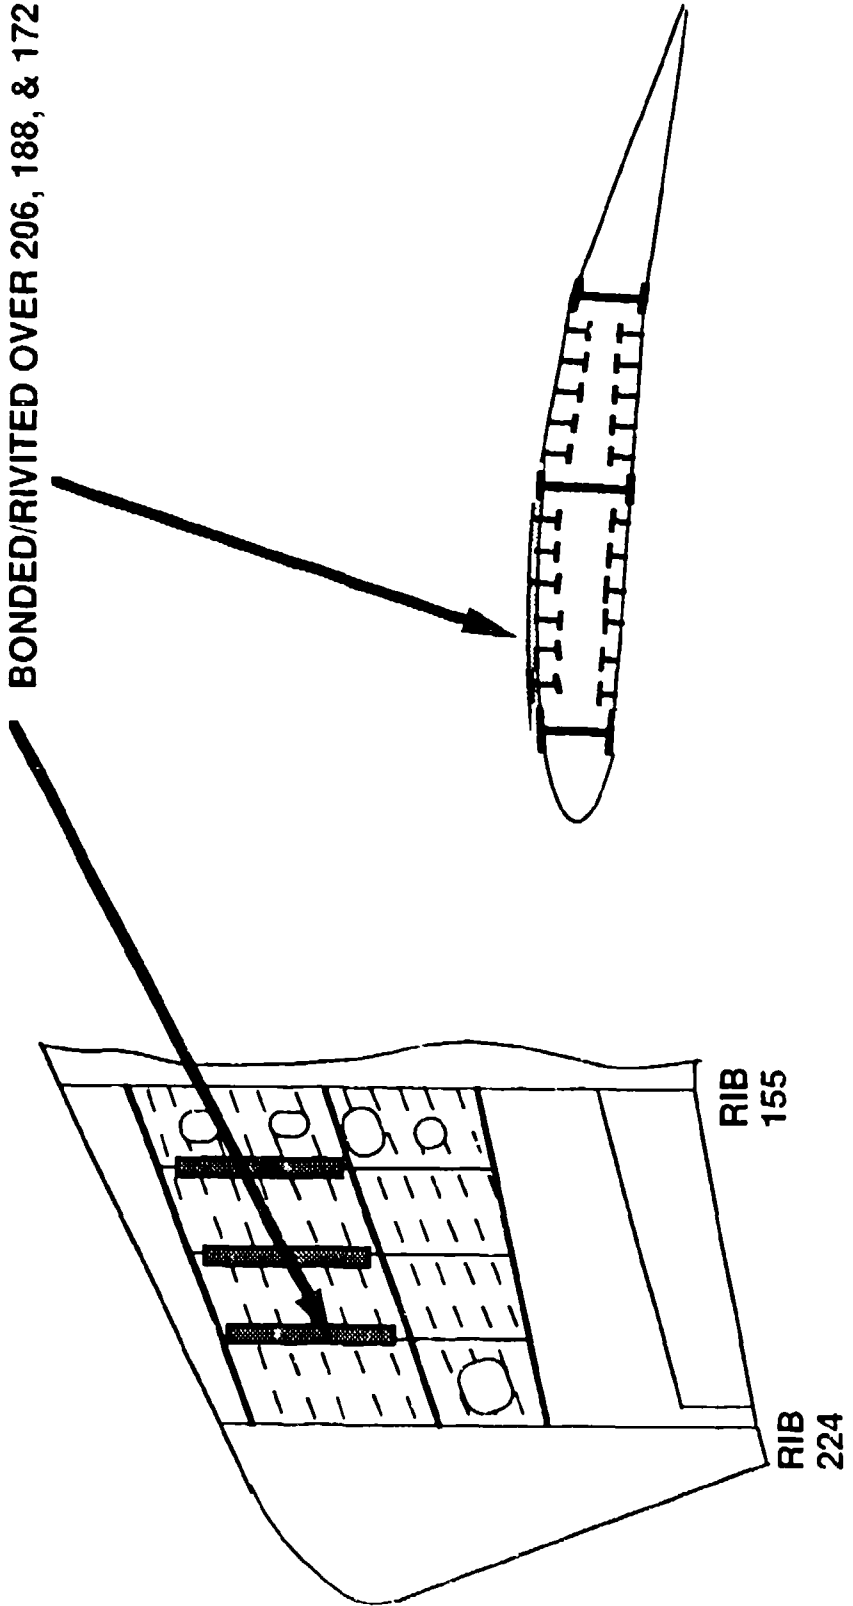
FIELD INSTALLED STAINLESS STEEL STRAPS TO EXTEND SERVICE LIFE

5 INCH WIDE BY 1/8 INCH THICK STRAPS BONDED/RIVITED OVER 206, 188, & 172 RIBS

Figure 5. Detail of External Straps

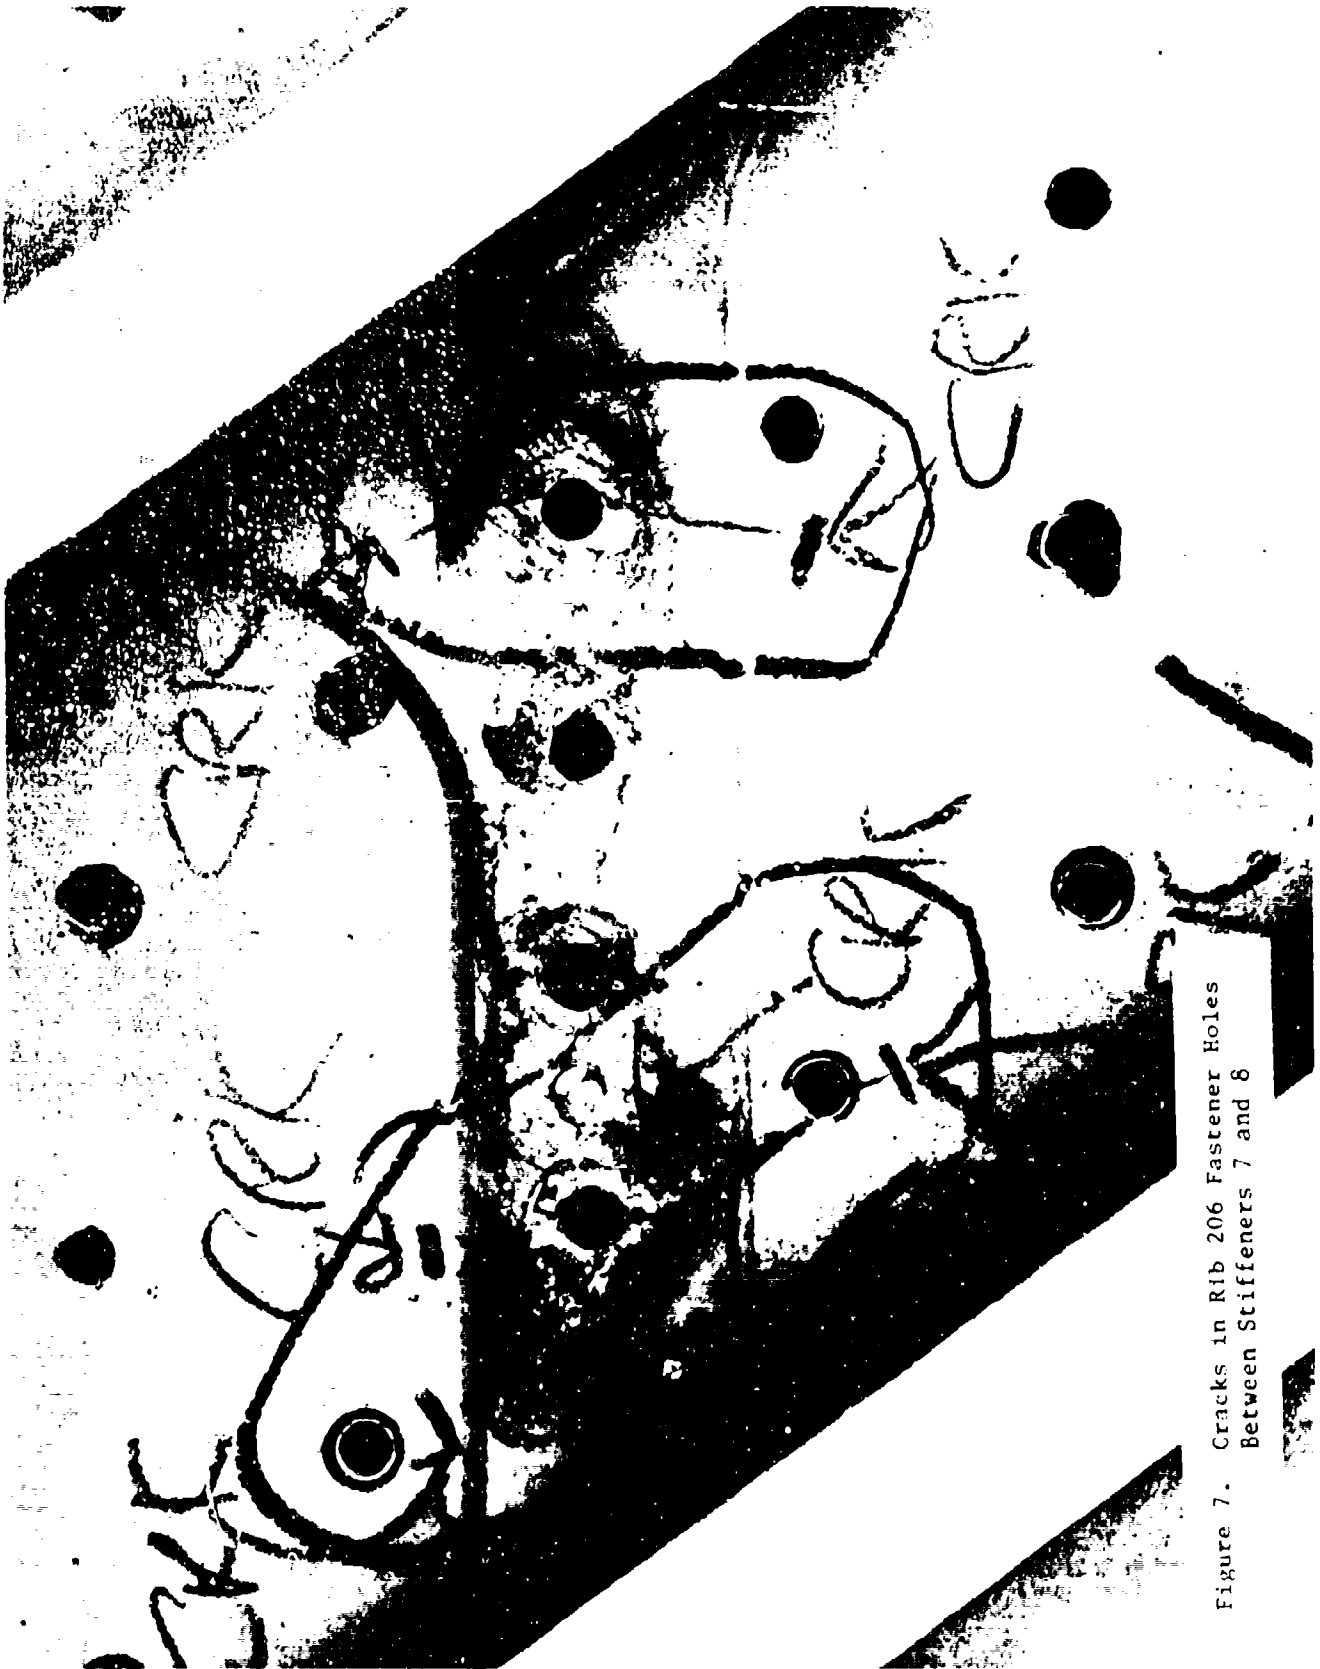
Figure 7. Cracks in Rib 206 Fastener Holes
Between Stiffeners 7 and 8

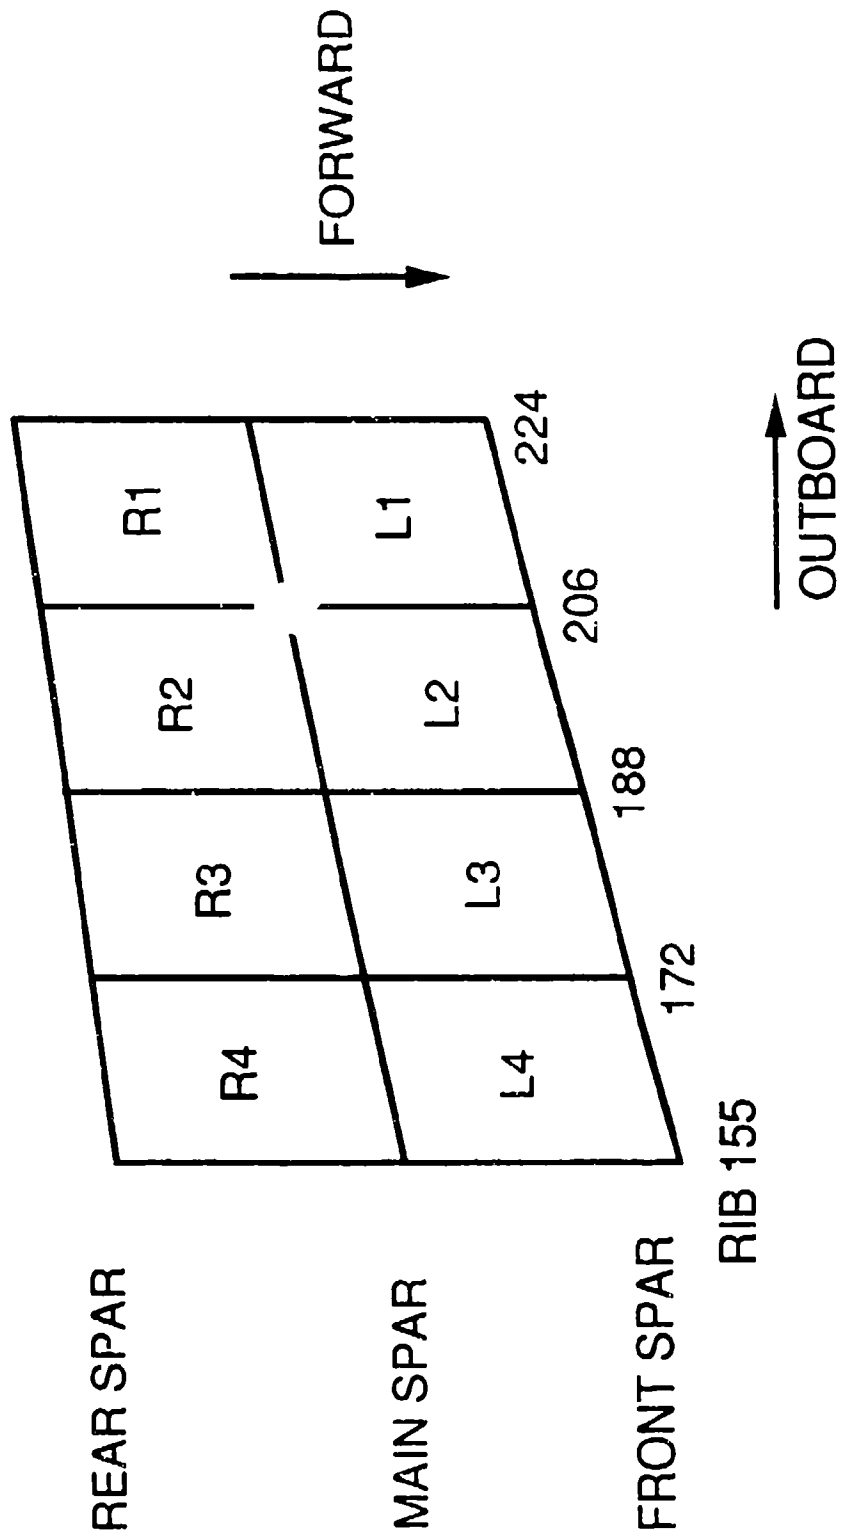
Figure 9. Spar-Rib Bay Designation

The locations where UOWS fatigue cracks were observed evolved during the course of this investigation. Initially, the concern was for the web of stiffener 4 in bay L1 (see Figure 9) and over rib 206 between bays L1 and L2. Next, it was observed that cracks also occurred over rib 188 between bays L2 and L3. Finally, it was learned that cracks occur over ribs 188 and 206 between the main and rear spars. Ribs 188 and 206 themselves crack, but were not specifically addressed in this study. The reinforcements around the numerous access panels in bays L4 and R4 result in a significantly heavier structure and made this area less susceptible to fatigue cracking. Thus, with the exception of bays L4 and R4, high cycle fatigue cracks were observed over the entire UOWS panel.

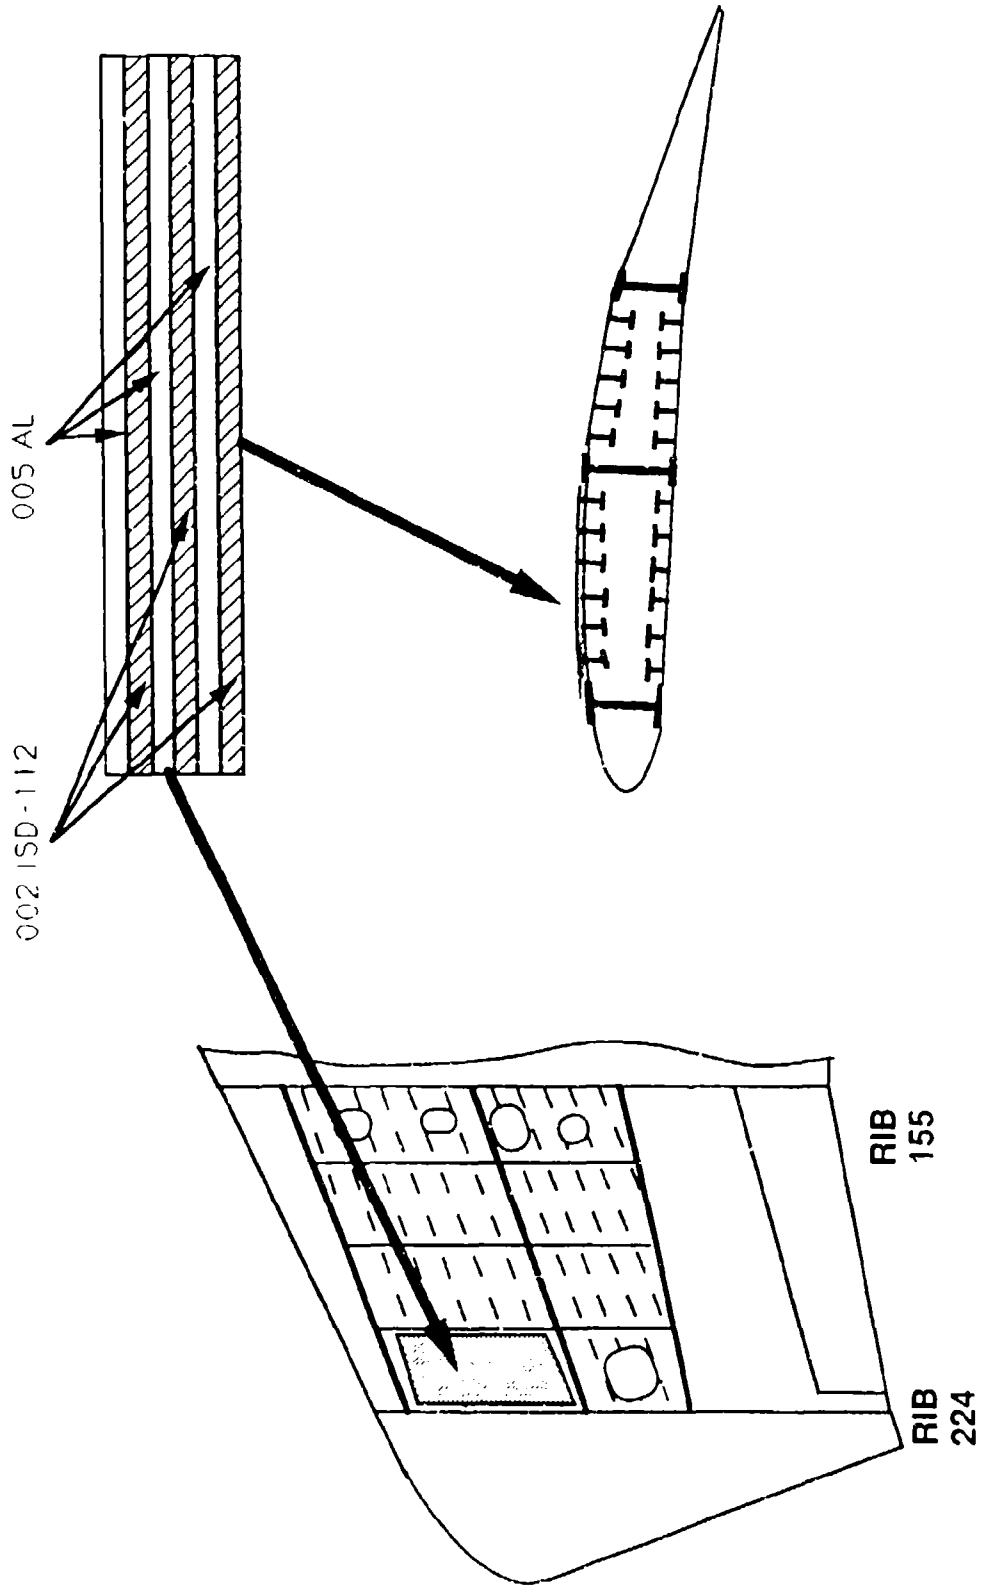
Figure 37. "1980 Damping Treatment"

A previous attempt by MCAIR to correct the UOWS fatigue cracking included the application of a multiple constrained-layer damping treatment referred to as the "1980 Damping Treatment." The treatment was applied externally over bay L1 of the skin (see Figure 9) because at the time, the fatigue cracks were considered to occur only in this outer spar-rib bay. It consisted of three constrained layers, each containing a 0.002 inch layer of ISD-112 VEM and a 0.005 inch layer of aluminum. Figure 37 illustrates the "1980 Damping Treatment" which for this investigation was denoted Test Configuration 1 (TC1). Figure 38 is a photo of the "1980 Damping Treatment" installed on an F-15 wing. Note the ramp of sealant around the circumference of the treatment to protect the edge from the air flow and prevent moisture from getting under the treatment. After paint is applied to the top constraining layer and the sealant, the damping treatment is barely noticeable. The "1980 Damping Treatment" was installed and flown on numerous operational F-15 aircraft but it proved to be unsuccessful in eliminating the UOWS fatigue cracks.

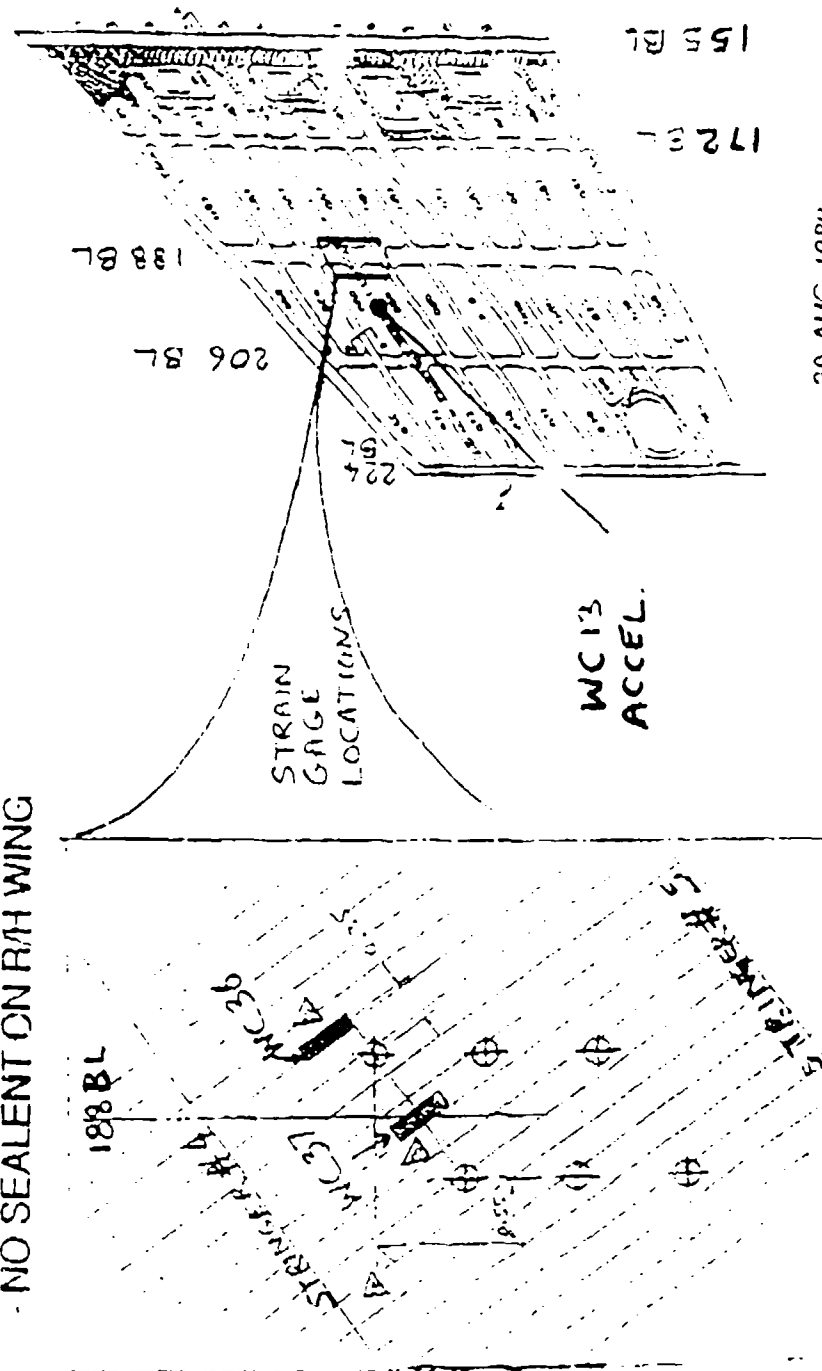
Figure 47. Strain Gage Locations for Flight Test

The location and orientation of these strain gages were such that the strains inducing the fatigue cracks should be measured. Historically, many cracks have been discovered along stiffener #4. Based on past analyses, it was observed that the response data obtained at the intersection of stiffener #4 and rib 188 could be used to represent the response over the remaining panel. Thus, the analysis performed centered on the UOWS response measurements taken at this location.

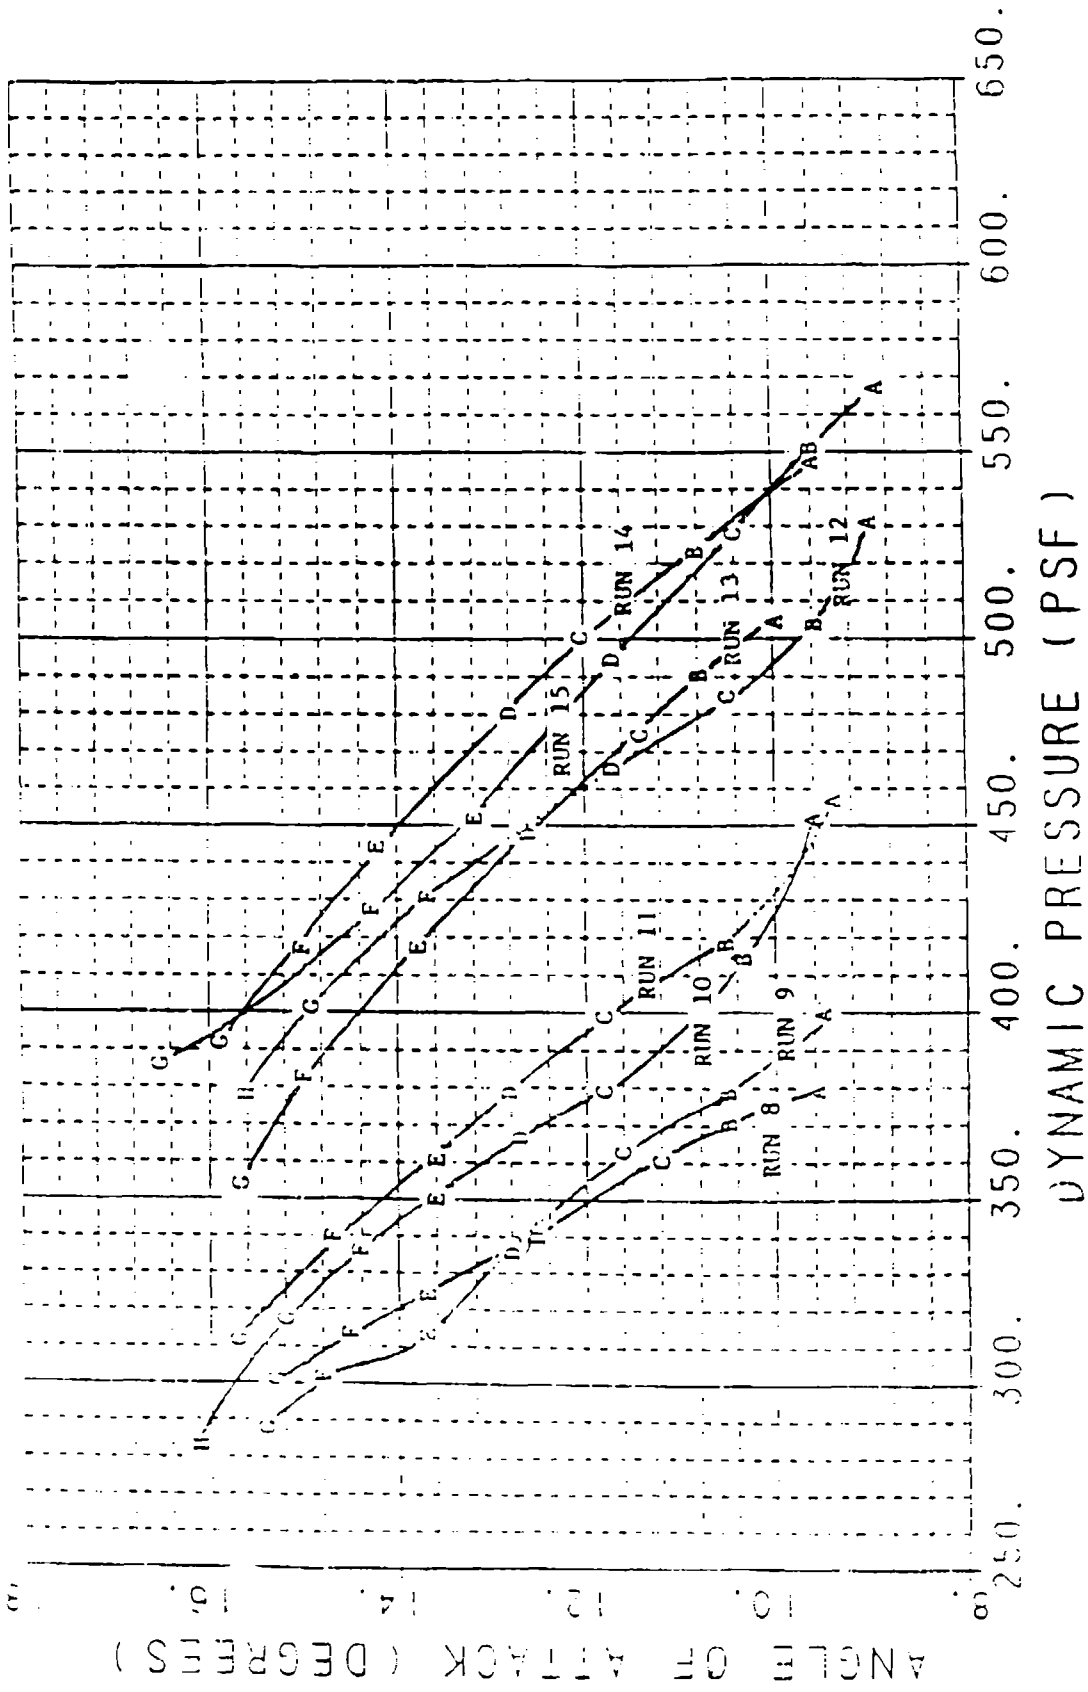
Figure 48. Typical Flight Conditions

A plot of angle-of-attack (AOA) versus dynamic pressure is given in Figure 48 for typical flight conditions for which high load factor maneuver data were gathered. The range of dynamic pressure, q of 350 psf to 500 psf, for the 12° AOA shown in this plot illustrates the difficulty, if not impossibility, of duplicating the service conditions for which damage is induced. The power spectral density (PSD), shown in Figure 49, was typical of the UOWS response at the strain gage locations shown in Figure 47 for an undamped panel. The flight conditions for this PSD were: 11° AOA,
