WL-TR-92-4017

X-RAY COMPUTED TOMOGRAPHY FOR FAILURE ANALYSIS

Boeing Defense & Space Group
P.O. Box 3999
Seattle, WA 98124

Interim Report for Period May 1991 to January 1992

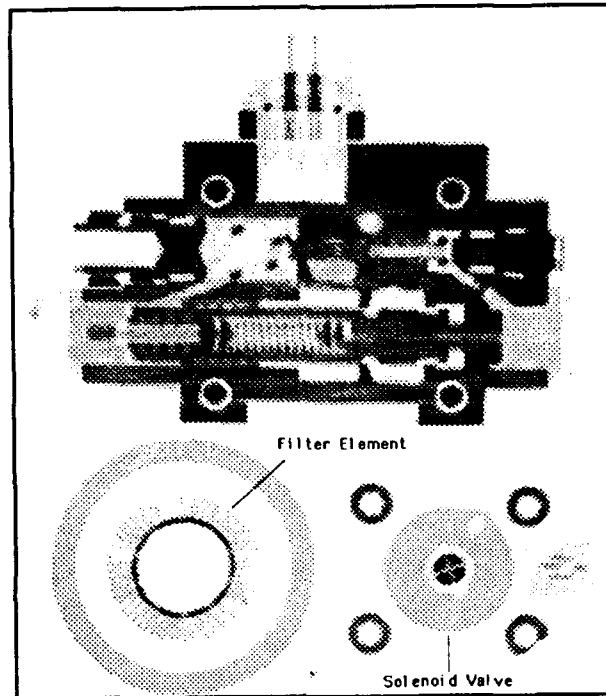
An autobrake unit, that was experiencing out-of-specification hydraulic pressure response, was evaluated radiographically, but the images contained a confusion of features with very poor sensitivity to internal detail. Digital radiography (DR) was also performed on the unit and compared to the film radiograph the DR was clearly superior for this analysis. However projection radiography of a complex component is not sufficient and in fact showed convincingly that CT or disassembly would be required to determine the failure mechanism of this assembly.

CT specifically provided the analyst direct evidence the spring was clearly not in the detent. This cannot be determined with certainty from any other nondestructive technique. Because disassembly causes the spring to float free when the end of the servovalve portion of the unit is removed, even disassembly of the unit would force the analyst to rely on the indirect evidence of scratches and rub marks.

Figure 3.1-4 CT slice through the autobrake module at the height of the pressure control servovalve.

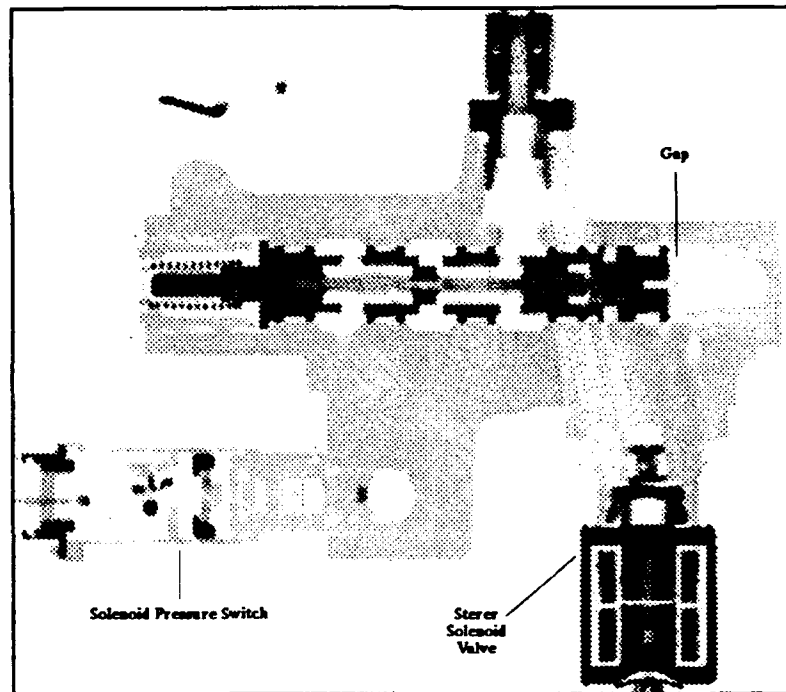
The problem experienced with this type of unit was incomplete shutoff and seemed to indicate a problem with the shutoff valve assembly. Figure 3.2-3 is a breakout drawing of the shutoff valve assembly. Previous experience with X-ray radiography of this part has shown that the part is too complex to use a radiograph for investigation purposes. CT provides a means to observe the internal detail of the shutoff valve without the confusion of the complex externals. The autobrake module was brought to a medium resolution CT facility for nondestructive evaluation. A digital radiograph was taken, and CT slice heights were then selected to inspect the suspect shutoff spool valve and the other control spool valves. The first CT slice, in Figure 3.2-4 and the enlargement of the spool image in Figure 3.2-5, show that the shutoff spool valve had not returned to its seated/deenergized position. Subsequent slices clearly showed the capability to inspect the other areas of interest in the assembly. A strong possibility exists in the process of disassembly that the valve would have seated leaving no clear evidence of the failure.

Figure 3.2-4 CT slice through the autobrake module at the height of the pressure control servovalve.

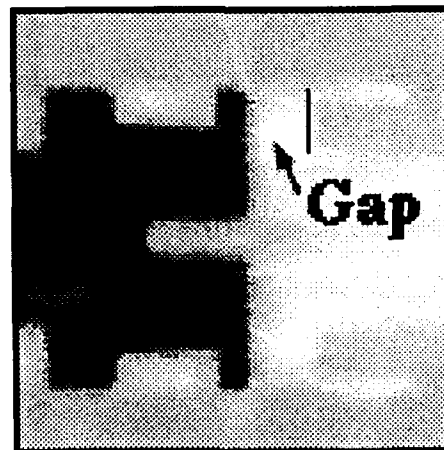
Figure 3.2-5 Enlargement of the shutoff spool valve showing gap.

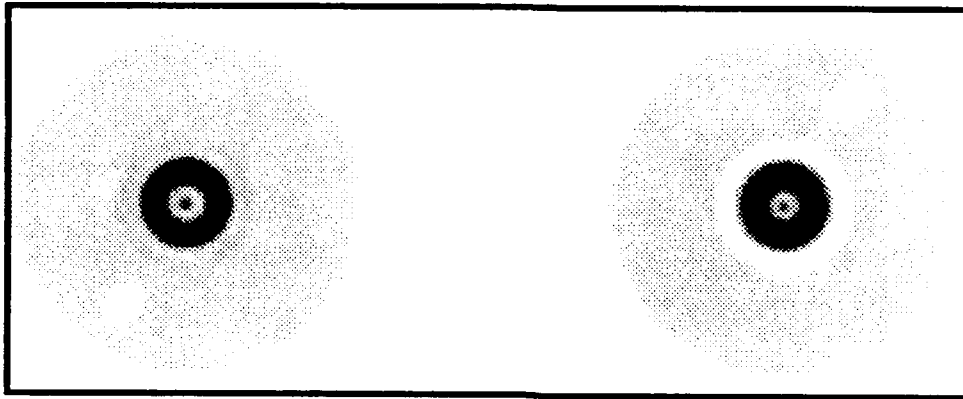
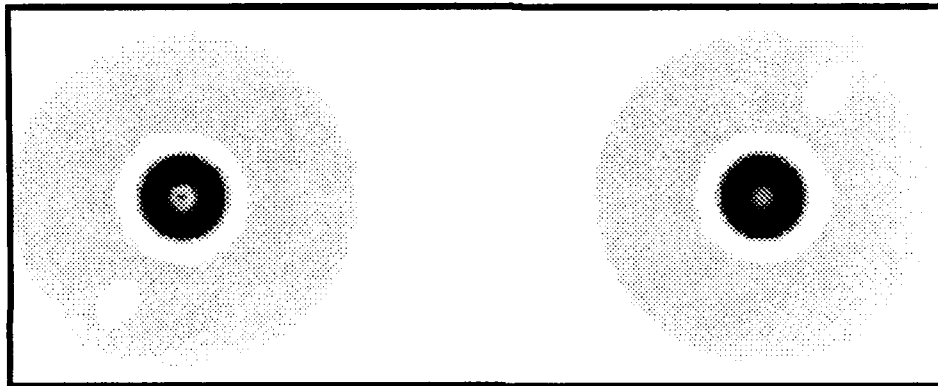
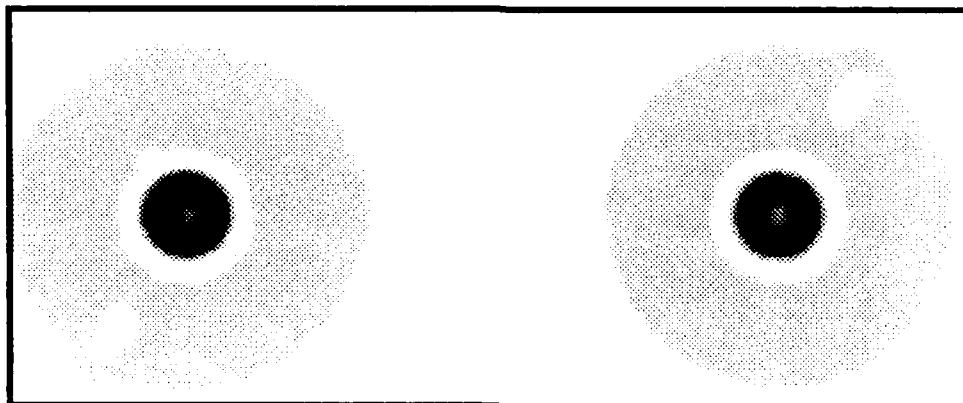
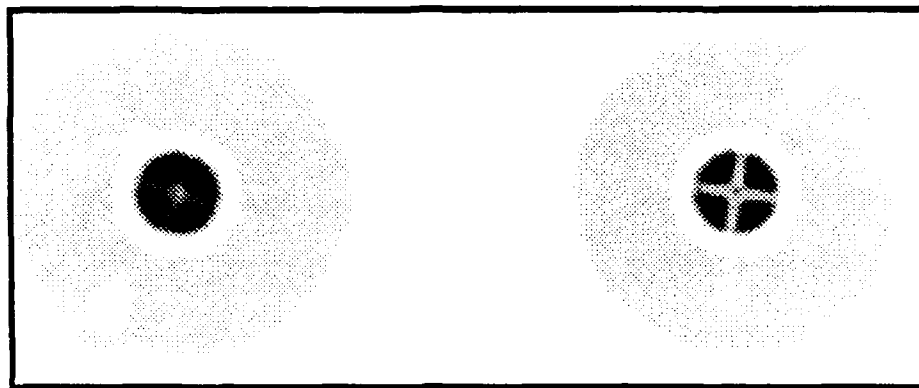
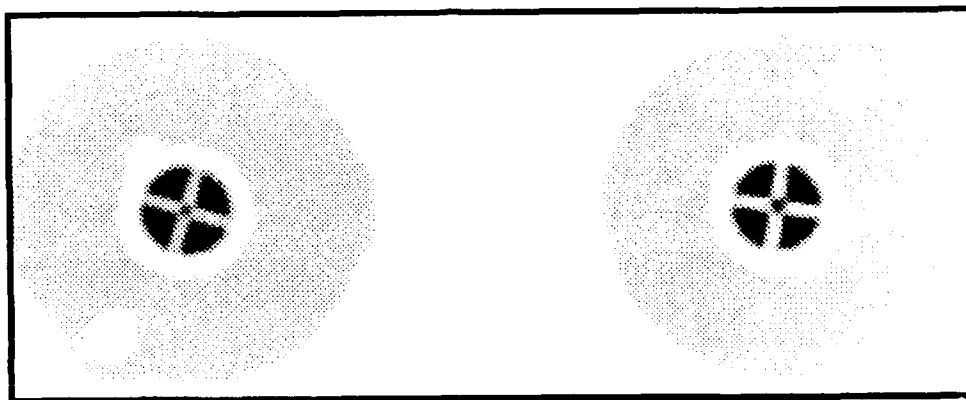
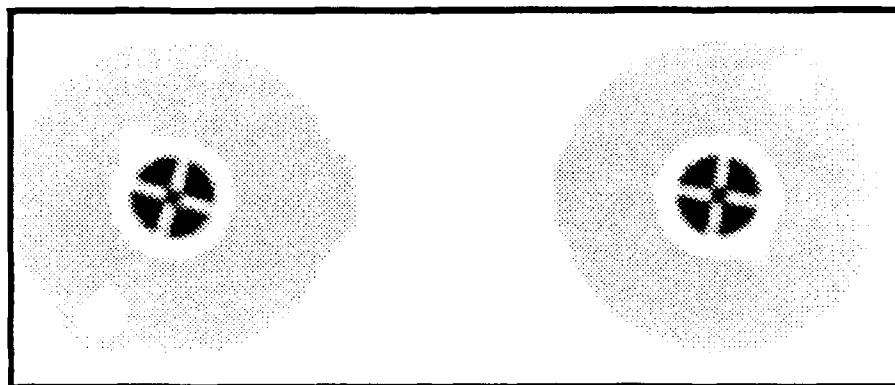
CT slices were also taken across the solenoid valve, through the region of the ball and seat. The new solenoid was scanned simultaneously with the burned unit so that the scans could be compared to verify that the burned unit was in the normally closed position. Figures 3.3-5 through 3.3-12 are CT slices taken through the plunger and body and then the ball and seat section of the two valves. The CT slices are in steps of 0.5 mm. Due to the heat damage and buckling of the base, these scans are offset slightly such that the burned unit on the right is slightly higher than the new unit on the left. Interpretation of these images indicates no significant difference between the burned unit and a closed new unit. The CT series measures the presence of material over the volume that is scanned. Fundamentally, the data is available to make a judgement about the position of the ball relative to the seat. However this was the first investigation of this type and with no prior experience, the CT analysis could not be definitive about the seating of the ball.

The nature of hydraulic systems is that small leak paths, even on the order of just thousandths of an inch, can be significant. Because the CT data was not definitive, there was a need to optically verify the actual seating of the ball. A destructive physical analysis (DPA) was performed and this fact was verified. Higher resolution CT and comparison to a "good" unit should be capable of the assessment of the status of the seating of the ball. Also, if the ball was not seated by any significant amount (>25 μm), it would most likely be very evident in the CT imaging, particularly in comparing a known, seated valve to an unknown.

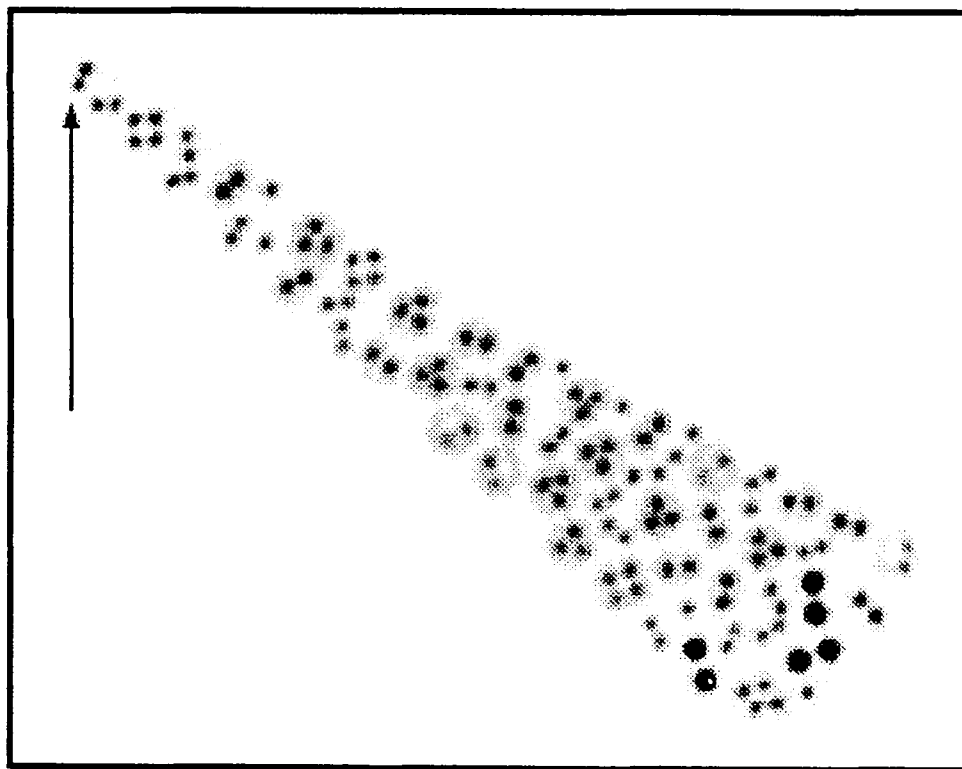
The first failed cable was CT scanned in a nine-slice CT series on steps of 1 mm. This scanning sequence covered a discolored region on the cable. Figure 4.2-1 is one image from this series. This image shows where the twisted pair on the thin side (pointed end of the trapezoid cross-section) edge had been compressed over about a 2-mm (0.08-in) length. The compression is a likely cause of insulation thinning which would have resulted in the Hi-Pot failure. The CT image also shows that there is marginal room in this assembly for the number of wires required. The wires are pushing the outside envelope of the potting; in addition the narrow edge does not have adequate room for the twisted pair. This is going to be a recurring problem area for damage from manufacture and handling for this design. Figure 4.2-2 is a CT slice taken near the termination of the cables to connectors. The image indicates a poor distribution of wires in the cable as noted by the large region containing no wires.

Figure 4.2-1 CT slice through the raceway cable in a region of surface discoloration for a failed cable.

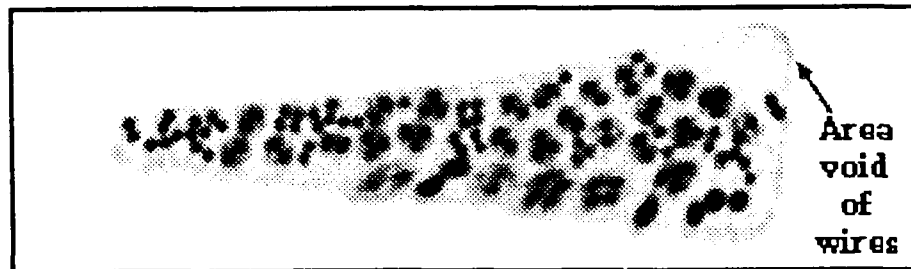
Figure 4.2-2 CT slice through the raceway cable near the termination of the cable at the connector.

On the second raceway cable assembly, a visible void existed at the site of the HiPot failure. The most probable cause of the failure is that the transition from the flat portion to the end block results in excessive density of conductors and compression of insulation and wire pairs. A solution to these cable problems, worked out in an informal brainstorming session while viewing the CT data, is to increase the available space in the cable by using the 1-mm (0.050-inch) margin and adding a wrap of woven material around the outside of the wire bundle. This would provide a standoff to the external conductive shield which is sprayed onto the outside of the potted urethane. In addition, this will provide the cross-cable support to avoid the lengthwise splitting that can be the result of handling on this type of assembly. There also is a need to change the transition from the flat length of the raceway cable to the end block connectors so that there is a gradual tapering to allow more room for the transition and, which will reduce the conductor density (Figure 4.2-2). These changes would result in a reduction of approximately 50 percent of the current failures experienced and most of the observed failure modes.

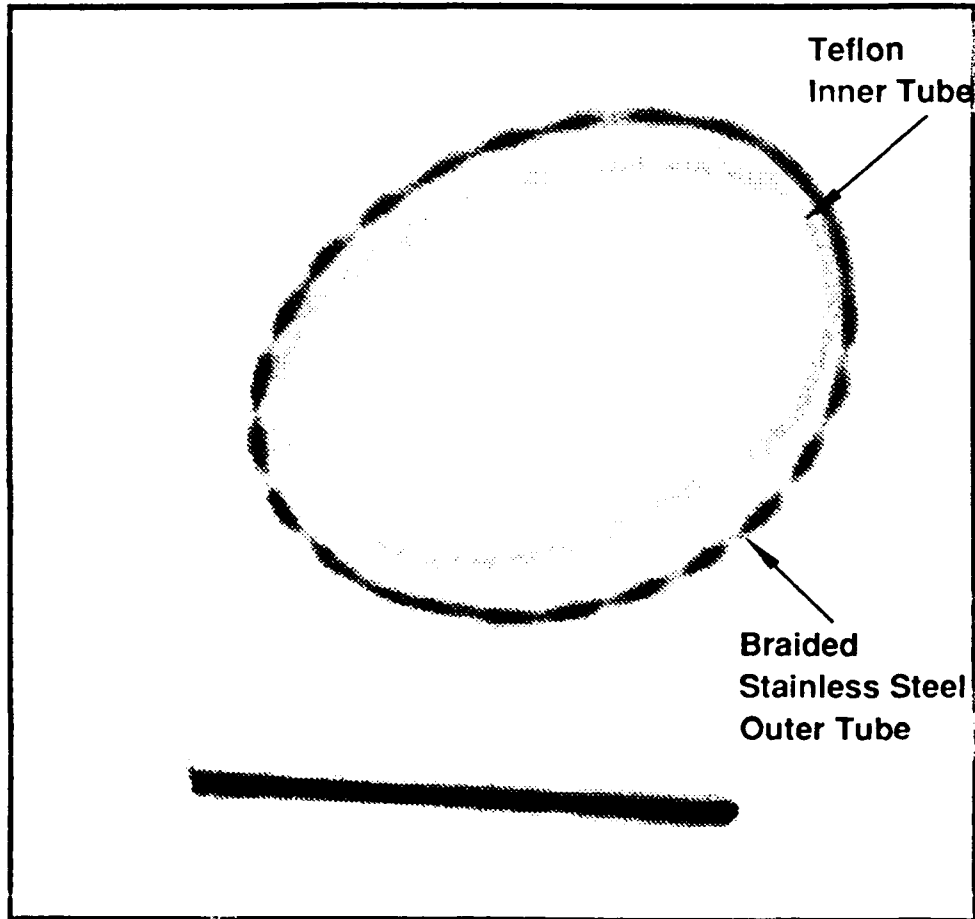
Figure 5.2-1 is a CT image of the fuel line at the maximum point of crush under vacuum, Figure 5.2-2 is at the same location at ambient pressure, and Figure 5.2-3 is the same location at full operational pressure. The CT images show how the inner and outer tubes behave relative to one another under the three pressure conditions. From this set of CT images, it was concluded that this fuel line could not have collapsed, and the ultimate finding of the investigation was that it was another section of fuel line that collapsed, causing the engine malfunction.

Figure 5.2-1 CT slice of a fuel line under vacuum conditions (2X actual size) showing teflon inner tube and braided stainless steel outer tube.

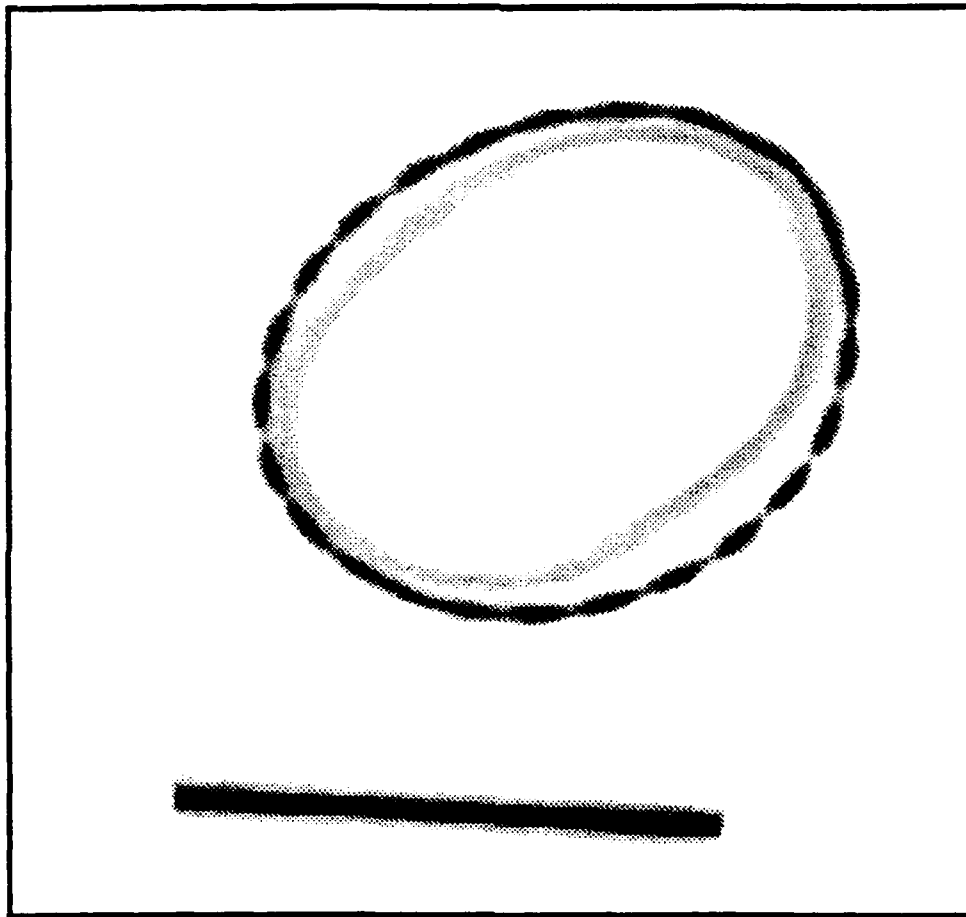
Figure 5.2-2 CT slice of the fuel line under ambient pressure.

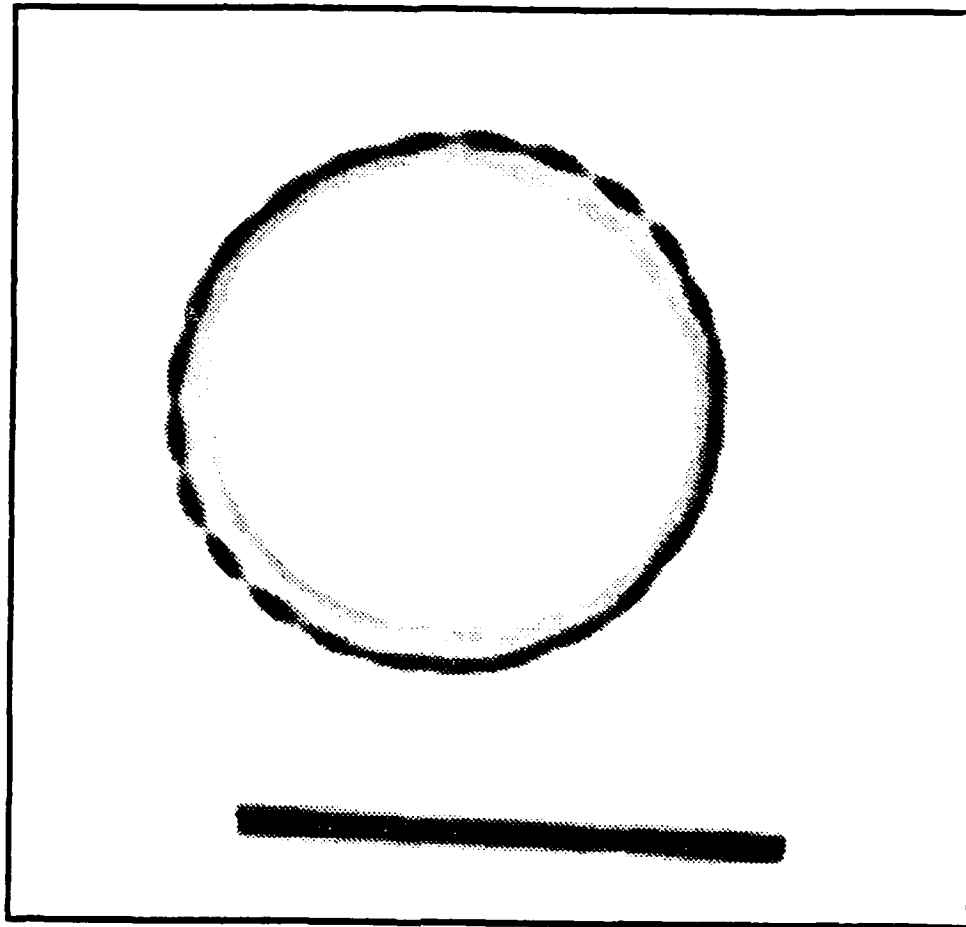
Figure 5.2-3 CT slice of the fuel line at operational pressure.

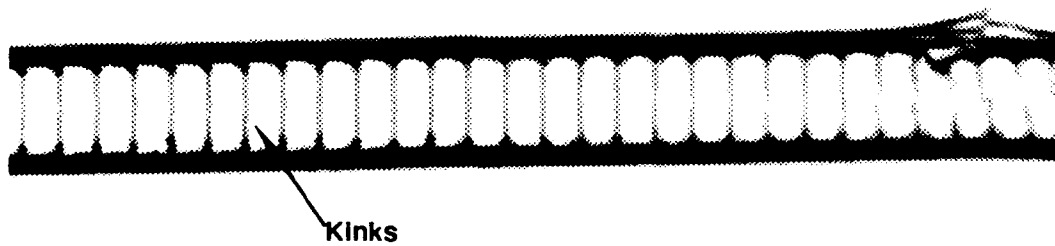
Figure 6.1-7 shows the left half of the image from slice location D. The features are equivalent to those identified in Figures 6.1-5 and 6.1-6. The only difference is that the kinking in the core walls is slightly more prominent and extends across the length of the left side.

Figure 6.1-7 CT slice at location D.

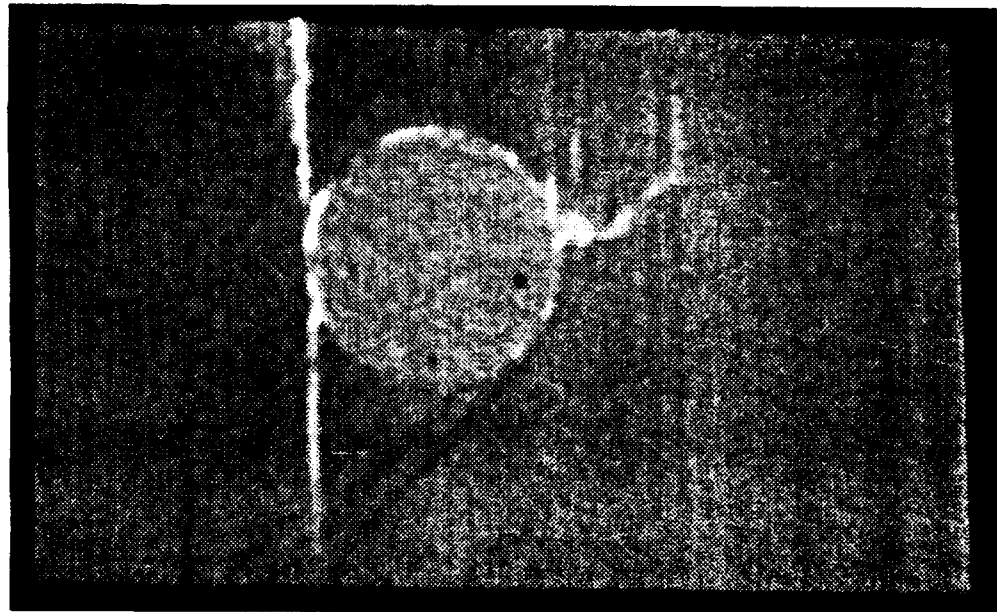
Figure 6.2-3 CT slice through a damaged graphite epoxy sample showing a transverse crack and a 0 degree crack intersecting a fastener hole.
