COMPOSITE UNIT ACCELERATED LIFE TEST  
OF THE HIGH GAIN ARRAY

Contract Number N00014-93-C-2021

Texas Research Institute Austin, Inc. (TRI/Austin)  
Reliability Engineering Division  
A.V. Bray, S.L. Arnett, and S.C. Liberty  
9063 Bee Caves Road  
Austin, Texas 78733  
(512) 263-2101

13. ABSTRACT (Maximum 200 words) This report documents the composite unit life testing (CUALT) of a 20-element hydrophone array. The array was subjected to a CUALT which simulated five years of service life. After CUALT was completed, an autopsy was performed on the array to determine failure modes and mechanisms. This report also documents array design, mission profile, CUALT schedule and measurement data, autopsy results, and failure analysis.

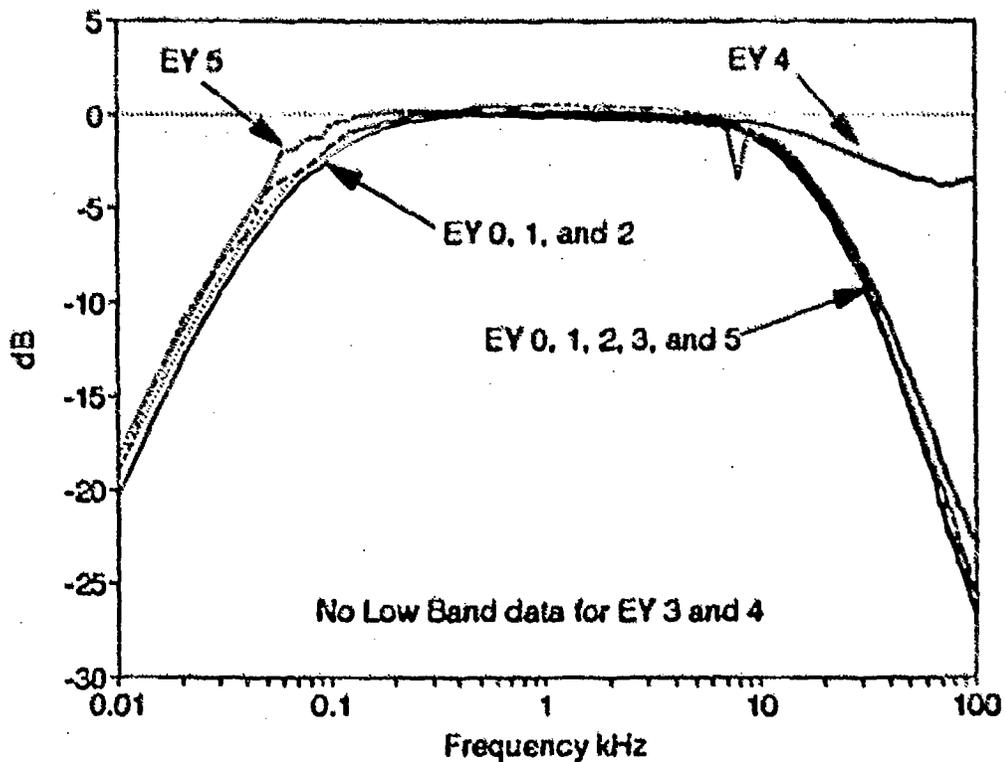
Figure 5. Hydrophone Gain Response Curves for Element H10

Figure 4 is an example set of hydrophone gain response curves for element H2 of the HGA prototype stove. Note that there is little or no variation from one EY to another for this element. Figure 5 shows the same data for element H10, whose response appears to be erratic for the EY 4 measurement period. The roll-off of EY 4 changed dramatically from the baseline data of EY 0 but was back to normal in EY 5 - an indication that the hot air exposure prior to the EY 5 measurement removed from the unit the moisture that had evidently been a problem in EY 4. The response curves for all elements are included in Appendix C.

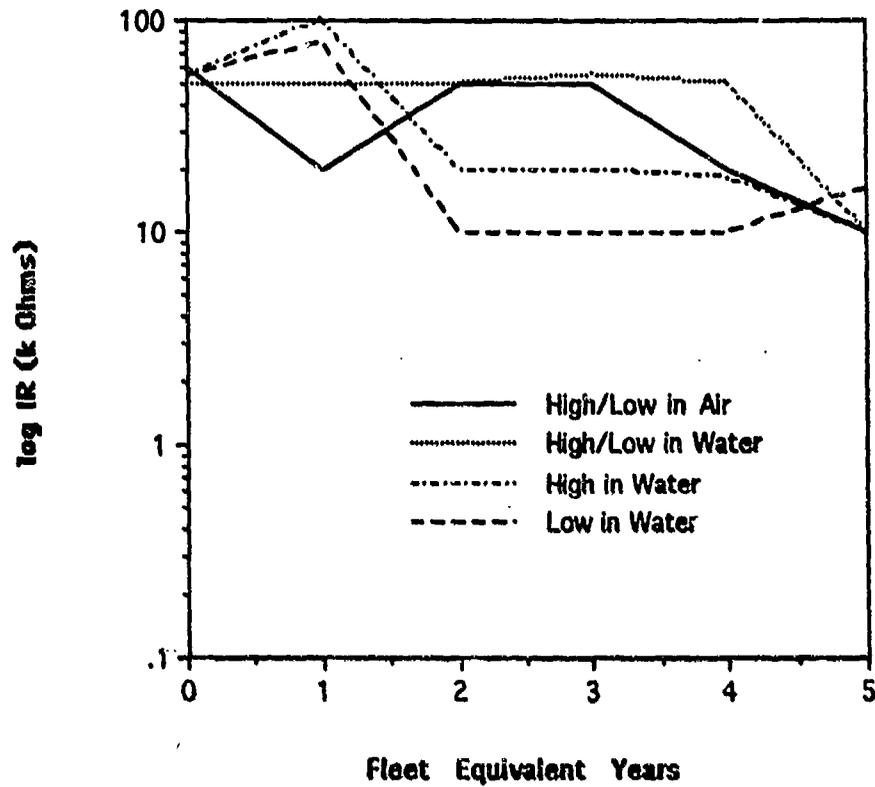
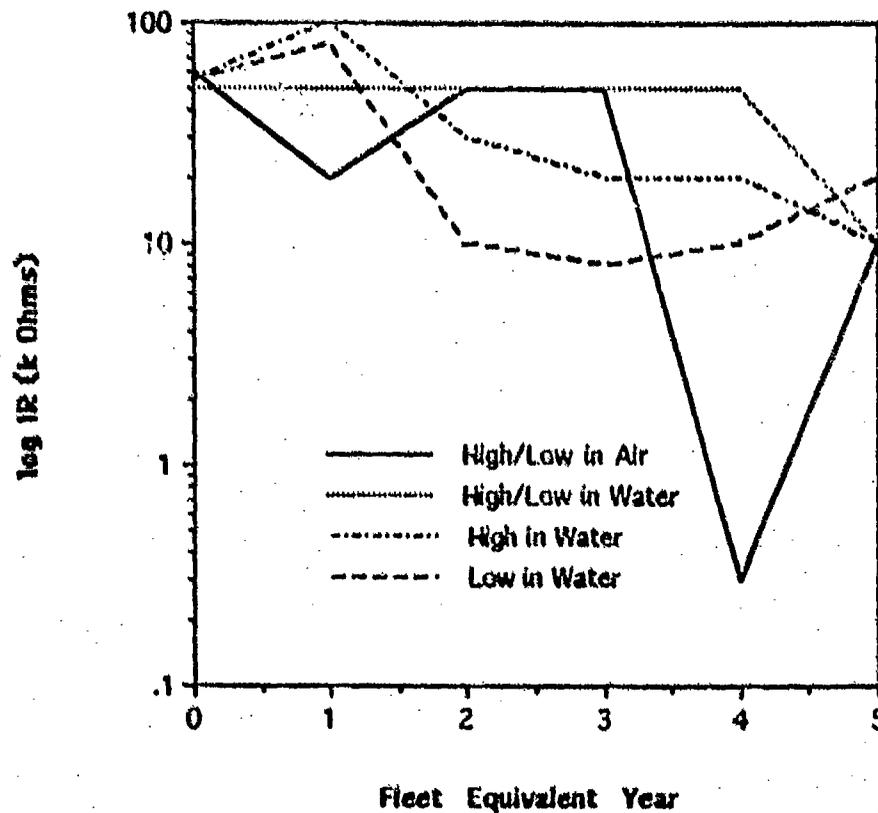
The insulation resistance data for elements H15 and H7 are shown in Figures 7a and 7b. The following comments apply to the IR data in general, and can be seen in the plots of Figures 7a and 7b:

1. Those elements which had dramatic changes in hydrophone gain response due to the dry out sequence between EY 4 and EY 5 also showed a dramatic High/Low air IR decrease prior to EY 4 followed by an increase in High/Low air IR between EY 4 and EY 5. This is another indication that these elements suffered at least partial loss of watertight integrity by the end of EY 4.

2. The low side IR in water tended to decrease somewhat between EY 1 and EY 2 and recovered between EY 4 and EY 5 for all elements. This is fairly typical IR behavior for ALT units – an early decrease in IR which shows improvement after a dry out cycle. This is different than the situation above in which a much more dramatic change is observed that is correlated with ingress into the unit for its conductors.
3. The High side in water data showed a small decrease between EY 1 and EY 2 and decreased somewhat between EY 4 and EY 5. The High/Low water IR was similar for those elements which had no watertight integrity problem.

Due to these anomalies, elements H7, H10 and H15 are cause for concern.
