USACERL Technical Report FM-93/07
January 1993
Corrosion Mitigation and
Management System

Corrosion Assessment of an Army Installation Gas Distribution System Using MicroGPIPER

by
Vicki L. Van Blaricum
Vincent F. Hock
Lewis F. Setliff

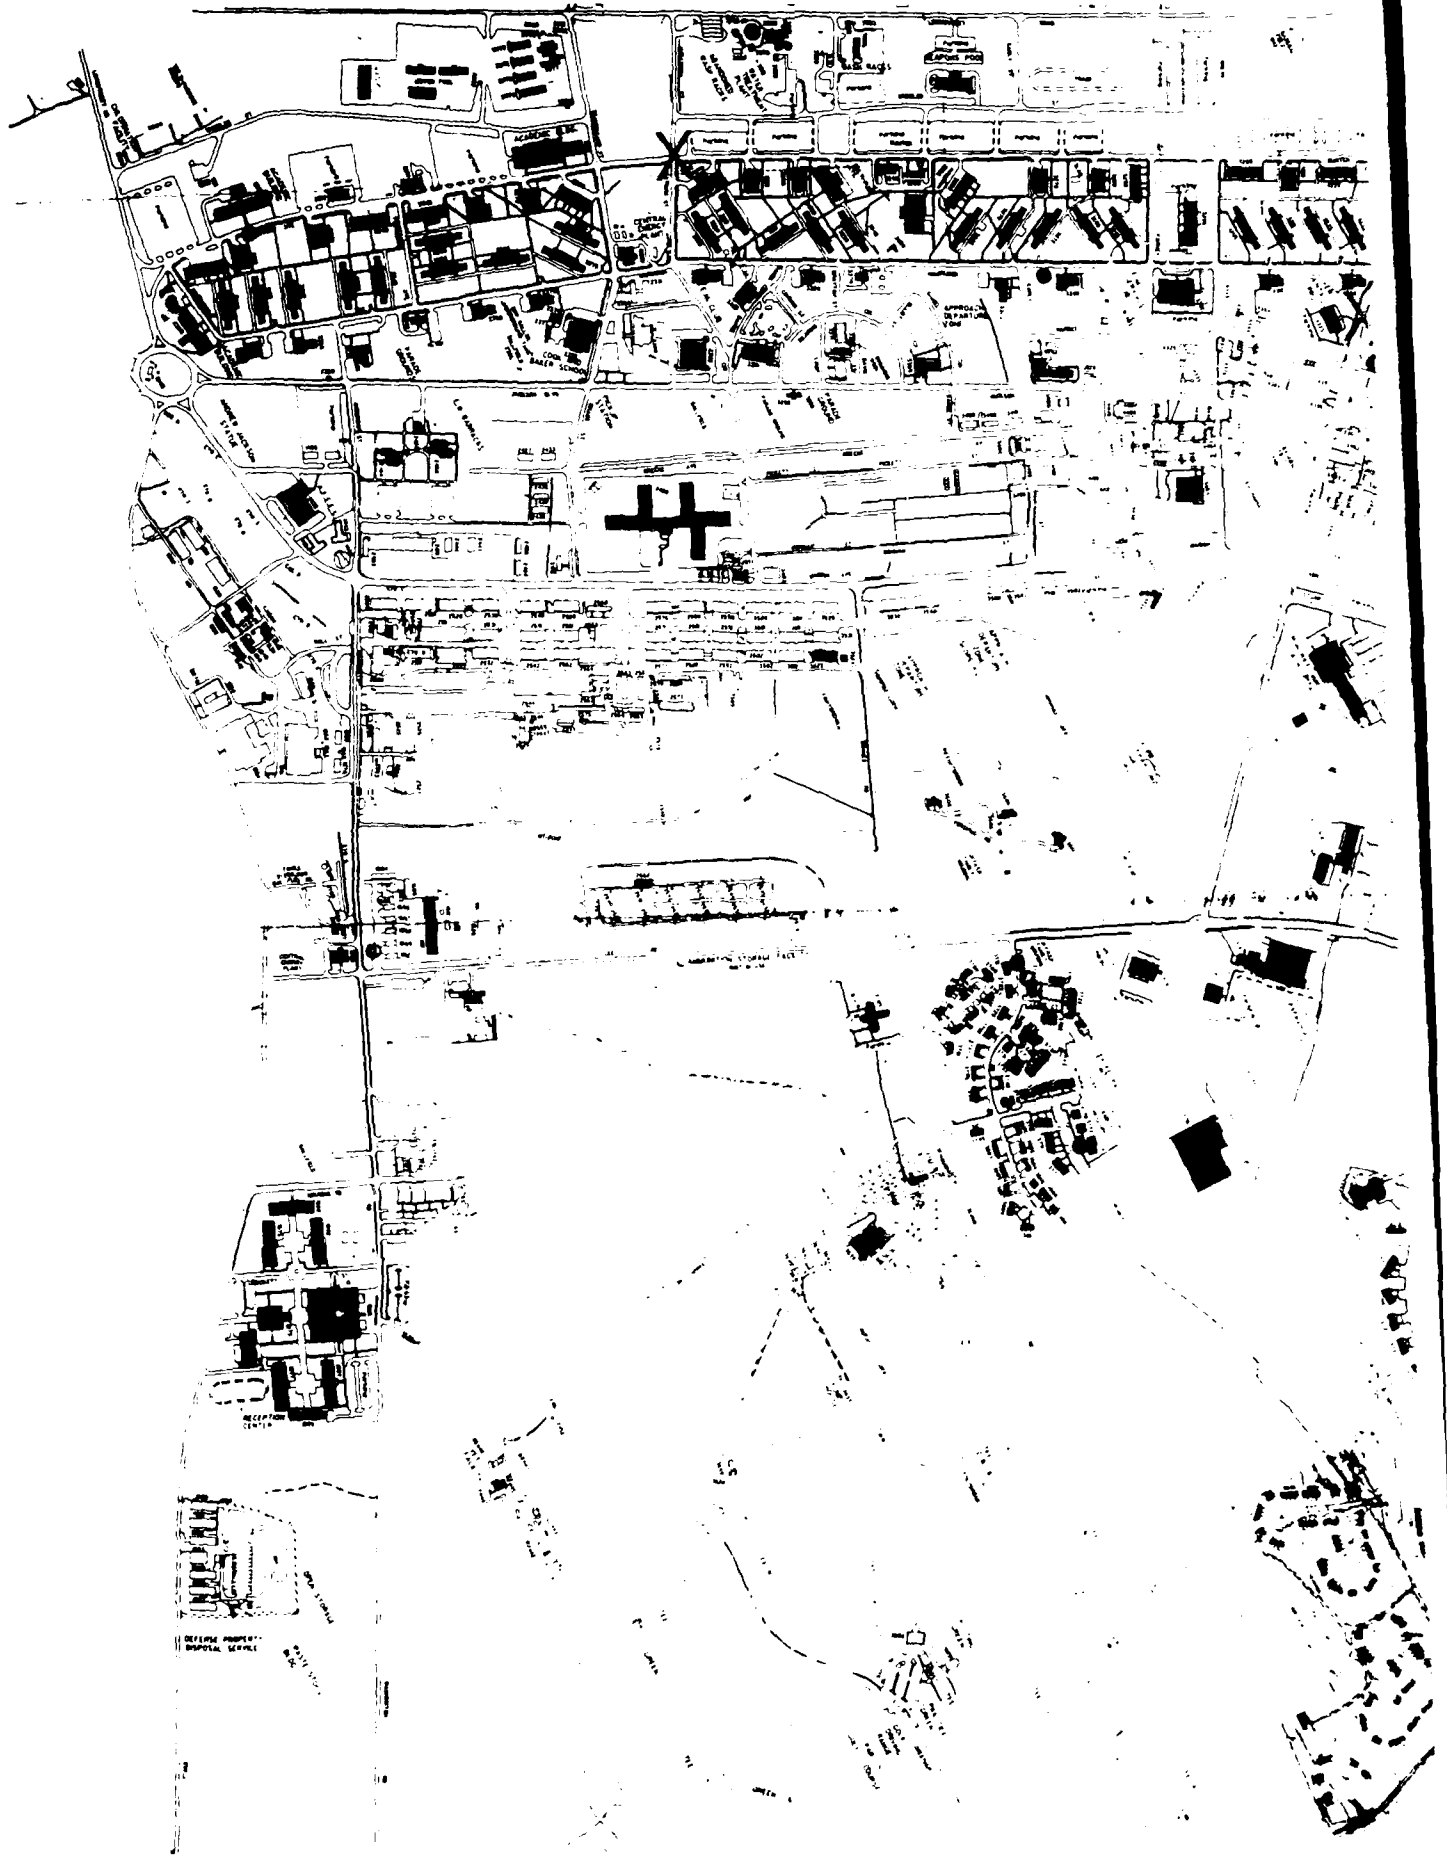
Figure 1. Fort Jackson Site Map.

The July 1991 survey (Southern Cross Corporation 1991) reported a total of 417 leaks, of which 40 were Grade I, 50 were Grade II, and 327 were Grade III. Of the leaks found in this survey, approximately 58 were caused by soil-side corrosion of the mains or service lines. The remaining leaks were primarily caused by faulty valves and fittings which were not in contact with the soil (i.e., they were aboveground, in valve pits, etc.) It is significant to note that 35 of the 40 Grade I leaks were in the group caused by soil-side corrosion. The locations of the leaks caused by soil-side corrosion that were found in the two surveys are plotted on the map in Figure 1.

The third step in the evaluation was to collect soil, coating, and pipe condition data. The GPIPER prediction model requires information on soil chemistry at the pipeline depth, as well as pipe material and coating. Based upon the leak history and the other information collected, locations were selected for soil sampling, bell hole inspections (for evaluation of the pipe and coating condition), and Wenner 4-pin measurements (American Society for Testing and Materials Standard G57) to determine average soil resistivities. Funding and time constraints precluded a large sampling effort, so representative areas were chosen. The sites chosen are shown on the map in Figure 1.

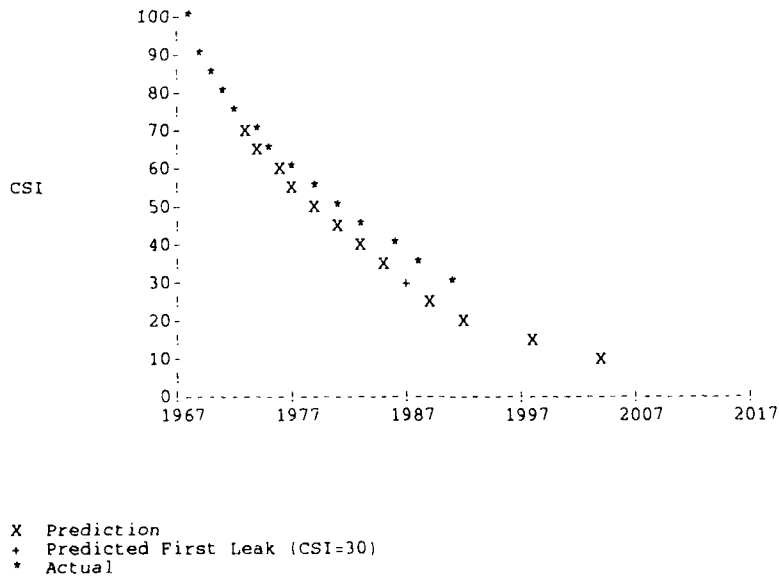
Figure 5. Corrosion Status Index (CSI) Report for Bldg. 5957 (Family Housing).

Appendix B contains CSI reports generated for the pipes at each of the soil sampling locations. The GPIPER predictions correlated quite well with the findings of the field survey. GPIPER correctly predicted the severe soil-induced corrosion problems that had been occurring in the family housing area, as well as the leak at Forest and Jackson streets. For example, the plot that was generated from the information taken at Building 5957 (family housing) is shown in Figure 5. GPIPER predicted that pipes under the soil conditions found at Building 5957 should be expected to begin leaking in 1987, and that by 1991, there should be roughly seven leaks per mile of pipe (cumulative). In addition, GPIPER predicted that a leak should have occurred at Forest and Jackson (pipe section FOR&JACKSN 2) streets in 1984. Given the severity of the leak that was observed at that location, it is likely that the leak began long before it was discovered in 1991.

PIPE IDENTIFICATION	: BLDG. 5957	SECTION NUMBER:	1
SOIL RESISTIVITY	: 6006.00	SOIL pH	: 5.60
COATING MATERIAL	: WRAP COAL TAR	WALL THICKNESS:	0.2800
YEAR INSTALLED	: 1968	PIPE SIZE (OD):	6.0
PREDICTED FIRST LEAK (CSI<=30):	1987	ACTUAL FIRST LEAK:	1991.05.14

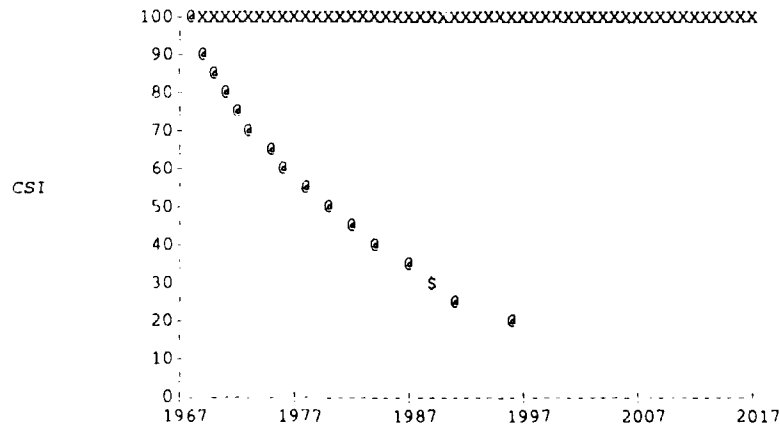
Figure 6. CSI Report for Cathodically Protected Main at Forest and Jackson.

The CSI report for the cathodically protected main at Forest and Jackson (pipe section FOR&JACKSN 3) shown in Figure 6, illustrates clearly that with the use of a properly maintained CP system (straight line comprised of X's on the plot), the CSI should remain at 100 (excellent condition) indefinitely. The other curve on the plot shows what will happen without cathodic protection.

PIPE IDENTIFICATION : FORandJACKSN SECTION NUMBER: 3
SOIL RESISTIVITY : 1449.00 SOIL pH : 5.95
COATING MATERIAL : WRAP COAL TAR WALL THICKNESS: 0.3220
YEAR INSTALLED : 1968 PIPE SIZE (OD): 8.0
PREDICTED FIRST LEAK (CSI<=30): 1989 ACTUAL FIRST LEAK: No leak.
CATHODIC PROTECTION w/ PIPE-to-SOIL POTENTIAL <= -0.85 VOLTS
