Miscellaneous Paper CERC-93-2
March 1993

Scour Hole Problems Experienced by the Corps of Engineers; Data Presentation and Summary

*by W. Jeff Lillycrop, Steven A. Hughes
Coastal Engineering Research Center*

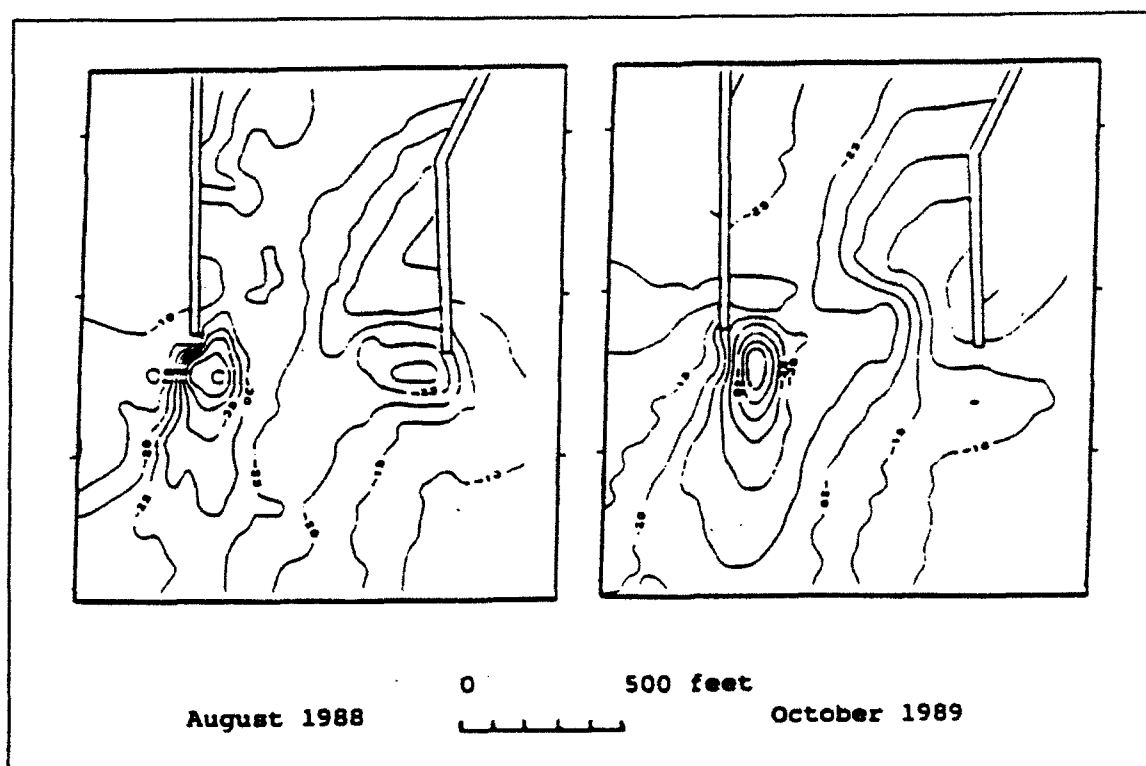
Figure 3. 1988 and 1989 bathymetry of Moriches Inlet

Between 1987 and 1989, both jetties at Moriches Inlet were refurbished at a cost of approximately \$4 million. It was found during the general design memorandum study phase that deterioration of the west jetty head was due in large part to undermining caused by the presence of the deep scour hole located just seaward of the jetty head. The scour hole is thought to be caused by swift ebb currents flowing out the east branch channel, moving diagonally across the entrance channel, and passing seaward of the west jetty tip. The intersection of the ebb jet with incoming waves creates an eddy which is thought to contribute to the scour problem.

Presently Moriches Inlet is being monitored by CERC to determine if the scour hole is continuing to grow, jeopardizing the west jetty toe protection. The study includes evaluation of the scour hole's evolution, an inlet monitoring program, and a regional geologic investigation. Scour hole evolution assesses historic bathymetry with wave and current data to determine rate of growth. The monitoring program includes measurement of currents and inspection of the jetty using side-scan sonar to determine present conditions. The geologic investigation evaluated the regional stratigraphy, which was determined to be a primary element in scour problems being experienced at Indian River Inlet, Delaware (see discussion of Indian River Inlet).

The scour hole problem at Moriches Inlet is very similar to the scour that is occurring at Shinnecock Inlet (see next section). The primary scour mechanism is thought to be the strong ebb flow currents that exit the bay from the east channel and move diagonally across the mouth of the entrance until they pass just in front of the west jetty. At this point there is a possibility of the jetty initiating a rotational flow similar to vortex shedding which, in turn, causes the scour problem. Another scenario is that incident wave energy is interacting with the strong ebb current as the flow moves beyond the sheltering influence of the east jetty. This interaction may result in turbulence strong enough to mobilize the sediment, which is then swept away by the currents.

It appears that armoring of the backside of the barrier island just east of the inlet promoted a strengthening of the ebb current flowing out of the east channel. This hypothesis is supported by the subsequent appearance of the scour hole shortly after completion of the repair.

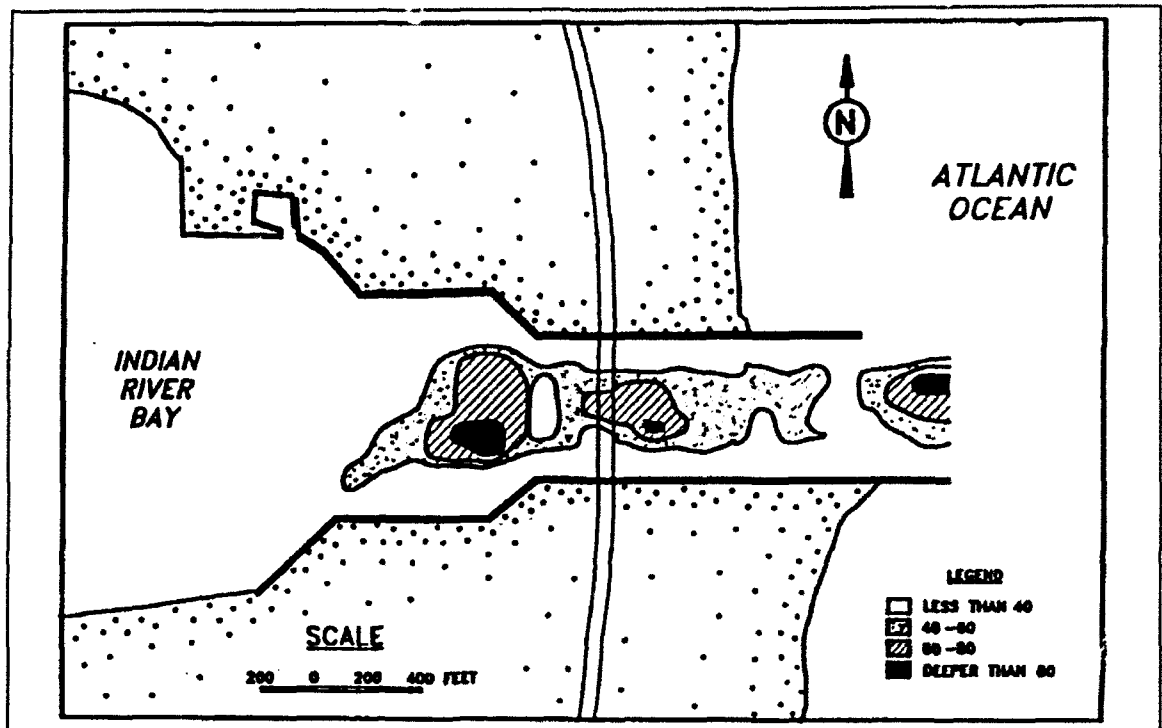
Figure 7. 1988 bathymetry, Indian River Inlet

Since construction of the Federal project, the inlet has gradually increased in depth, from elevations approximately -14 ft mlw to -40 ft mlw. Figure 7

shows 1988 bathymetry conditions, and Figure 8 presents inlet cross-sectional area at different dates since construction. The increase up until the mid-1970's was gradual. In the mid-1970's the inlet cross-sectional area increase accelerated. During this same period, several large, localized scour holes formed at the tip of the north jetty and immediately on either side of the bridge piers. The scour holes at the bridge piers have depths greater than elevation -90 mlw and are continuing to deepen. The scour hole at the jetty tip has caused structural failure, and approximately 300 ft of jetty has been lost. Scour at the bridge has caused remedial action to be taken by the Delaware State Department of Transportation. In 1989 the state spent \$2.7 million to place rubble material adjacent to the bridge piers in order to halt undermining.

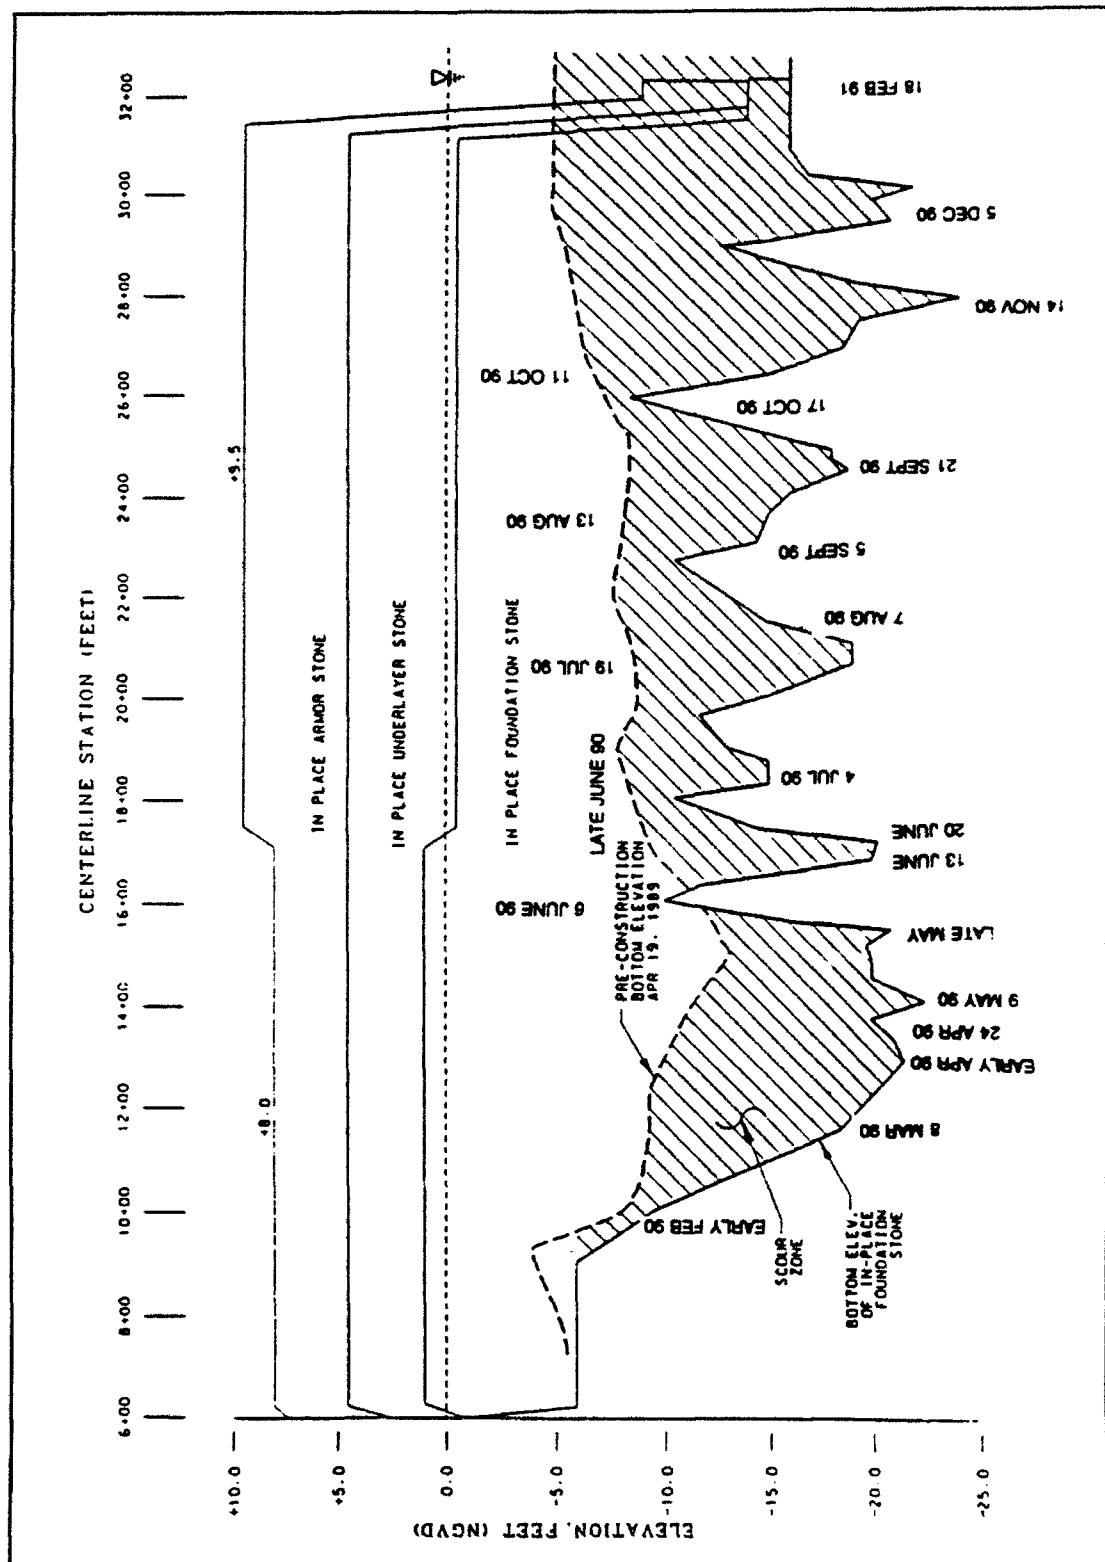
Figure 13. Scour during construction, Oregon Inlet, pre- and post-construction

It was speculated during the May 1991 workshop that the primary cause of scour at Oregon Inlet was the ebb-flow tidal current because the deepest scour was observed on the channel side of the groin. Waves were discounted as a process contributing to the scour because most waves break on the ebb shoal, thus decreasing their effect. However, there is a possibility that nearshore currents generated by waves during storm conditions could have contributed to the scour. Aerial photographs of the groin showed currents being trained along the structure.

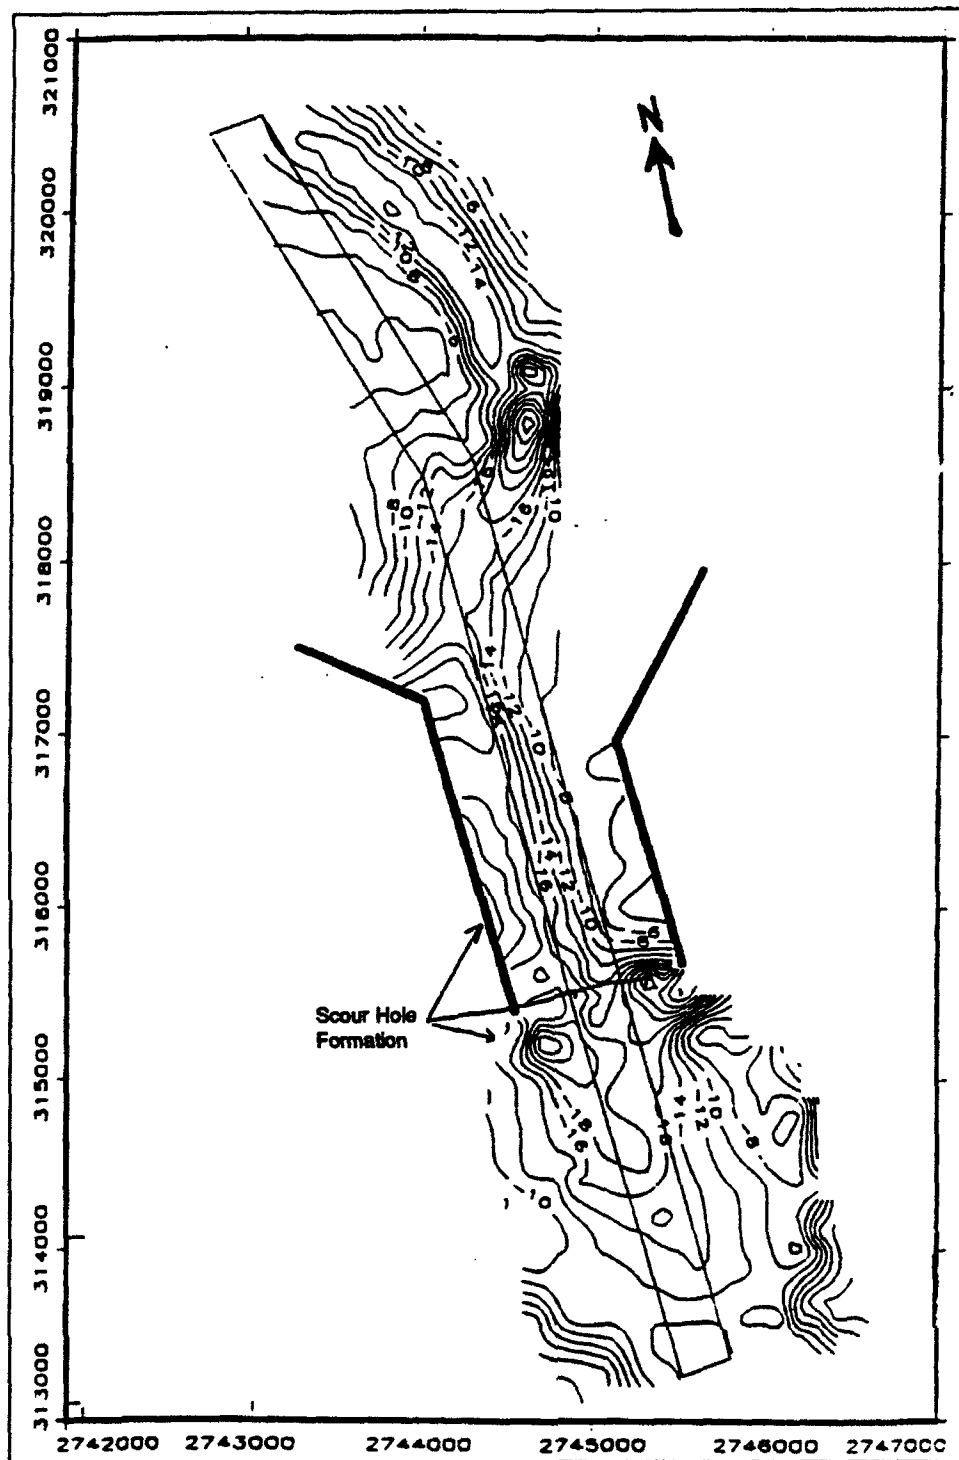
Figure 18. Scour holes at Little River Inlet

Scour at the tip of the east and west jetties appears to be caused by tidal current and structure interactions. The west jetty scour hole is approximately 10 to 15 ft deeper than the surrounding bottom. The hole at the east jetty is larger than the west jetty scour hole. The east scour hole began to form around October 1982 and had increased to a depth greater than 25 ft mlw by April 1983. In December 1983, material dredged from the inlet was used to fill the east scour hole. This filling was short-lived, however, as the deepening trend continued, and at this writing the hole was deeper than 30 ft mlw. The cause of scour at the jetty tips was suggested by Chasten and Seabergh (in preparation) to be due to tidal current and structure interaction. The deeper scour hole occurring at the east jetty is probably due to the proximity of the ebb tidal shoal, causing increased current speeds around the jetty tip.

Scour is also occurring along the west jetty adjacent to the inlet channel, and the cause appears to be different from that at the tips. Along this section, natural thalweg migration appears to be shifting the channel toward the jetty, scouring to a depth of about 20 to 25 ft mlw. Prior to construction of the navigation project, the natural channel shifted frequently; and at the time of construction of the west jetty, the natural channel was toward the southwest and Waties Island (Chasten and Seabergh, in preparation). This flow route was closed off as the west jetty was constructed and the ebb tidal flow began channelizing along the west jetty. In December 1983, dredged material from the inlet was placed in the scour hole but has since eroded away, and the hole continues to enlarge. Figure 19 shows a survey taken along the west jetty prior to dredged material placement and following placement. Note that the deepening trend continued immediately following fill placement.

However, scour at the tip of the jetties is continuing, which may eventually result in damage. Chasten and Seabergh (in preparation) stated that collapse of either jetty head section would not immediately affect the functionality of the jetties to stabilize the inlet, and reported that the rate of scour at the west jetty has slowed.

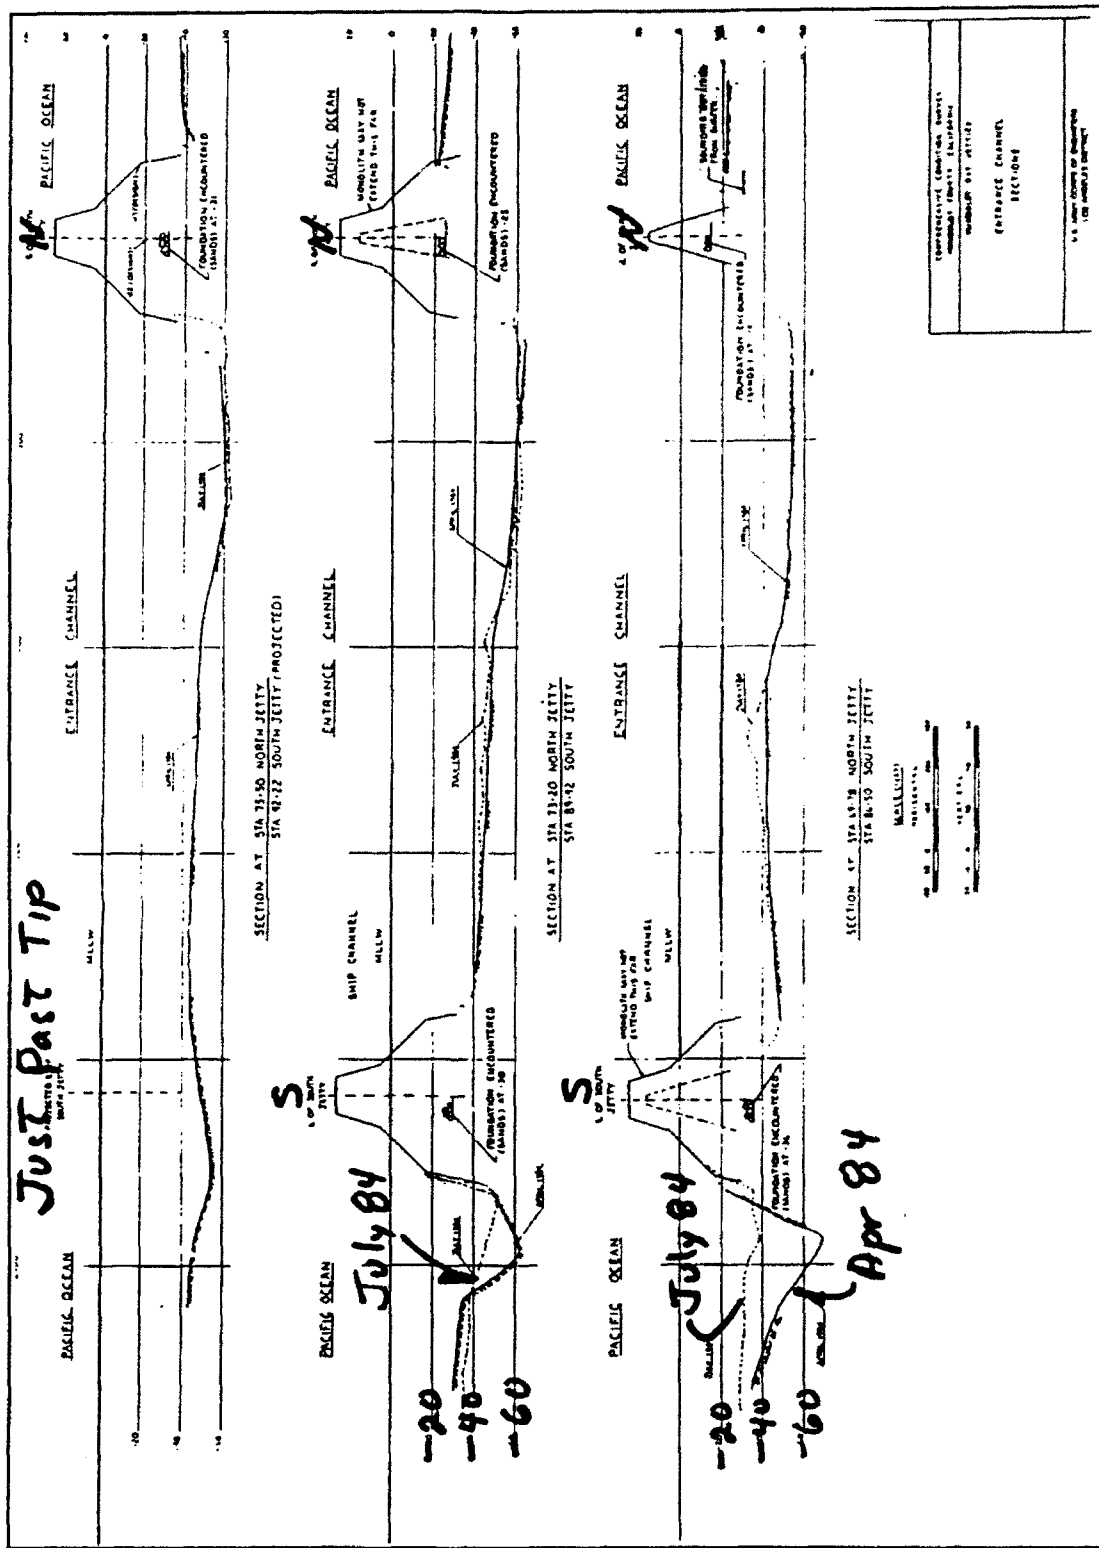
Figure 33. Humboldt Bay south jetty rip channel scour

Bathymetric data show three areas with significant active seasonal changes. Two are off the southwest side of the two jetty heads, and the third is along the channel side of the south jetty. The large holes tend to scour in the summer and fill in the winter. Off the south jetty head, soundings indicated depths almost to -70 ft mllw in August 1983 at station 85+50 and 350 ft off the center line. Surveys in 1984 showed this area had shoaled to -40 ft mllw in April,

According to the U.S. Army Engineer South Pacific Division, operation and maintenance (O&M) costs directly or indirectly associated with scour at the Humboldt Bay jetties were \$1.7 million in 1983, \$6.8 million between 1983-86, and \$1 million in 1991, for a total of \$9.5 million over the 8-year period.
