**DEPARTMENT OF DEFENCE  
DEFENCE SCIENCE AND TECHNOLOGY ORGANISATION  
AERONAUTICAL RESEARCH LABORATORY**

General Document 37

**AIRCRAFT ACCIDENT INVESTIGATION AT ARL  
THE FIRST 50 YEARS**

*Early Australian experience with the investigation of aircraft accidents is covered briefly as a prelude to the foundation of the Aeronautical Research Laboratory. With its foundation, a more scientific approach was possible. ARL was quickly involved with accident investigation, an activity which has been maintained throughout its fifty year history. This report examines ARL experiences during those fifty years with the idea of providing some useful guidelines for the next half-century.*

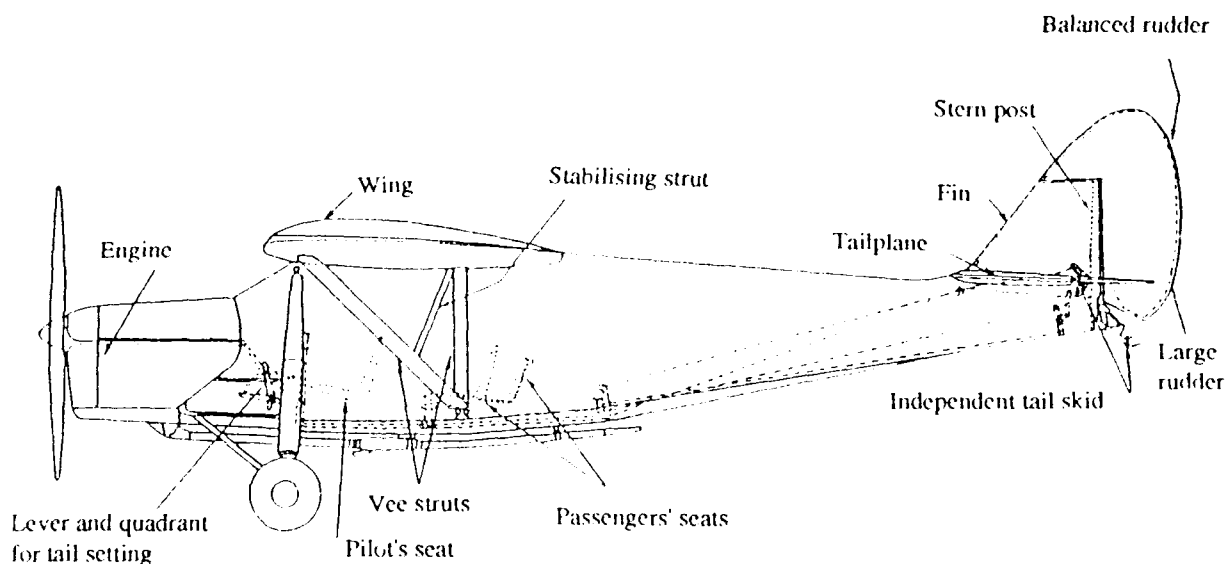
it easily met the load factor requirements of +5.5g and -2.75g specified for the normal category when the type certificate was issued in May 1930. Additional tests carried out by the RAE Farnborough supported this conclusion but indicated the desirability of fitting a stabilising bar to the forward leg of the vee strut; see Fig. 1. This mod was incorporated on 21 March 1932.

**Fig. 1** DH Puss Moth showing location of stabilising strut

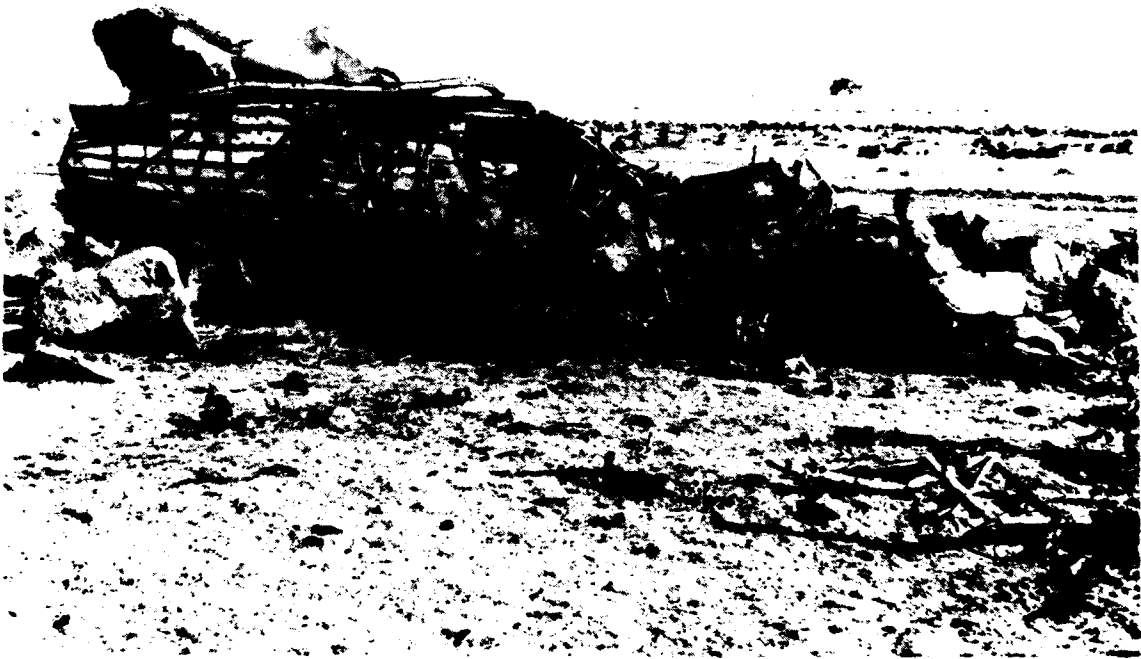
**Fig. 5**            **The burnt out fuselage of A20-679 marked the end of the wreckage trail**

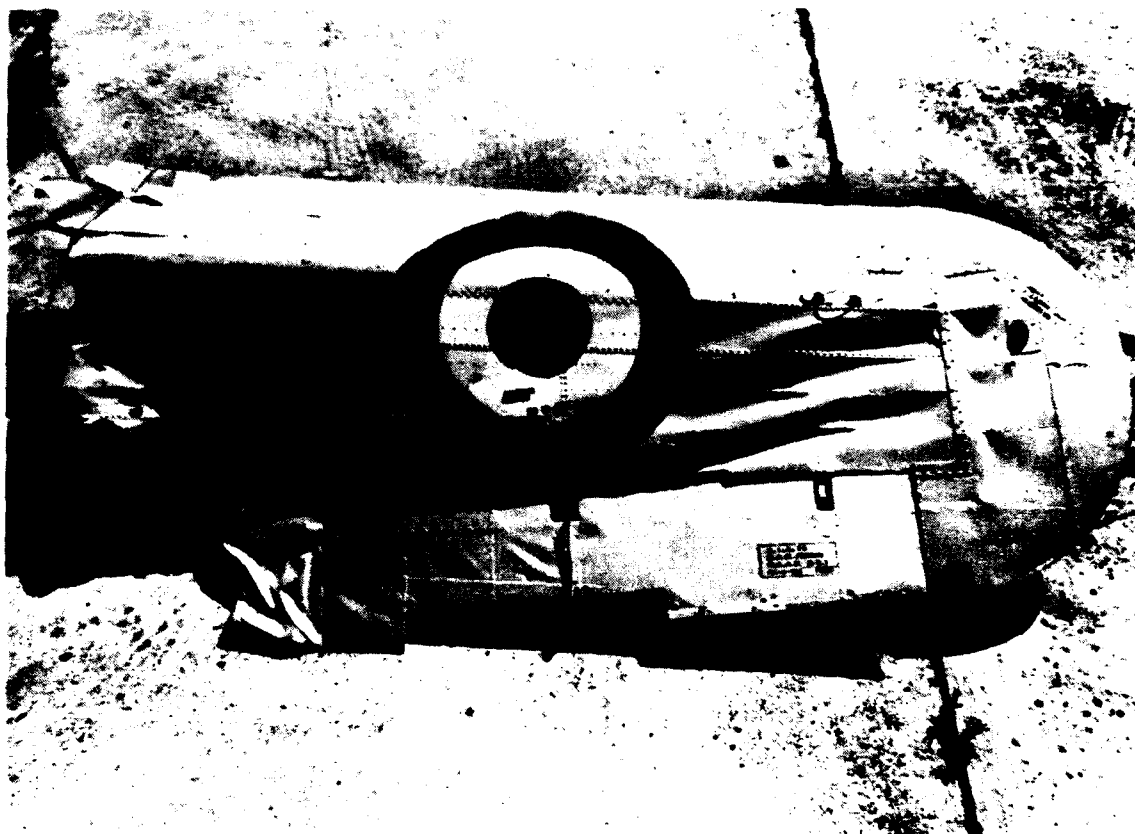
Examination of the wreckage revealed that the mode of wing failure was virtually identical with that exhibited by A20-201, Fig. 6. In the later accident, ARL had the benefit of being able to inspect all of the wreckage, not just the detached wing section, Applied Report 6. This confirmed that the starboard wing had incurred no in-flight damage and that the port aileron was up at the moment of wing failure; two features which could only be inferred during the investigation into A20-201.

**Fig. 6** Lower surface of the detached port wing from A20-679 showing the upward collapse of the leading edge. The downwards bending failure of the tip occurred under inertia and aerodynamic loading when the wing failed

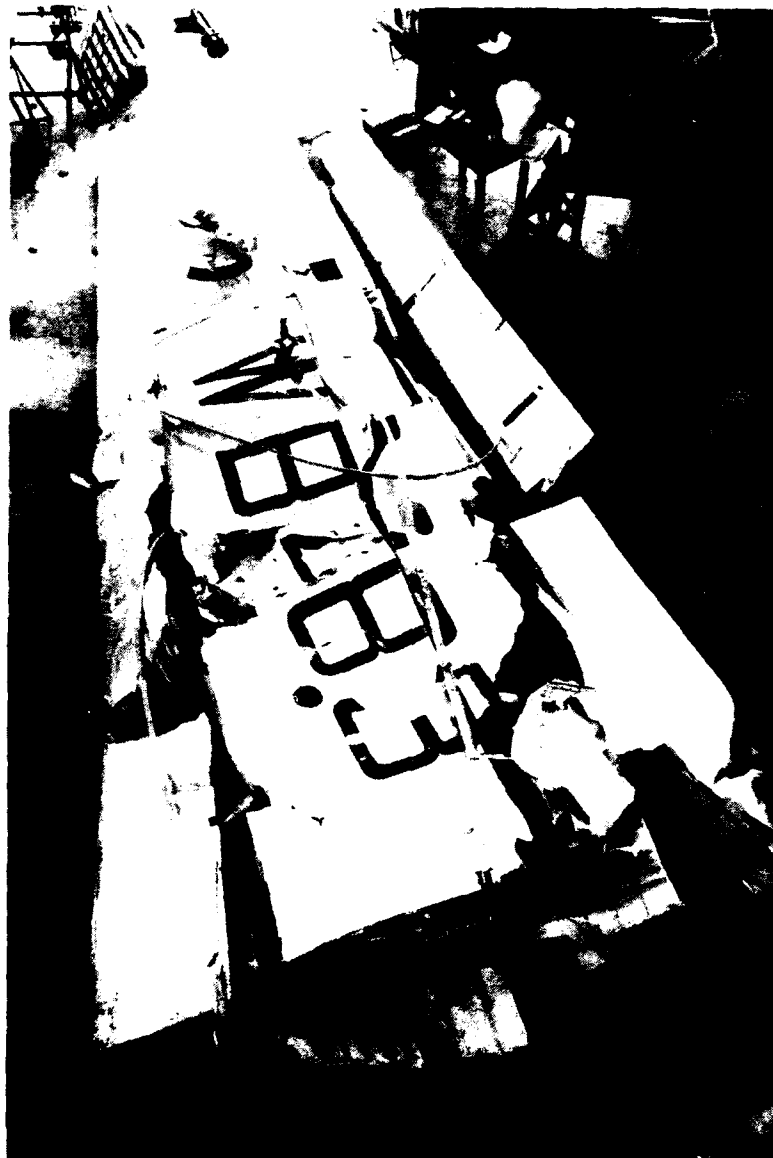
On 25 November 1953 near Mallala, SA, A81-2 was observed to be diving at a speed approaching the placard limit speed ( $V_{NE}$ ). As it pulled out of the dive at an altitude of 4,000 ft, the port wing failed and the aircraft crashed killing the crew of two. An examination of the separated port wing, Fig. 7, showed that the wing had failed in overload bending without the prior leading edge collapse which characterised the Wirraway wing failures. The examination also showed that the port aileron was deflected  $10^\circ$  down when wing failure occurred, S & M Report 224.

**Fig. 7** Port wing of A81-2 re-assembled to show the mode of failure. The lower surface retained the aircraft's original RAF serial

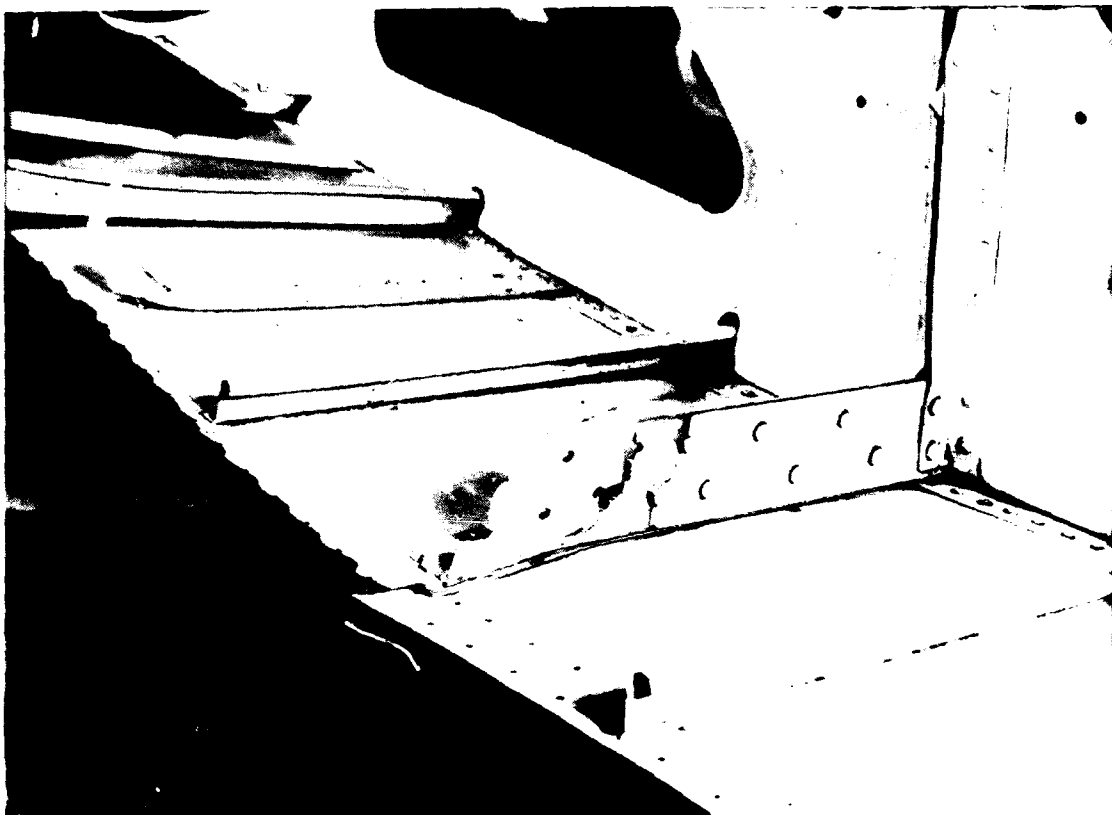
When the starboard wing sections arrived at ARL, it was immediately obvious that the wing failure initiated at the inboard end of a repair which had been carried out on the lower surface leading edge skin between wing stations 168-180. This area is located in the outer wing panel outboard of the wing joint at station 119. The repair was poorly designed in that it terminated in a double staggered row riveted joint using 3/32 in. rivets at one inch pitch. This joint had failed through shearing of the rivets without any associated tearing of the skin edge, Fig. 9. It is most unusual for riveted joints to fail in this way and indicates a gross mismatching between skin tensile strength and rivet shear strength.

**Fig. 9** Starboard wing of A16-38 showing failure details. Forward of the spar, the joint has failed by shearing of the rivets (lower centre) in contrast with the skin tearing evident aft of the spar (upper left)

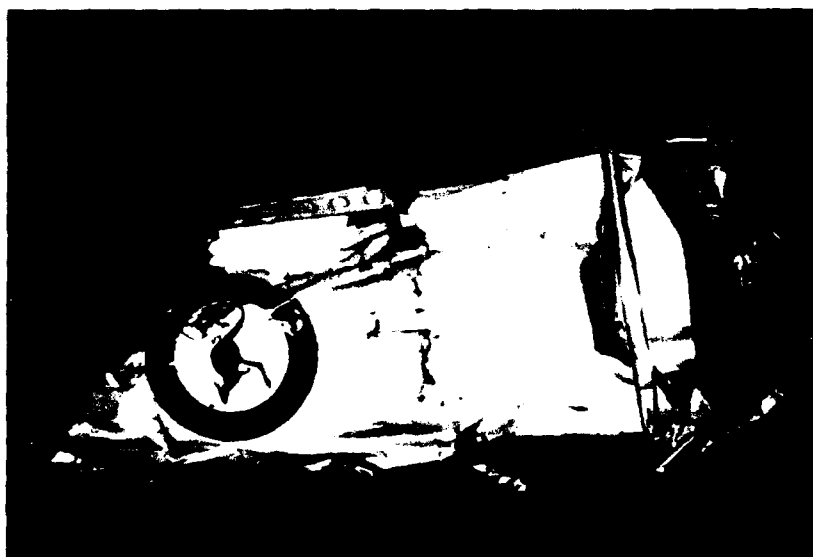
rotate upwards about station 62, a second failure occurred further outboard at station 180 in downwards bending and torsion under the combined action of the high inertia and aerodynamic loads induced by the primary failure. This second failure is analogous to that experienced by the Wirraways; see Fig. 6. The section outboard of station 180 then separated and struck the starboard tailplane which failed in turn.

**Fig. 10** A85-416 starboard wing upper surface. Note the deep compression buckle immediately outboard of the wing joint and the missing wing tip. The leading edge damage resulted from impact with the tailplane

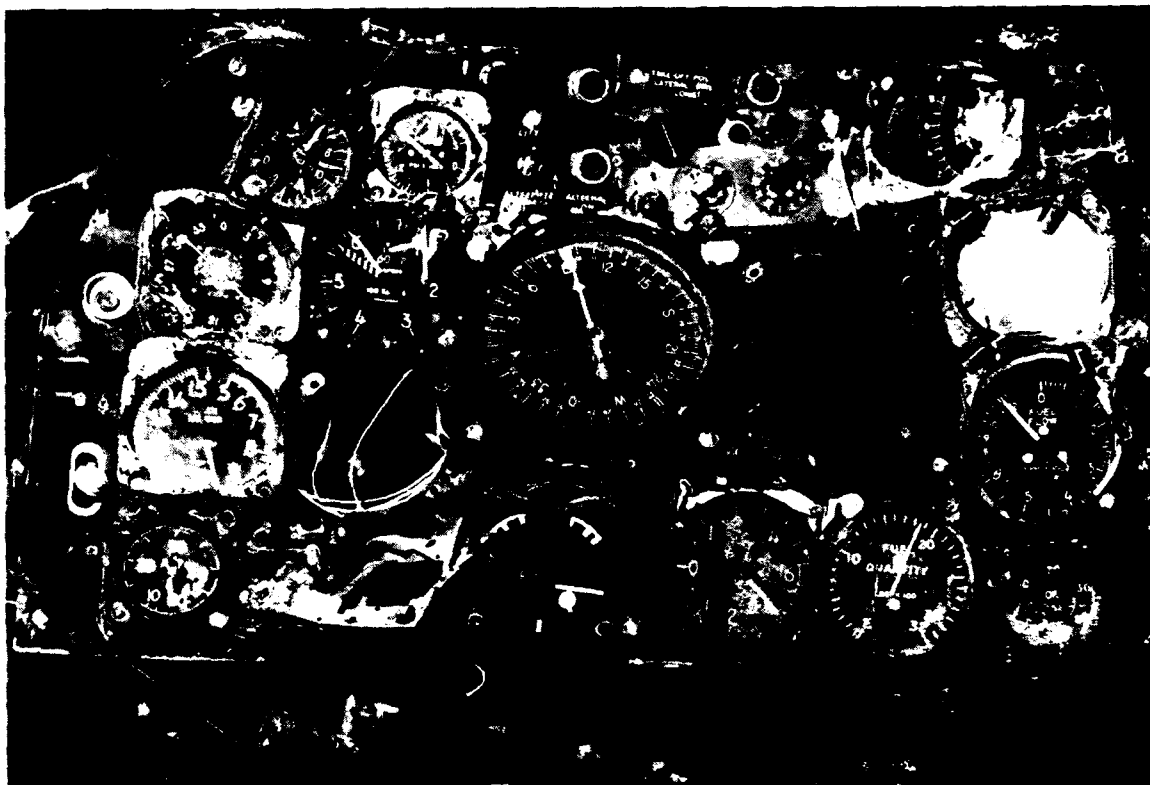
**Fig. 15** Instrument panel from A94-360 with Mach meter at left centre

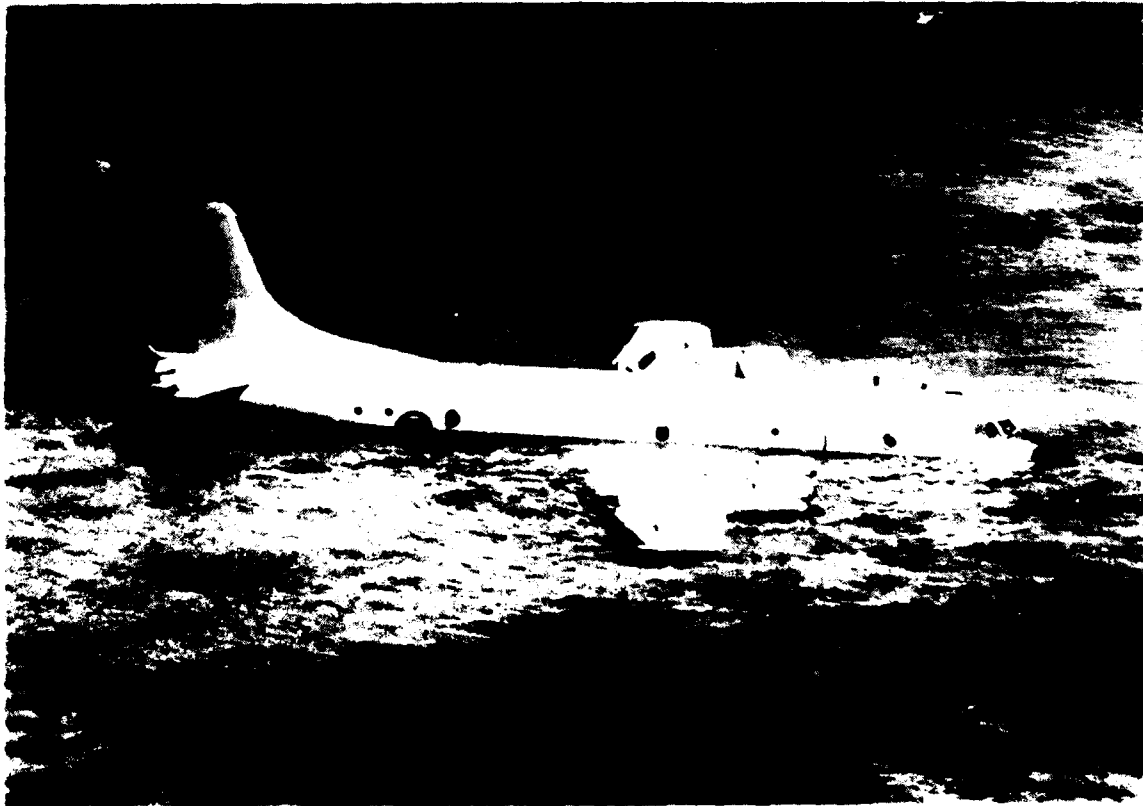
Water impact occurred with the aircraft in a nose high, slightly left wing low attitude. Because all engines were at full power, torque reaction caused all four propellers to separate from their respective engines when the blade tips touched the water. Since their direction of rotation was clockwise when viewed from the rear, the propellers separated by moving to starboard and the port inboard propeller (No. 2) penetrated the port side of the forward fuselage killing one of the occupants. Similarly, the detached starboard propellers inflicted some damage on the outer section of the starboard wing leading edge, the starboard aileron and the starboard flap. As its speed diminished, the aircraft finally slewed to port and come to rest on the sea bed, Fig. 16.

**Fig. 16** Orion A9-754 in the lagoon at Cocos Island. Note the missing propellers

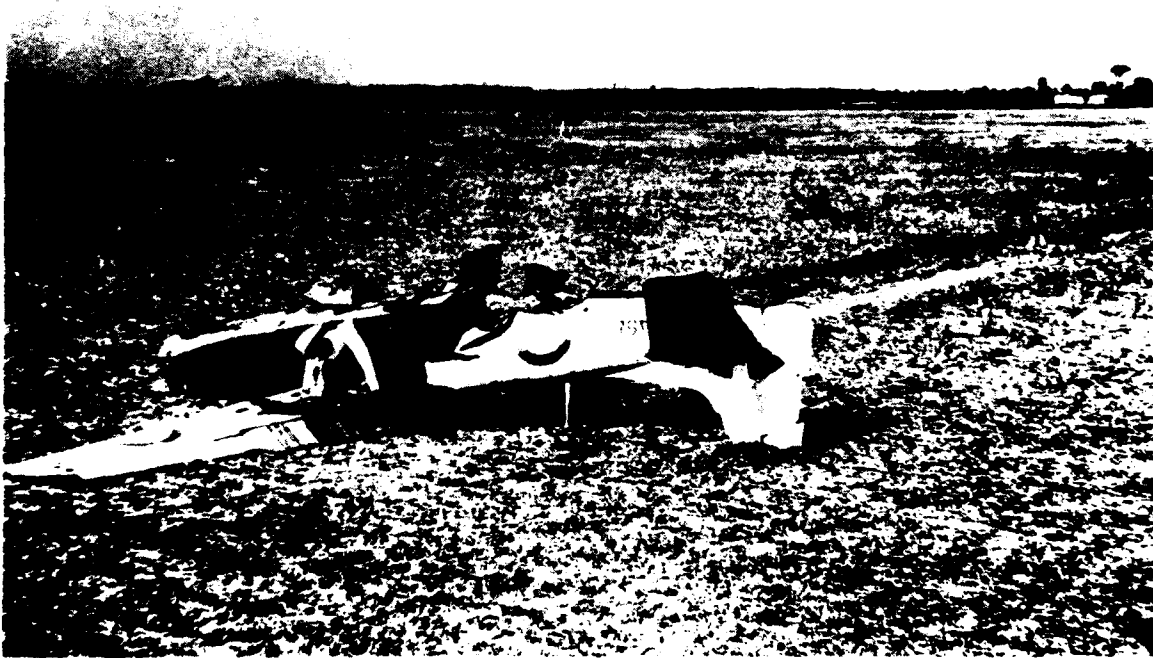
**Fig. 22**      **The wreckage of A68-123 with its detached propeller in the distance**

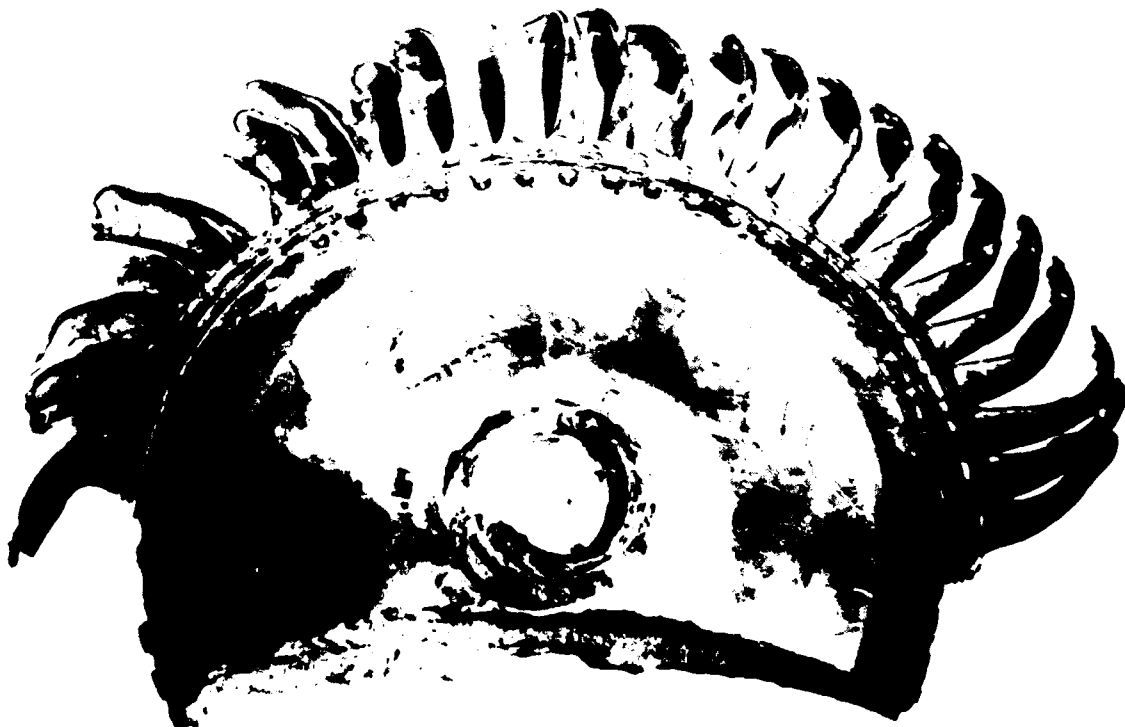
**Fig. 23**      **Fractured turbine disc recovered from the wreckage of WM374**

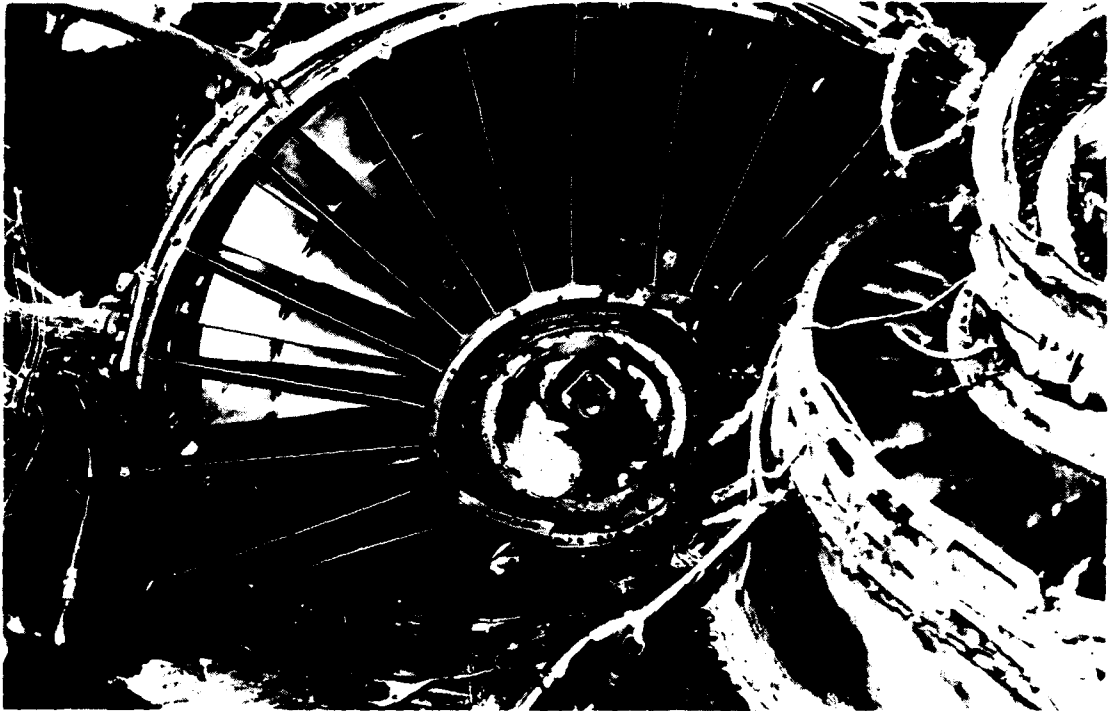
**Fig. 26** Fan stage of engine No.1 from A20-103 showing minimal rotational damage to blades

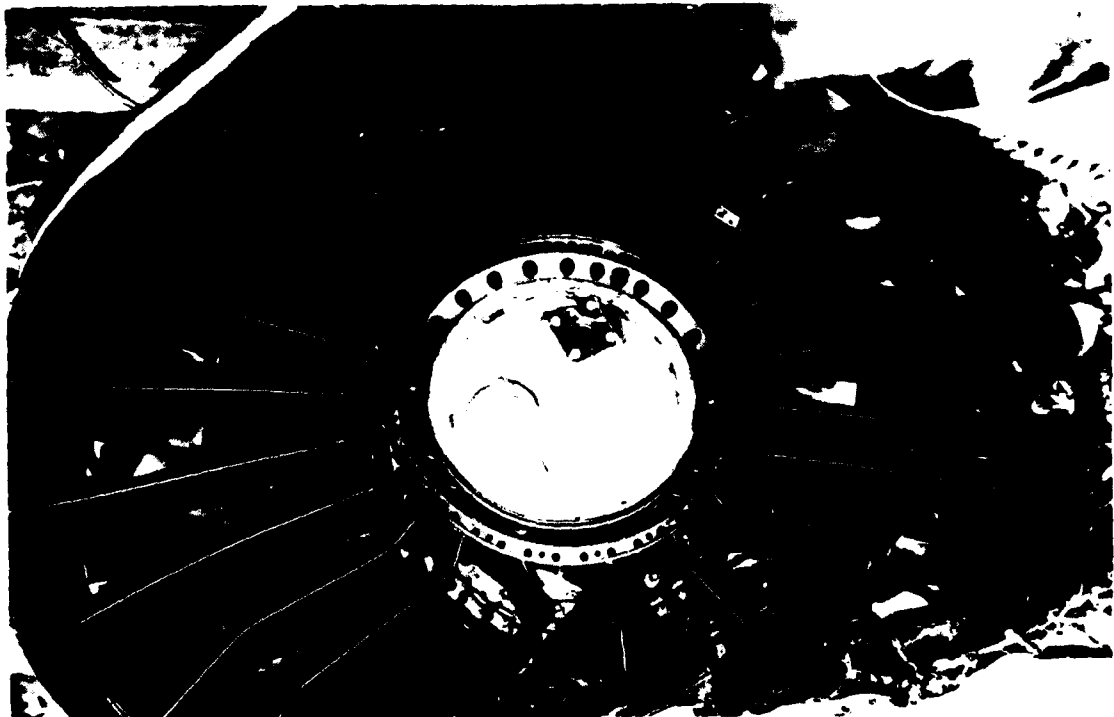
**Fig. 27** Fan stage of engine No. 2 as recovered. The blade damage is still small although greater than that for engine No. 1

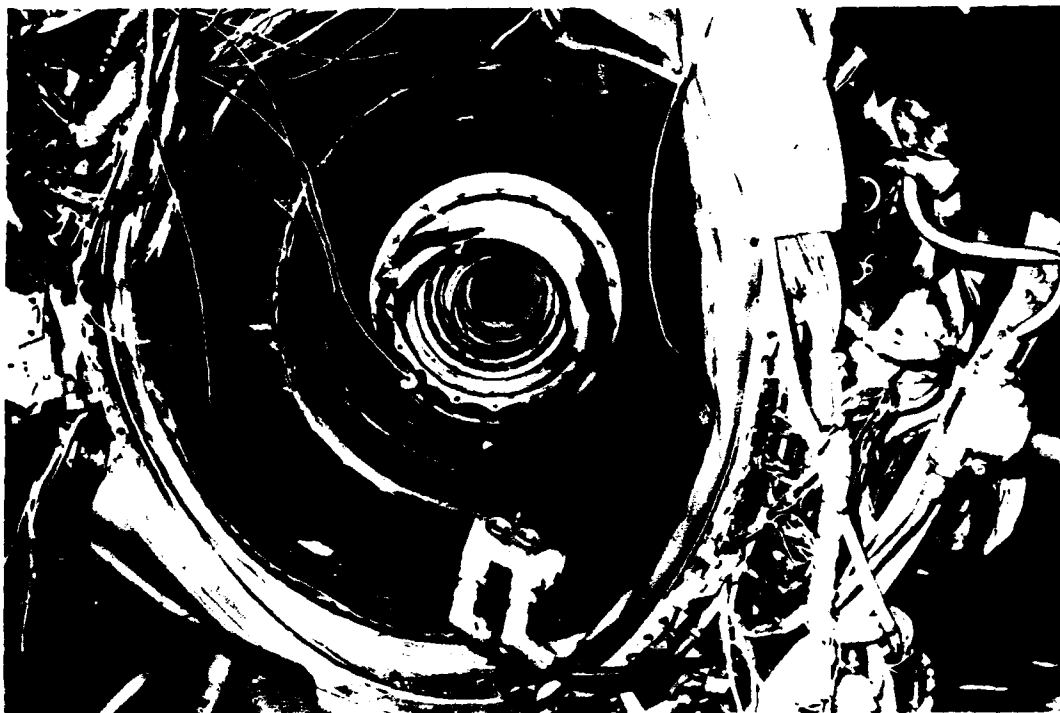
**Fig. 29** Front view of engine No. 4 as recovered showing the compressor damage and the sheared fan drive shaft

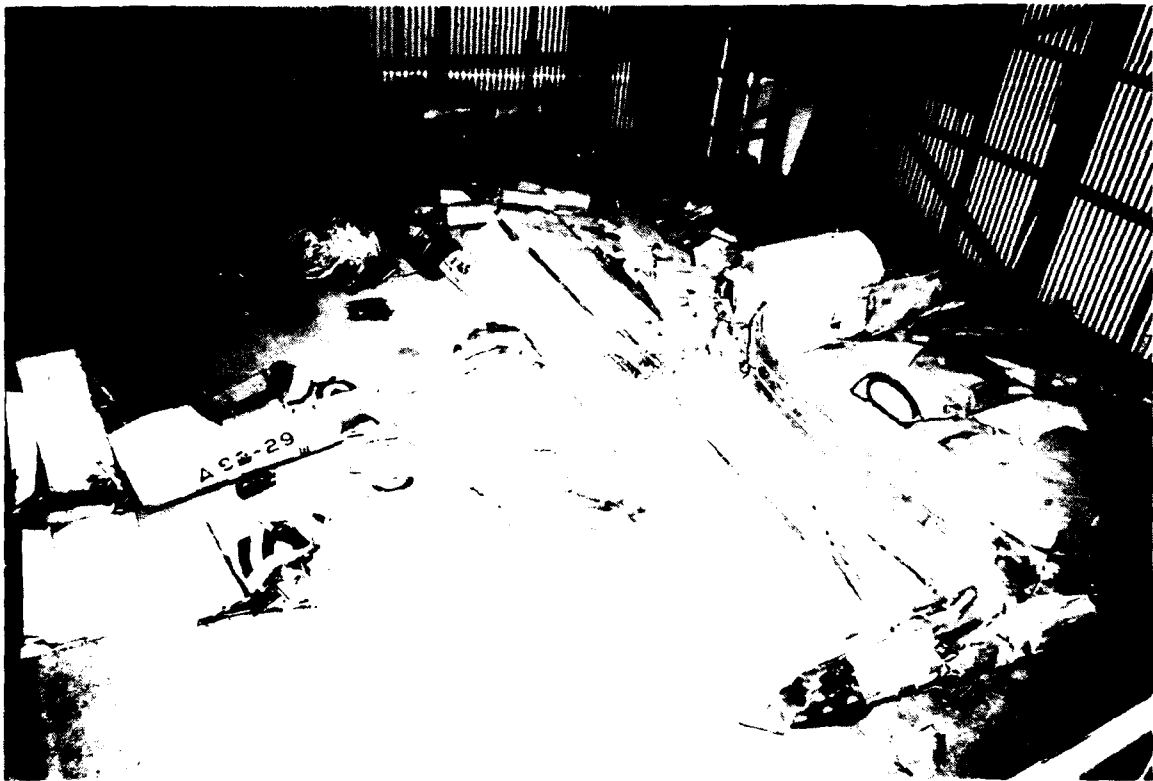
**Fig. 30**      **Wreckage of A92-29 re-assembled to show the multiplicity of structural failures**

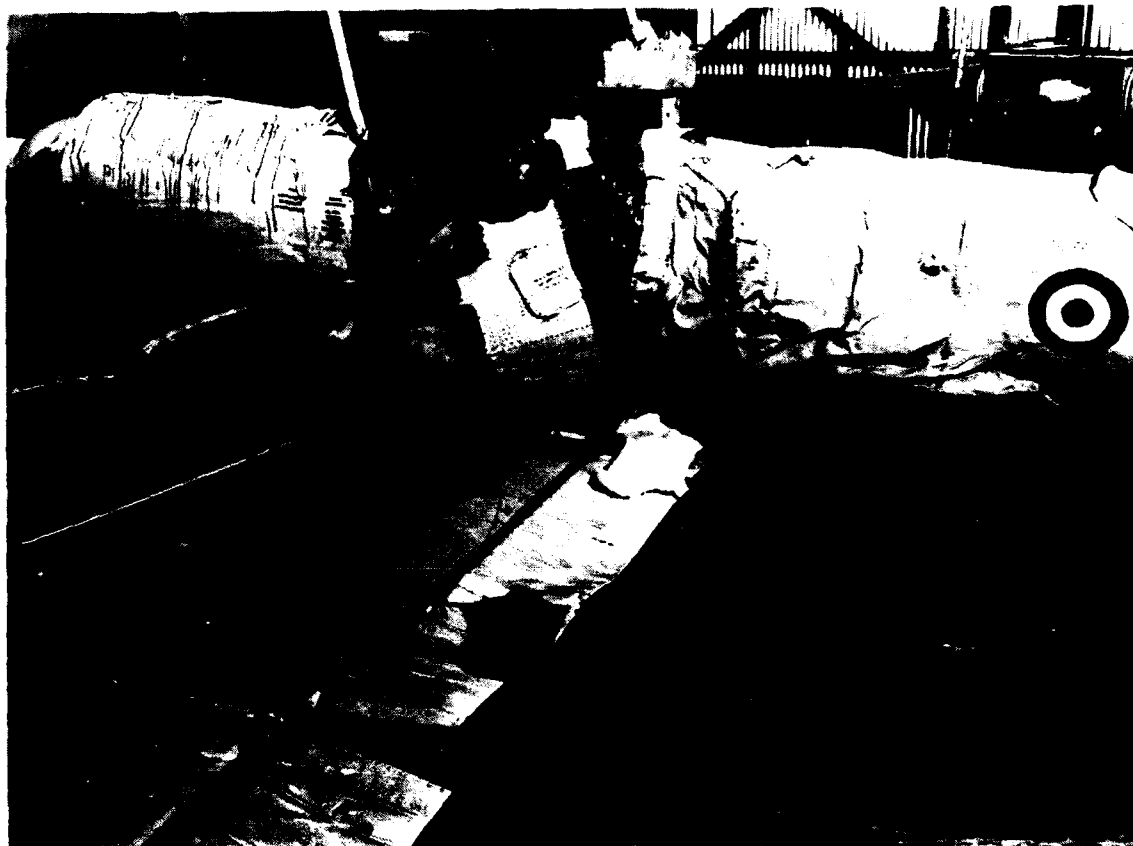
**Fig. 31**      **Upwards bending failure of the port wing of A92-45. Note the fuselage failures at stations 130 and 162 and the break-up of the centre fuselage. The underwing fairing was not recovered**

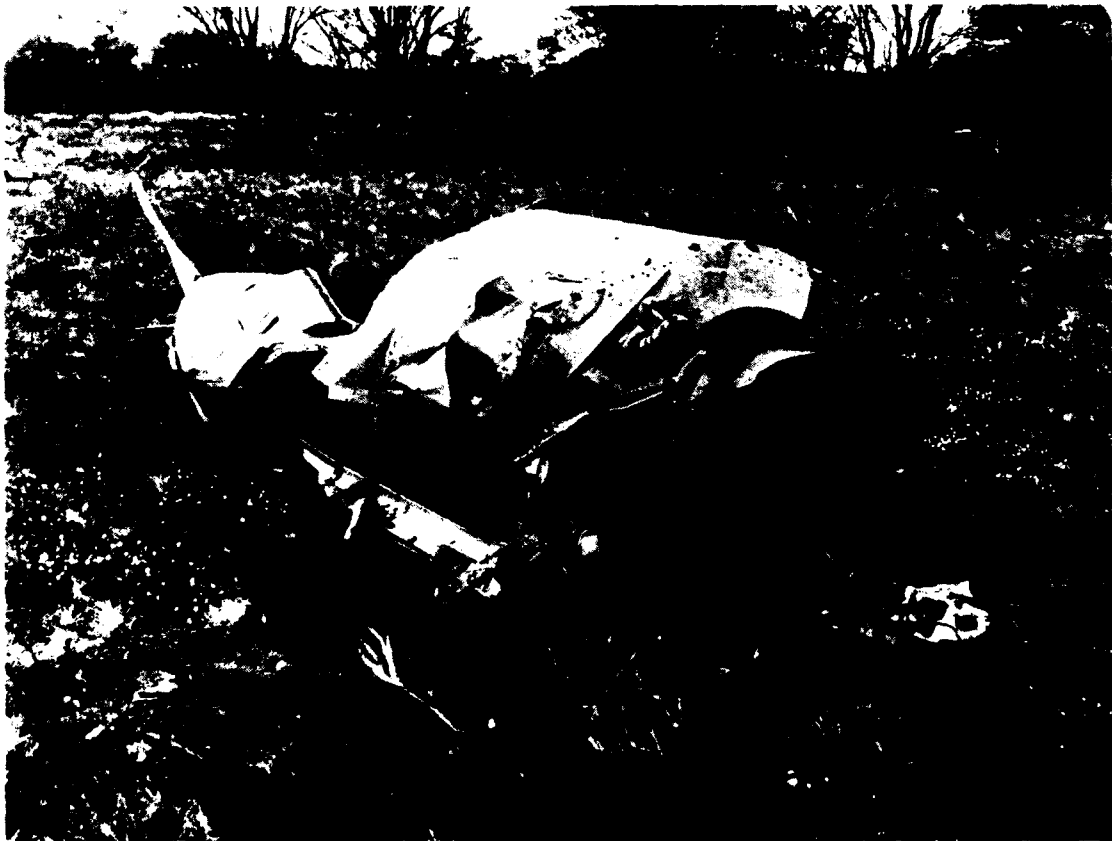
**Fig. 32** A familiar pattern of fuselage failure. The forward fuselage of A92-90 after failure at station 130

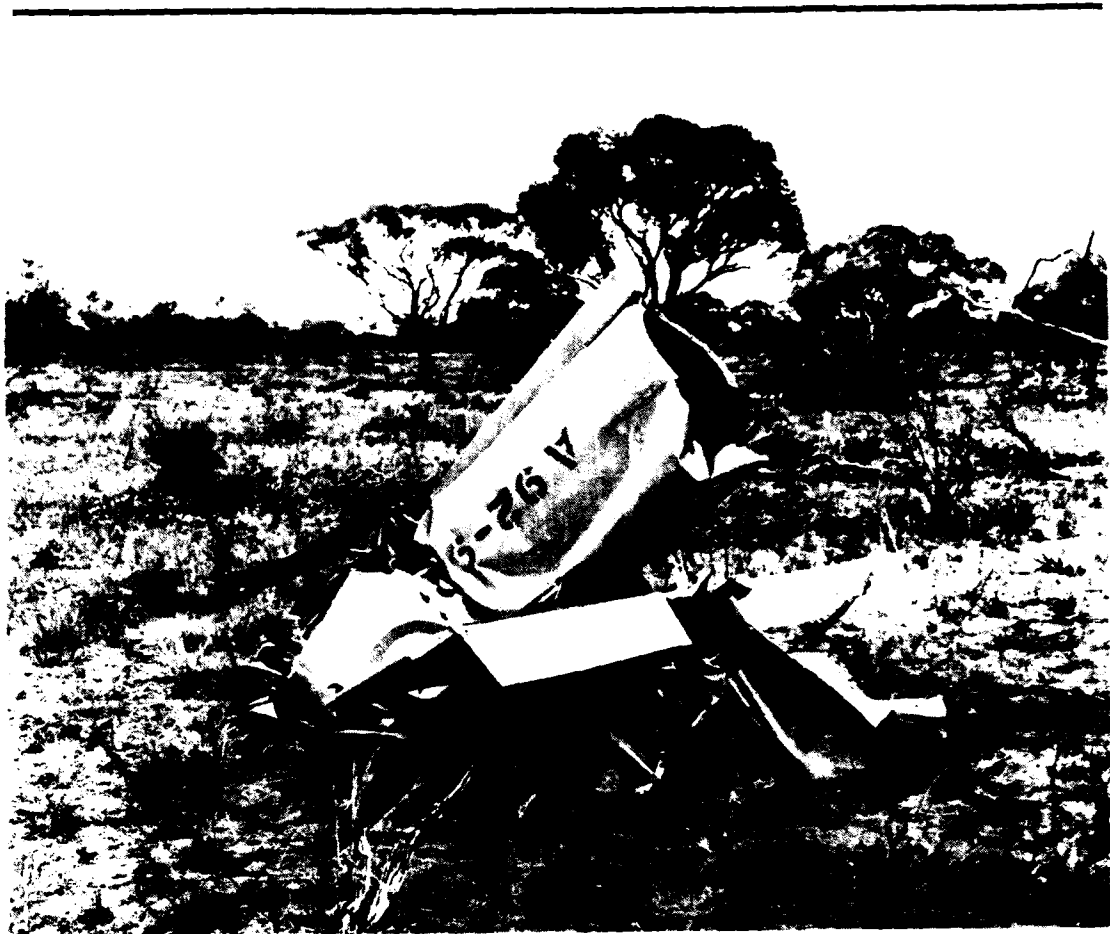
**Fig. 33** Tail unit of A92-90 showing damaged elevators with mass balances still attached

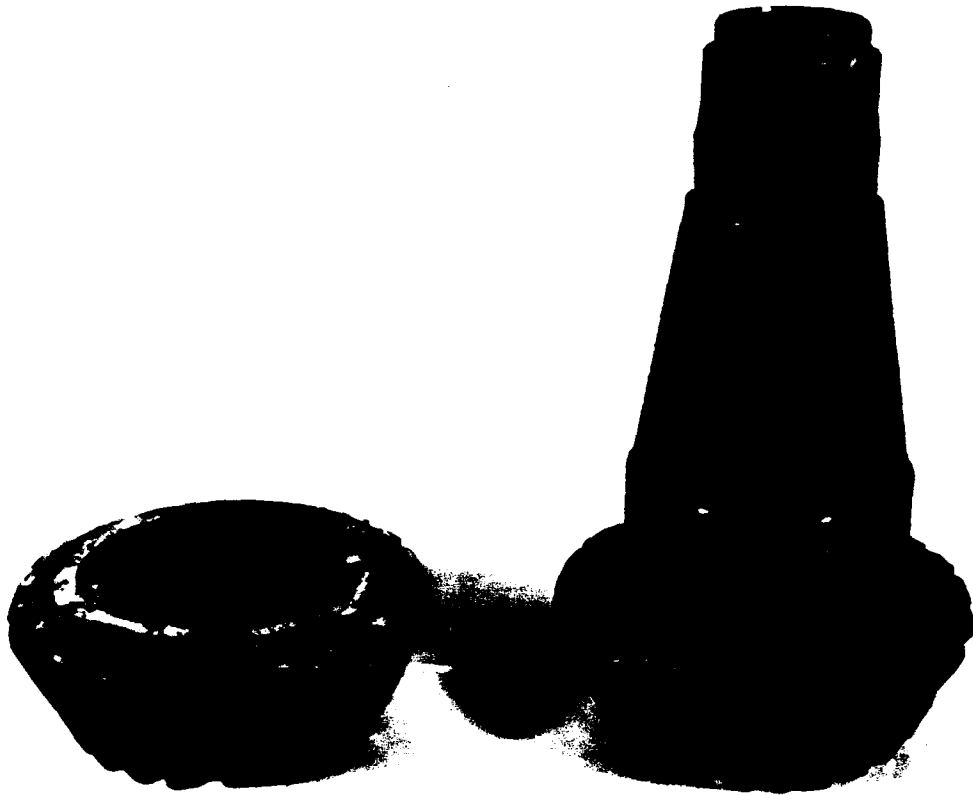
**Fig. 37**      The power input pinion from N7-215 as recovered compared with a new pinion. Note that the radial crack passes completely through the gear ring

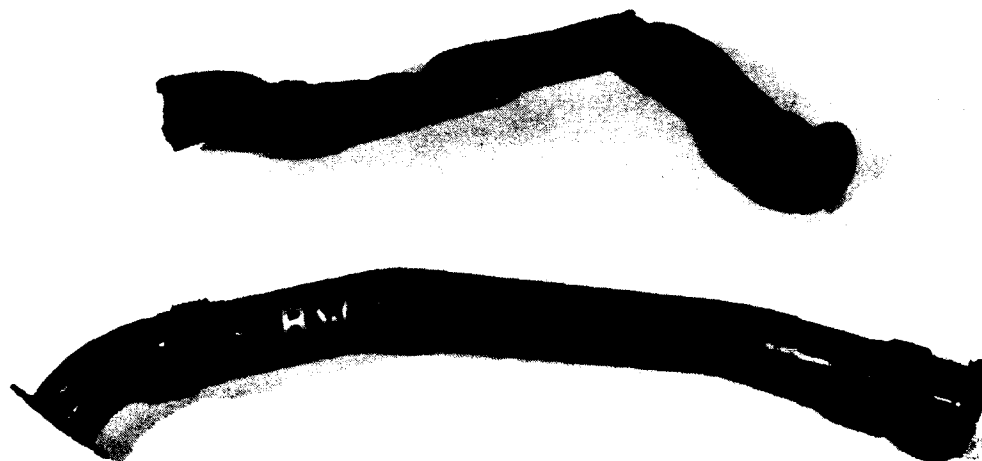
**Fig. 38** Hot air duct from A8-136 as recovered compared with a new duct

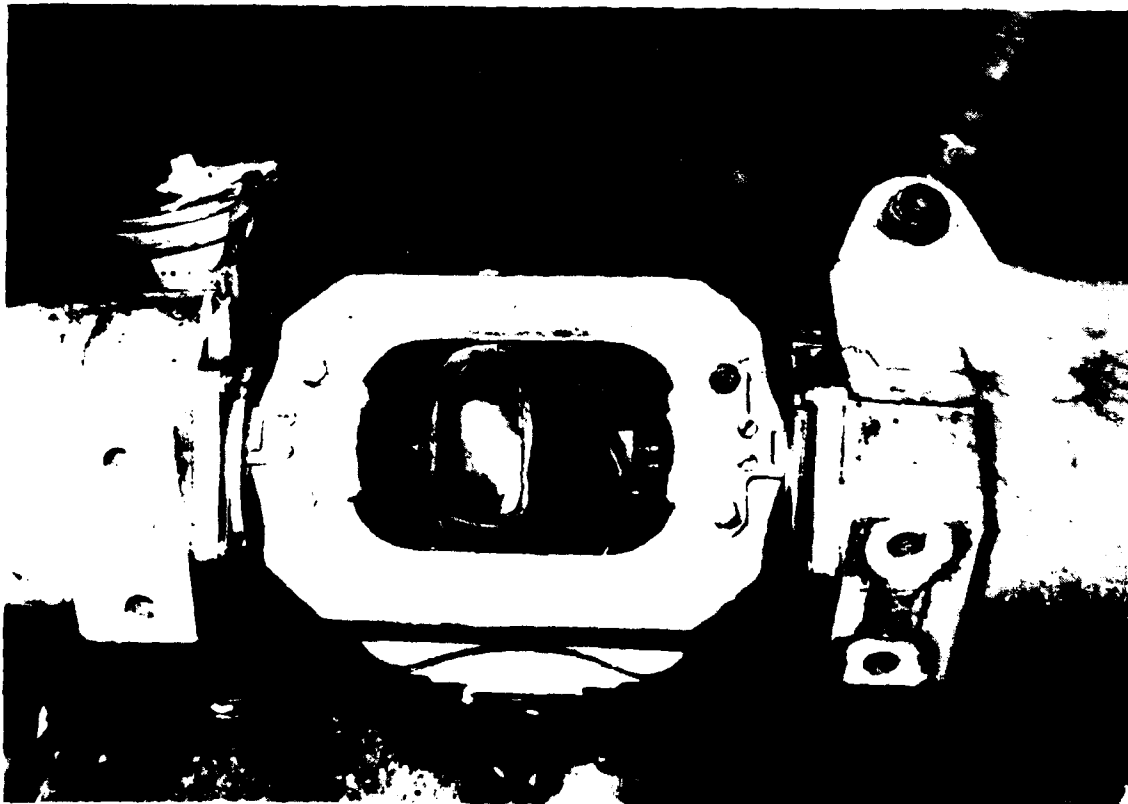
Fig. 41 Main rotor yoke of A2-719 showing the deformed and broken mast

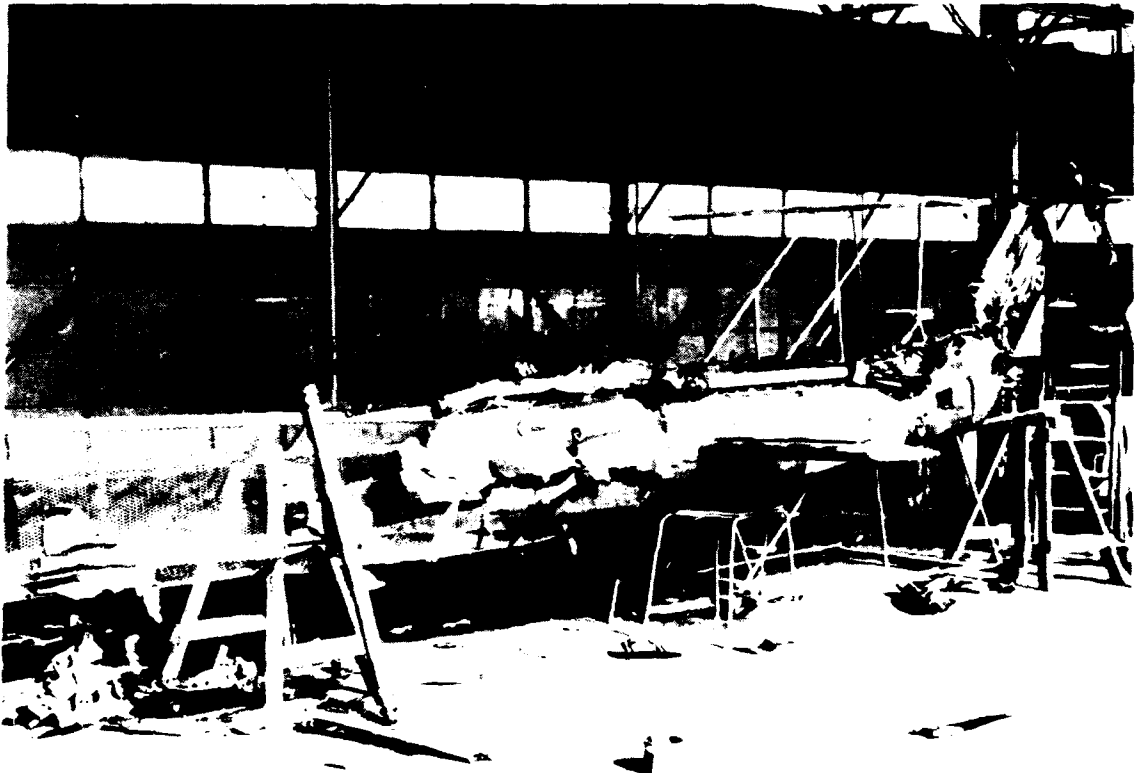
**Fig. 42** A2-719 at an early stage of re-assembly. The tail boom was severed forward of the elevator by a single main blade strike as indicated by the single impact damage to the tail rotor drive shaft

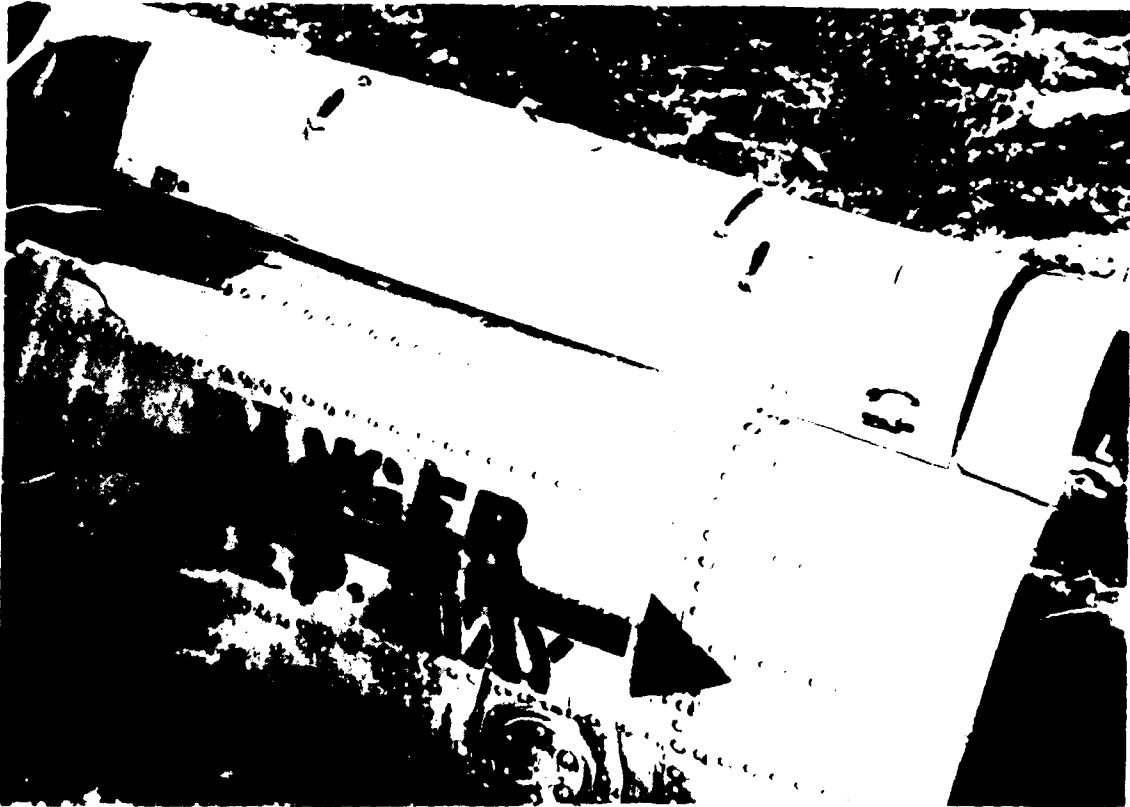
**Fig. 43** Transverse holes in the drive shaft tunnel cover of A2-386 made by a flailing pitch control cable

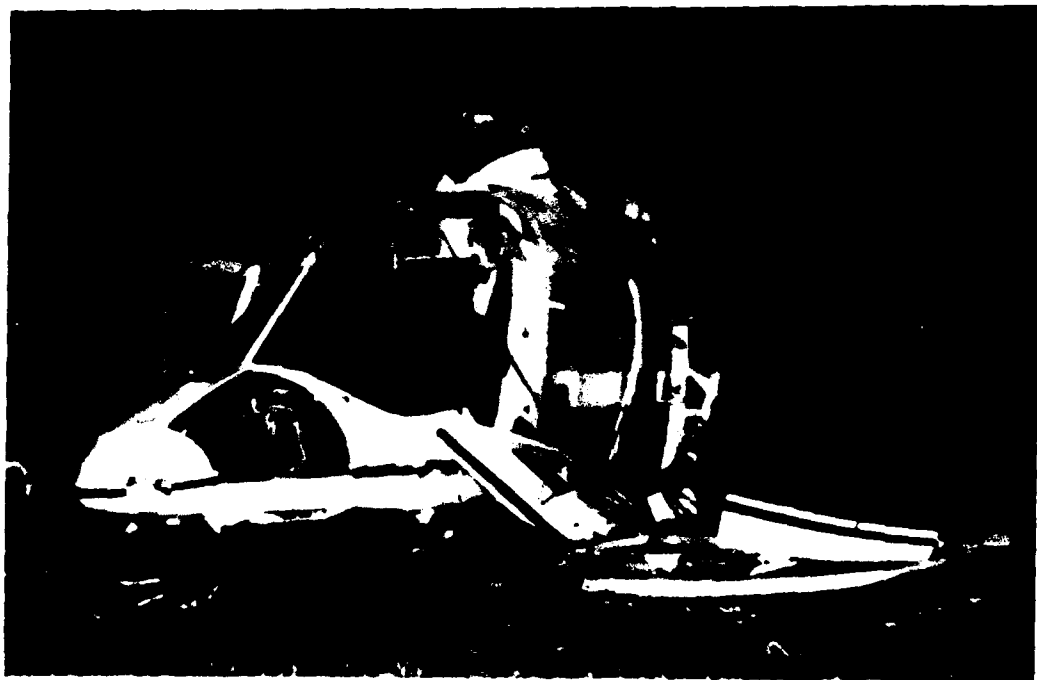
**Fig. 51**      **Wreckage of Agusta A109C M38-02**

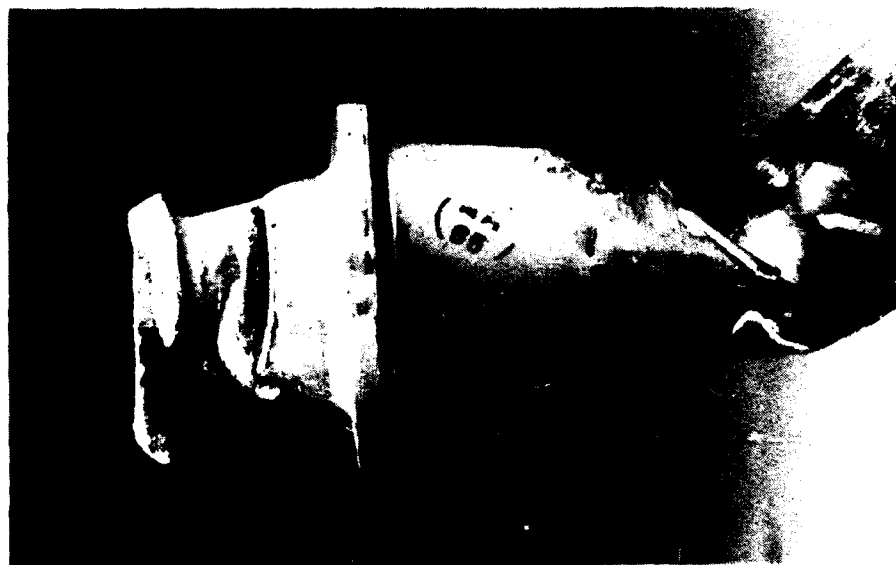
**Fig. 52** The failed drive shaft coupling from M38-02. Note the broken lugs at right caused by contact with the compressor drive drum, the cut in the end fitting made by the firewall, and the ground impact buckling of the shaft at left

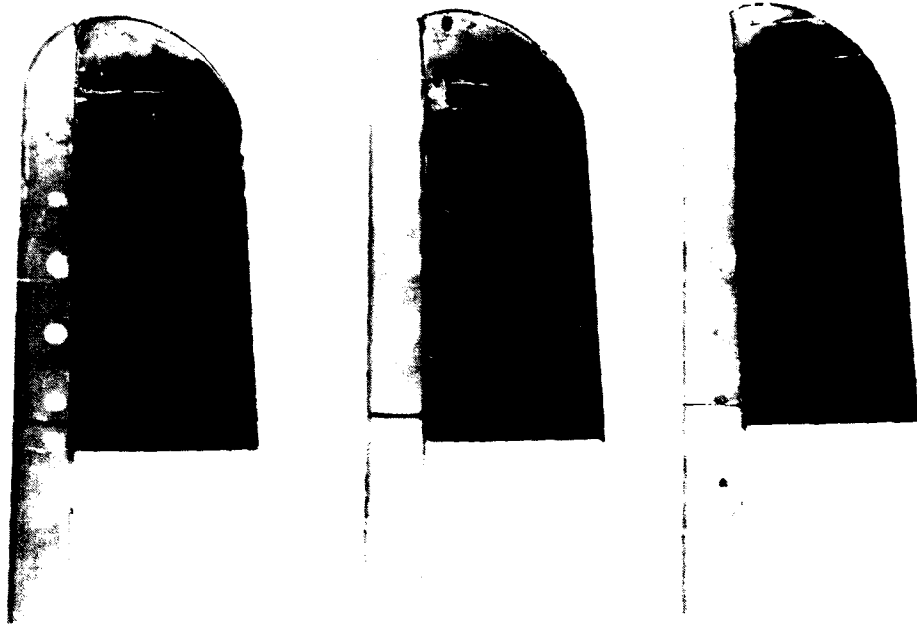
**Fig. 54** The three tail rotor blades from XN449 showing chordwise scratches on their outboard faces

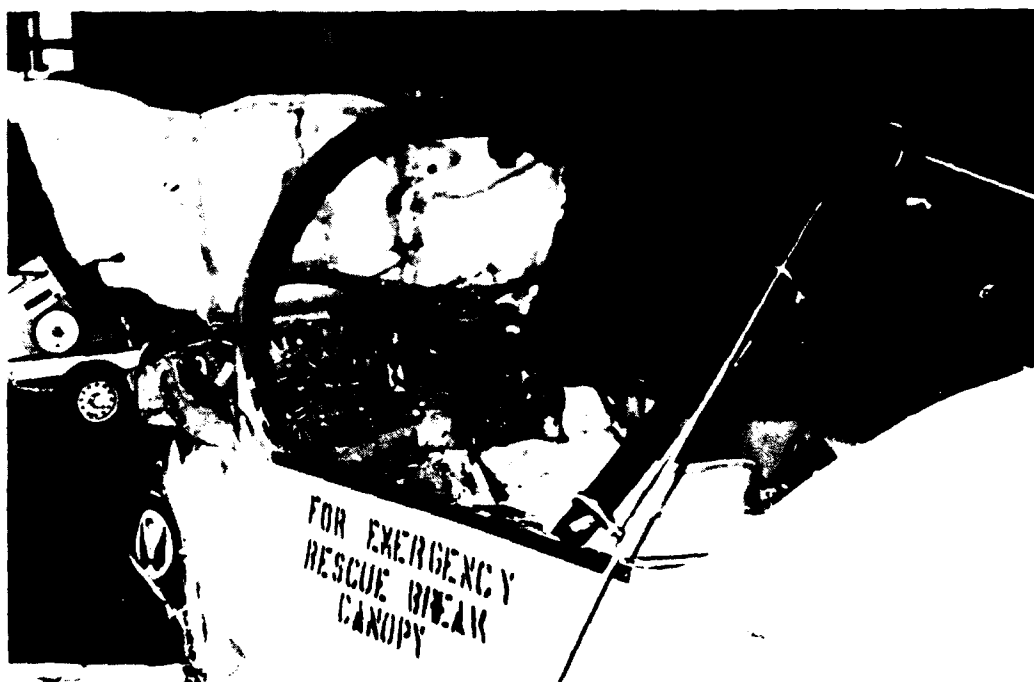
**Fig. 58** Cockpit structure of A19-028 after the accident. Note the impact damage to the instrument panel and the missing windscreen
