United States  
General Accounting Office  
Washington, D.C. 20548

January 29, 1991

# Executive Summary

On April 19, 1989, 47 sailors died when five bags of propellant ignited in the open chamber of the center 16-inch gun of the battleship U.S.S. Iowa's turret II. The Navy's investigation concluded that the explosion resulted from a deliberate act and not from a defect in the gun or propellant.

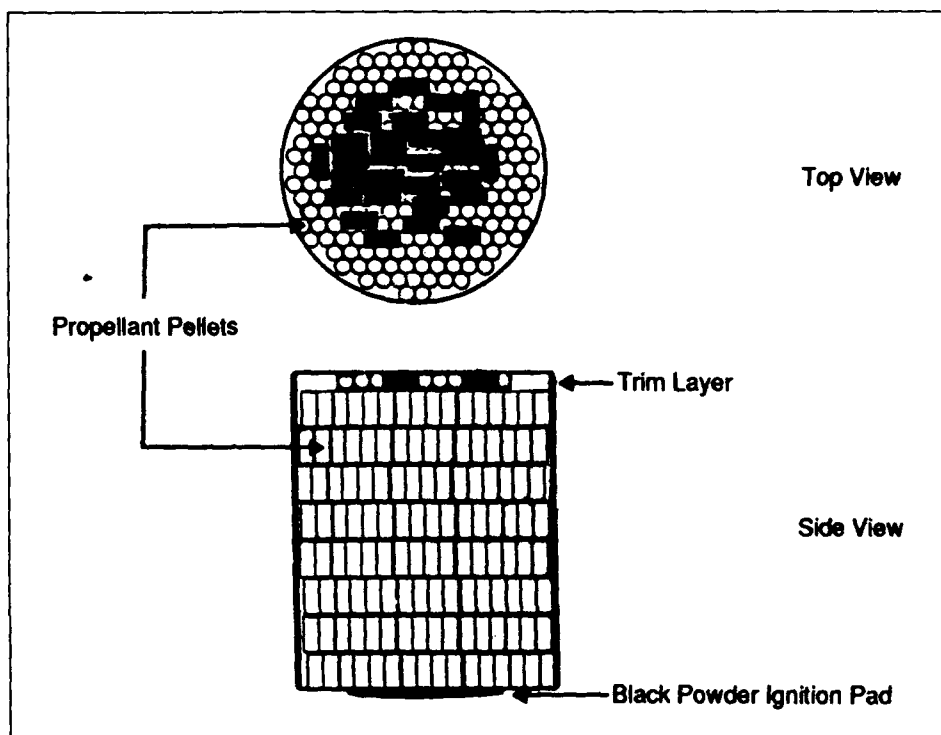
**Figure 1.3: Powder Configuration of the Type of Powder Involved in the Iowa Explosion**

The powder for the 16-inch guns is contained in silk bags. Six bags are the standard charge to fire a projectile. Each bag of the type of powder involved in the Iowa explosion contained about 94 pounds of propellant pellets. As shown in figure 1.3, these pellets are stacked vertically in the bag in eight layers. Each bag also contains a trim layer that consists of a variable number of propellant pellets placed horizontally on the top layer of vertically stacked pellets when necessary to standardize the weight of the charge. Additionally, a pad containing black powder is sewn to the base of the bag.

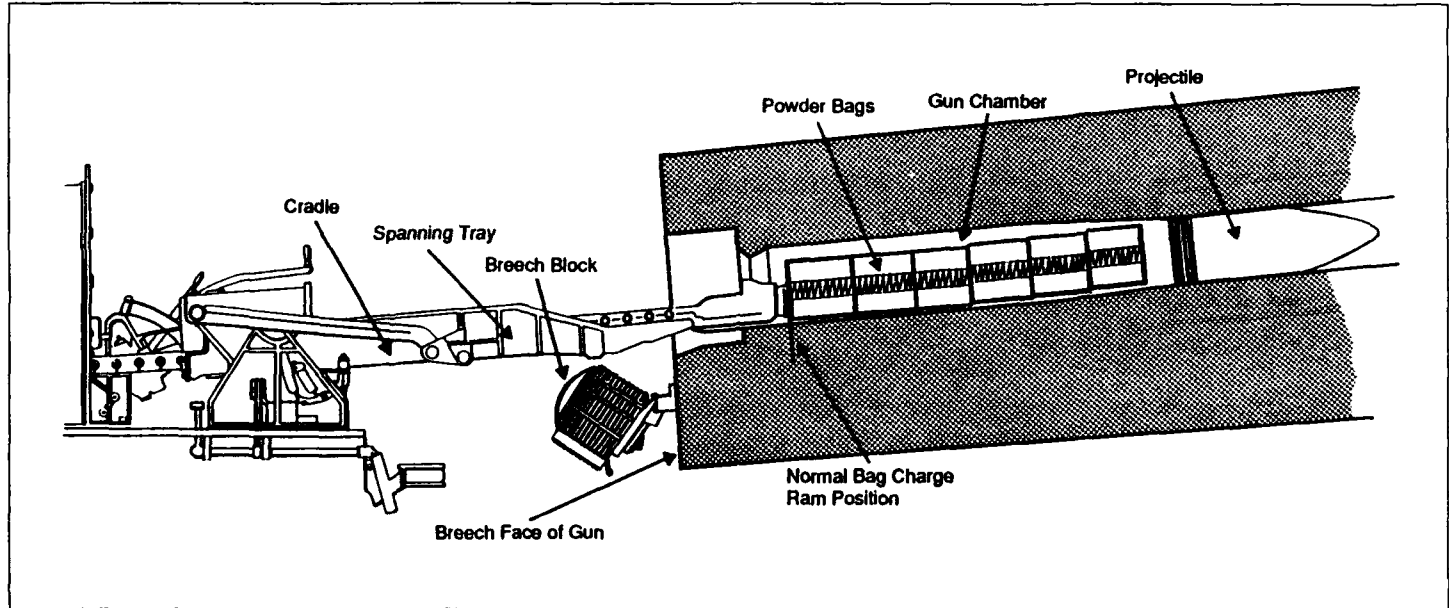
Figure 1.4: Gun and Rammer

Both the projectiles and the powder are loaded into the 16-inch guns using an electric-hydraulic rammer mechanism (see fig. 1.4). The projectile is loaded first, after which the powder bags are loaded. A crew member, responding to hand signals from the gun captain, controls the speed and length of the ram with a manually operated lever. Projectiles are to be rammed at a speed of about 14 feet a second, while the powder charge is to be rammed at about 1 to 2 feet a second. When a gun is fired, the black powder of the bag closest to the breech block is ignited by the primer, which ignites the propellant.

While the Navy's report stated the powder had only been rammed about 21 inches too far, Sandia concluded from its analysis of the damage the rammer chain caused as the chain was blown out of the chamber that the powder had been rammed about 24 inches too far. According to Sandia's analysis, the longer overram compressed the powder charge against the base of the projectile before it ignited.

Sandia made three recommendations in its report. First, it recommended that the 16-inch guns be equipped with a mechanism to control the speed of the rammer and the placement of the powder bags. Second, it recommended that the powder bag be redesigned to eliminate the need for a trim layer to reduce the propellant's sensitivity to impact. Third, it recommended that further testing be conducted to fully define the safe limits of pellet configuration, bag compression, rammer speed, and other relevant 16-inch gun and turret operations.
