Technical Report GL-93-20  
August 1993

## **Effects of Variable Tire Pressure on Road Surfacing**

### **Volume I: Design, Construction, Behavior Under Traffic, and Test Results**

Prepared for U.S. Department of Agriculture Forest Service

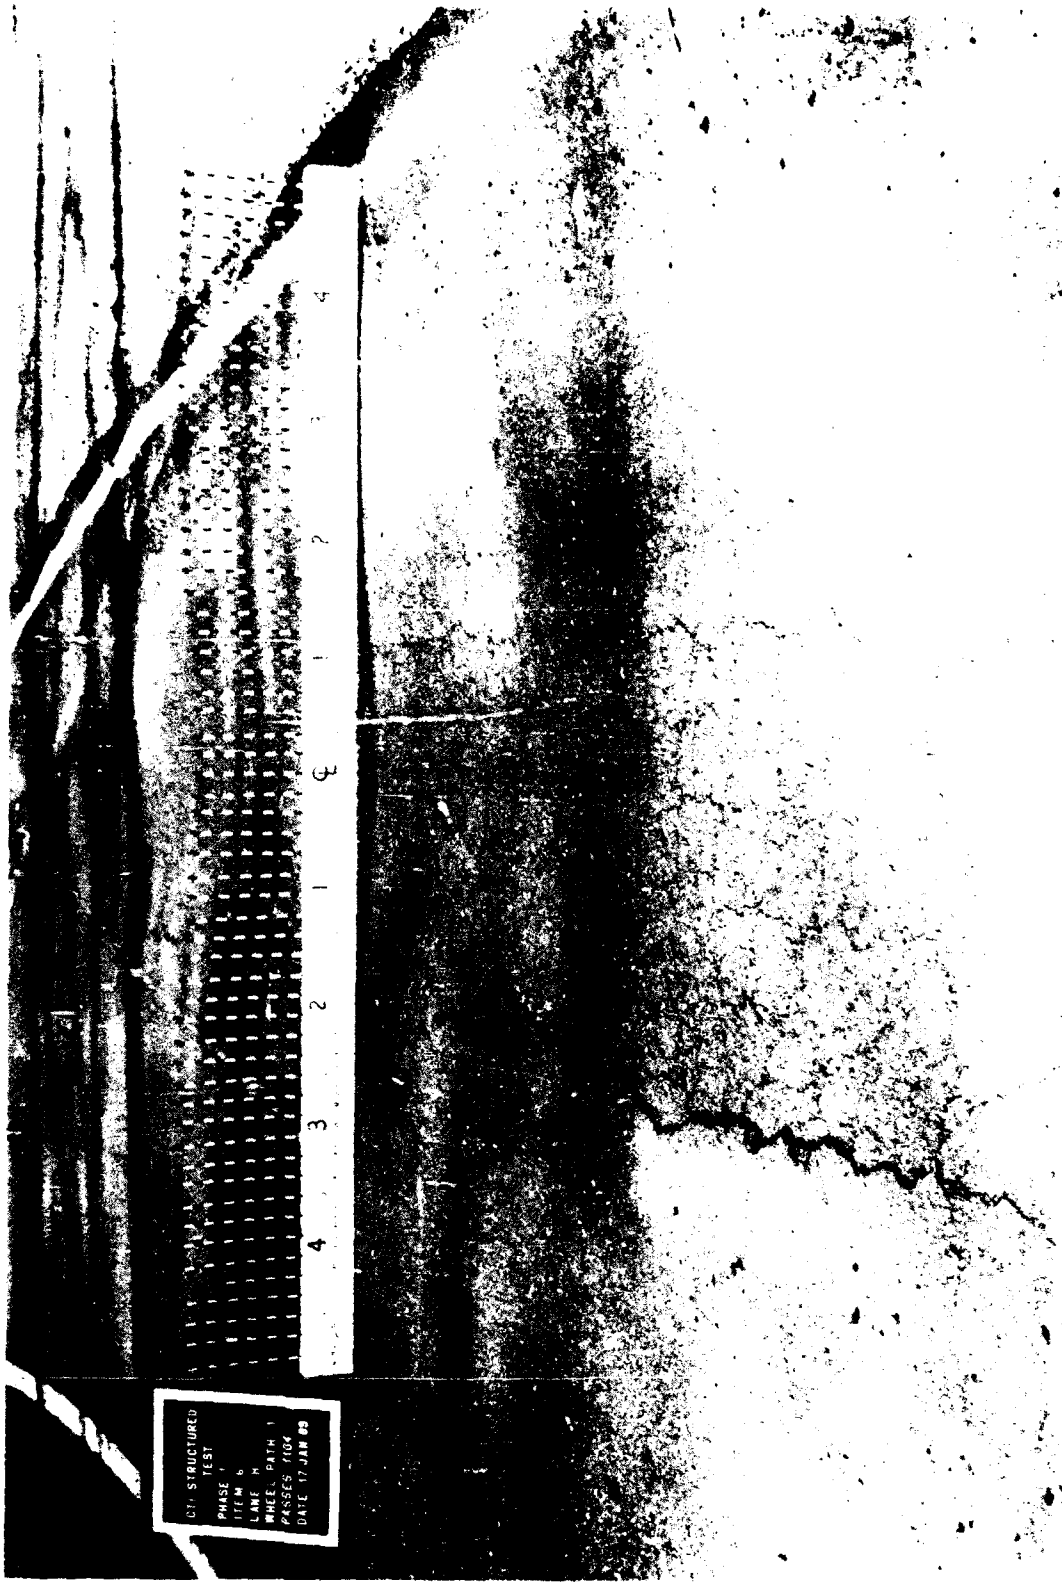
Photo 19. Item 6, high-tire pressure lane general view of failed area after 1,104 passes

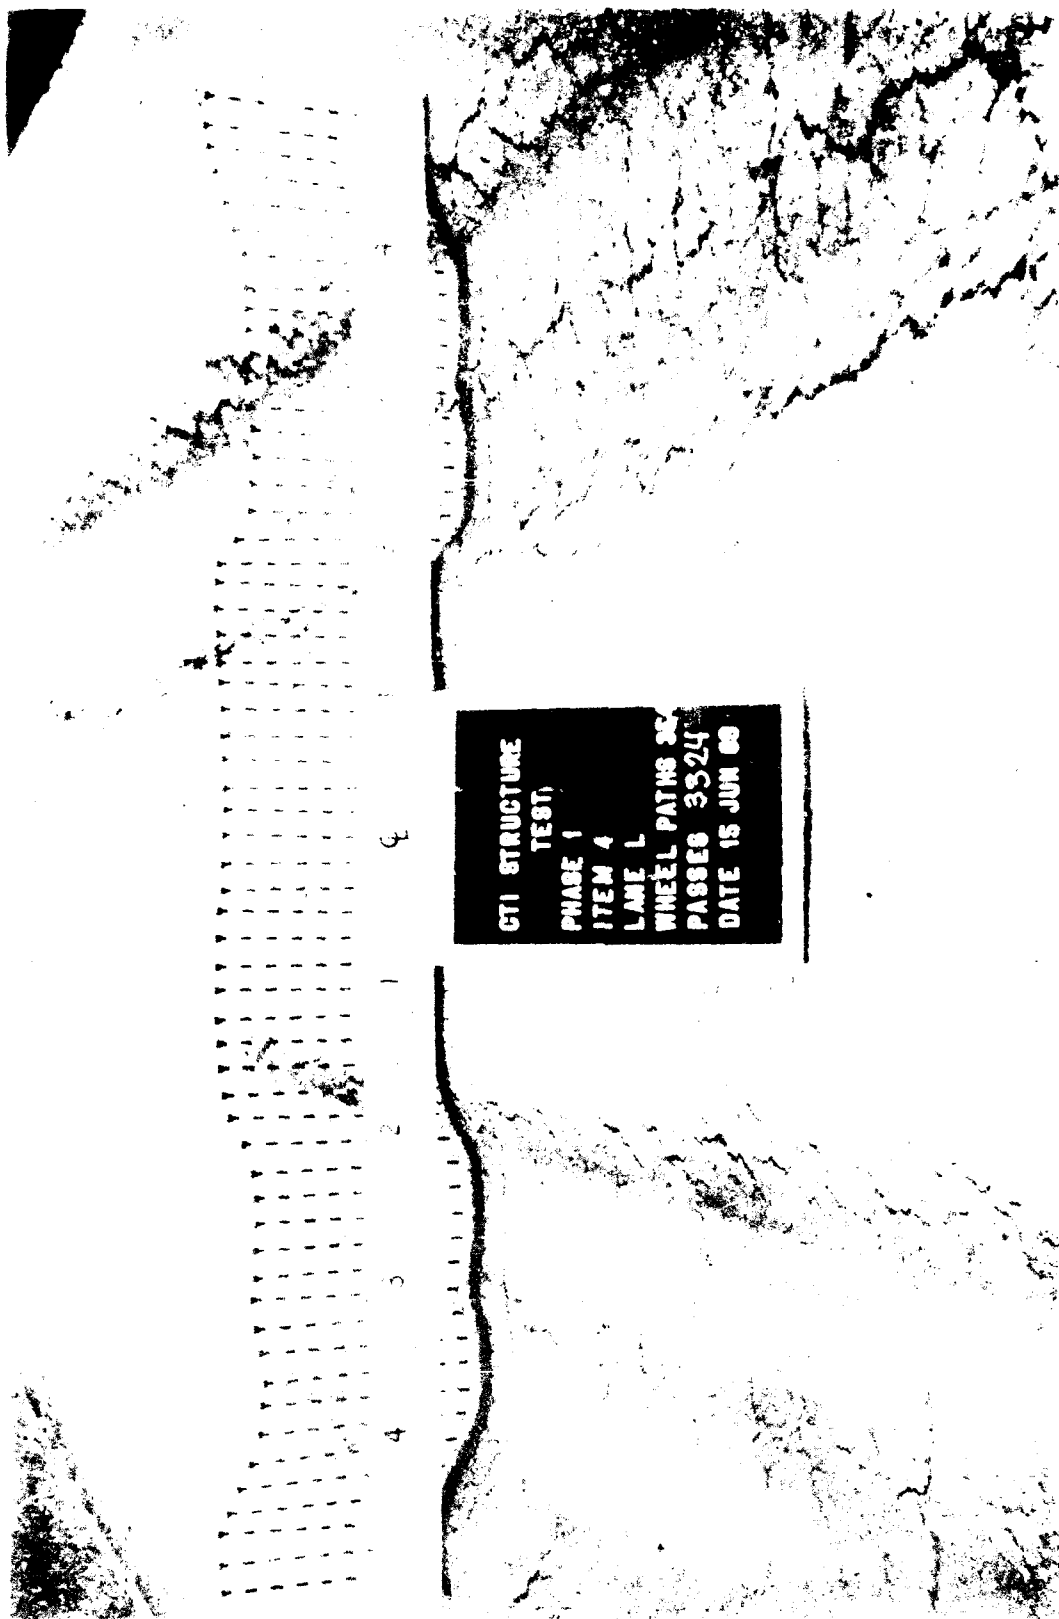
Photo 23. Item 4, low-tire pressure lane, general view of failure after 3,324 passes

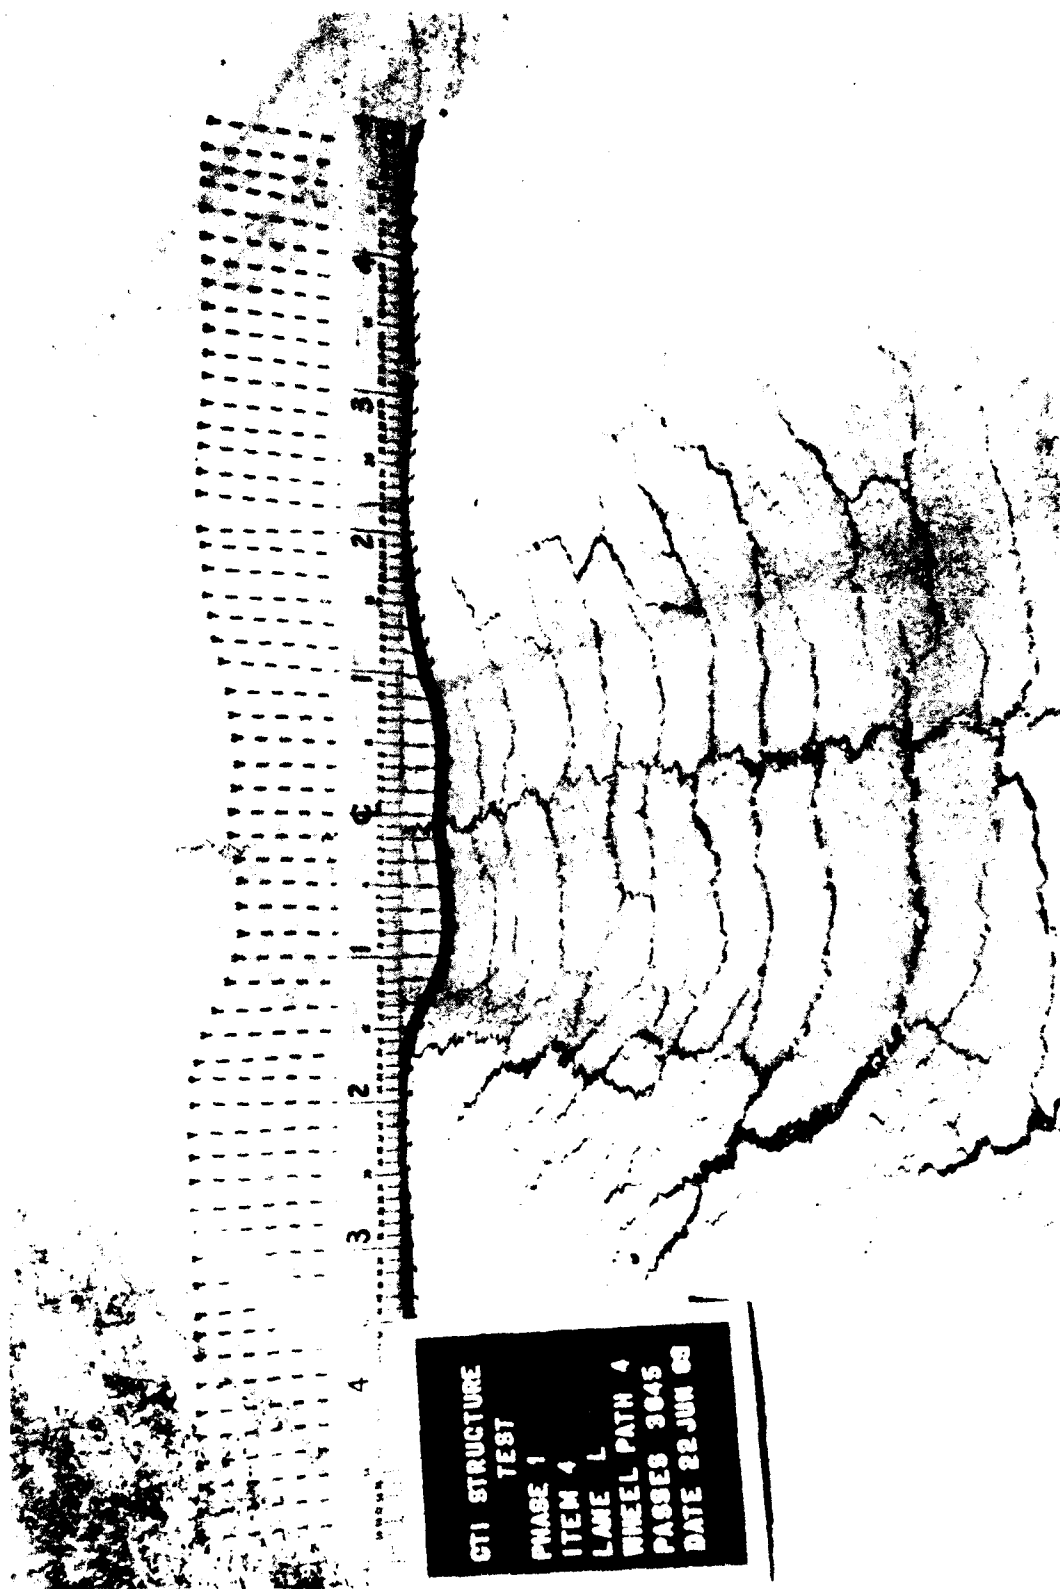
Photo 24. Item 4, wheel path 4, failure after 3,845 passes

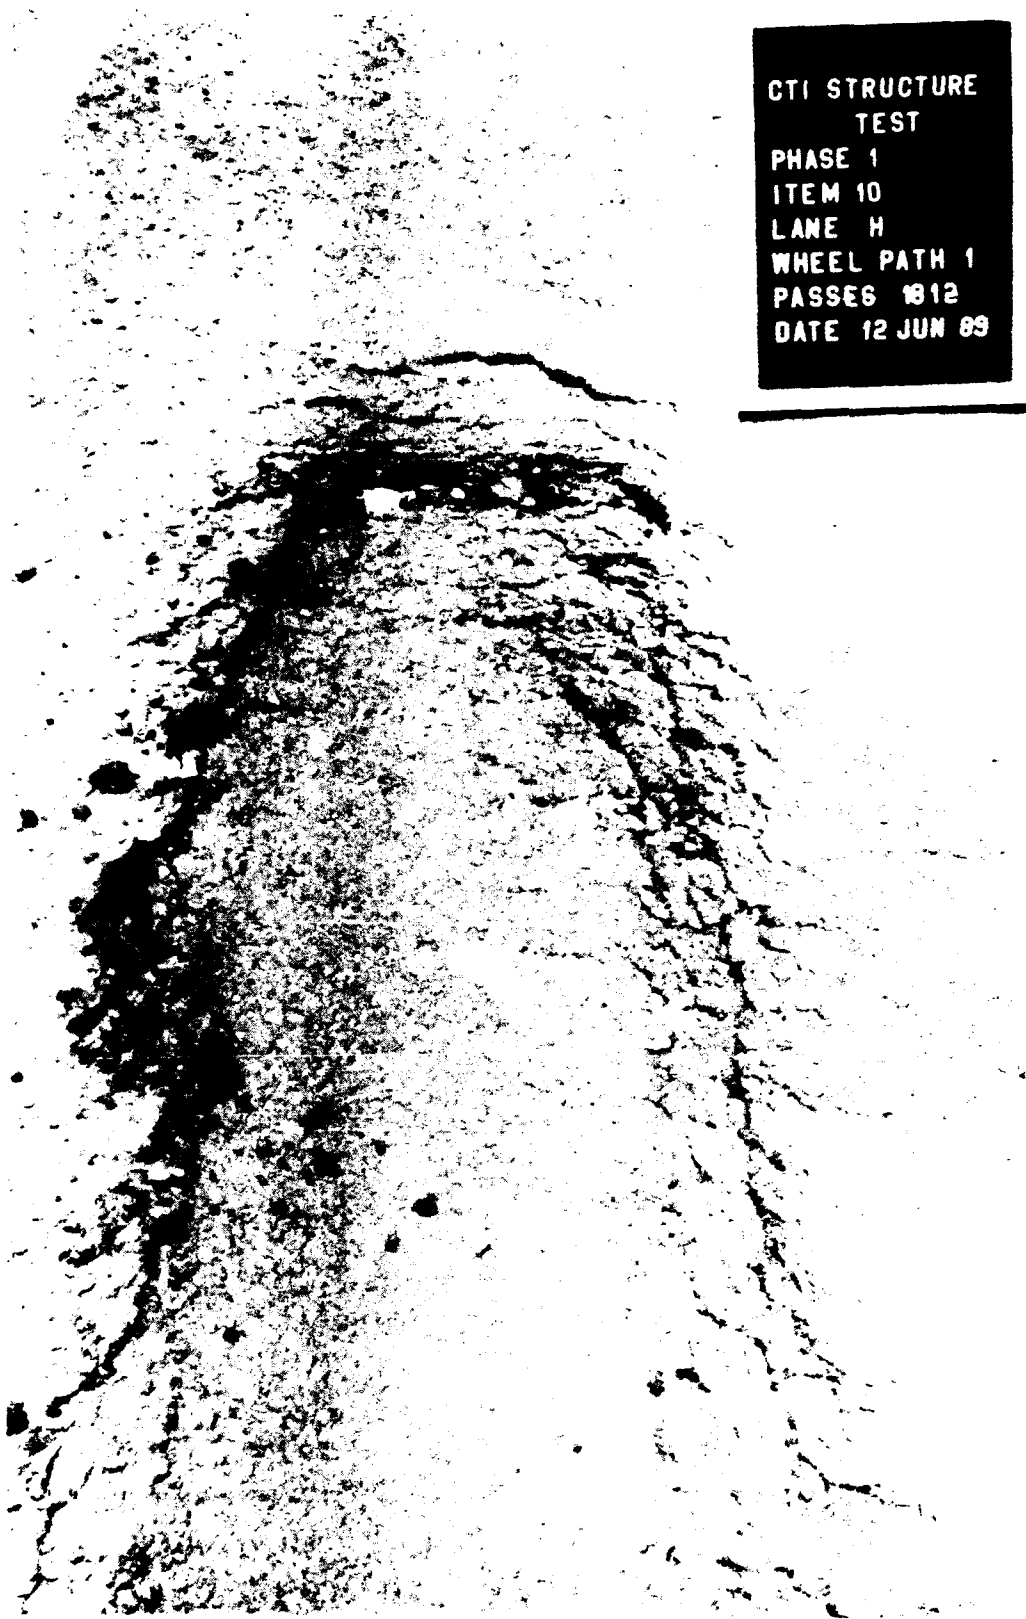
Photo 31. Item 10, wheel path 1, high-severity shoving after 1,812 passes

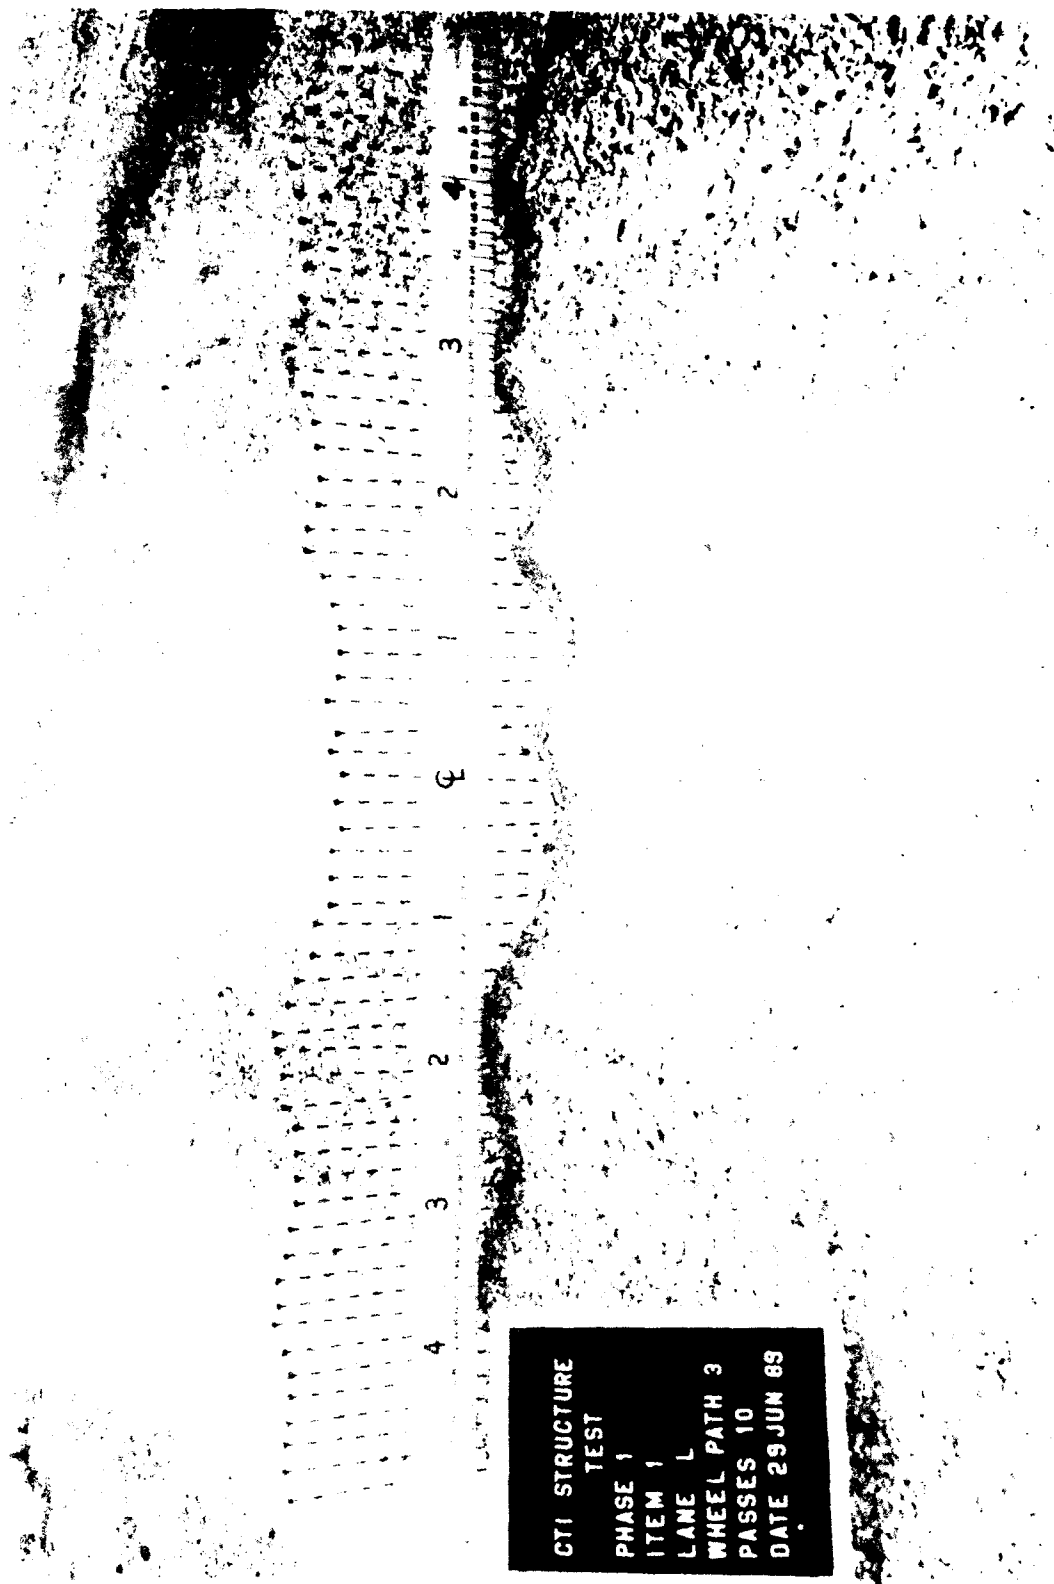
Photo 41. Item 1, low-pressure tire lane 5.5 in. rutting after 10 passes

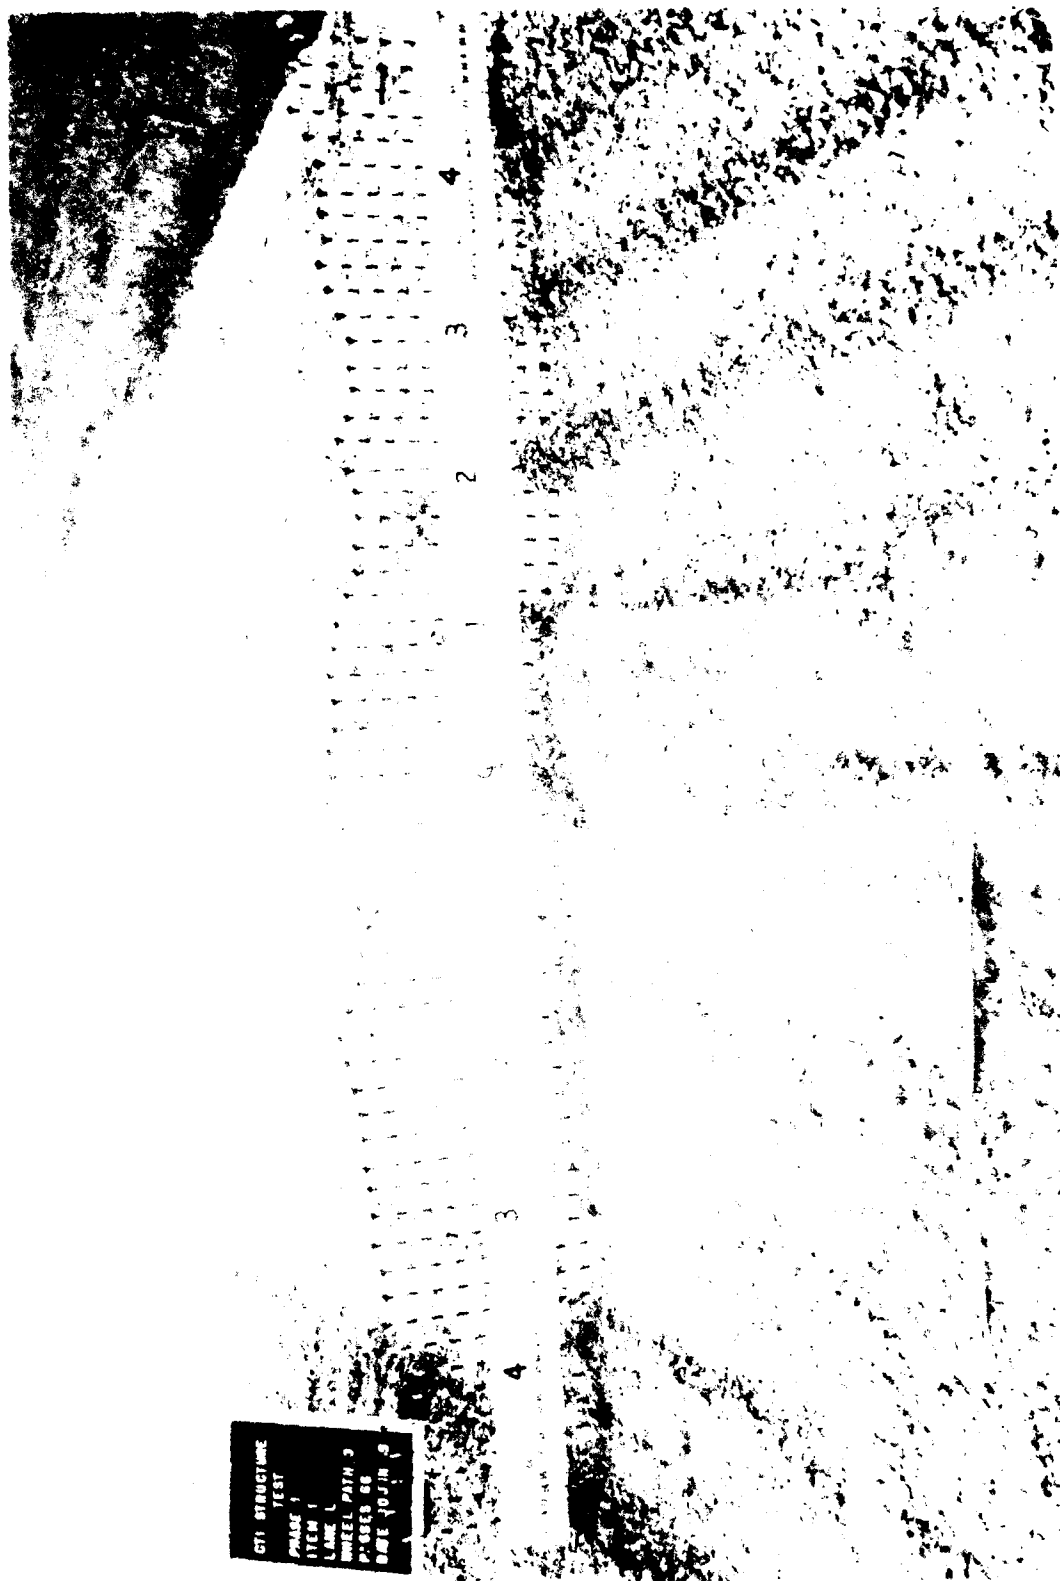
Photo 42. Item 1, low pressure tire lane, failure after 66 passes

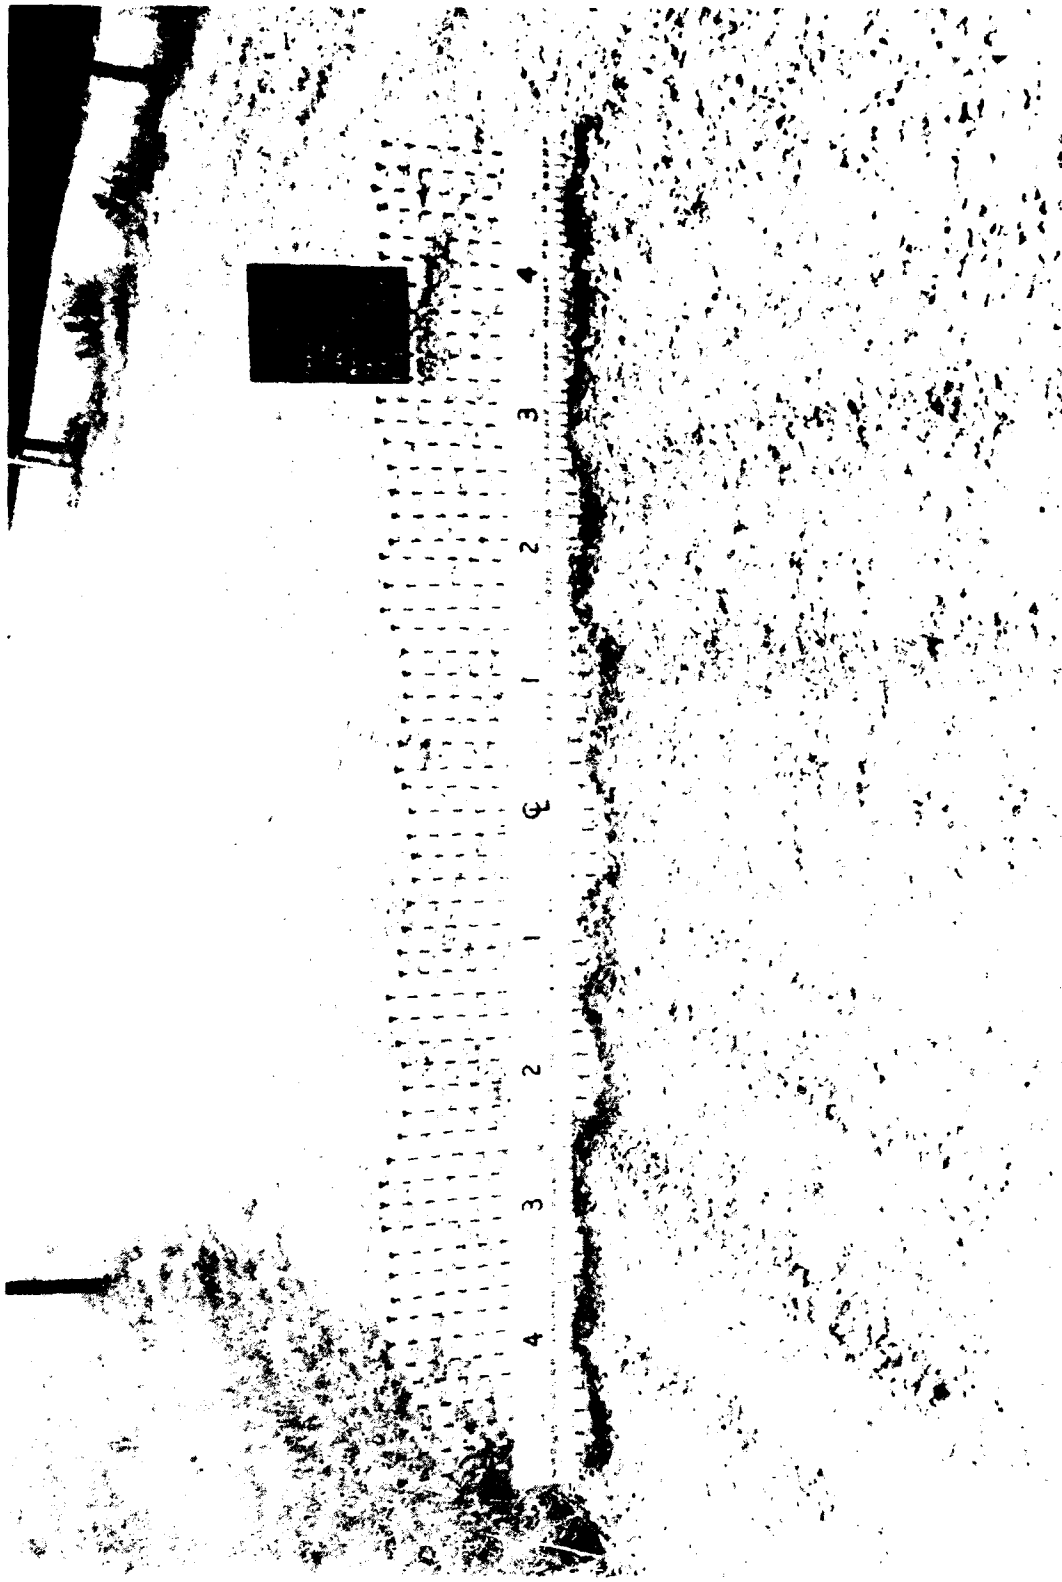
Photo 43. Item 1, high-pressure tire lane, failure after 58 passes

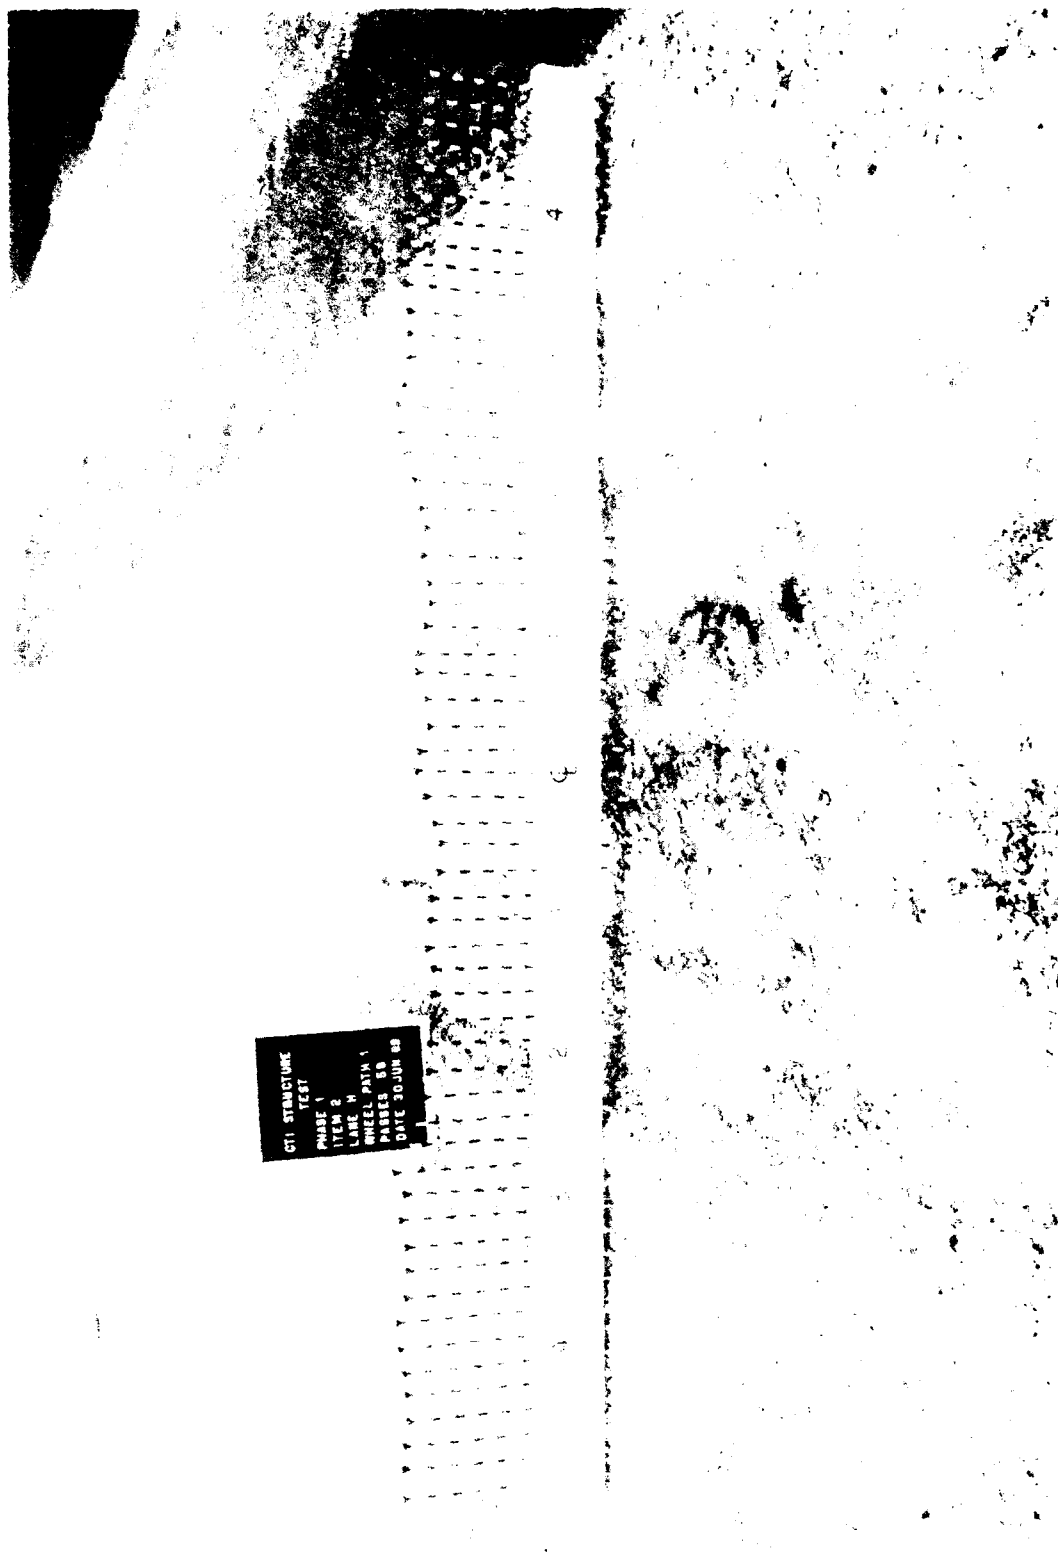
Photo 44. Item 2, high pressure tire lane, failure after 58 passes

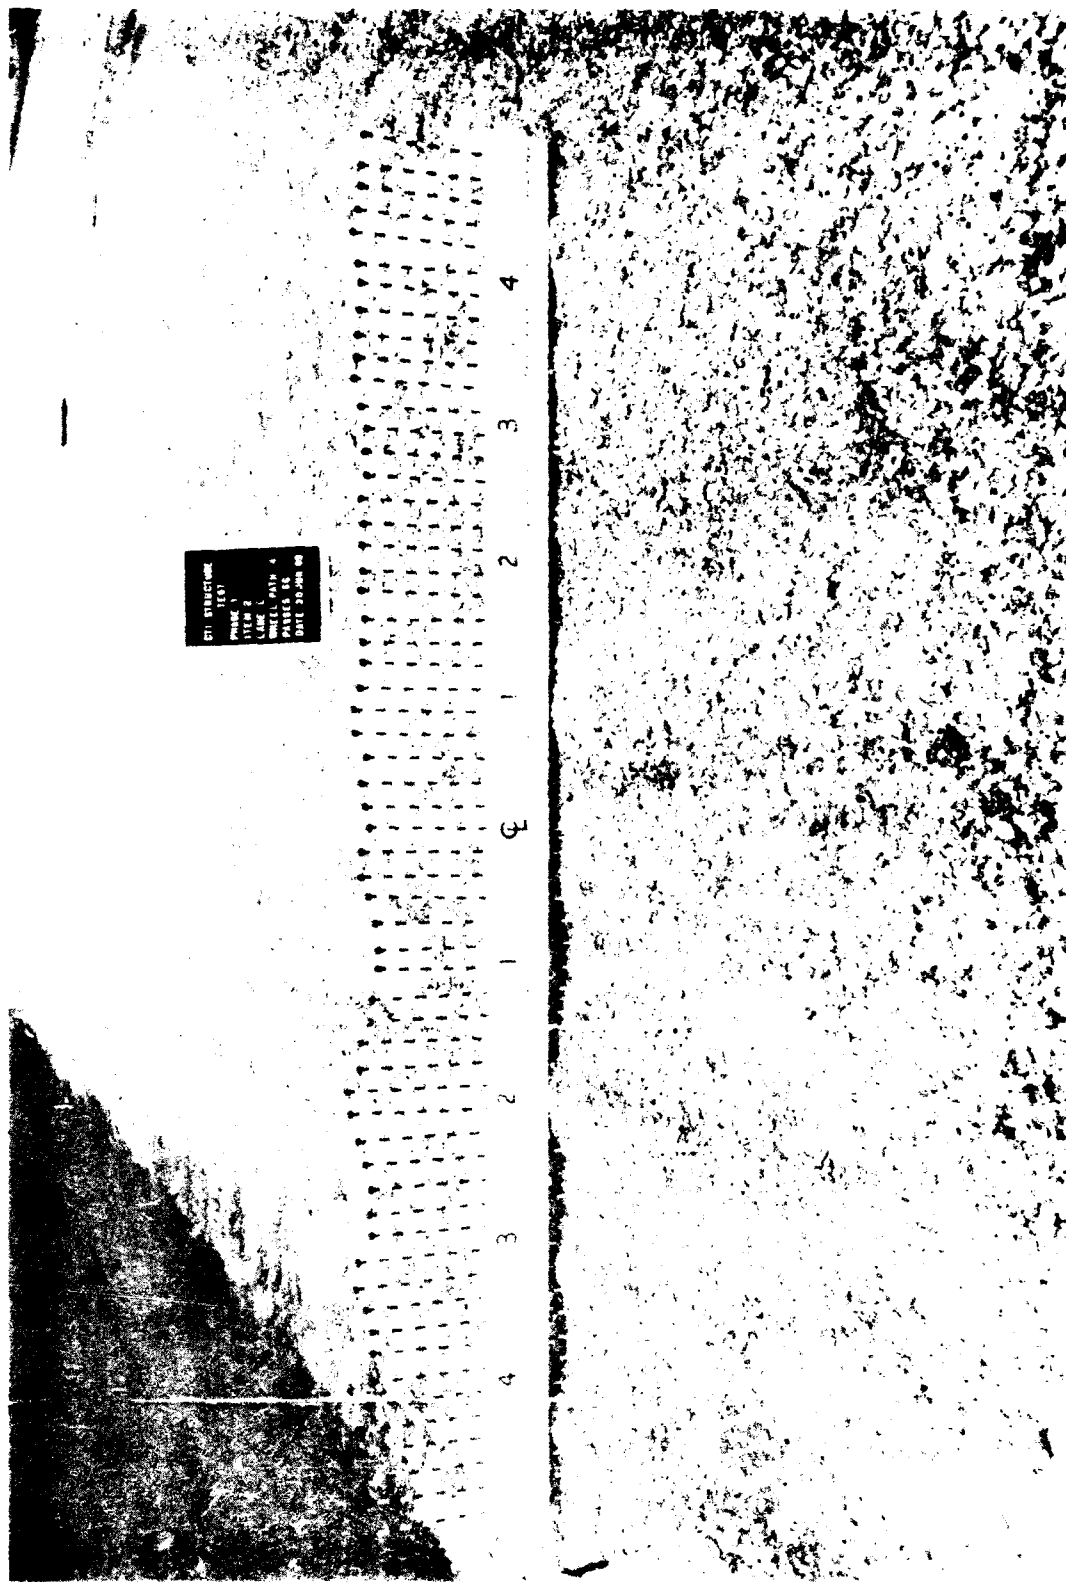
Photo 45. Item 2, low-pressure tire lane, failure after 66 passes

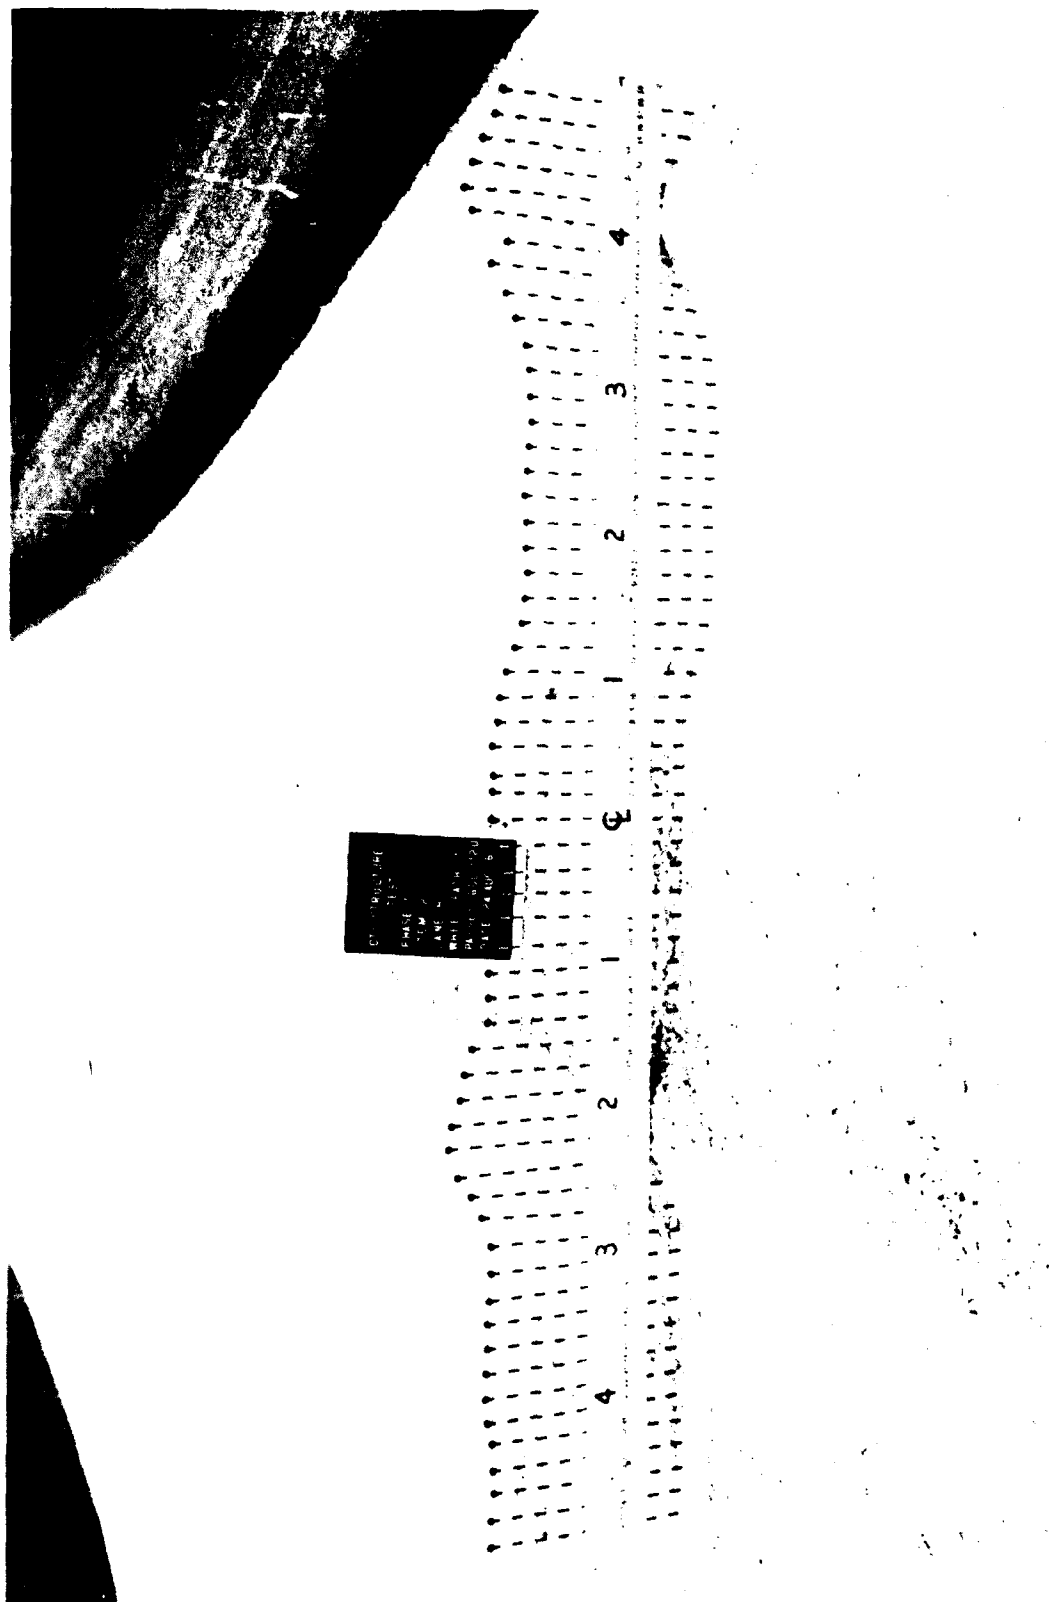
Photo 47. Item 2, high-pressure tire lane, failure after 112 unloaded passes

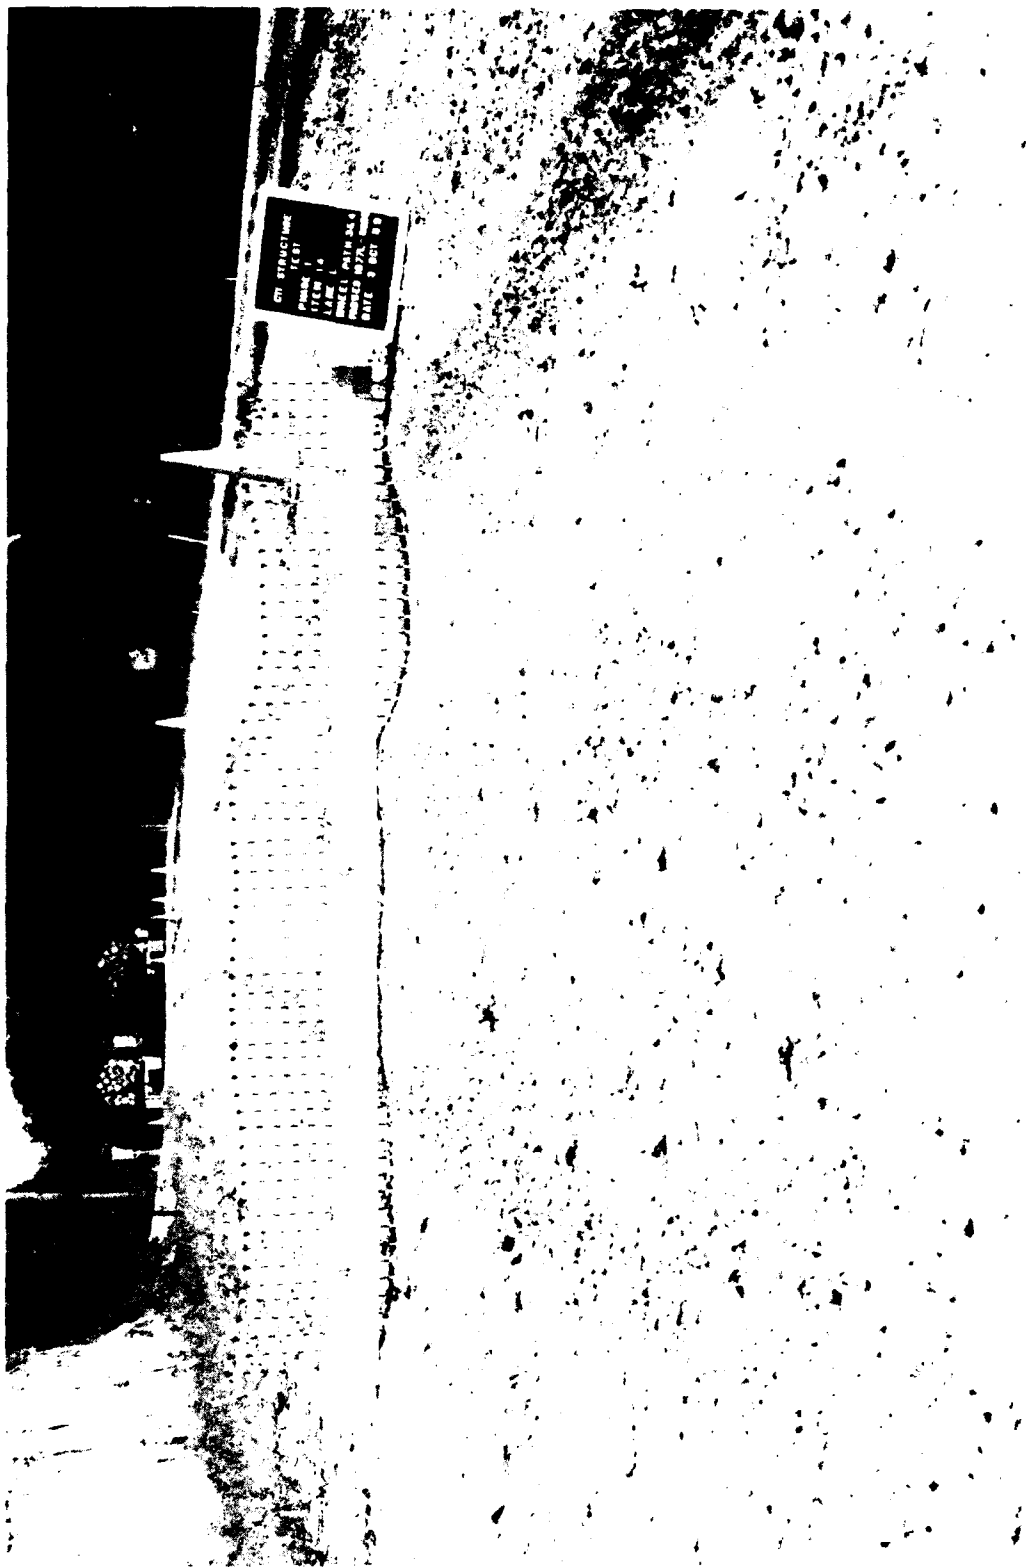
Photo 53. Item 14, low-pressure tire lane, high-severity rutting after 90 passes over a wet subgrade

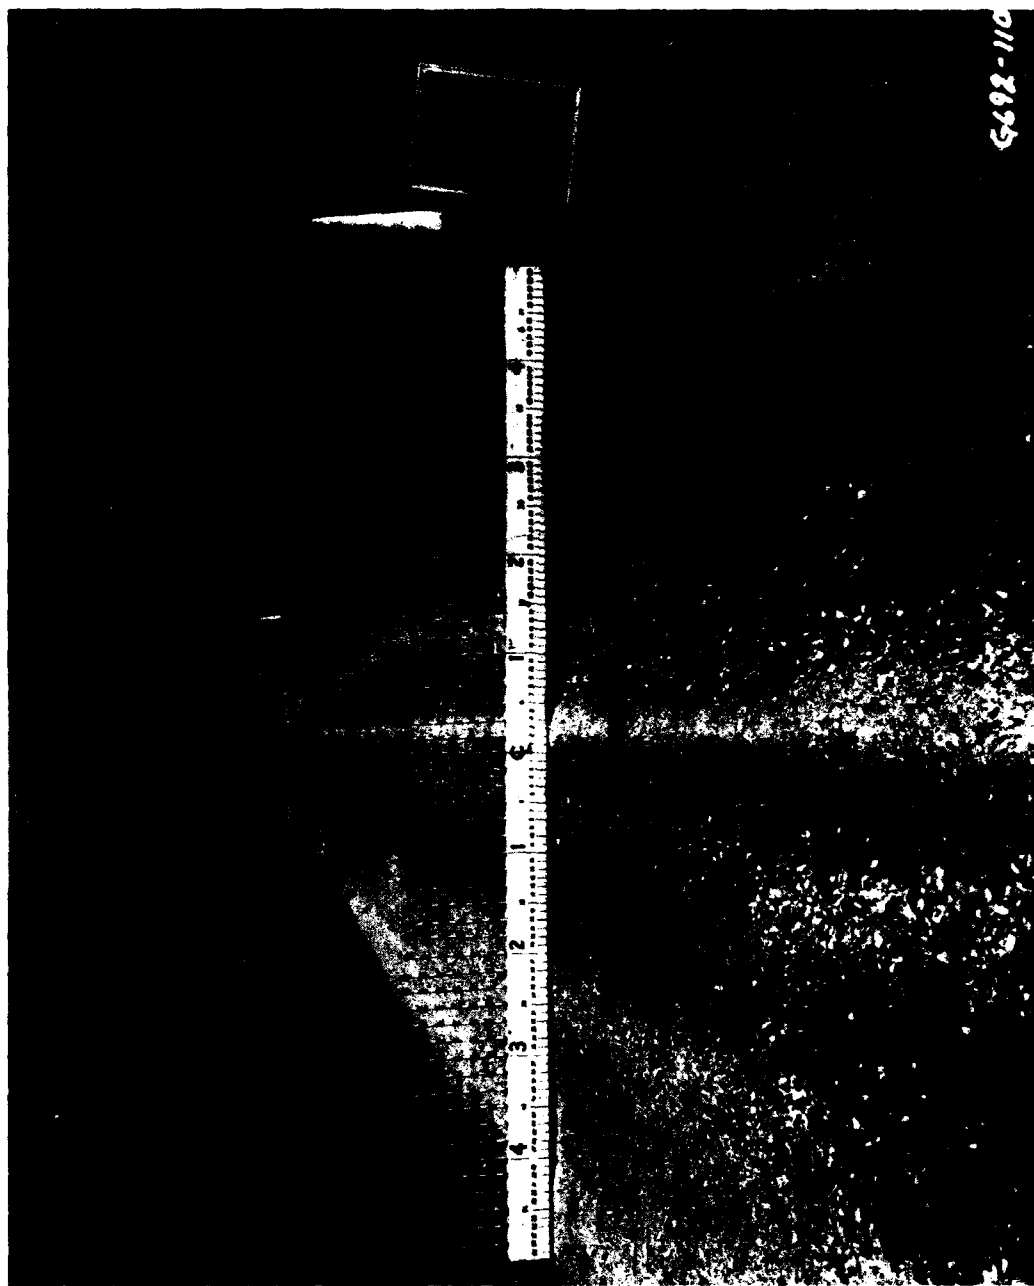
Photo 55. Item 14, low-pressure tire lane, high-severity rutting after 130 passes during induced failure plan

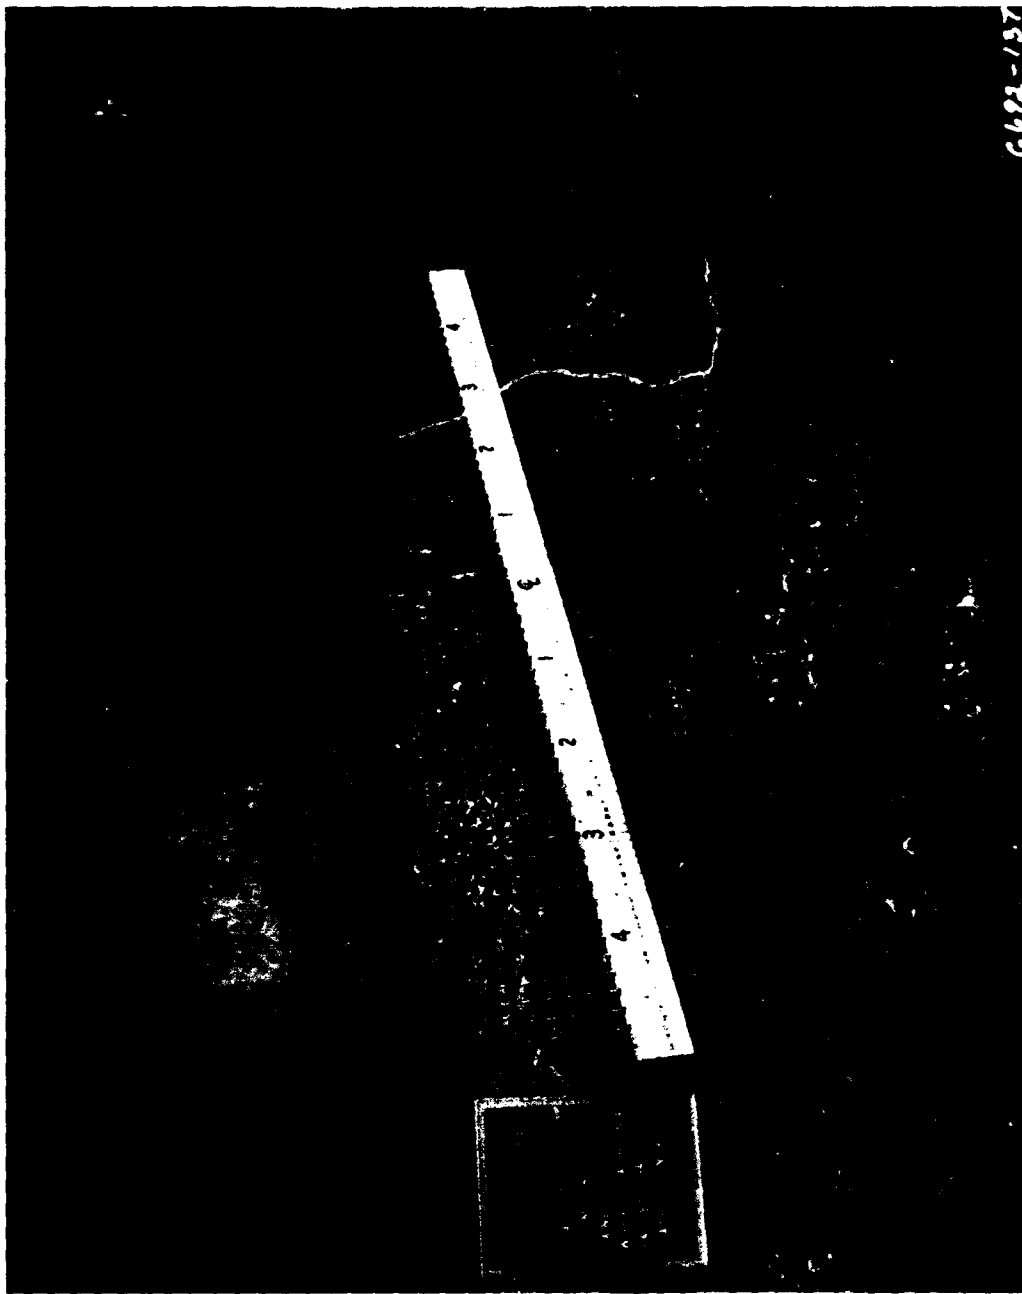
longer, and as shown in Photo 64 after 570 passes, it had developed into a low-severity depression instead of a high-severity pothole. The failures in item 15 were attributed to high-severity rutting with medium-to high-severity washboarding. A typical view of washboarding after item 15 was rated as failed and is shown in Photo 65. At this same time the washboarding in the low-tire-pressure lane was measured as low-severity (see Photo 66). As traffic continued, the majority of additional distress occurred in the high-tire-pressure lane of item 15. The aggregate became very loose and deep ruts developed. A general view of item 15 depicting this condition is shown in Photo 67. Although rutting up to 6.5 in. was measured in item 13 the maximum length never measured 20 ft; therefore, the failure criteria were not met. On 22 November 1989 the decision was made to stop all test traffic. At this time a total of 3,698 and 4,407 passes had been applied to the high- and low-tire-pressure lanes, respectively. The total traffic applied to the high- and low-tire-pressure lanes under the induced failure plan was 1,135 and 1,309 passes, respectively.

Photo 64. Item 14, low-pressure tire lane, low-severity depression after 570 passes during the induced failure plan

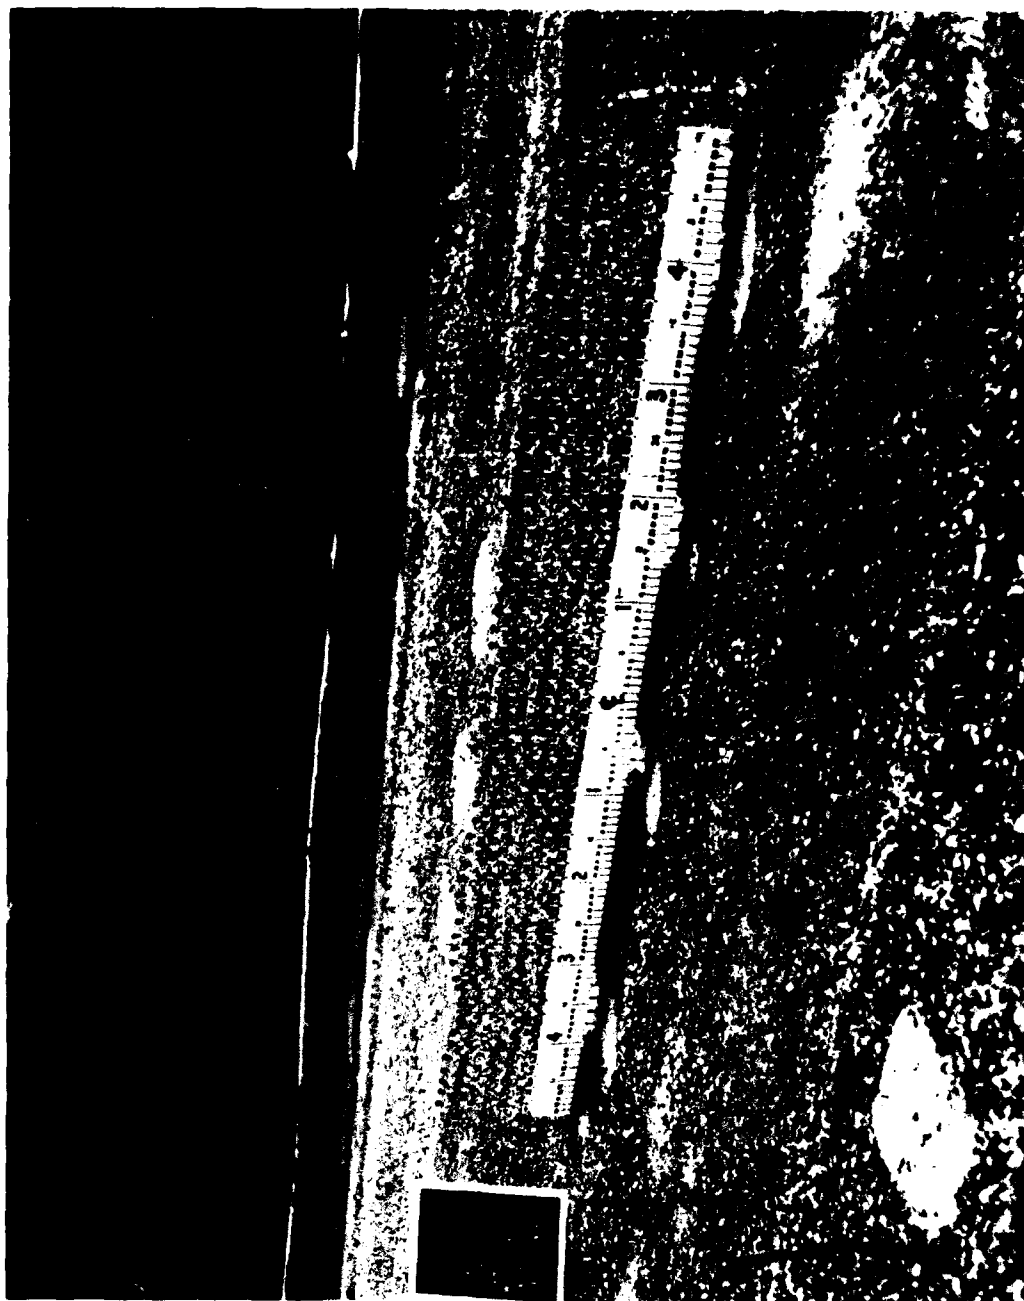
Photo 65. Item 15, high-pressure tire lane, typical high-severity washboarding after 535 passes during the induced failure plan
