Technical Report GL-93-20  
August 1993

## **Effects of Variable Tire Pressure on Road Surfacing**

### **Volume I: Design, Construction, Behavior Under Traffic, and Test Results**

Prepared for U.S. Department of Agriculture Forest Service

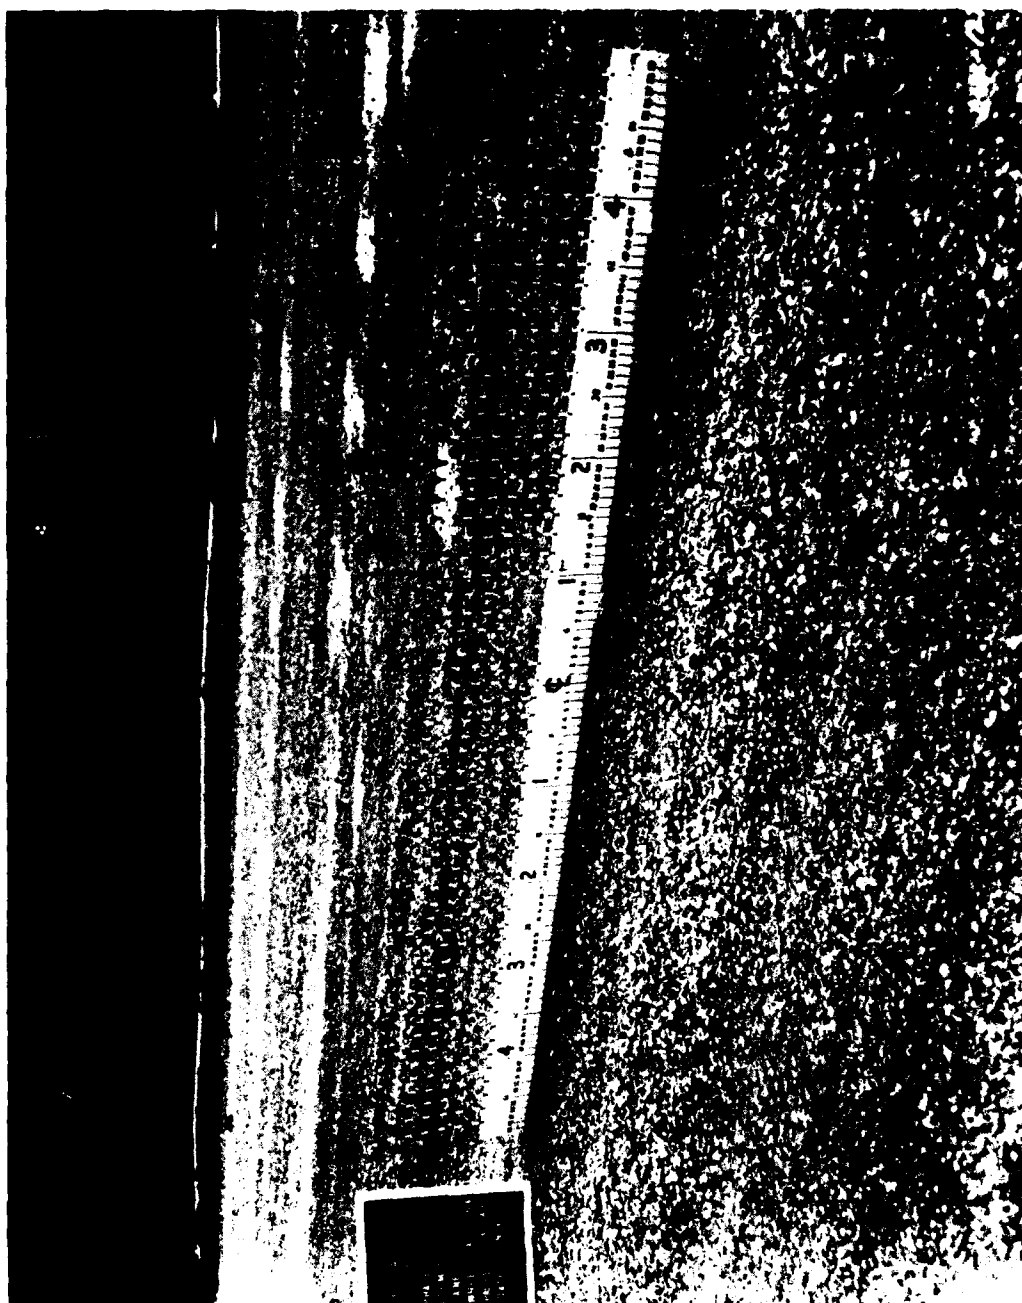
Photo 66. Item 14, low-pressure tire lane, typical low-severity washboarding after 491 passes during the induced failure plan
