**DEPARTMENT OF DEFENCE
DEFENCE SCIENCE AND TECHNOLOGY ORGANISATION
AERONAUTICAL RESEARCH LABORATORY**

Research Report 12

**DAMAGE STATES AROUND FASTENER HOLES IN THICK
GRAPHITE/EPOXY COMPOSITE LAMINATES**

**S.C. GALEA
G.K. DEIRMENDJIAN
D.S. SAUNDERS**

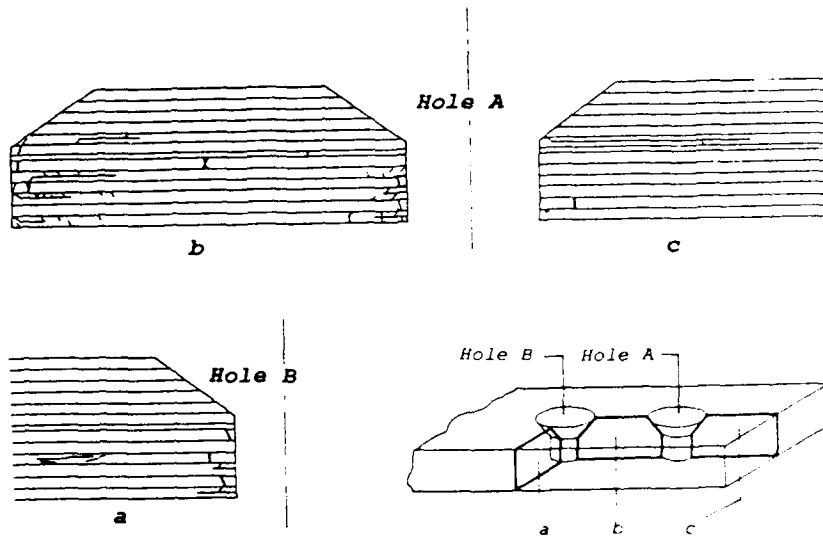
Coupons 04-01, 04-03 and 06-05 were sectioned at the completion of testing. Damage maps of the regions studied were drawn to scale and are presented in Figures 23 to 25, respectively, where individual section maps are also provided. These coupons were tested under the lower MACSEQ spectrum loads and results of the scanning electron and optical microscopy were reported in [9]. The damage conditions of the hole surfaces developed under fatigue loading are reproduced from reference [9] in Appendix 1. Here Figures A.1 to A.4 show the fastener hole surfaces and profiles for coupons 04-02, 04-01, 04-03 and 06-05 at loading blocks 5, 15, 45 and 90 respectively.

Figure 23. Damage maps from coupon 06-05, fatigued to 90 blocks MACSEQ (30 kN peak load).

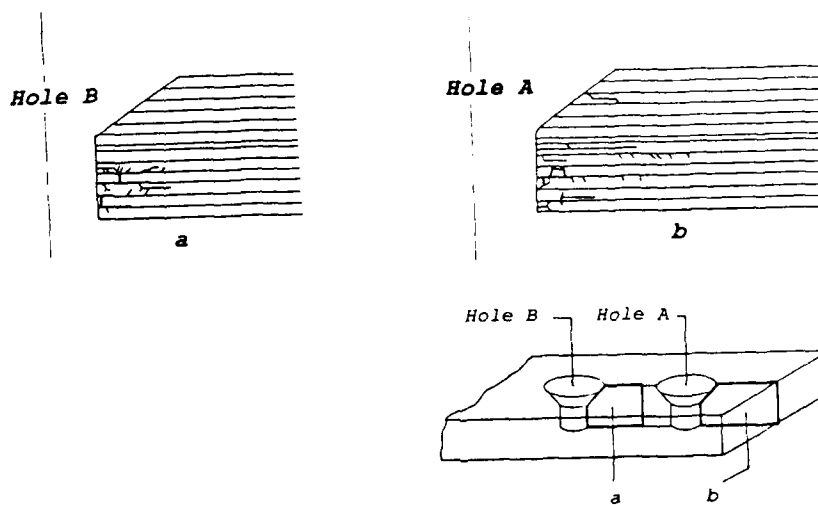
Figure 24. Damage maps from coupon 04-03, fatigued to 45 blocks MACSEQ (30 kN peak load).

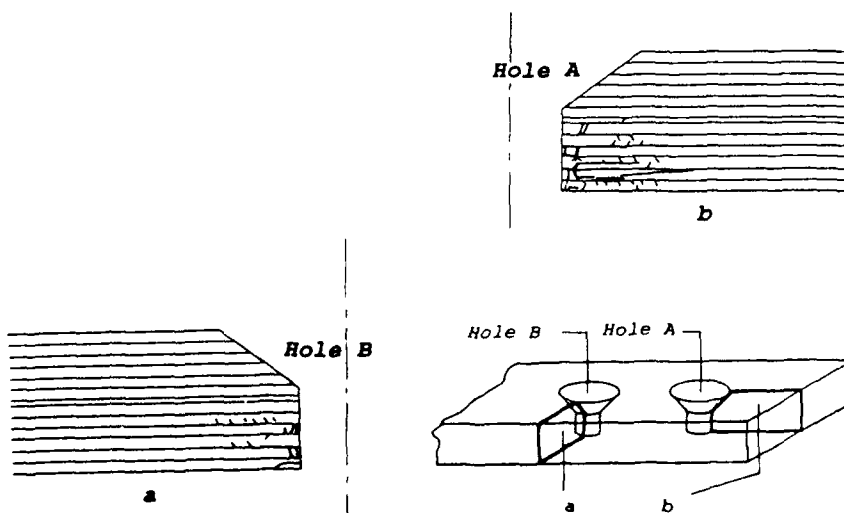
Figure 25. Damage maps from coupon 04-01, fatigued to 15 blocks MACSEQ (30 kN peak load).
