USACERL Technical Report FF-93/09  
July 1993

## **Eight-Year Summary of Fort Irwin, CA, Family Housing Comparison Test: Operation and Maintenance Costs of Manufactured vs. Conventionally Built Units**

| | <b>Page</b> |
|---|---|
| <b>APPENDIX F: CERL Letter Report "Summary of Findings for Fort Irwin Polybutylene Pipe Failure," to U.S. Army Engineering and Housing Support Center, Dated 30 Sep 92</b> | <b>62</b> |

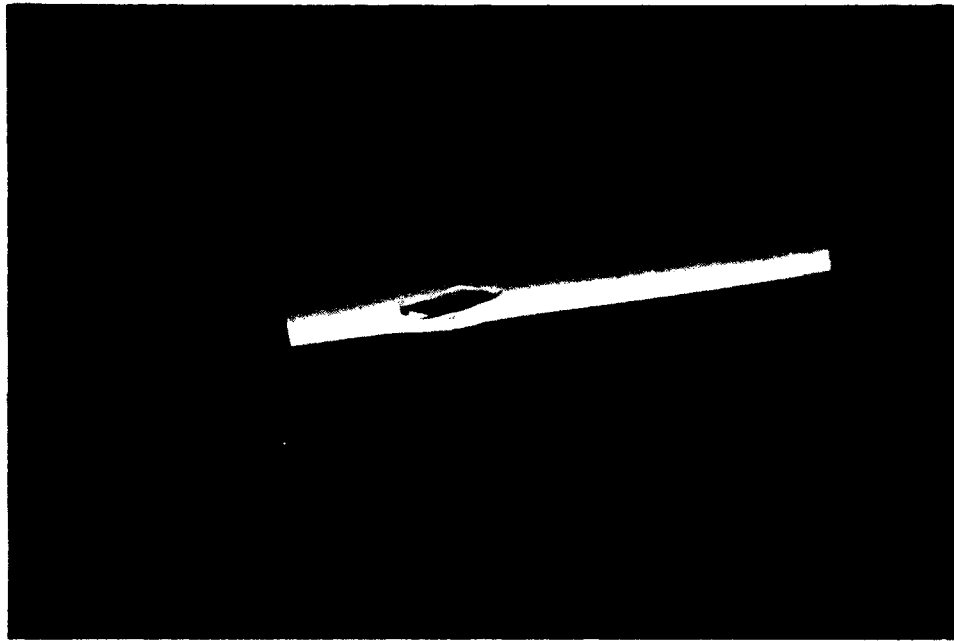
The visual examinations of the polybutylene pipe failures revealed that at the locations where leaks occurred, the pipe cross-section was oval shaped instead of round. Four sections of failed polybutylene pipe were secured for investigation as to the cause of the failures: two were provided by Mr. Walt Perry and two by Mr. Don Andrews. One pipe provided by Mr. Perry (Figure 19) was ruptured, having a hole 1.56 inches long (in the longitudinal direction) and 0.44 inches wide. There were two long narrow strips of pipe wall material broken free

**Figure F19: Ruptured Polybutylene Pipe from Building 3858, Unit C**

from one end of the rupture. The other three pipe failures had longitudinal hair line cracks in them (Figures 20 and 21).

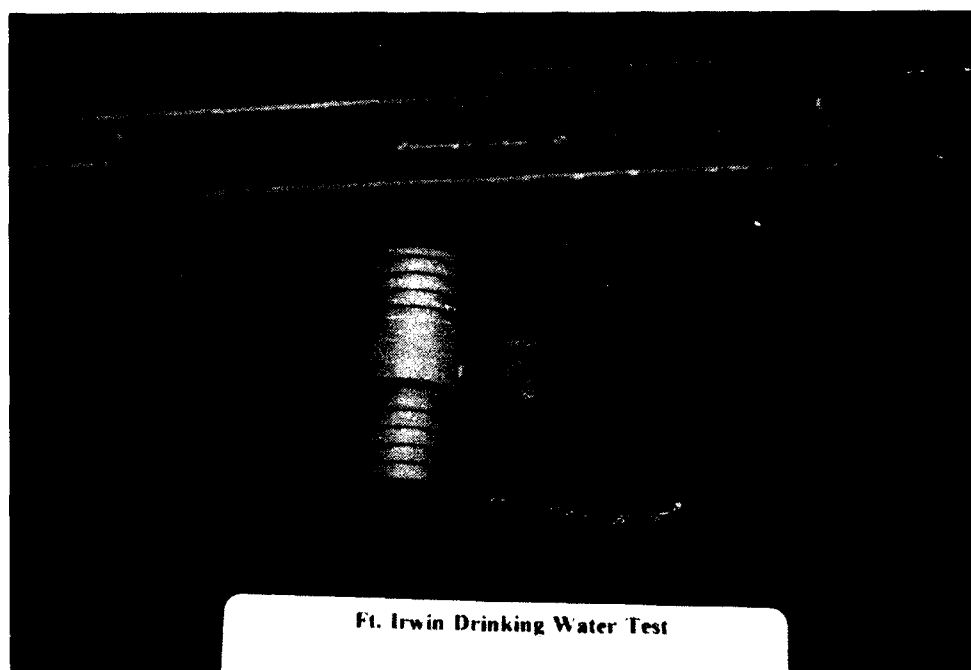
In order to identify what the inorganics are, X-ray Diffraction Spectroscopy was used. The X-ray Diffraction indicated that titanium was present in the polymer material. Since titanium dioxide is commonly used as a colorant and natural acetal is white in color, the titanium dioxide is probably the coloring component used in the fittings. The colorant would correspond to the IR peak at  $2030\text{ cm}^{-1}$ . The peak at  $2332\text{ cm}^{-1}$  is a sulfite or sulfate formed from reaction with the high sulfate content water.

**Figure F28: Acetal Fittings Exposed to Ft. Irwin Drinking Water**
