**TECHNICAL
REPORT**

FEAP TR-FM-93/06
July 1993

Demonstration of Polyscann Ultrasonic Butt-Fusion Inspection System for Polyethylene Pipes

by
Orange S. Marshall, Jr., and James B. Hunt
U.S. Army Construction Engineering Research Laboratories
Champaign, IL 61826-9005

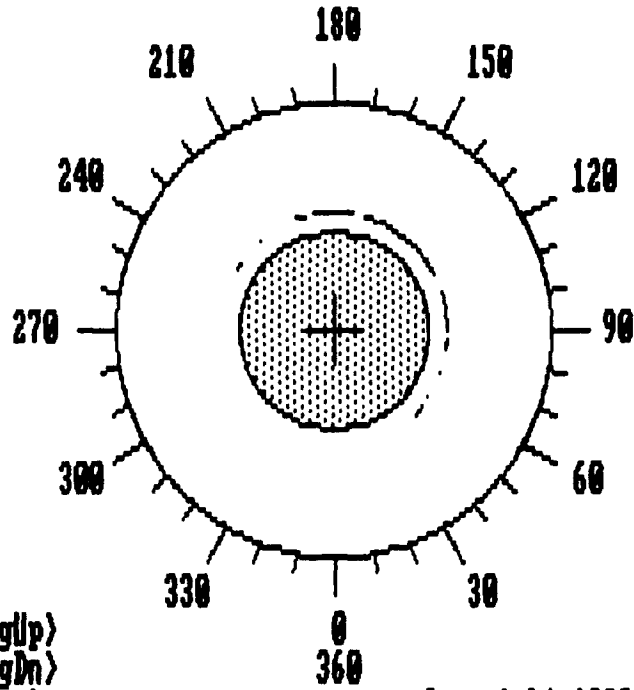
Figure 23. Inspection Report Screen for Weld Made Under Insufficient Pressure.

ECM #: ECM004
INSPECTION #: 000011
PIPE SIZE: 8
INSPECTOR #: 000000011
ECM STATUS:
- FLAWS FOUND -

COMMENTS:
Ft. Hood Pipe
Not Enough Pressure

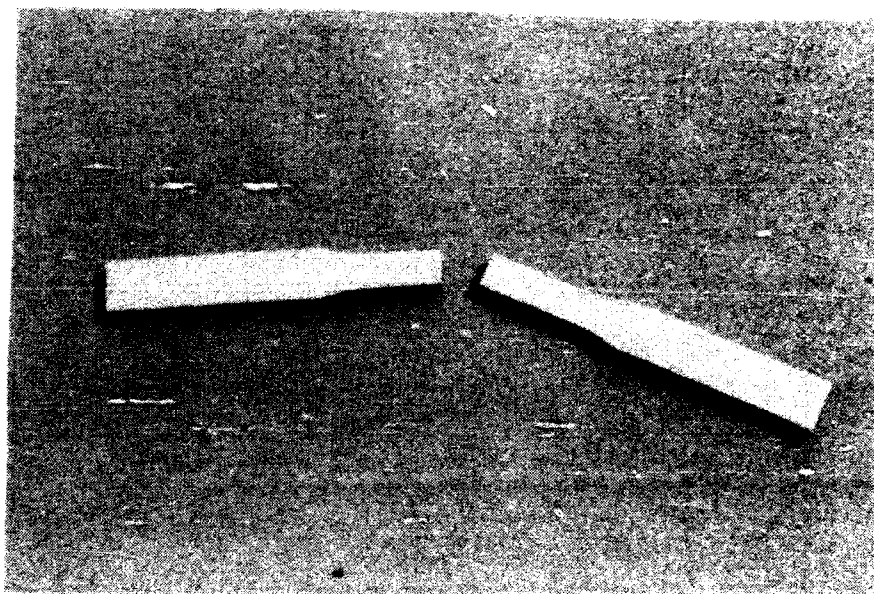
Figure 29. Example of Non-necking Failure in Joint Specimen.

necking of the sample to minimize the likelihood of catastrophic pipe failure. Figure 28 shows the normal necking phenomenon for polyethylene. Figure 29 shows a non-necking break at the butt-fusion joint. Pipe samples where both the inside and the outside tensile samples failed were judged as failures. Where only one of the two tensile samples failed, the joint was judged as marginally passing.
