DOT/FAA/CT-93/78
DOT-VNTSC-FAA-93-10

Full-Scale Testing and Analysis of Curved Aircraft Fuselage Panels

Final Report

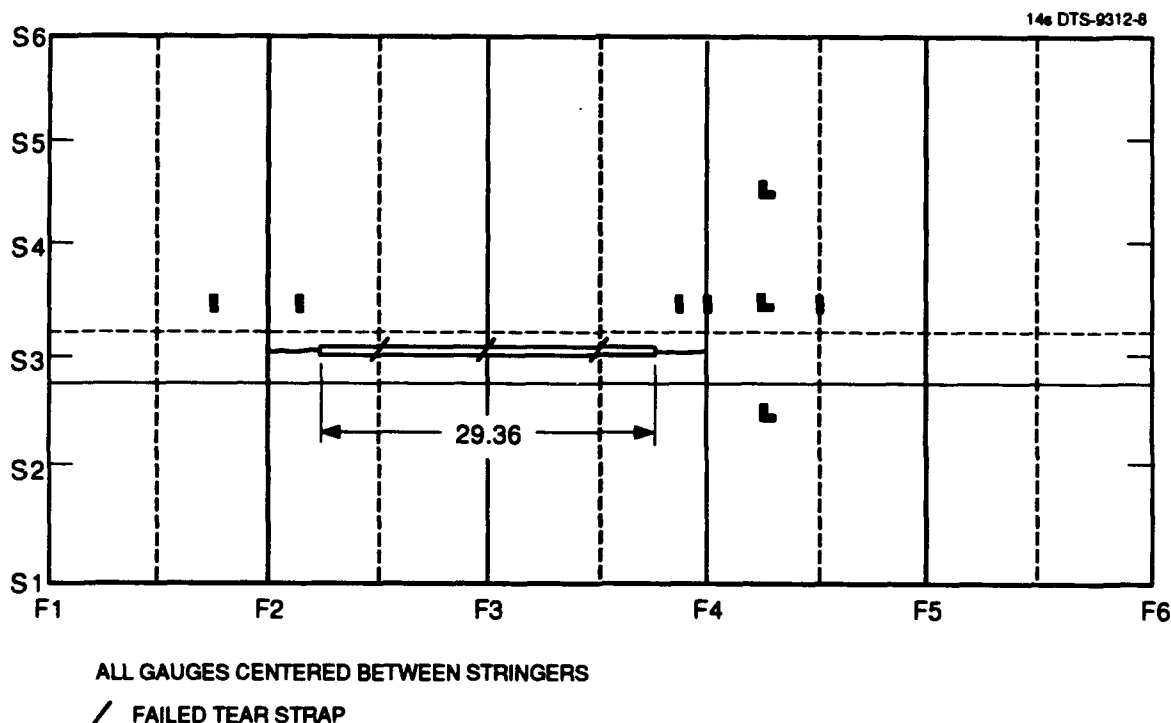
Figure 14. Panel 10 - After Fracture

Stable crack growth was observed in Panel No. 10 at approximately 6.2 psi. The total crack extension reached 0.1 in. at 6.9 psi. The three center tear straps failed at 8.1 psi. From the crack propagation gauges, it is evident that complete failure of the first ligaments also occurred at 8.1 psi. The crack propagated in both directions to the next frame. The final crack is shown in Figure 14. A photograph of the failed panel is shown in Figure 15.
