AL/CF-TR-1993-0095

ASSESSMENT OF INTERIOR MODIFICATIONS
IN C-130 AND C-141 AIRCRAFT FOR
NIGHT VISION GOGGLE OPERATIONS (U)

MAY 1993

FINAL REPORT FOR THE PERIOD MARCH 1992 - DECEMBER 1992

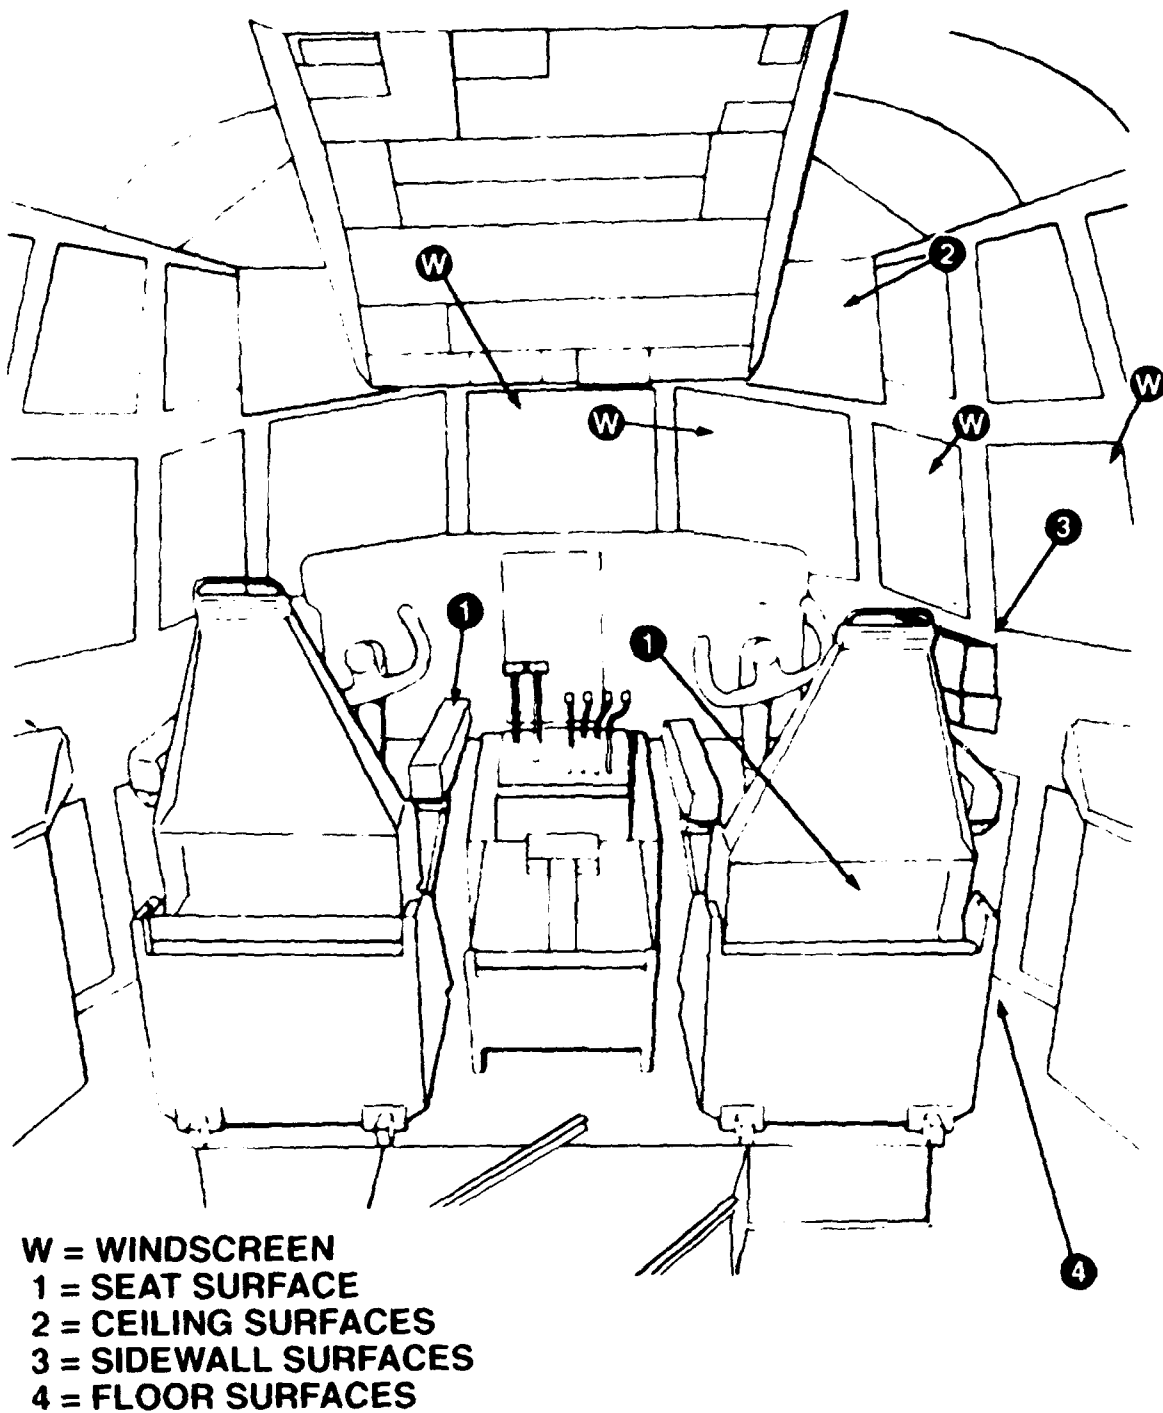
Figure 1: Radiance Measurement Locations on the C-130 Flight Deck.

were not calculated for these windscreen locations. These NVIS radiances were interpreted in terms of the guidelines in MIL-STD-85762A. The measurement locations for the C-130H and C-141B flight decks are shown in Figures 1 and 2, respectively.
