TECHNICAL MEMORANDUM MAA-66-20

TITANIUM-6Al-4V LOW DENSITY INCLUSION PROBLEM

W. P. CONRARDY

JULY 1966

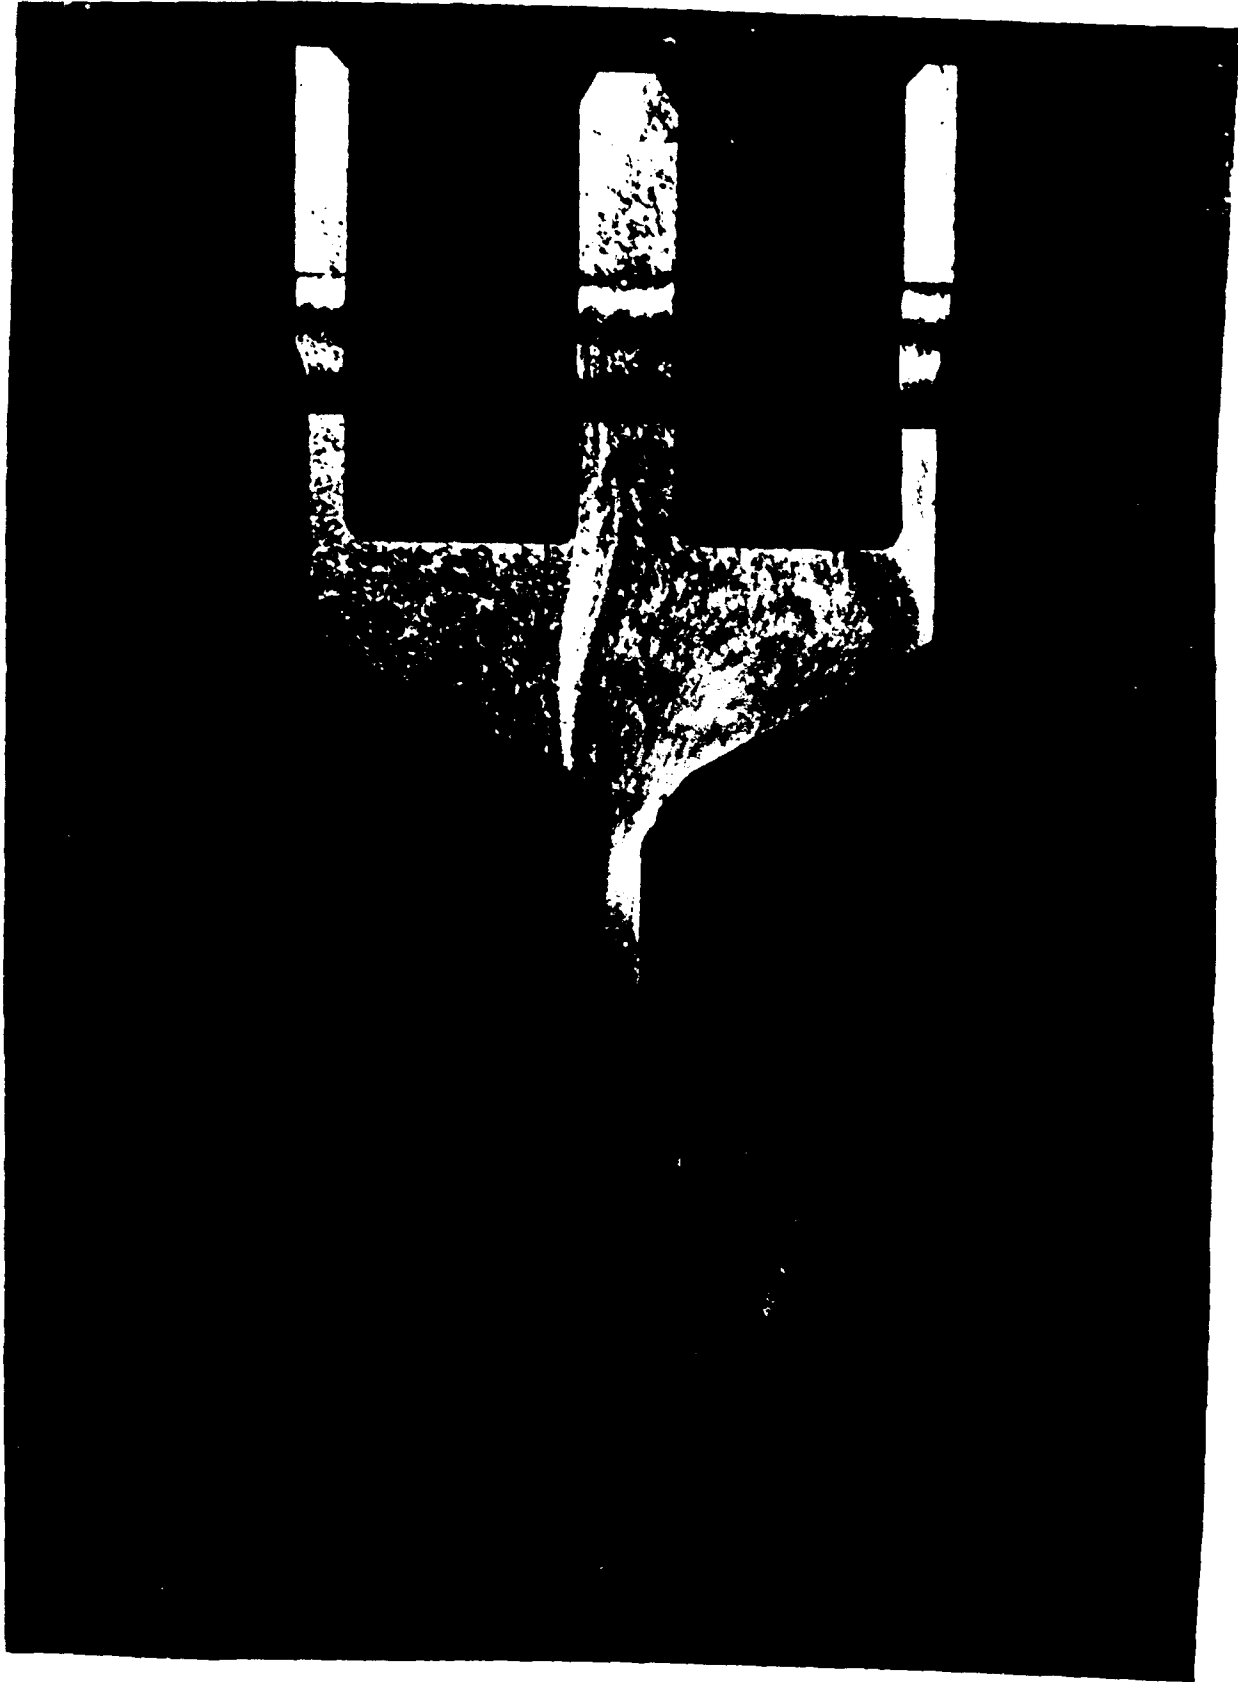
FIGURE 1

cracking and rupture of Ti-6Al-4V compressor discs (forgings) on aircraft and on test stands or spin pits (See Figs 1, 2, and 3). Failure from this cause was also reported in relatively thin wall missile case material. The anticipated increase in titanium usage for both rotating engine components and advanced airframe structural uses precipitated this investigation.

MACROETCHED RADIAL SECTION OF FAILED COMPRESSOR DISC SHOWING EVIDENCE OF CORROSION AND CRACKING.

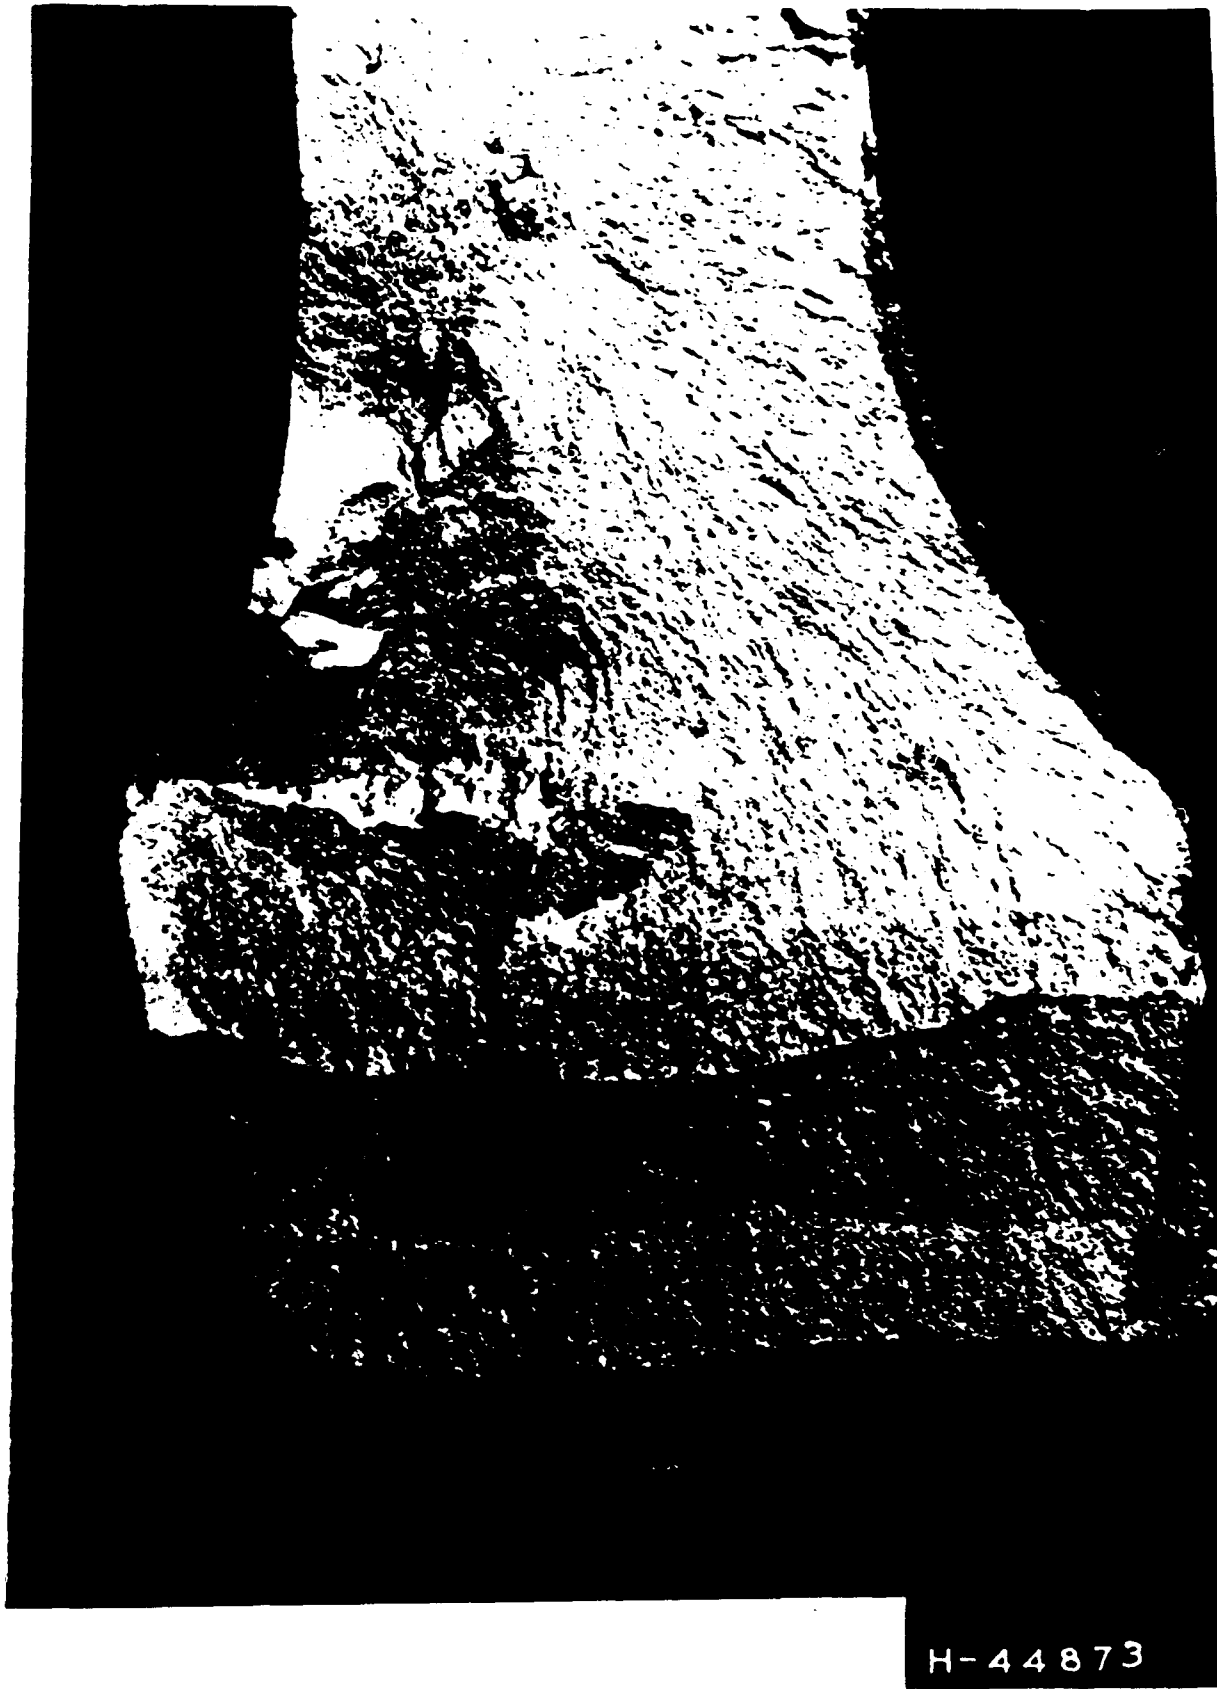
FIGURE 2  
MAG: 6-1/2X  
SURFACE OF COMPRESSOR HUB FRACTURE SHOWING TENSILE FAILURE PROGRESSING FROM GRANULAR,  
BRITTLE FRACTURE AREA INDICATIVE OF CONTAMINATION.

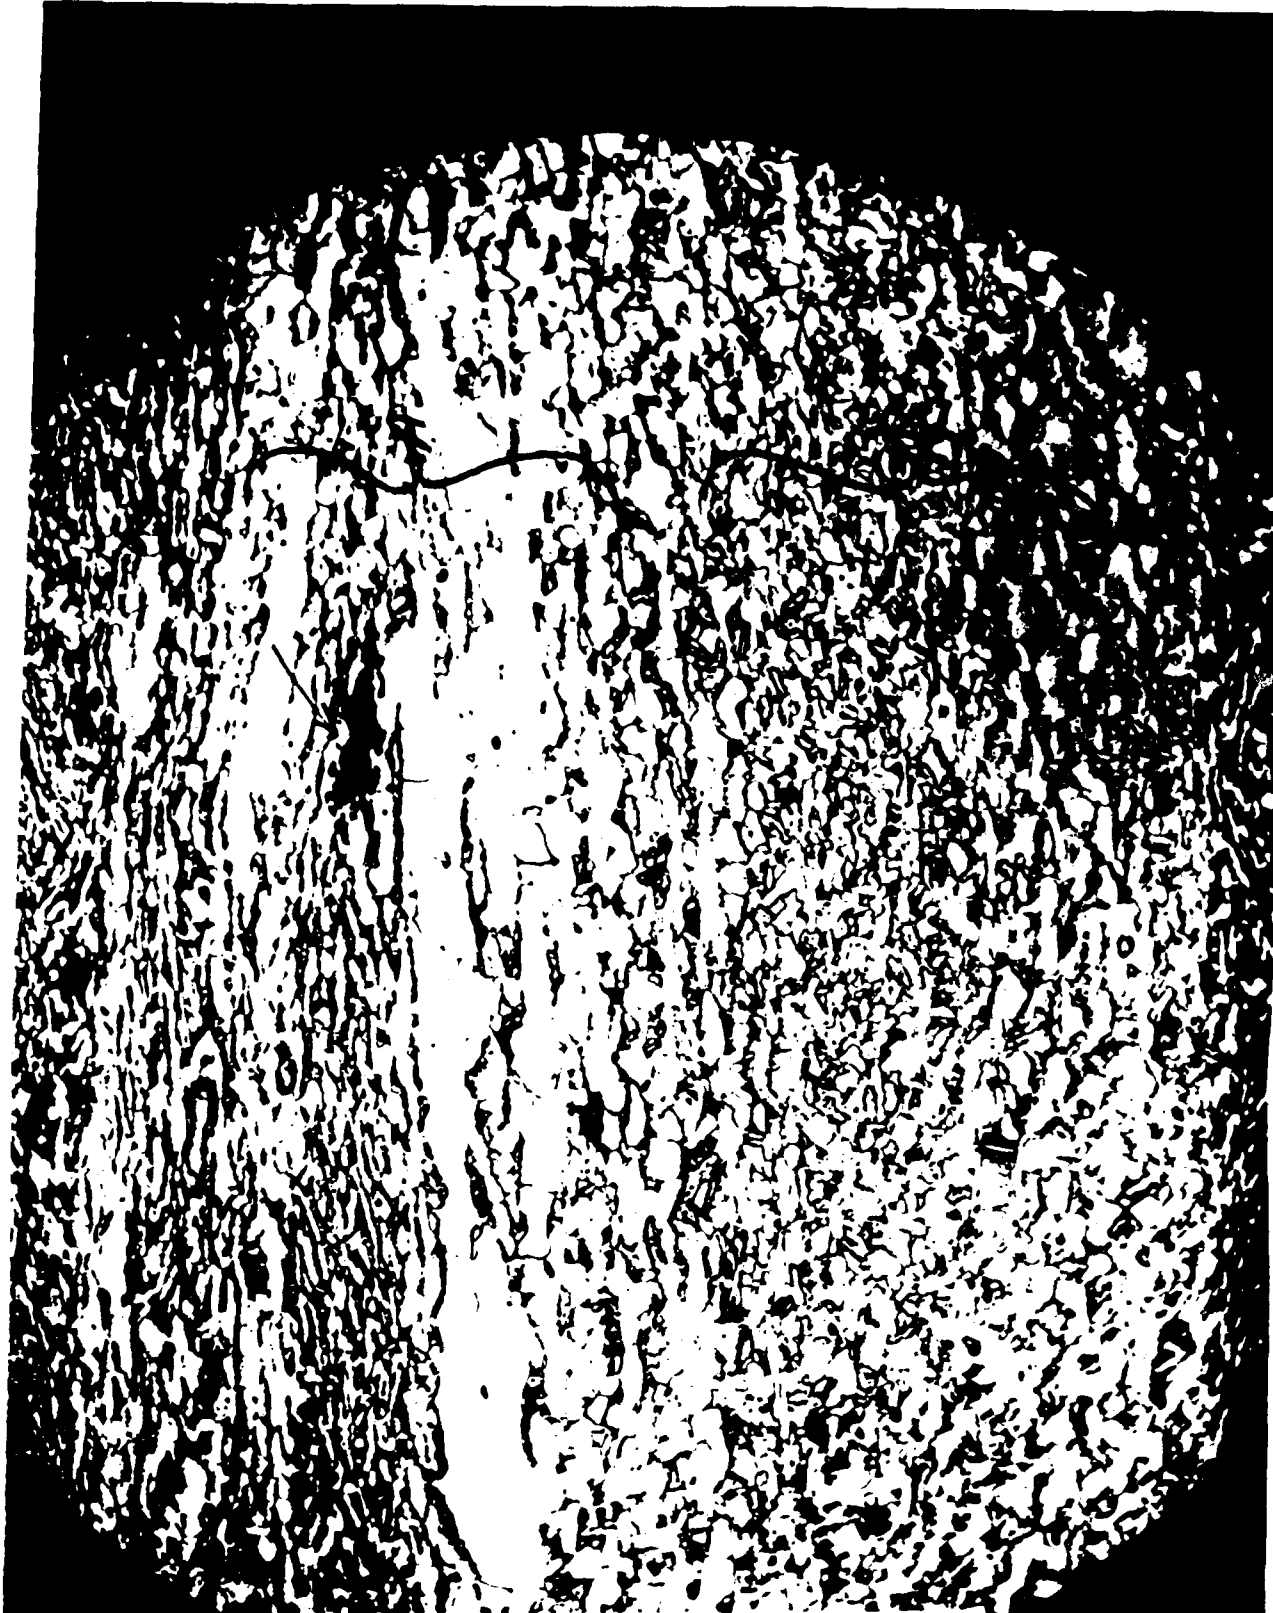
FIGURE 4

3. The low density inclusions observed have often consisted of voids surrounded by hard (Rc 50), brittle, stabilized alpha grains. (Fig 4) In addition to the relatively massive type inclusions shown in the figures, of greater concern are the smaller ones which probably occur more frequently and are more difficult to detect. It has not been established that all of these defects spring from the same source. The aluminum content in these areas has varied from slightly below to considerably above specification requirements whereas the vanadium has been generally below the requirement. In each instance the oxygen and/or nitrogen contents (as accurately as can be determined) have exceeded permissible specification values.

PHOTOMICROGRAPH OF SECTION THROUGH CONTAMINATED AREA SHOWING A VOID (ARROW), HARD STABILIZED ALPIA STRUCTURE (BRACKET A) AND SOFT ALPIA STRUCTURE (BRACKET B).
