WL-TR-92-4040

DURABILITY OF ADHESIVELY BONDED STRUCTURE

Al E. Hohman
Charles M. Standard
LTV Aerospace and Defense Company
Missiles Division
P.O. Box 650003
Dallas, Texas 75265-0003

Final Report for Period April 1991 - March 1992

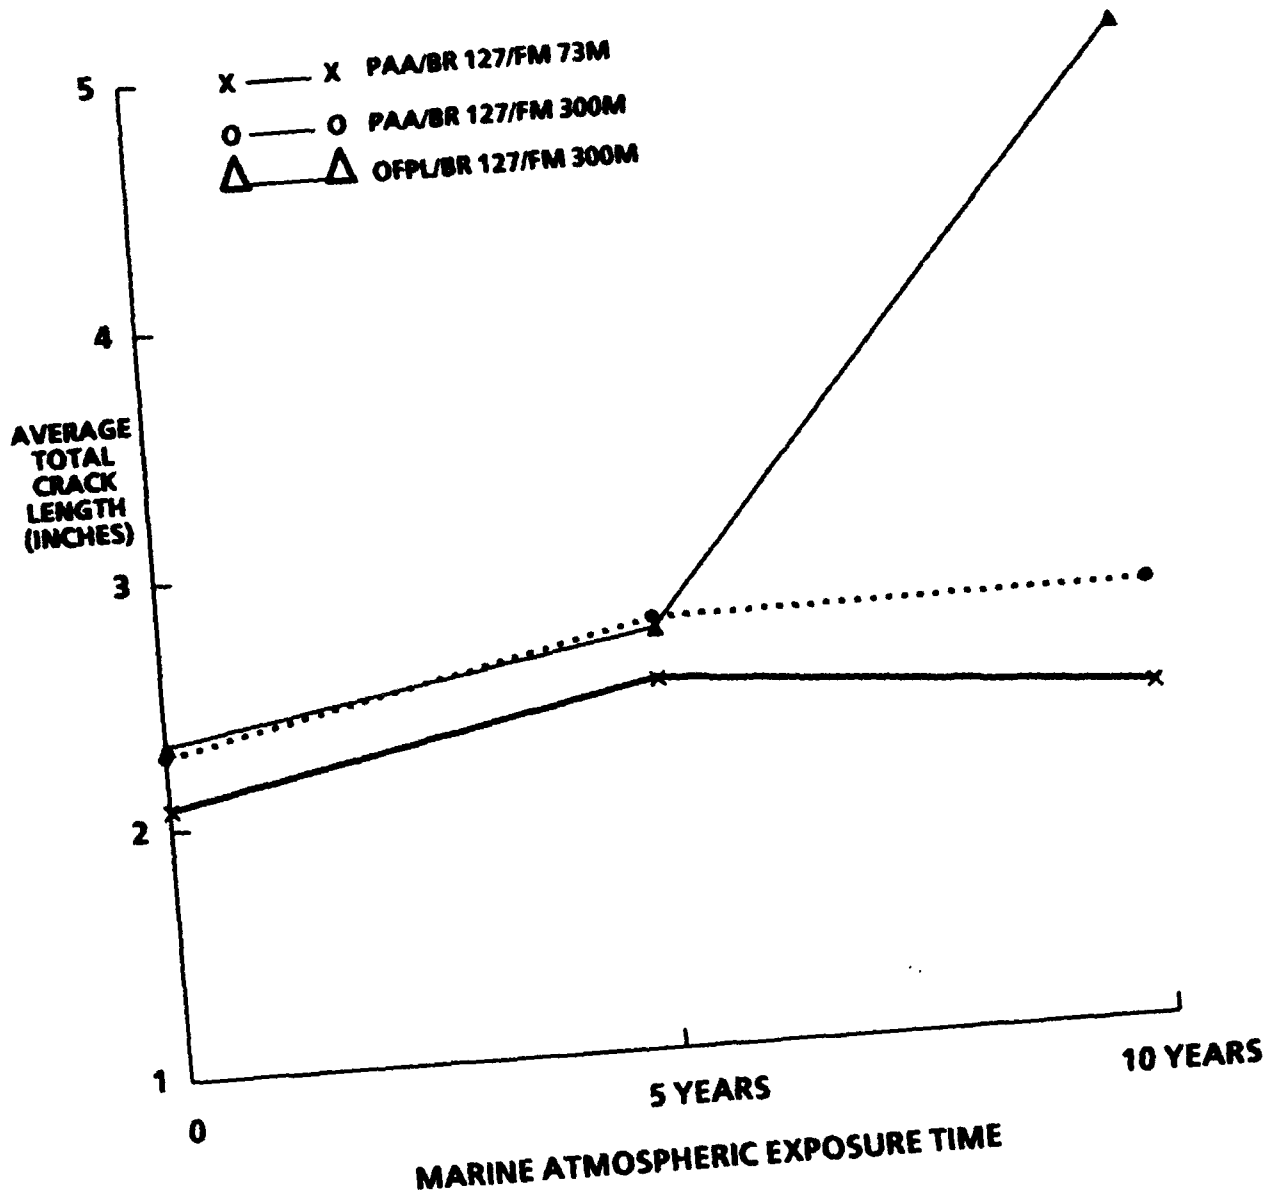
Crack extensions for the three adhesive systems are shown in Table 3 and Figure 2. Table 4 shows the crack extension failure modes. Table 5, 6, and 7 show the lap shear strengths and modes of failure occurring after 5-year exposures for specimens exposed with no tensile load, 800 pounds and 1200 pounds nominal spring loads. Tables 8, 9, and 10 compile shear strengths over the 10-year exposure period.

Figure 2: Crack Extension Specimens Total Length of Damaged Bond

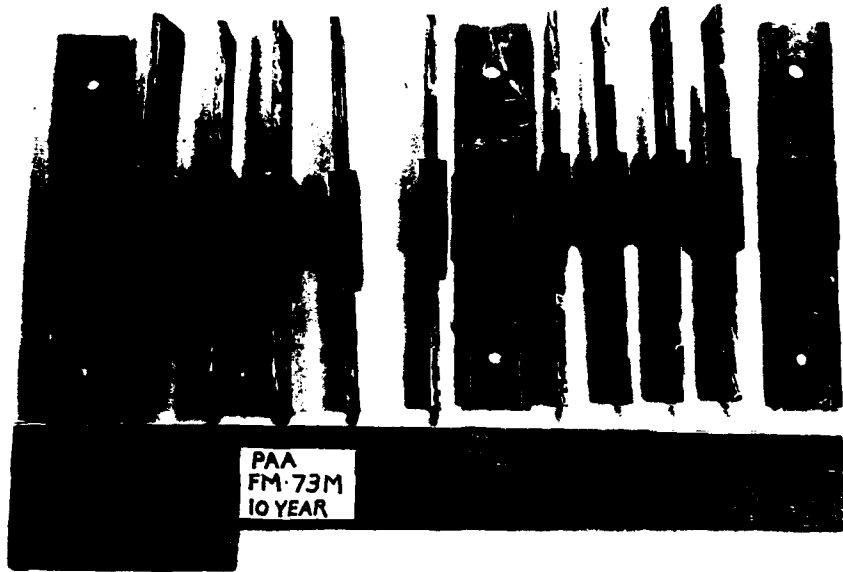
Figure 5: PAA/BR 127/FM 73M Specimens Stressed 800 psi and 1200 psi for 10 years

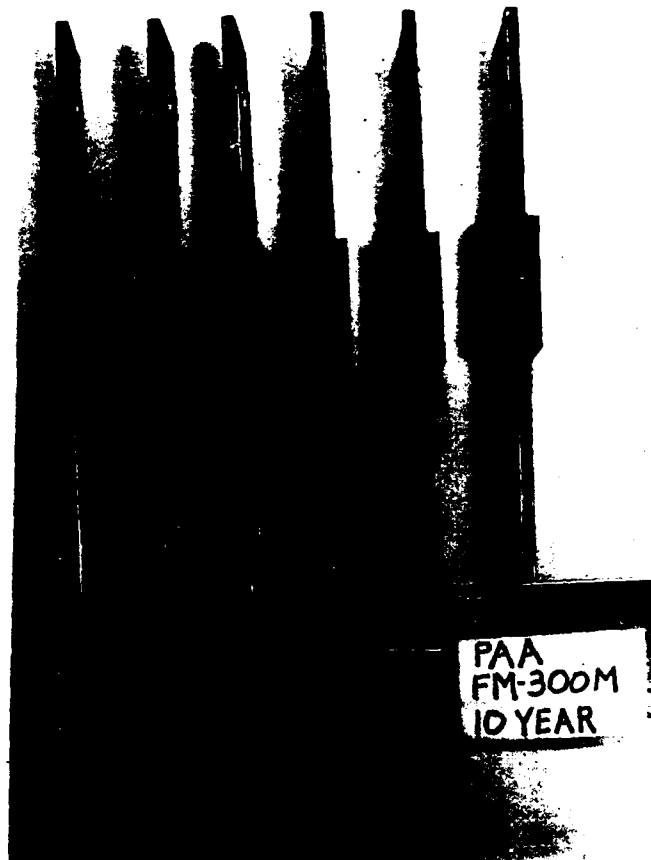
Figure 10: PAA/BR 127/FM 300M No Load Specimens After 10 Years Exposure

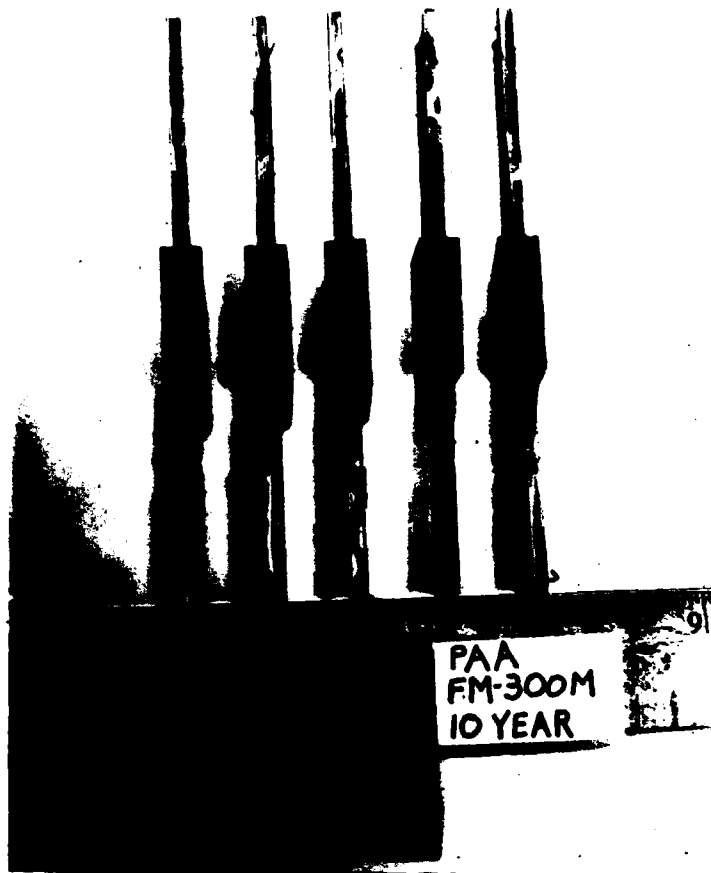
Figure 11: PAA/BR 127/FM 300M Specimens Exposed 10 years at 800 psi Nominal Stress

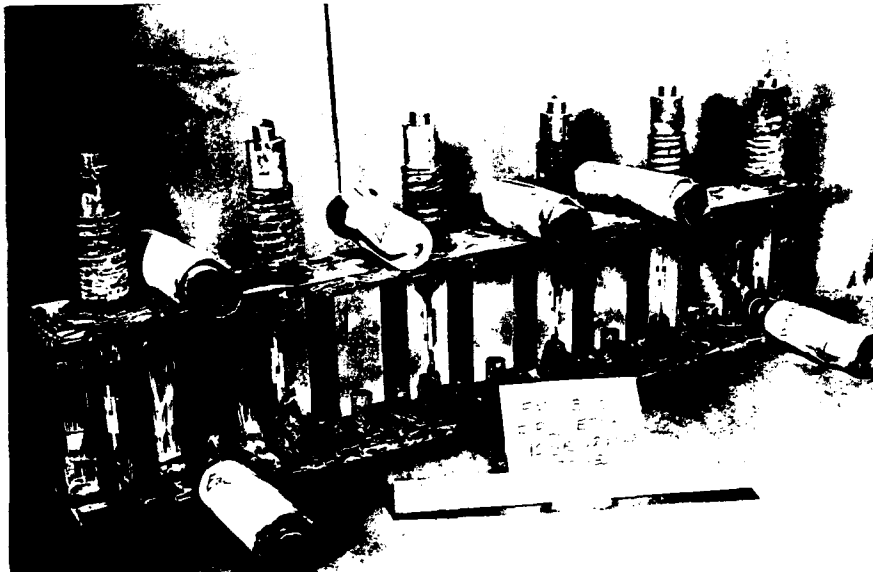
Figure 14: OFPL/BR 127/FM 300M in Rack following 10 years Exposure at Nominal 1200 psi Stress

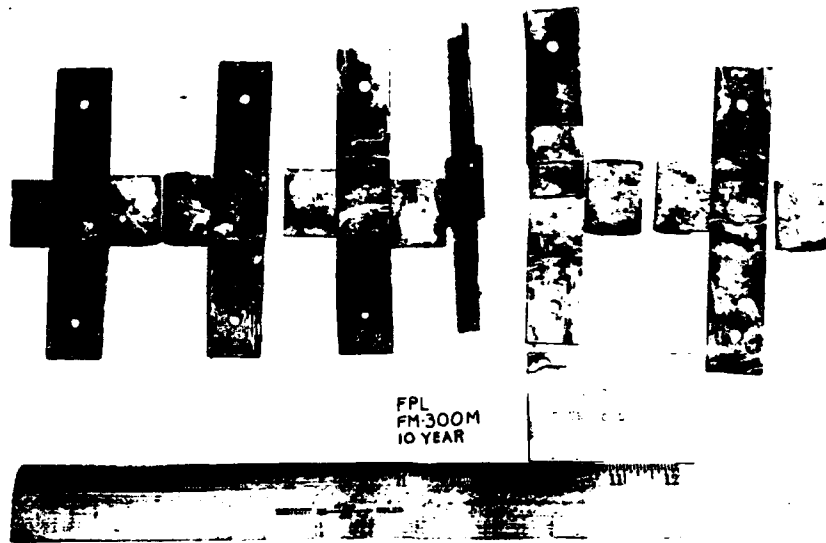
Figure 15: OFPL Specimens Delaminated During Removal from Rack

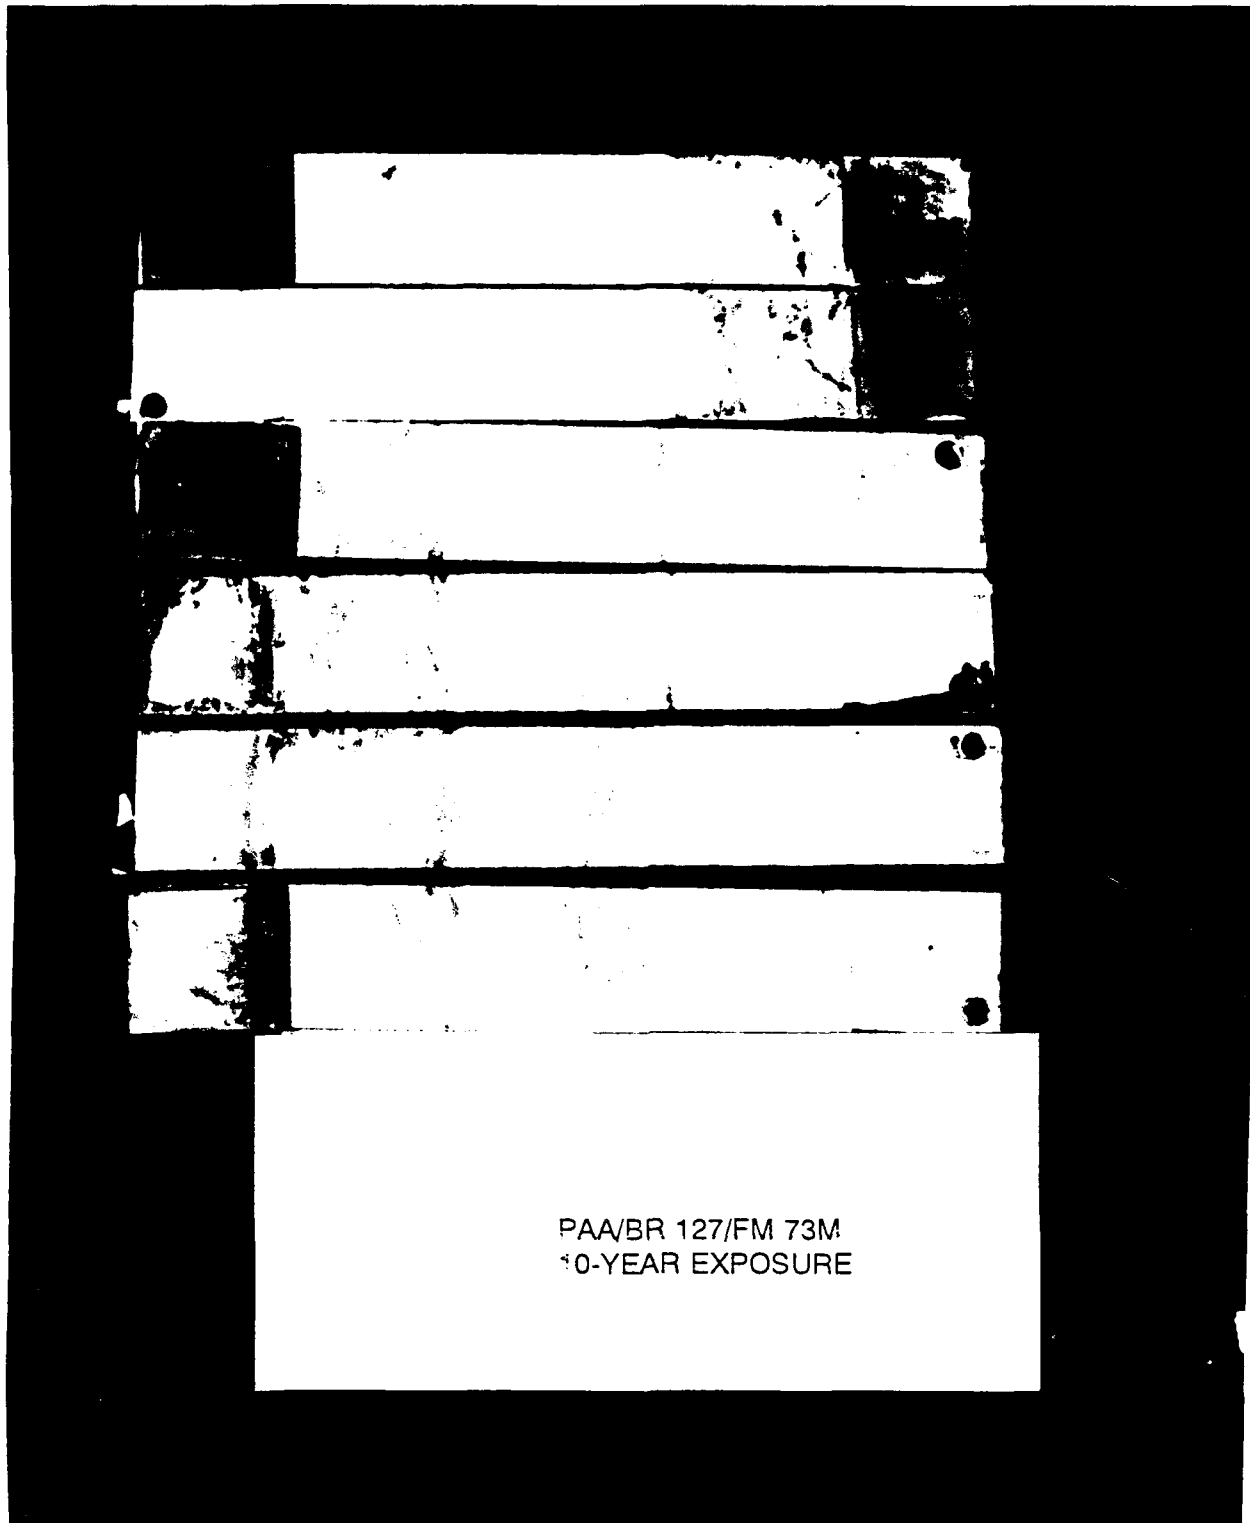
Figure 20: PAA/BR 127/FM 73M Crack Extension Specimens Exposed 10 years in Marine Atmosphere

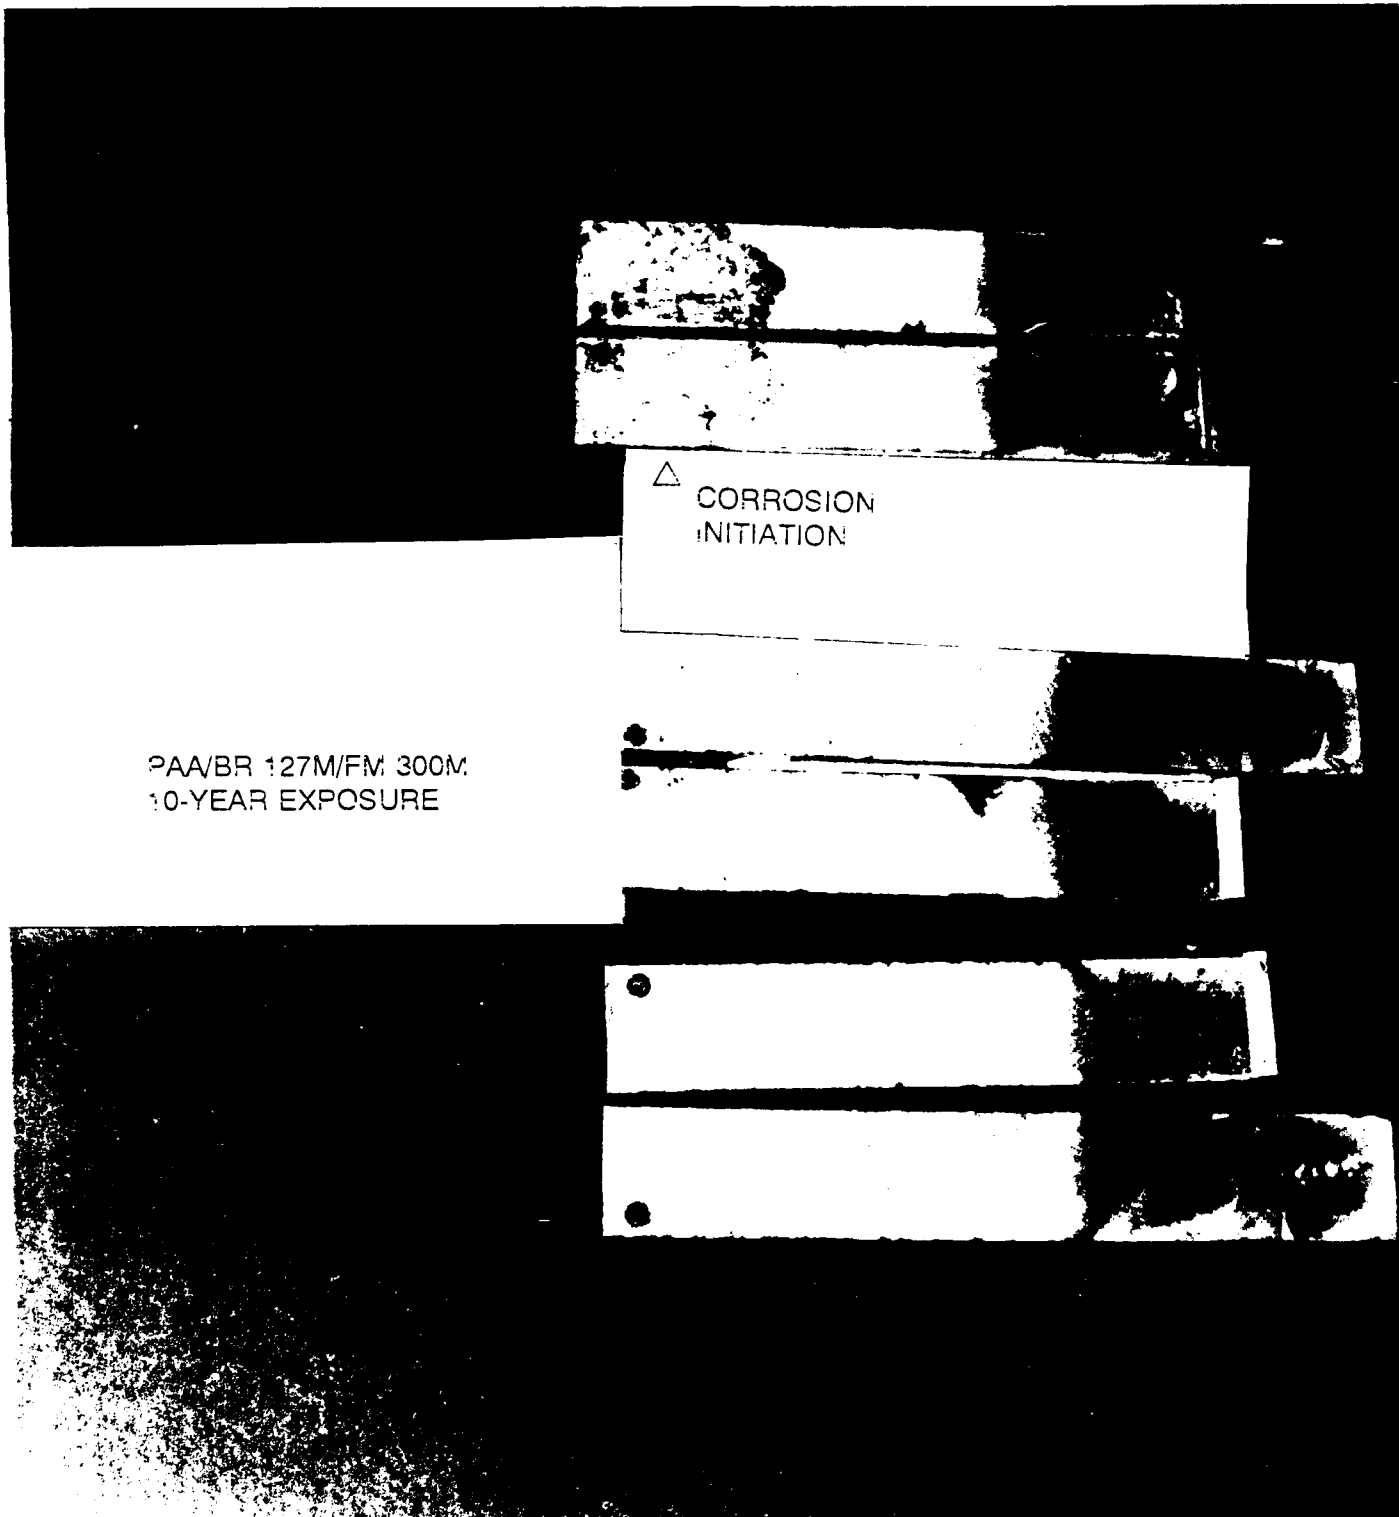
The mode of separation changes when corrosion becomes a factor. This is shown in Figure 24 where filiform has initiated bond line strength loss in the Phosphoric Acid Anodize, BR 127/ FM 300M crack extension specimens shown in Figure 2. Figure 25 shows most of the features which can be used to understand the filiform action in reducing the adhesion. An initiation site is seen at the notch which was used to mark the initial crack extension. This also provided an unprotected corrosion initiation site at the specimen edge. The dark area adjacent to the initiation site is a mature filiform. The shadow is filiform in a less developed condition to a point near the FM 300M adhesive edge. An aluminum hydroxide eruption is located slightly to the left of the V shape area of missing adhesive. This eruption is like the more translucent eruption adjacent to it and the eruption next to the smaller filiform initiation on the right hand upper portion of the figure. The adhesive has been lifted from this bond by

△ CORROSION
INITIATION

Figure 24: Crack Extension Specimens PAA/BR 127/FM 300M Showing Fillform: initiations after 10 years Exposure
