CULTURAL RESOURCES SURVEY

LONG BRANCH LAKE

Macon County, Missouri

HISTORIC ARCHITECTURAL RESOURCES

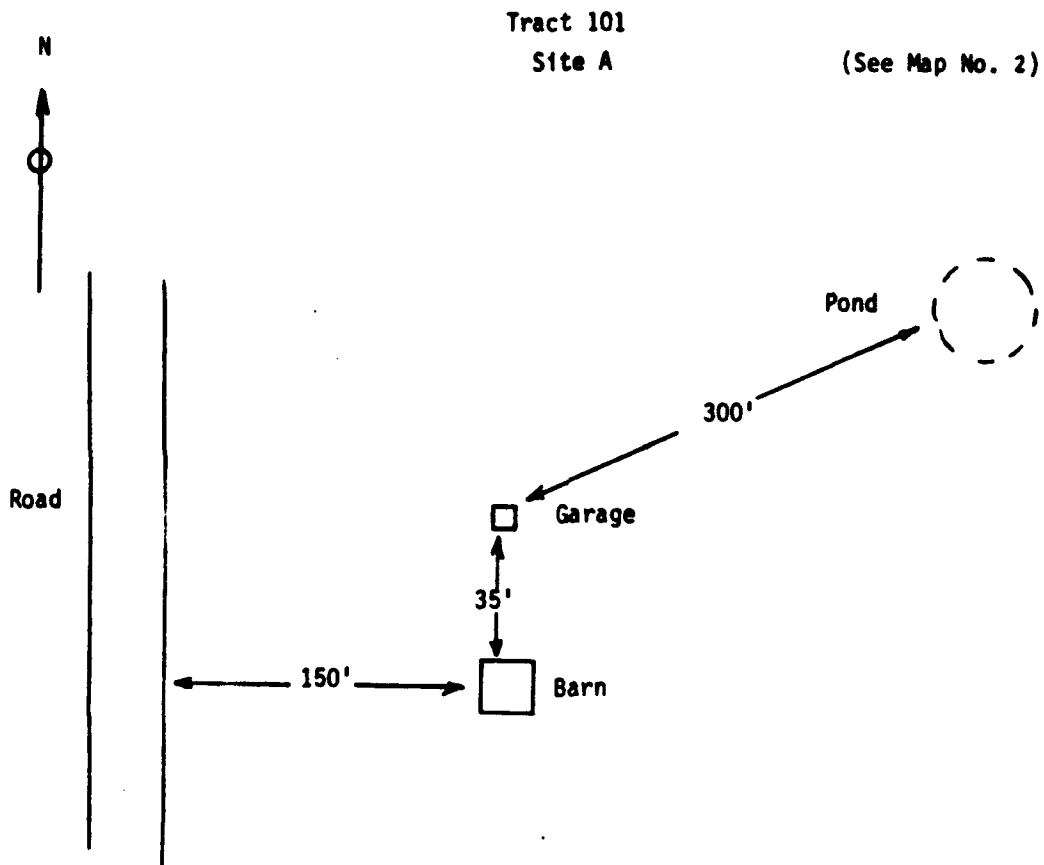
This barn was nearly square, and perhaps the most unremarkable barn examined on the Project. Regular in every way, it symbolized the functional, no-nonsense barn of the 30's, when the small farmer was still a major force in the agriculture of the region. It had been wired for electricity early, with knob-and-tube wiring which, in turn, had been replaced by more modern romex wiring. The siding was plain "barn boards" and the roof was of corrugated metal.

West front of barn

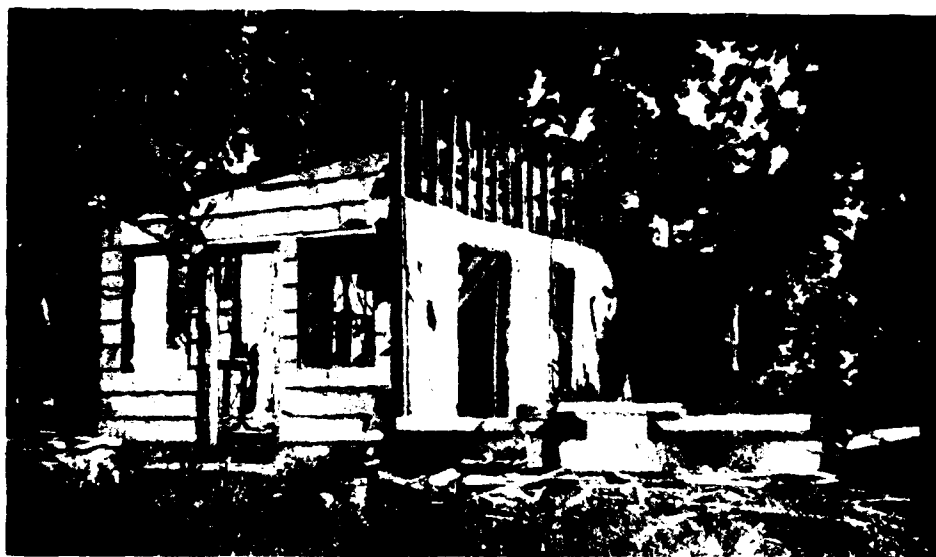
The house on Tract 105 A had been partially dismantled, and some of its lumber retrieved by the owner. What remained at the time of inspection showed the typical balloon frame construction, with lath and plaster walls.

Remains of house, facing North-northwest

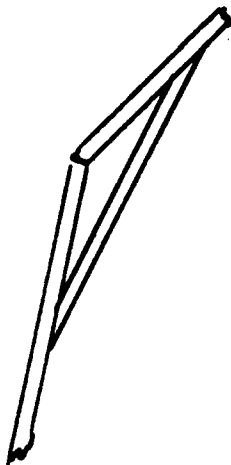
This was, in part, caused by

the custom of bracing the gambrel angle with a long spar, as shown at the left. The resultant triangle is so flat as to offer little rigidity, so that the roof tends to sag under the weight of snow, and with age.

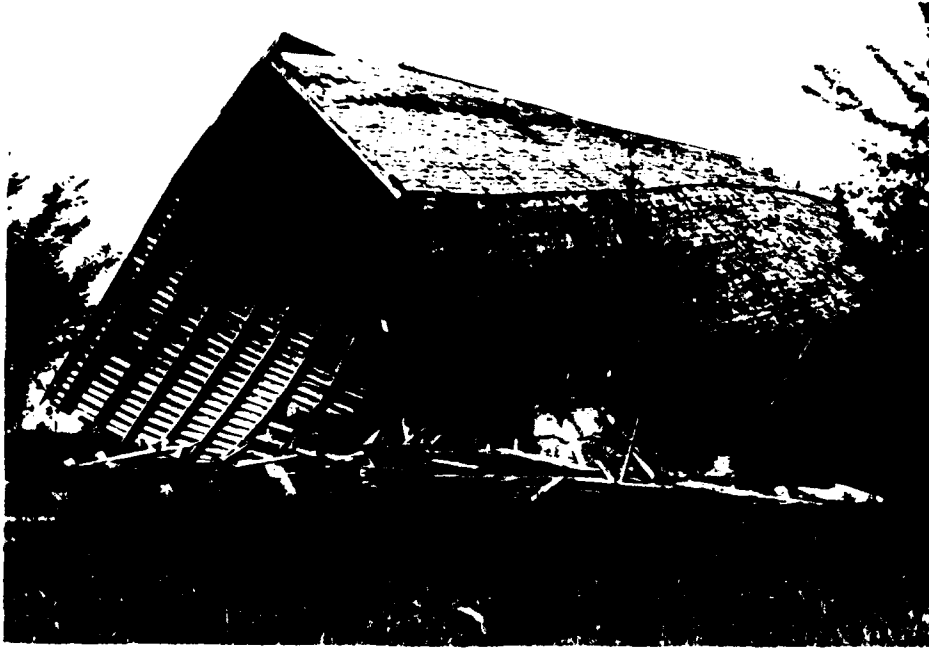
Collapsed barn roof, facing Southwest

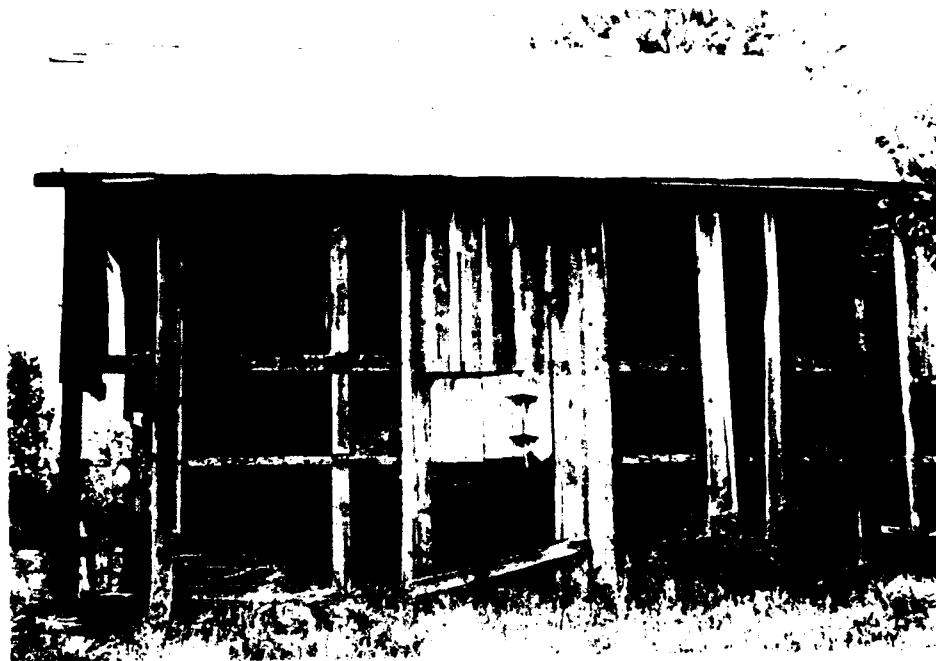
When observed, the barn was still upright and sturdy but many of the side boards and battens had been stripped off, preparatory to dismantling. The barn roof was shingled

The west section of the barn, viewer facing North

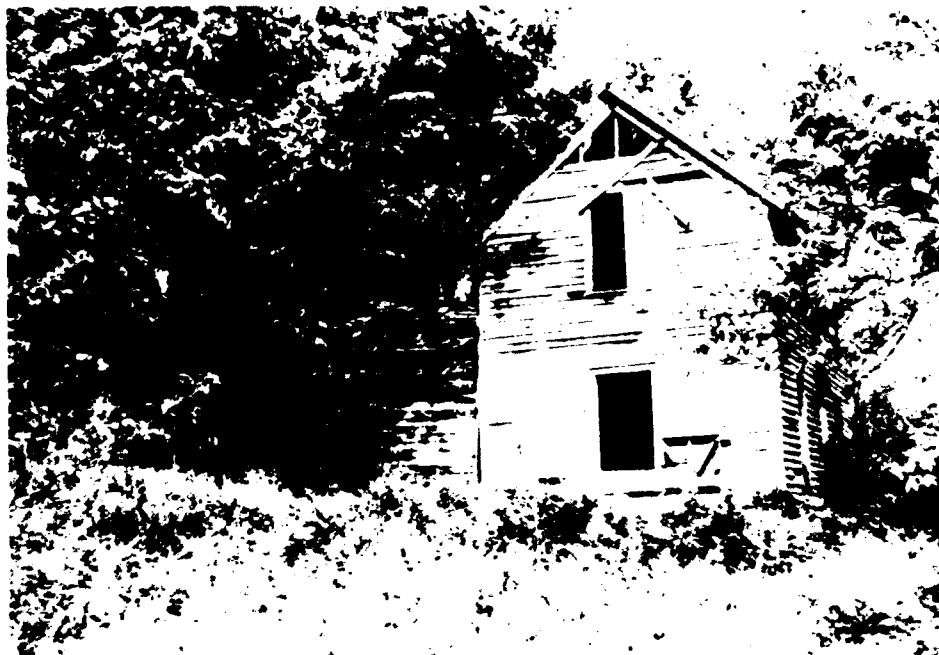
The house, viewer facing East

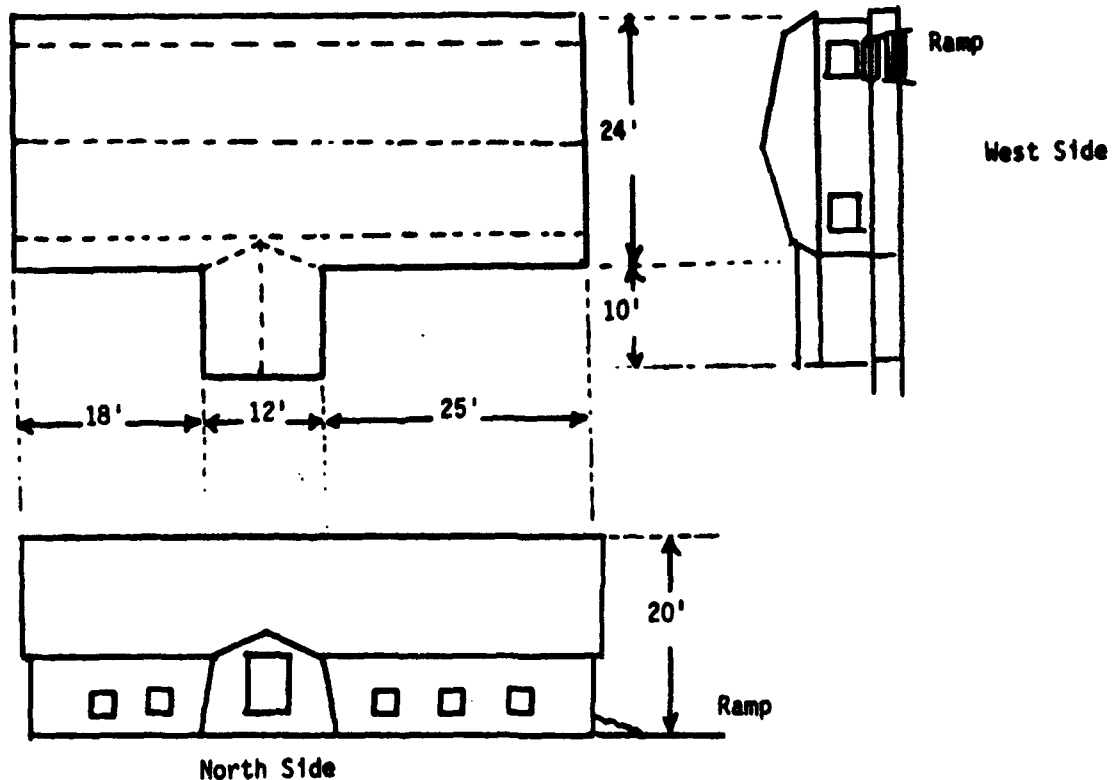
The hog house was nearly collapsed at the time of the survey. A strong wind appeared to have blown the roof to the north some six feet, crushing the supporting timbers and making the interior impassable.

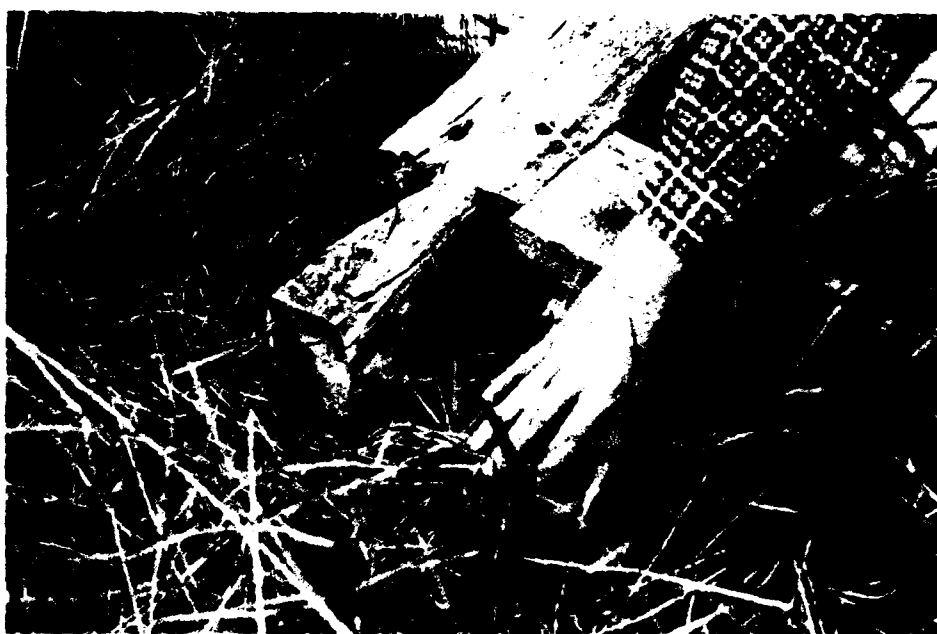
Remains of shed walls, showing dovetail joint

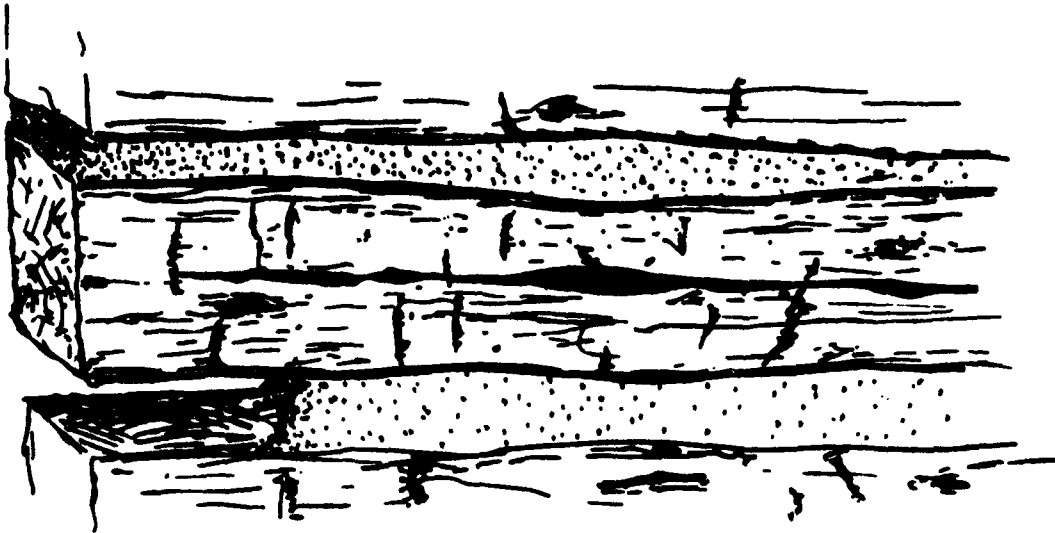
Details of Log Construction

The walls of the cabin were made of hand hewn timbers 8" x 10". The irregular spaces between were filled with plaster originally, and then covered over with cement.

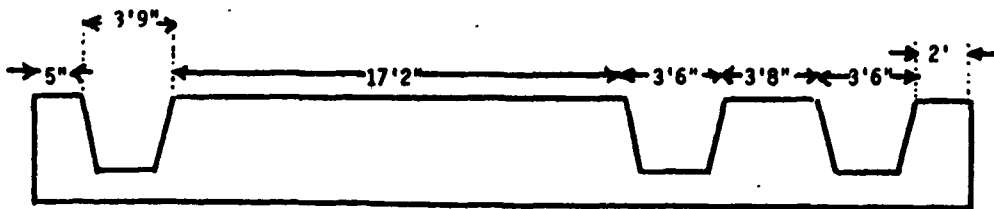
Detail of Barn Foundation (south wall)

The openings set into the barn foundation (see drawing below) may have served as access to crawl space below the floor, or to assist in removal of waste.

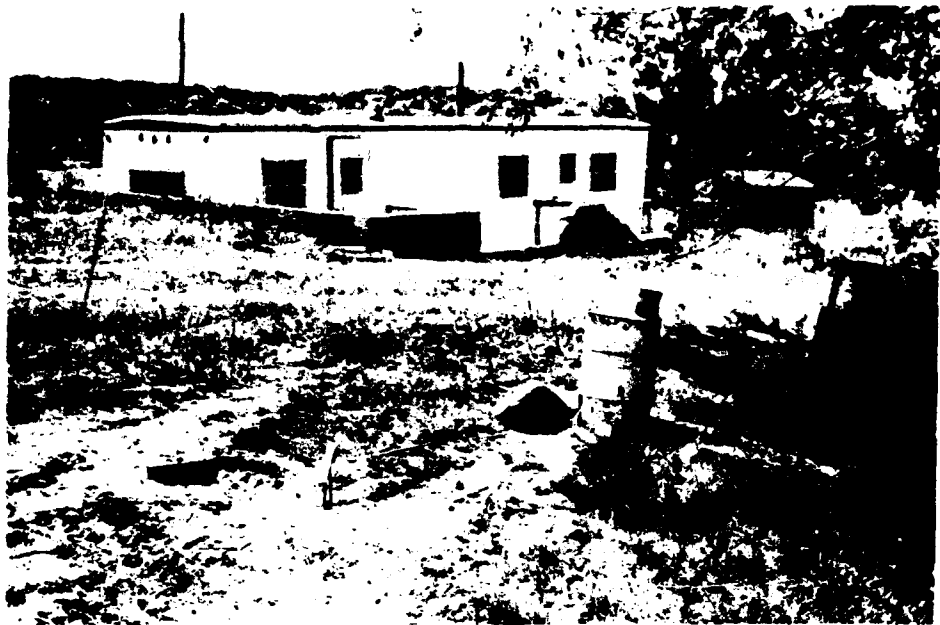
Remains of foundations on site. Trailer used by Army Corps of Engineers. Viewer facing Southeast
