DOT/FAA/CT-92/13

Rotorcraft Ditchings and Water-Related Impacts that Occurred from 1982 to 1989 - Phase I

October 1993

Final Report

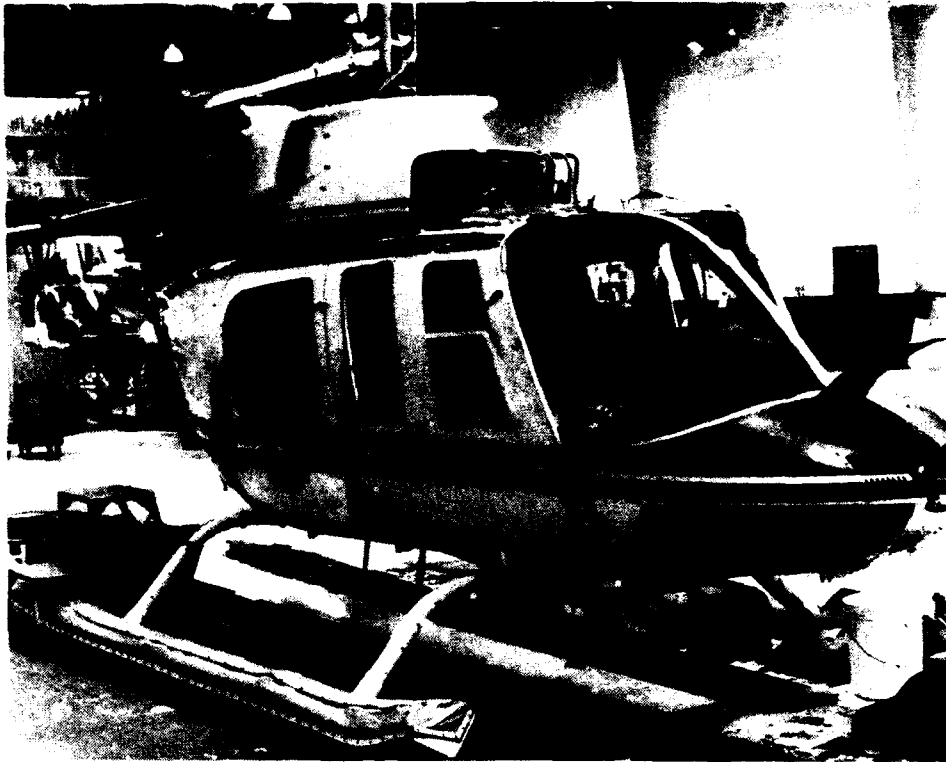
Figure 8.1 Case Study 1, Right Side View of Aircraft

- Tail boom severed in two places, fore and aft of stabilizer.
- Tail rotor blades, hub assembly, gear box, and aft-most section of tail boom missing (figure 8.1).
- Damage to one main rotor blade because of striking tail boom.
- Both chin bubbles broken (figure 8.1).
- Both forward windshields missing (figure 8.1).
- Left passenger door missing (figure 8.2).
- Right passenger door deformed (figure 8.1).

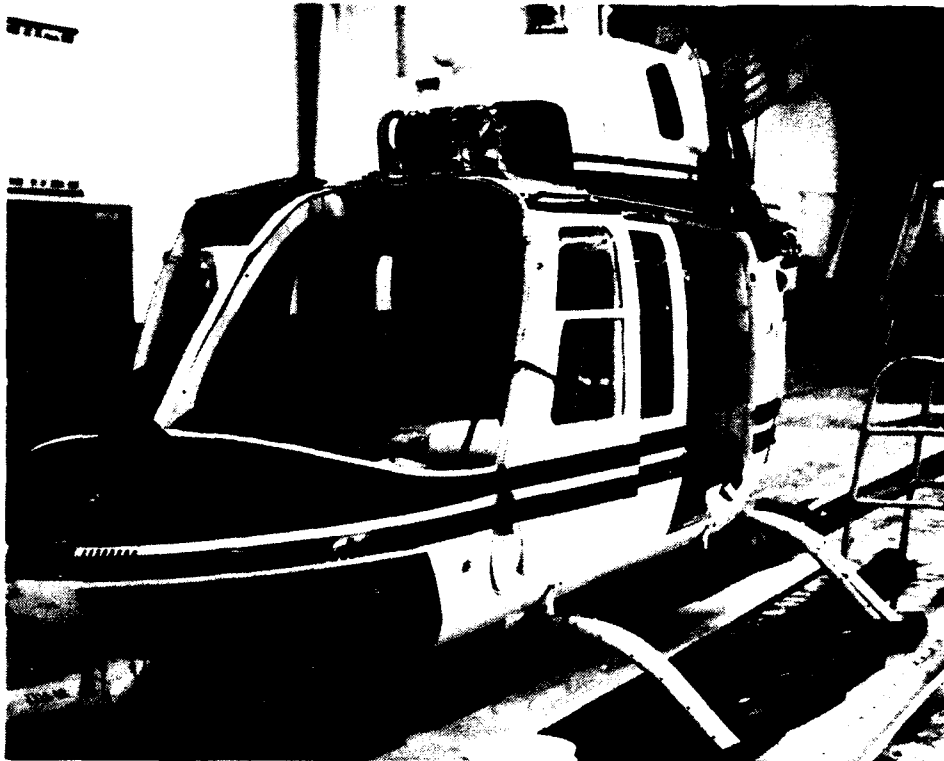
Figure 8.2 Case Study 1, Left Front View of Aircraft

- Airframe cracked three ft. forward of aft cross-tube (figure 8.3).
- Aft crosstube fairings crushed (figure 8.3).
- Cabin roof displaced three in. toward floor (figure 8.2).

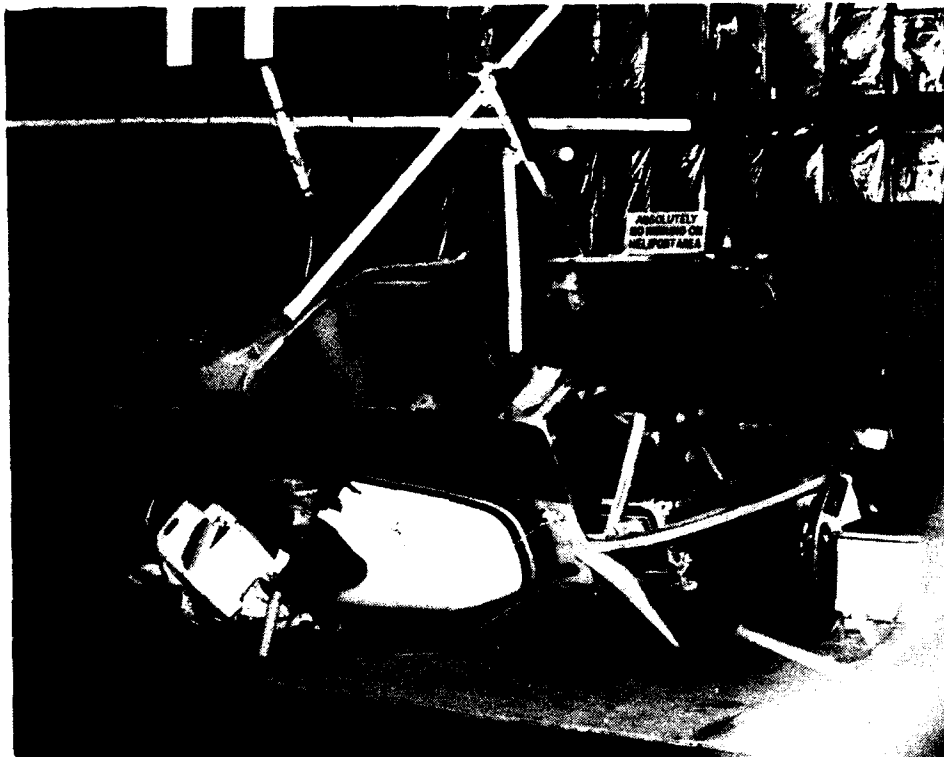
Figure 8.4 Case Study 3, Top View of Aircraft

- Both front chin bubbles and windshields destroyed (figure 8.4).
- Both front doors and posts torn away (figure 8.5).
- Left front seat and pedestal ripped out (figure 8.5).
- Tail boom broken off (figure 8.6).
- Main rotor blades and head assemblage broken off (figure 8.4).
- Transmission displaced forward and partially separated (split top of fuselage) (figure 8.4).
- Extensive damage to left side of cockpit and cabin and relatively minor damage to right side (figures 8.4, 8.7).

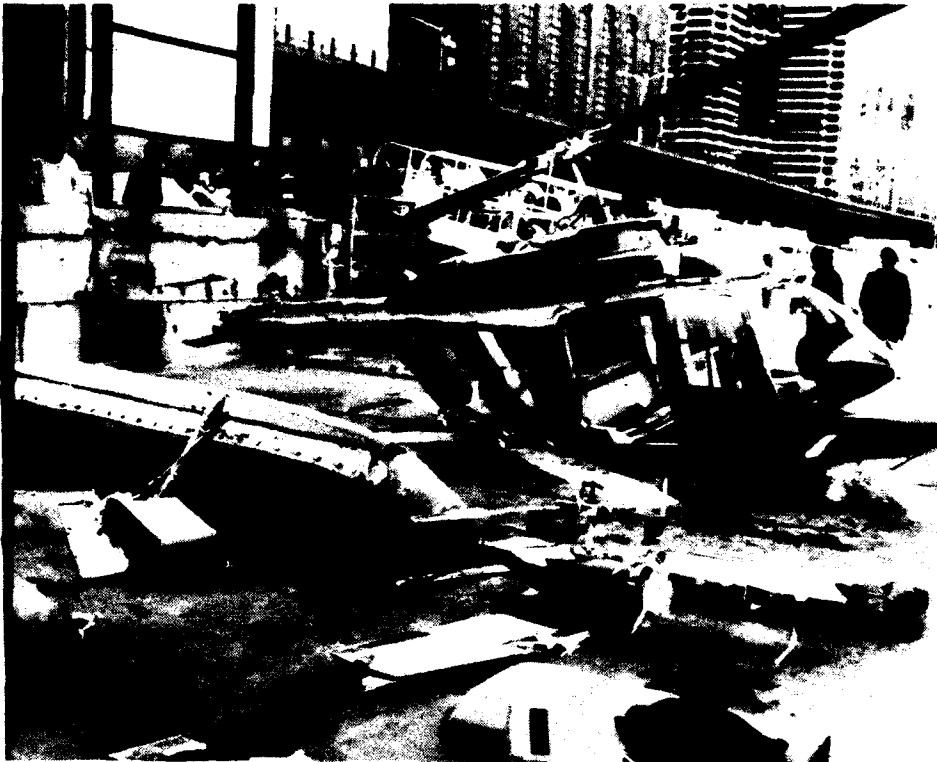
Figure 8.8 Case Study 5, Right View of Salvaged Aircraft

The floats were inflated at impact and then separated from the aircraft (figure 8.8).
