Report No. CG-D-05-94

AIRCRAFT CORROSION STUDY

J.T. Stropki
and
R.D. Smith

FINAL REPORT
December 1993

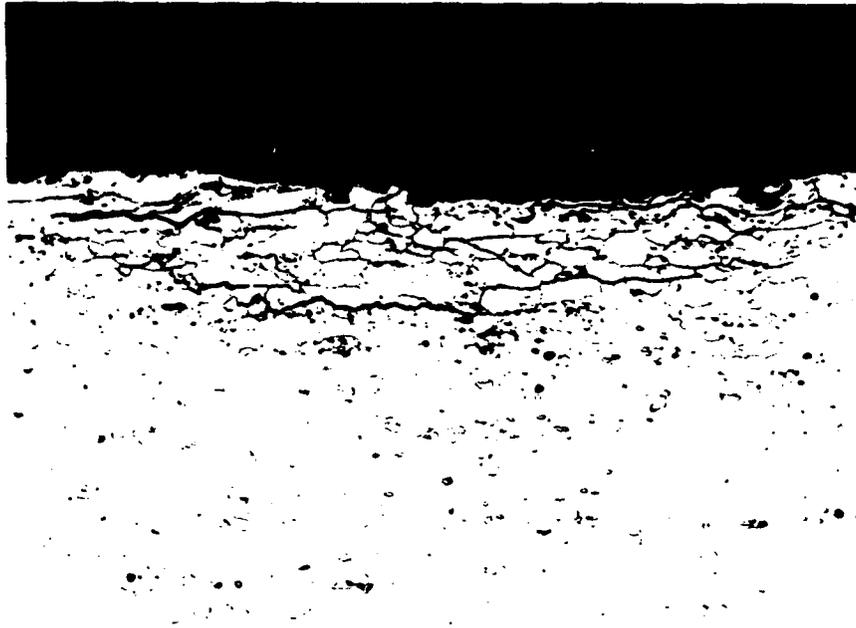
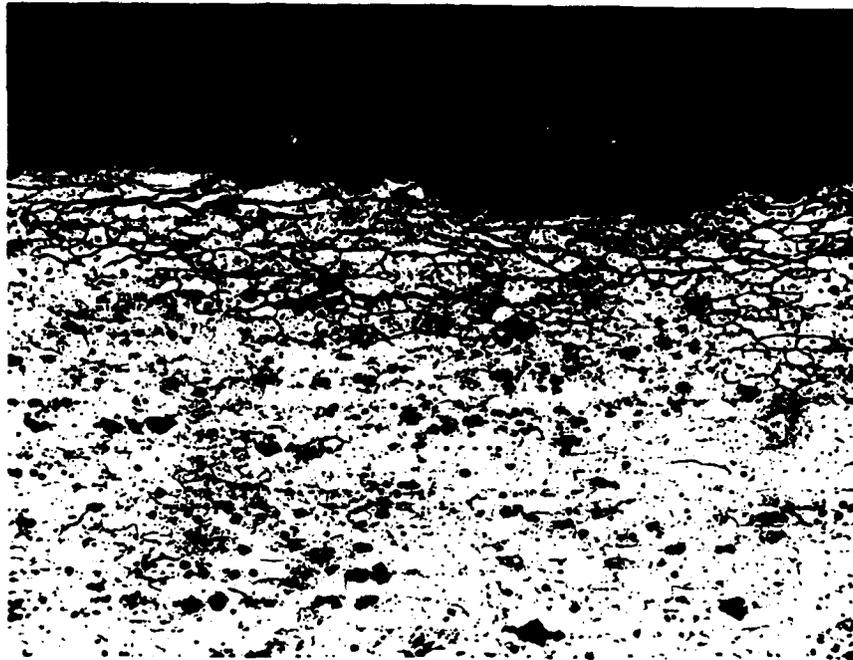
The microstructure of an "aged" French alloy that was removed from a wing slat of an HU-25A Falcon jet aircraft is provided in Figures 4a and 4b. Intergranular and exfoliation corrosion was evident along the internal surface of the sample. Metallographic examinations confirmed that the attack was concentrated beneath a primer coating applied to the internal surface of the wing slat. Battelle's ability to determine if the attack was induced as a

Figure 4. Photomicrographs documenting the microstructure of Specimen No. 4, the French alloy (primed).

result of (1) elevated temperatures (during antiicing of slat), (2) atmospheric corrosion, or (3) both, prior to being primed, was limited by a lack of service history on this particular component. No attack was noted along the external surfaces of the sample. As shown in Table 1, the average Knoop microhardness of this material was 153.

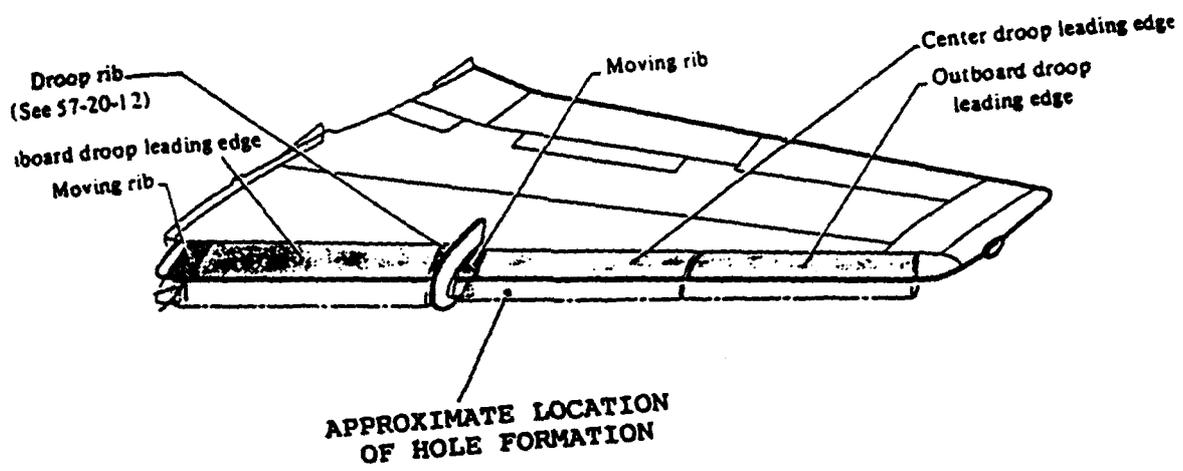
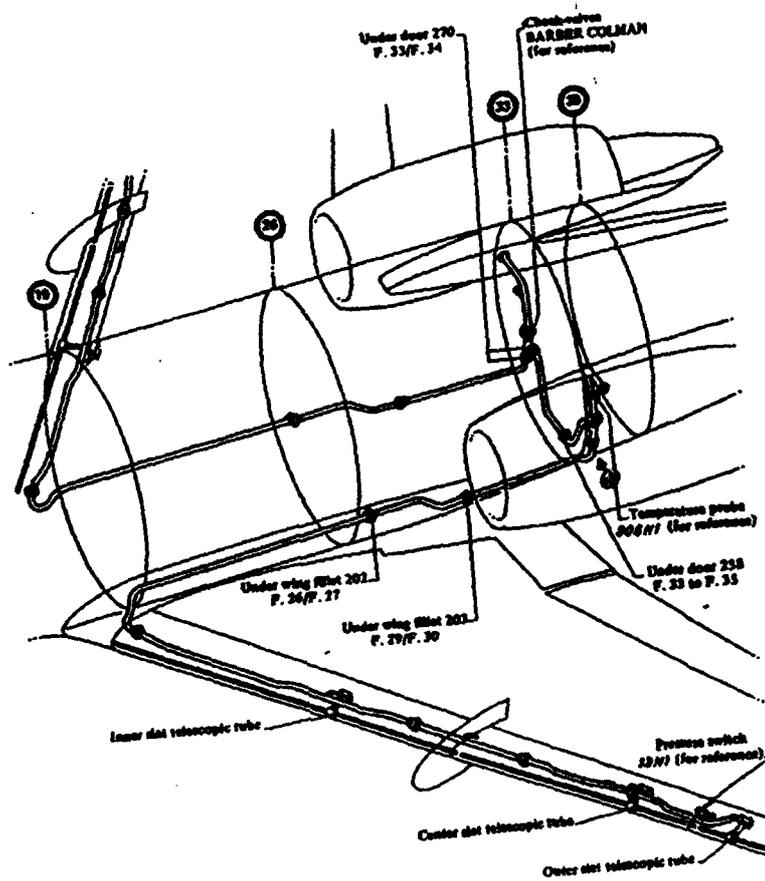
Corroded Test Sample. The metallographic examination of a small (1.0 inch by 1.0 inch) piece of eroded/corroded wing slat (see Figure 5) that was removed from an HU-25A aircraft (T/N 2131 - MY2014730G01 SN159F) was completed.

Figure 5. Diagrams of NU-25A RH wing documenting location of corroded slat and anti-icing tubes through inboard and center wing slats.

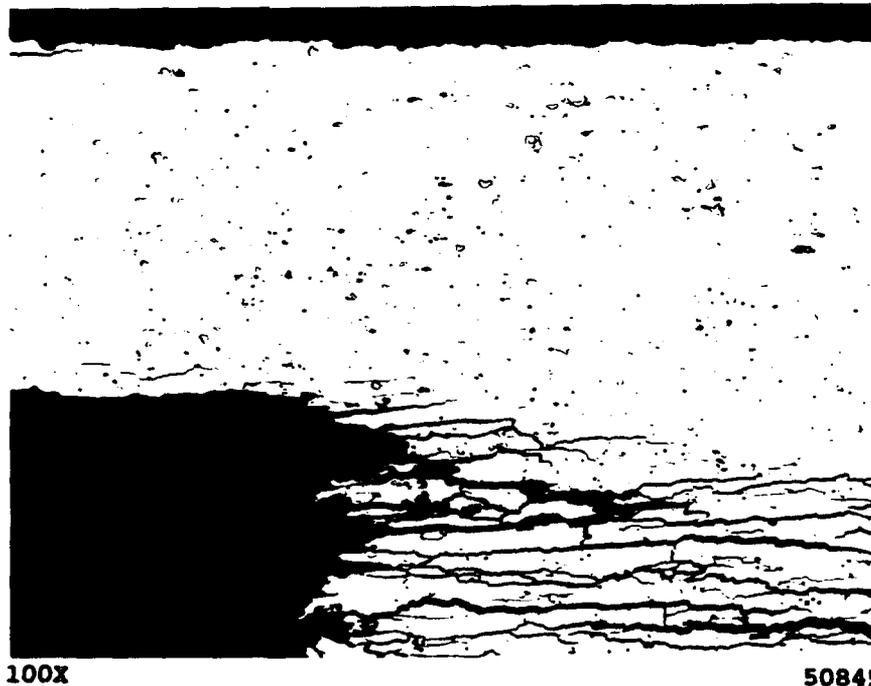
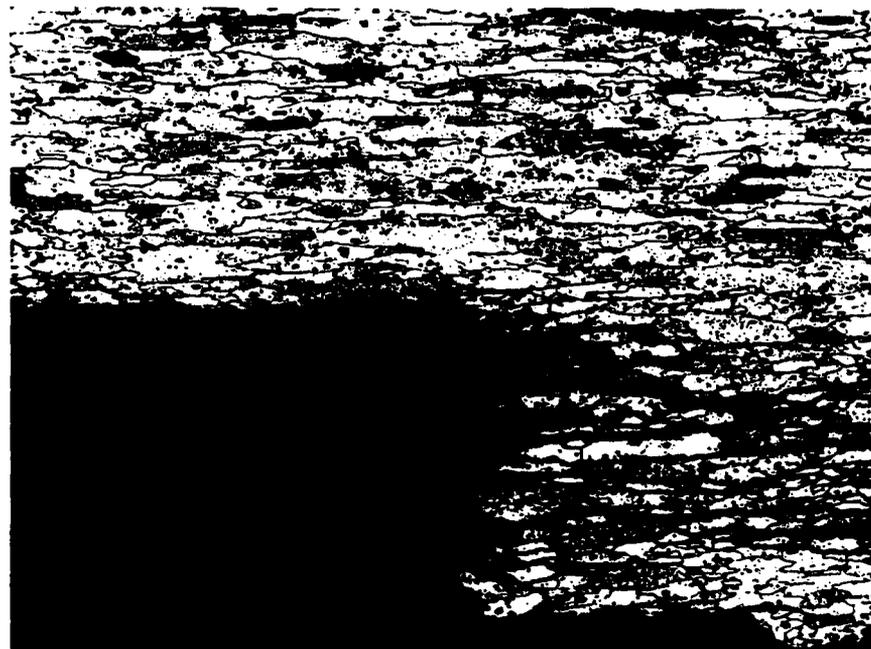
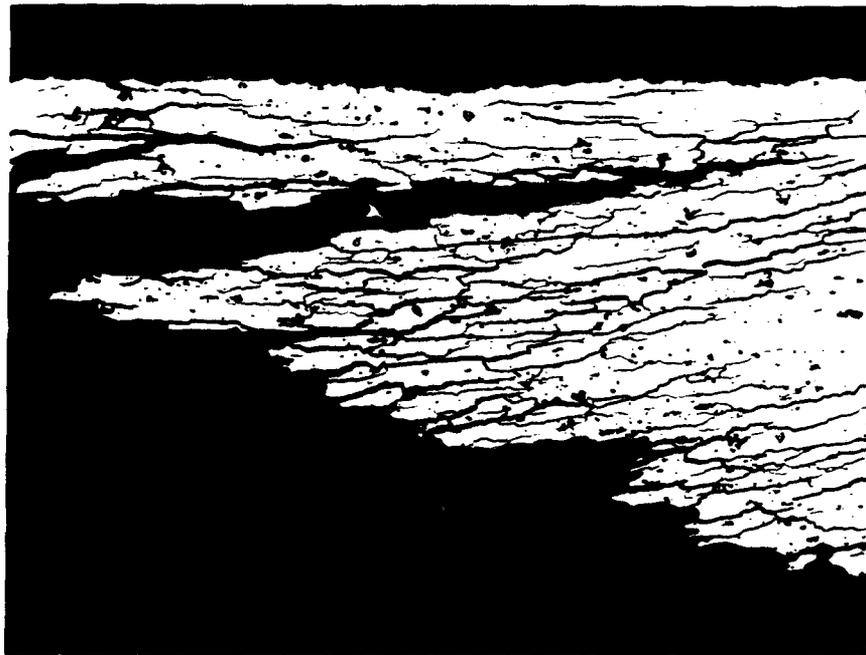
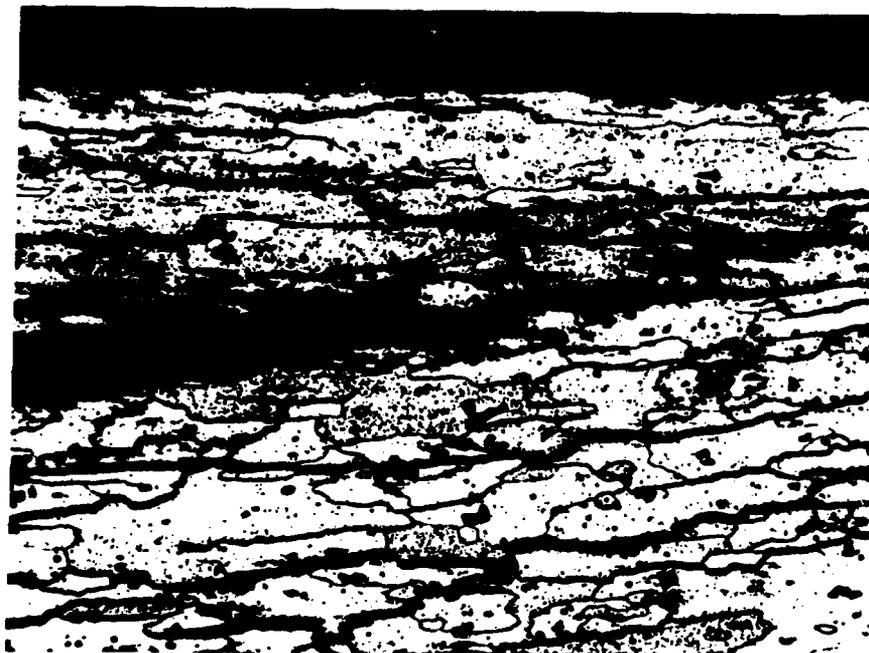
Additional processing of the damaged wing slat sample included mounting the entire sample in an epoxy material and selectively cutting the sample into four separate sections. Each section was then metallographically polished and etched for an examination of the sample's microstructure. Photomicrographs documenting the "as-polished" and "as-etched" condition of the alloy in two representative sections of the sample are shown in Figures 9a through 9d. An examination of each photomicrograph confirms the presence of severe intergranular and exfoliation corrosion. These failure modes are characteristic of the high strength aluminum materials, especially if the materials are overheated (retempered) and exposed to corrosive contaminants such as sulfates and chlorides.

Figure 9. Photomicrographs documenting the intergranular and exfoliation corrosion attack noted in two separate metallographic cross-sections taken through two areas of the damaged wing slat sample.

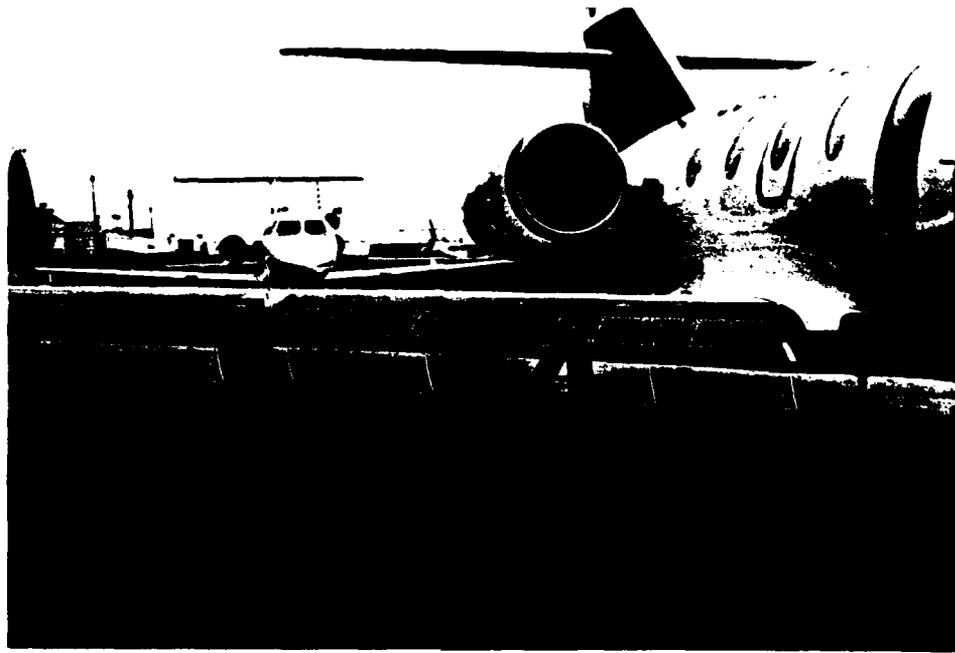
In response to the results obtained from the initial exposure, an additional set of temperature labels were installed on a single aircraft in the locations shown in Figure 16. The temperature range of these labels was 200 to 400°F. All labels were installed into the same areas as the initial set of labels. The results collected by the second set of labels indicated that the temperatures along the center wing slat were between 285 and 320°F. Coast Guard and Falcon Jet personnel stated that these temperatures may be slightly lower than the actual skin temperatures because of the air flow condition.

Figure 16. Photographs documenting approximate placement of temperature labels on inboard and center wing slats of HU-25A Falcon jet.
