**AIRBASE STRUCTURAL FACILITY
POSTATTACK RECOVERY - FOAL
EAGLE DEMONSTRATION**

**D.H. MERKLE, D.L. READ,
R.A. REID, J.M. UNDERWOOD,
N.F. KARASZEWSKI**

APRIL 1993

FINAL REPORT

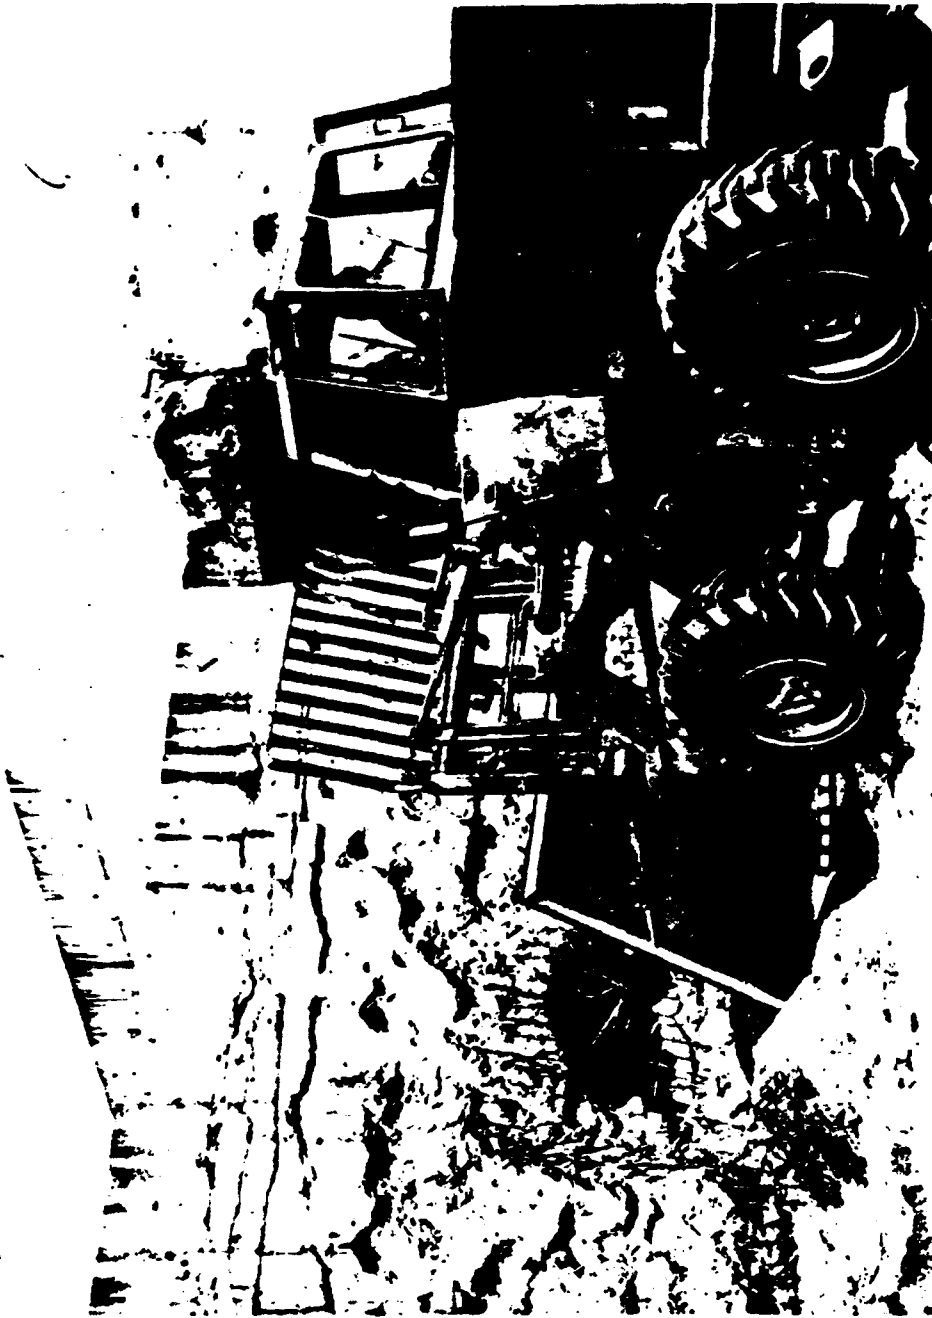
Figure 11. Earth Berm Wall Replacement Repair In Progress.

Earth berm repair practice took place on 24 September 1991. Four personnel were used to carry out the repair. Following the procedure outlined above, the plywood backing portion of the repair took 28 minutes and 33 seconds, placement of one precast slab with a front-end loader took 9 minutes 57 seconds, and forming the earth berm with a front-end loader took 15 minutes 12 seconds. Total repair time was 53 minutes 42 seconds. Figure 11 shows the earth berm repair in progress.

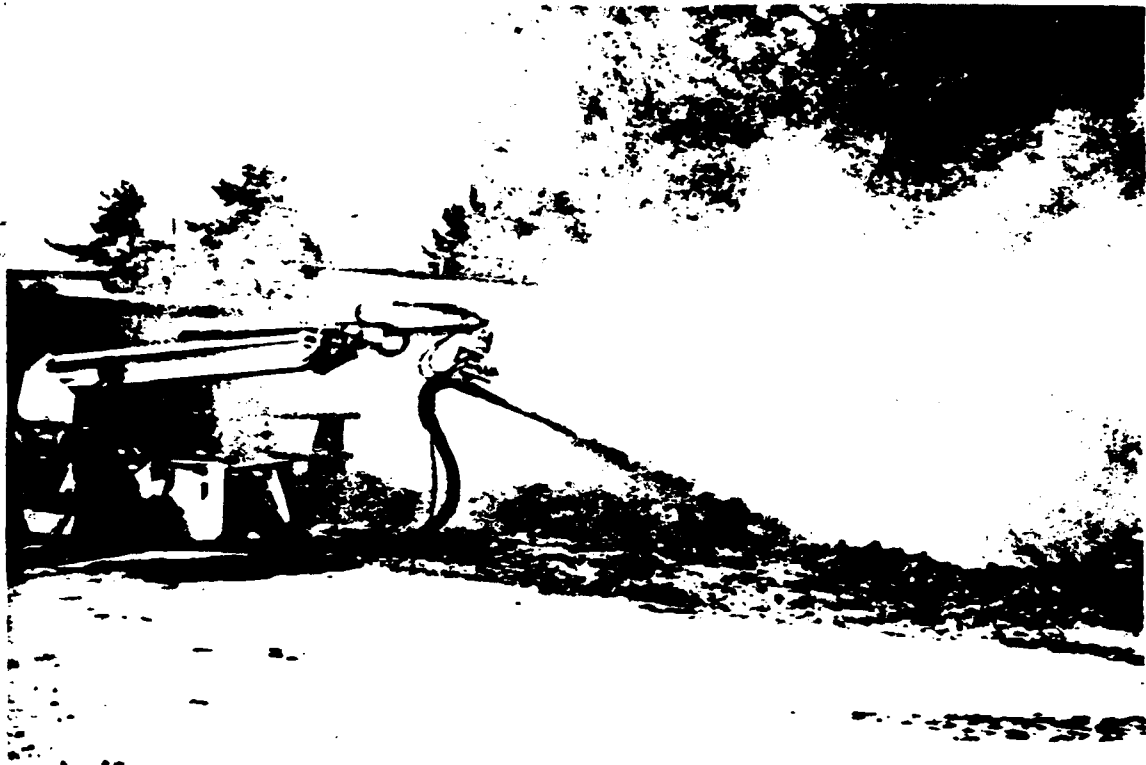
Figure 18. Lining Drainage Ditch With Shotcrete.

Two significant problems were encountered while lining the ditch. The first involved control of the water flow rate to the shotcrete nozzle, which in turn controlled the water content of the shotcrete material. If the water flow rate is too high, the shotcrete material becomes too wet and sloughs off instead of building up on the repair surface. If the water flow rate is too low, the material is too dry and will not stick to the repair surface. It took approximately 30 minutes to troubleshoot the water supply system and obtain the correct flow rate in a reliable manner.

The second problem involved supplying shotcrete material to the shotcrete gun hopper. The material was supplied in supersacks, which are plastic-lined bags with four lifting loops on top and a drawstring funnel at the bottom. Each sack contains 3,500 pounds of material, which when mixed with water makes 1 cubic yard of shotcrete. To supply material to the shotcrete gun hopper while lining the ditch, a lifting harness was placed through the loops in the top of the supersack. The harness was then secured to the forks of an all-terrain forklift, which then lifted the supersack over the hopper. The funnel at the bottom of the bag was opened, and the shotcrete material flowed into the hopper. Once, during this process, the lifting harness was not secured to the forklift forks. When the supersack was lifted, the harness slid off the forks, and the supersack fell to the ground and ruptured. The material then had to be fed into the hopper by hand with shovels. This oversight, in addition to slowing down the ditch-lining process, posed a safety hazard. Subsequently, while completing the lining of the drainage ditch, and during the actual shotcrete wall replacement demonstration the following week, great care was taken to ensure the lifting harness was securely fastened to the forks of the forklift.

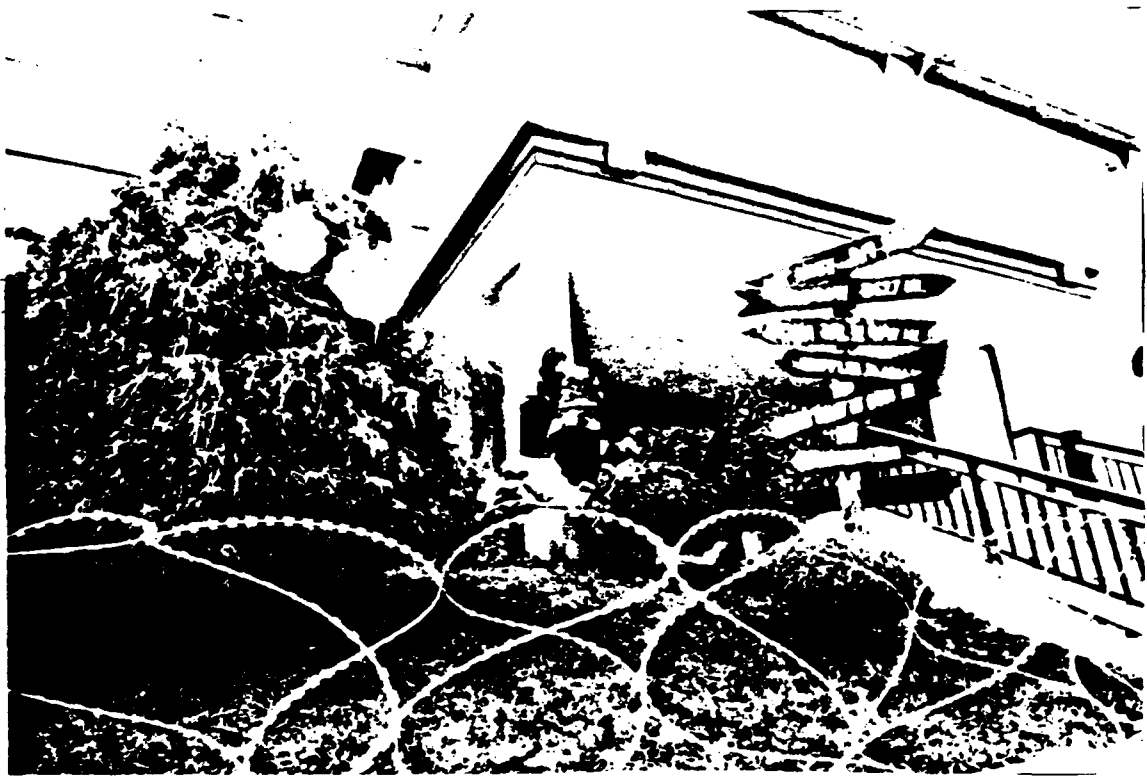
Figure 25. Completed Column Splint Repair At 7AF Headquarters During The FOAL EAGLE Exercise.

The second column splint demonstration took place on the afternoon of 6 November 1991. A 14-inch square column located at the front entrance to the 7AF headquarters building was used to conduct the demonstration. The repair team consisted of two 92 CES personnel: SRA Christopher Berens and SRA Ronald F. Snider. The splint repair was conducted following the repair procedure described in Subsection II.C.1.a of this report. Results from this column splint demonstration are summarized below in Table 11.

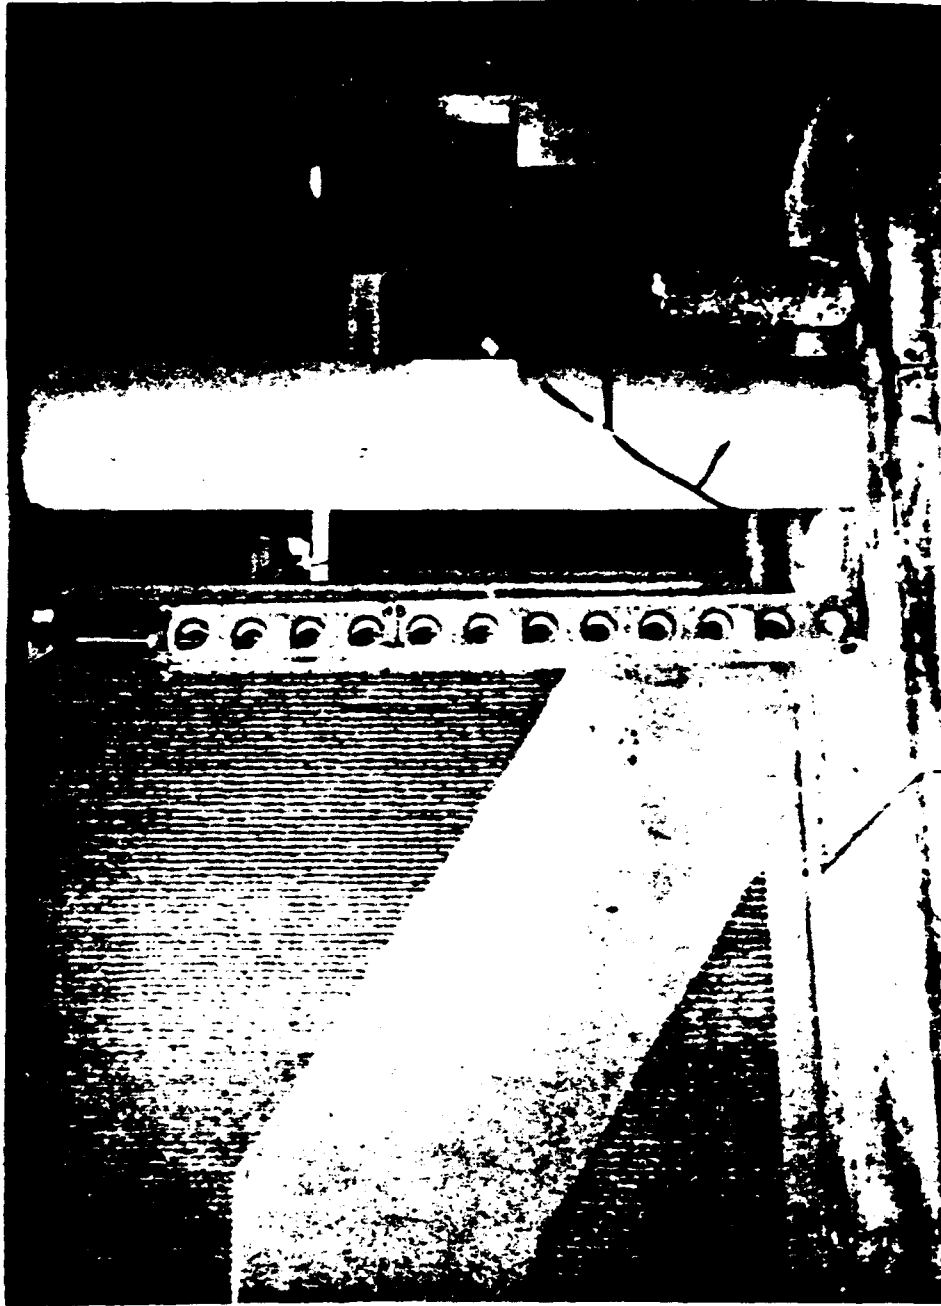
Figure 26. Completed Column Replacement Repair During The FOAL EAGLE Exercise.

The column replacement demonstration took place in mid-morning of 6 November 1991. A 10-foot 9-inch tall, 25-inch diameter circular column located in the emergency entrance to the base hospital was used to conduct the demonstration. The repair team consisted of SSgt Karl T Apsey, SRA Dean D. Berube, and A1C Curtis W. J. Stewart of 51 CES, and SSgt David D. Lott of 92 CES. One repair was conducted, following the repair procedure described in Subsection II.C.2.a (2) of this report. Results from the column replacement demonstration are summarized in Table 12.

The column replacement demonstration went well. No significant problem was encountered during the process. The completed column shoring repair is shown in Figure 26.

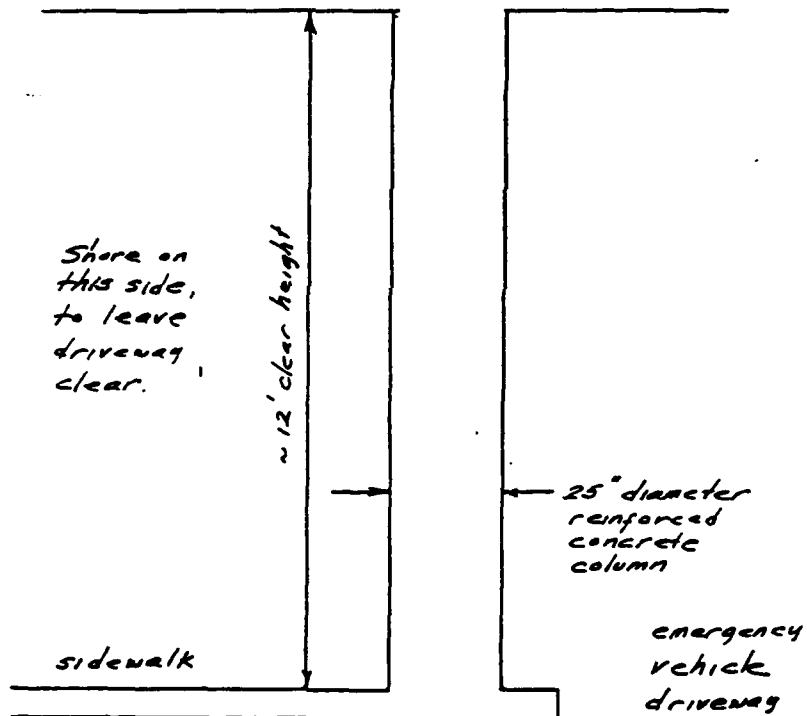
25"  $\phi$  R/C Column, ~ 12' high

Scenario - repair by shoring
