## INVESTIGATION OF THE GENERATOR ROTOR BURST AT THE PITTSBURG STATION OF THE PACIFIC GAS AND ELECTRIC COMPANY

The recent fracture of a large generator rotor (125,000 kw - 3600 rpm) led to an extensive investigation aimed at determining the cause. This paper describes the various facets of this investigation, the results obtained, and the probable cause of the burst.

On March 18, 1956, the generator rotor of the 169,118-kva Pittsburg Unit No. 1, of the Pacific Gas and Electric Company, burst during an overspeed-governor trip test. This test was being made before placing the turbine-generator into operation following an inspection and overhaul of the turbine.

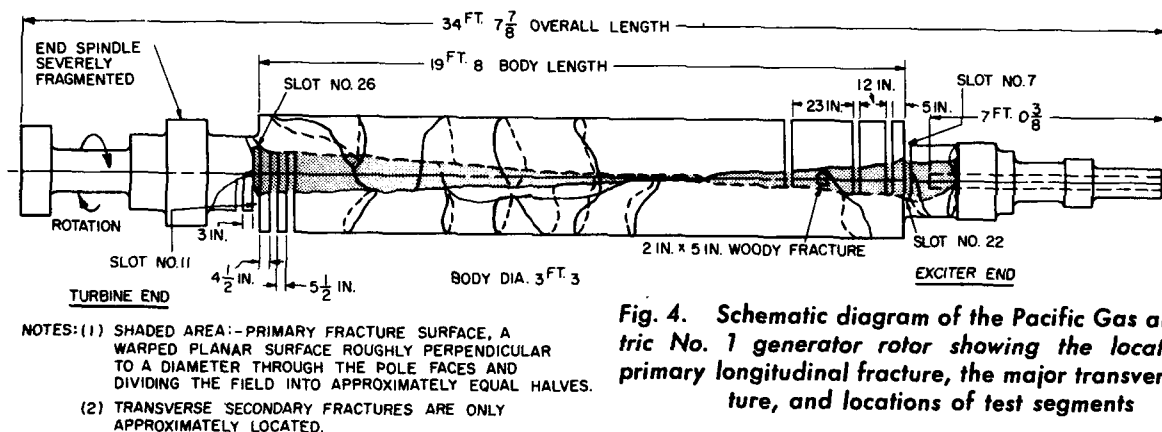
Fig. 4. Schematic diagram of the Pacific Gas and Electric No. 1 generator rotor showing the locations of primary longitudinal fracture, the major transverse fracture, and locations of test segments

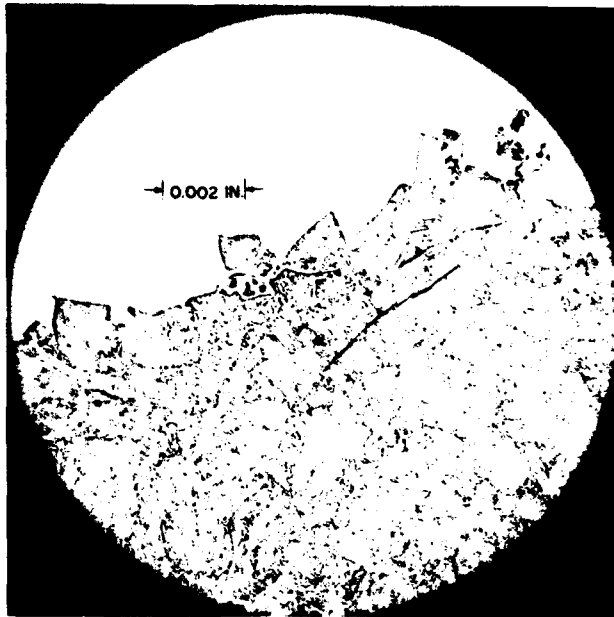
Fig. 12. Photomicrograph depicting transcrystalline fracture outside woody area

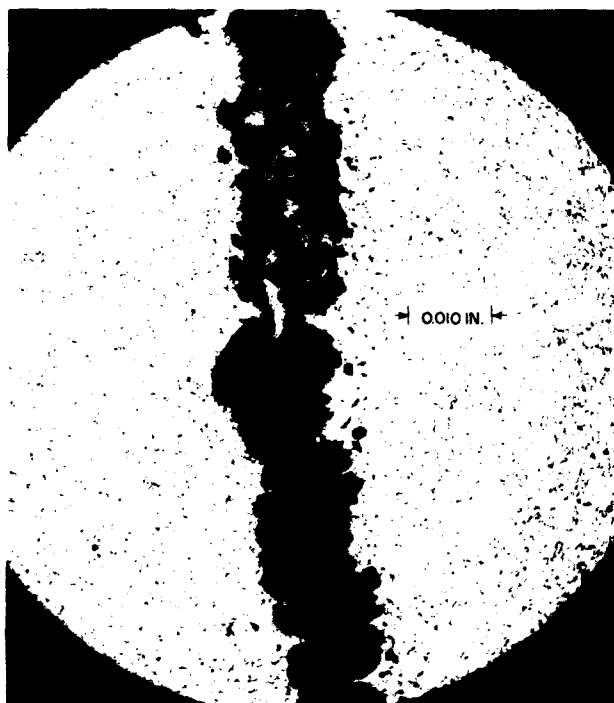
verse section of the 1 1/2-in. x 8-in. plane of inclusions can be seen contained within this slice. Figure 15 is a photomicrograph of one of the thickest sections of inclusions which tapers gradually to the very thin extremities as shown in Fig. 16. The surface of the metal in contact with the plane of inclusions is intergranular, and appears similar to that found along the surface in the 2-in. x 5-in. area of the Pittsburg No. 1 rotor.

Fig. 15. Photomicrograph of a thick portion of the non-metallic inclusion array and surrounding structure

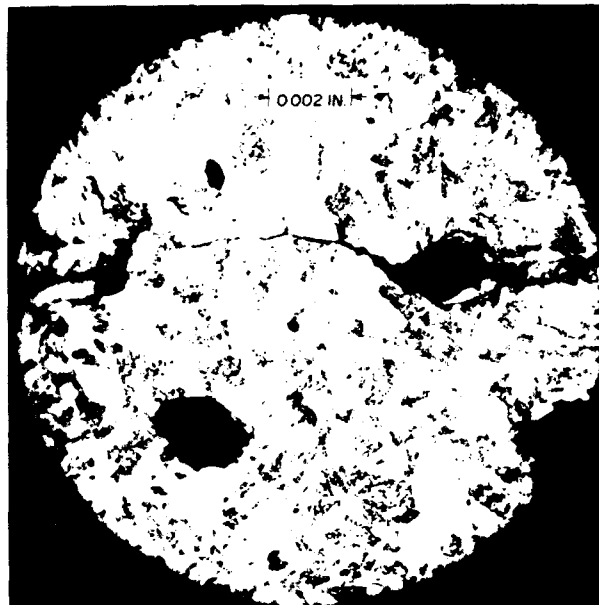
Fig. 16. Photomicrograph of the extremities of the inclusion array and surrounding structure

3. The microstructure surrounding the "woody area" in Pittsburgh No. 1 consisted primarily of coarse-grained upper bainite as shown in Fig. 11, while the microstructure in the vicinity of the large inclusion in No. 3 consists of a mixture of tougher fine-grained ferrite and some bainite as shown in Fig. 16.
