Structural Evaluation of Riveted Spillway Gates

Final report

Prepared for U.S. Army Corps of Engineers
Washington, DC 20314-1000

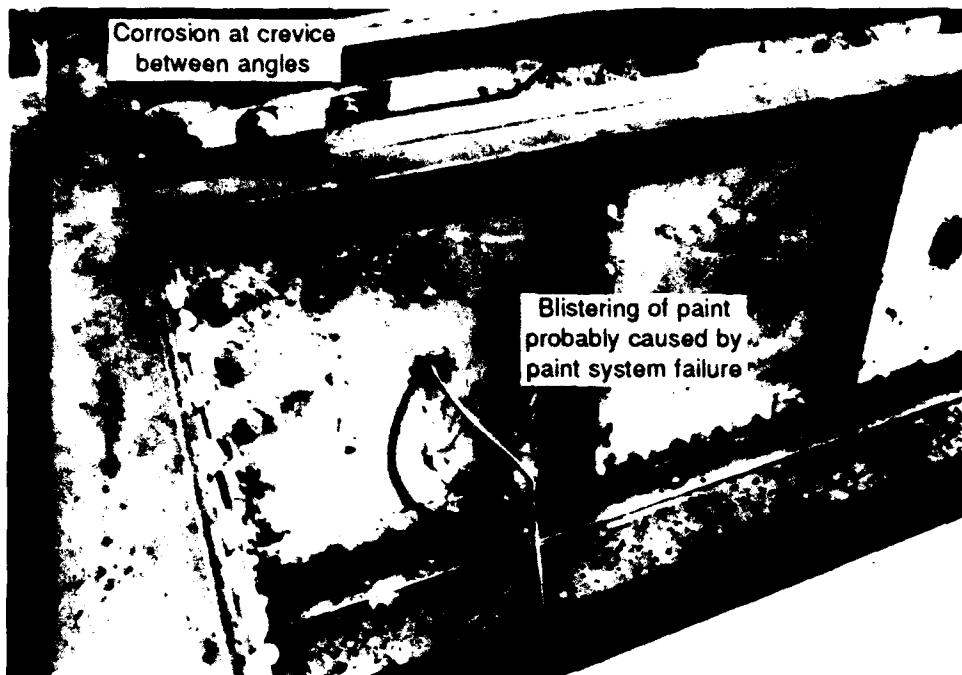
Figure 19. Vertical lift gate at Bankhead Lock and Dam with paint blistering and corrosion

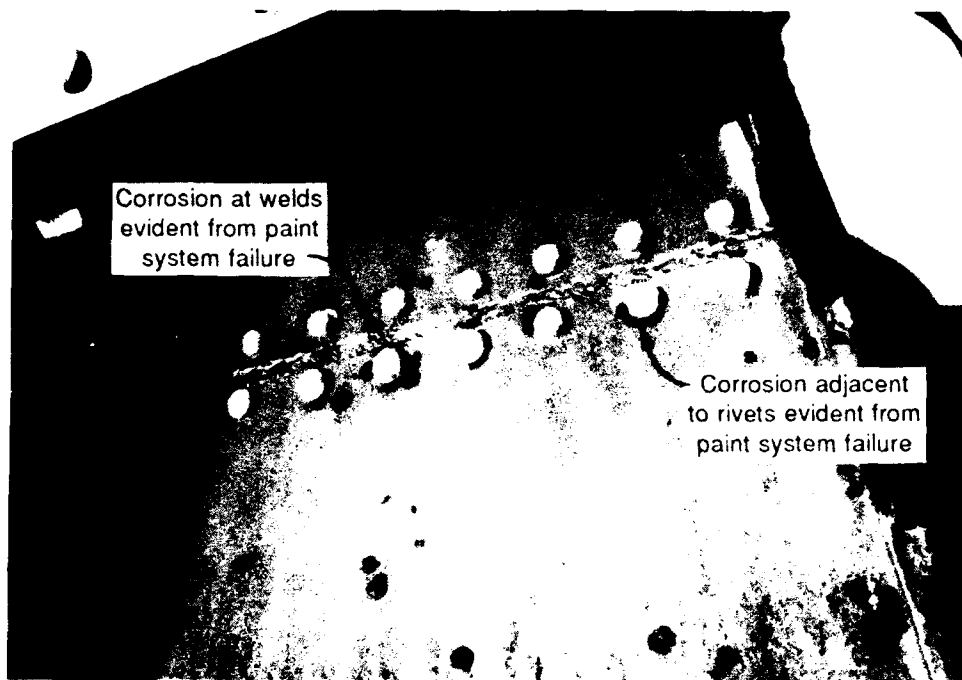
Figure 20. Tainter gate at Mississippi Lock and Dam No. 5 with seal weld and localized corrosion

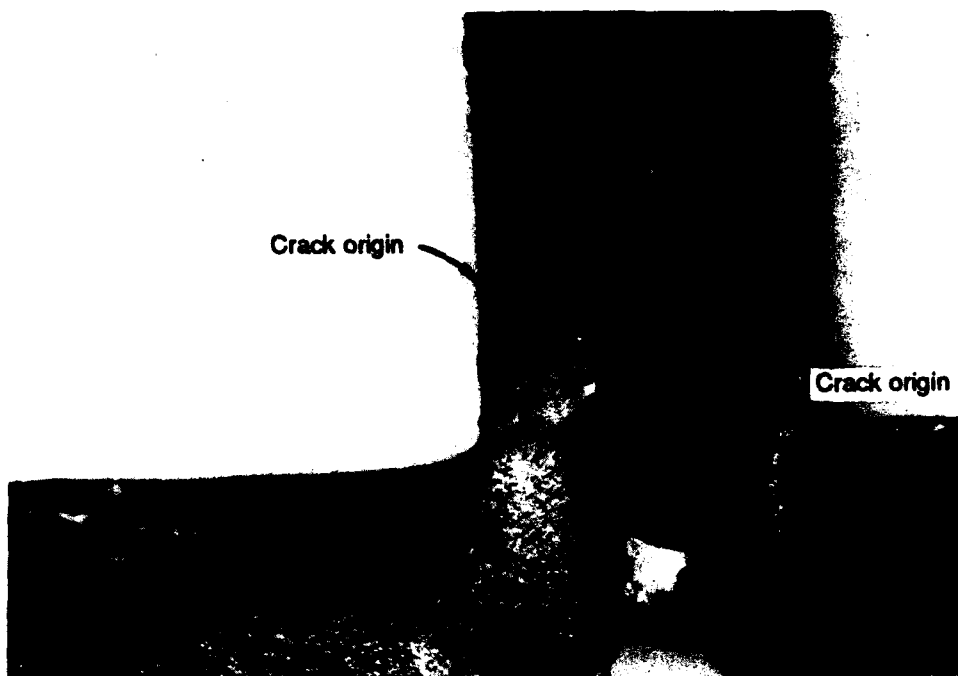
Figure 26. Crack surface at the edge of a rivet hole

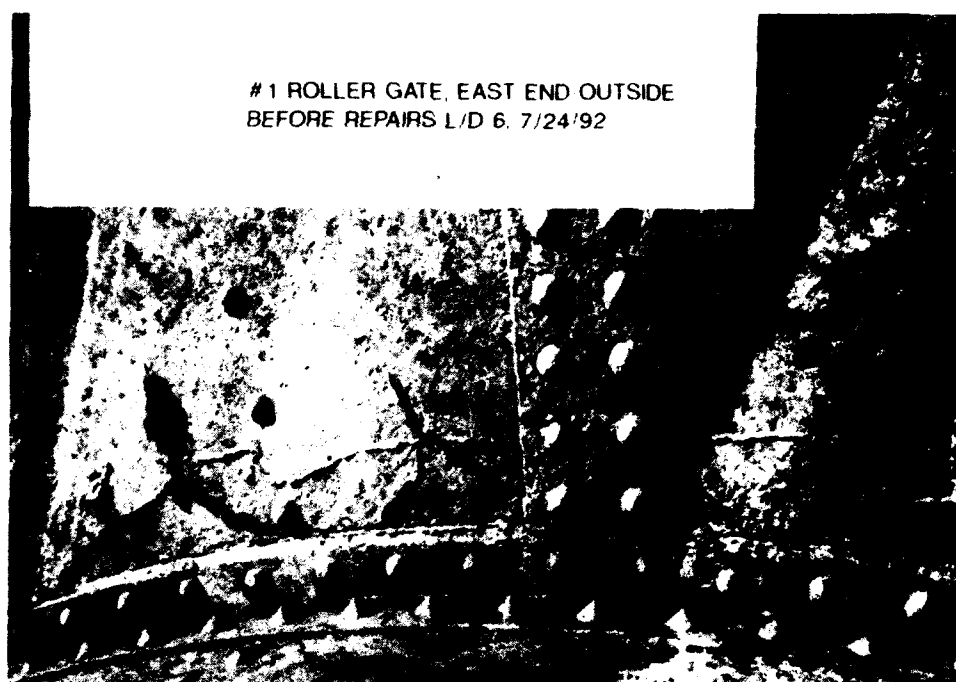
b. Fatigue cracks redeveloped at previous repair welds

Dam No. 6 in the St. Paul District.¹ Figure 32b indicates cracks reinitiating from previous repair welds. In this instance, attempts to strengthen a riveted gate by adding welded stiffening plates created very poor fatigue details. Repairs such as this should be avoided. Figure 33 shows a fatigue crack starting from a tack weld on a riveted bridge member. The crack initiated at the toe of the tack weld and grew into the riveted plate in the direction perpendicular to the primary tensile stress. Similar damage could occur on a riveted gate member.
