FEAP-TR-FM-94/09
June 1994

Demonstration of a Field Rehabilitation Technique for Removing Corrosive Solder Flux in Cold Water Copper Piping Systems

by
O.S. Marshall, V.L. Van Blaricum, R.H. Knoll, V.F. Hock, and J.R. Myers
U.S. Army Construction Engineering Research Laboratories
Champaign, IL 61826-9005

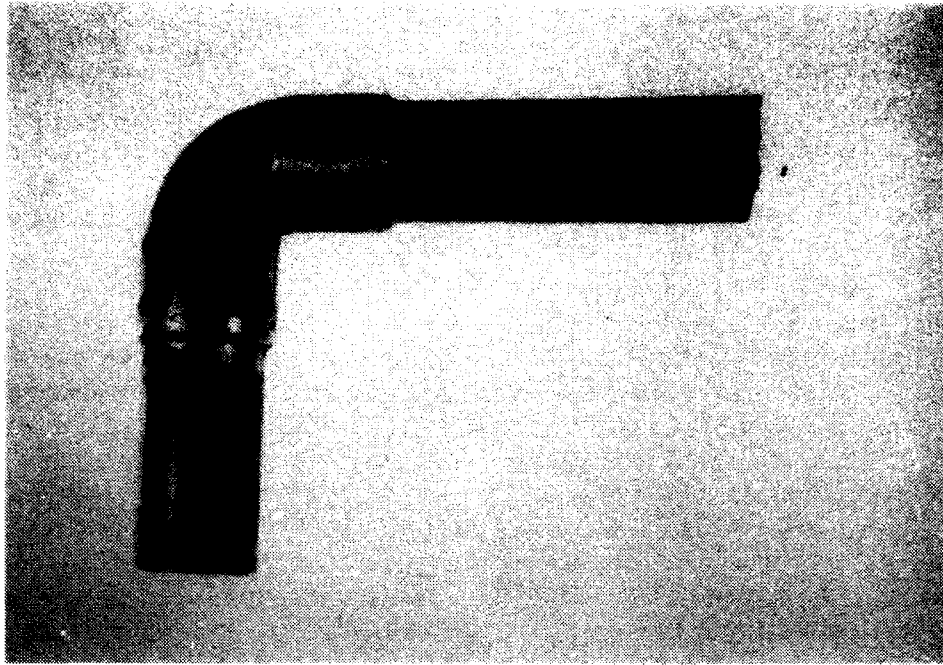
A visual examination of the external surfaces of the specimens revealed no significant degradation by the external environment (Figures 1 and 2). The external surfaces of each specimen were covered with a protective tarnish film of reddish-brown cuprous oxide (Cu_2O). As stated earlier, pinhole leaks had occurred in two of the specimens. Stereomicroscopic examination of the interior surfaces of the specimens showed that the pinhole perforations had initiated on the water (internal) side of the pipes.

Figure 2. External Surface of Specimen 3.

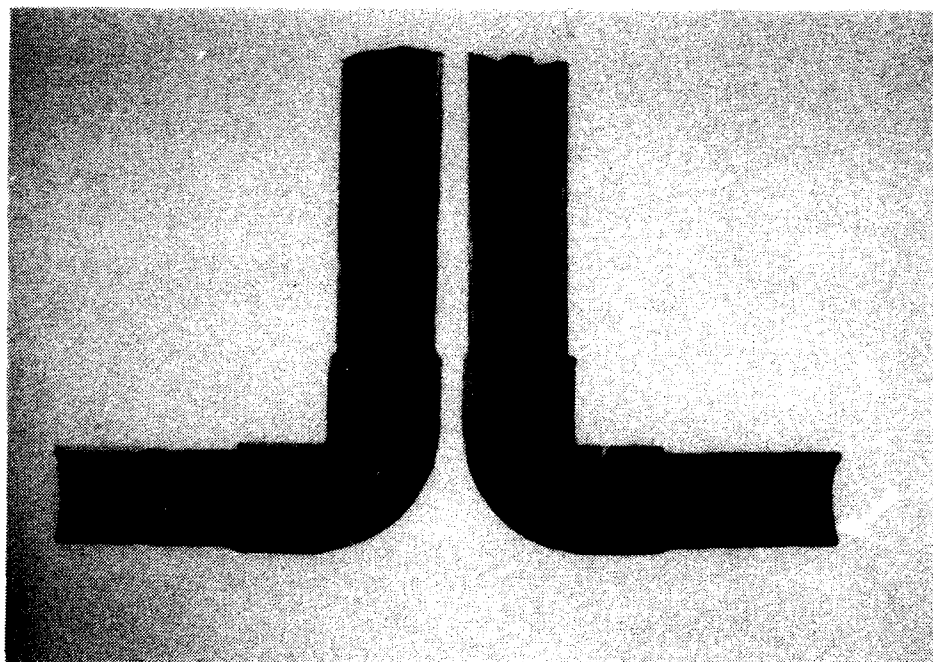
Specimen 3 (Figure 4) contained a strip similar to specimen 1. Again, corrosion-induced pits contained reddish-brown cuprous oxide and were overlaid with friable, greenish-colored tubercles. Chemical composition of the deposits was similar to that of specimens 1 and 2. Zinc and chloride were also found in the corrosion products, which confirmed the belief that soldering flux was involved in the corrosion process.

Figure 4. Internal Surface of Specimen 3.

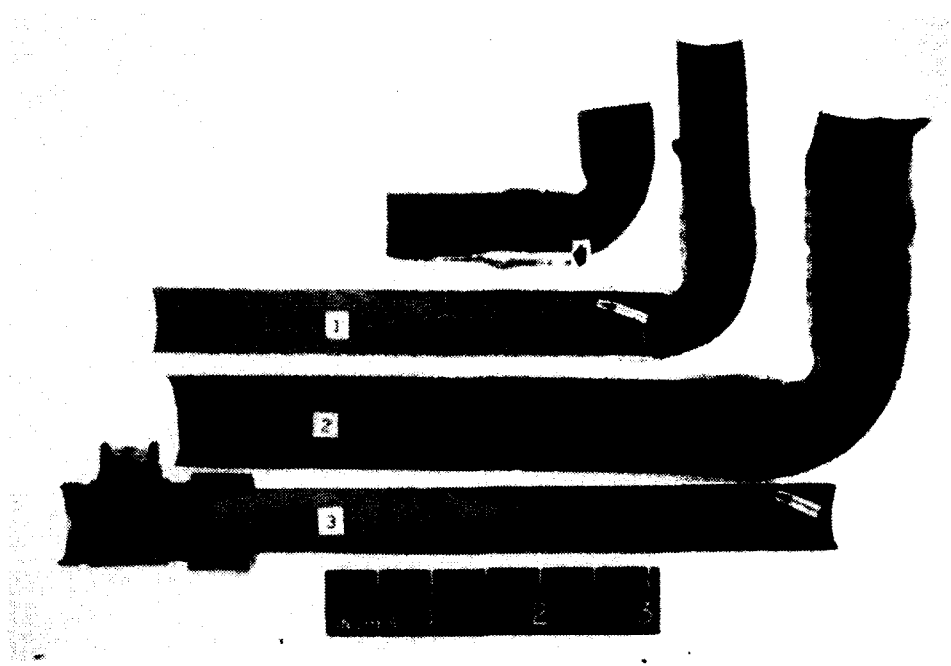
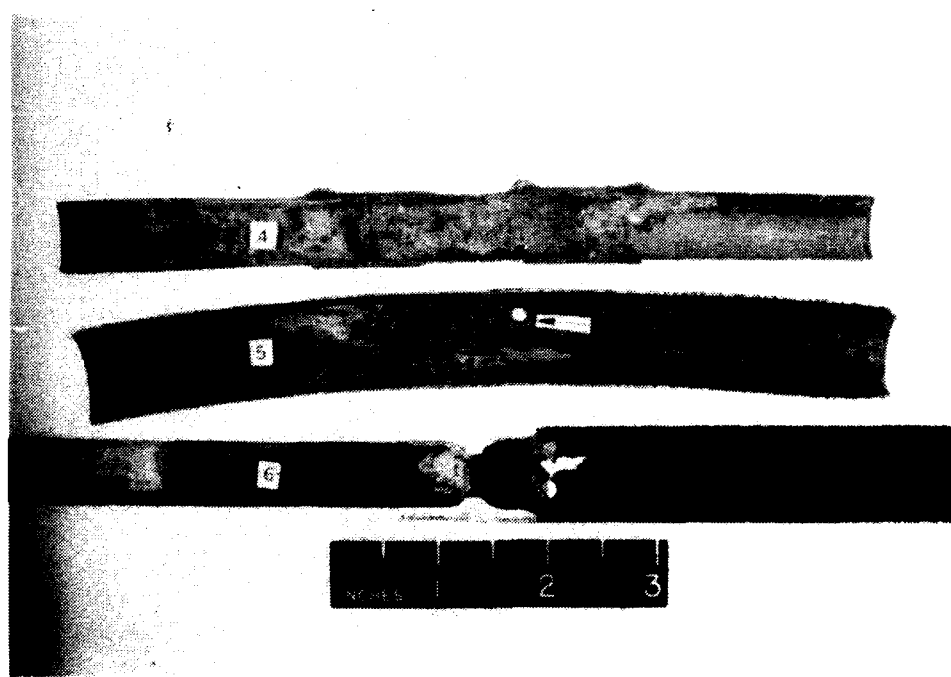
The specimens were sectioned lengthwise and their water-side surfaces were examined (Figures 6 and 7). The perforation in specimen 6 had been caused by erosion corrosion (accelerated attack related to localized, high velocity water inside the system). Most significant was the observation that soldering flux-related corrosion had occurred in all six of the specimens. Typically, the areas of corrosive attack were covered with voluminous, friable mounds of greenish-colored copper corrosion products. Porous cuprous oxide existed in the pits underneath these corrosion products. Sticky, petroleum-based soldering flux was found on the water-side surfaces of specimens 1 and 3. EDS analysis supported the belief that the localized corrosion had been induced by soldering flux; chlorides were found in the copper corrosion products. As discussed earlier, soldering fluxes typically contain activating chlorides. In addition, EDS analysis revealed the presence of lead and tin in the soldering flux runs, which indicated that a paste type solder (finely granulated solder suspended in a paste flux) had been used when the tubes and fittings were installed. On areas of the water-side surfaces where corrosion had not taken place, the copper was covered with a protective tarnish film of reddish-brown cuprous oxide. In general, the film was overlaid with a

thin layer of greenish-colored copper corrosion products that appeared to be a deposit from the water. It is likely that the source of the greenish-colored products was the soldering flux-induced corrosion of copper occurring upstream in the system.

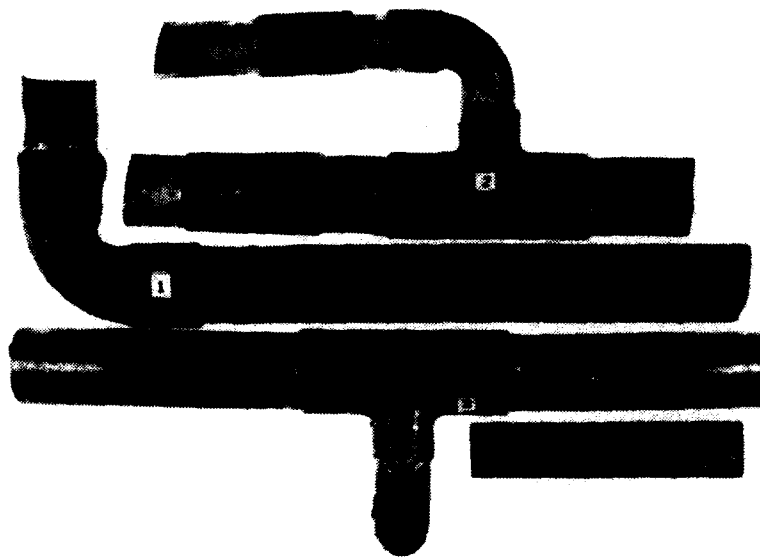
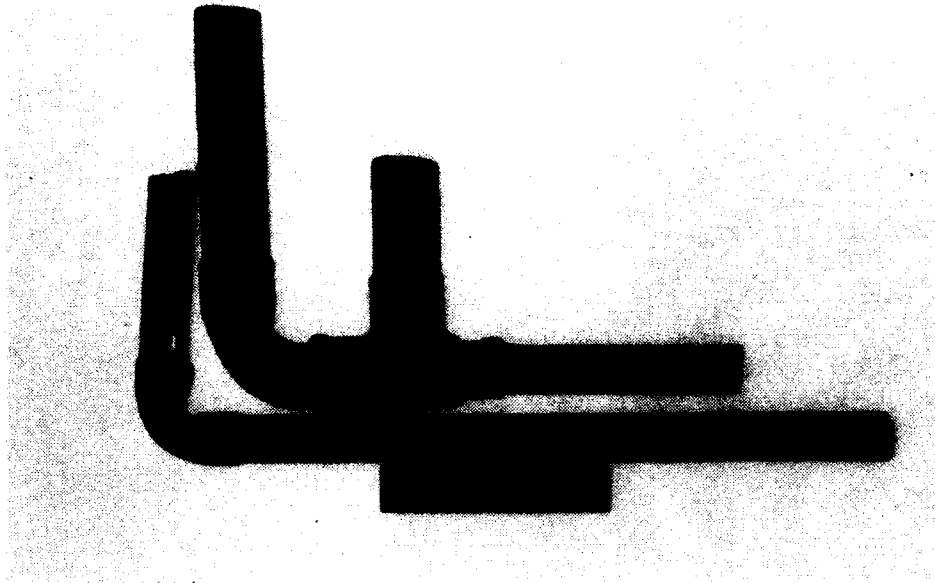
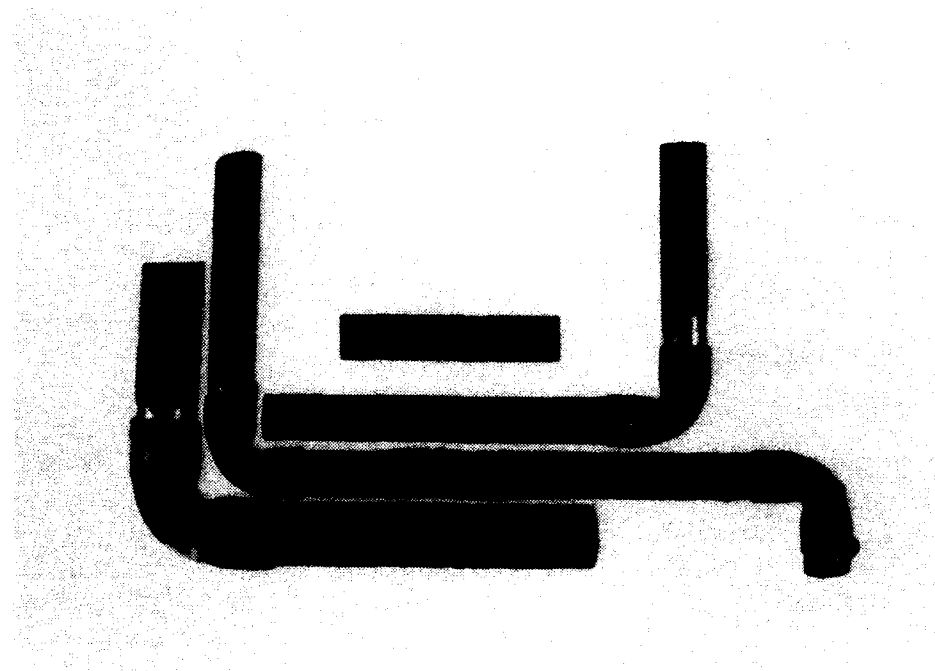
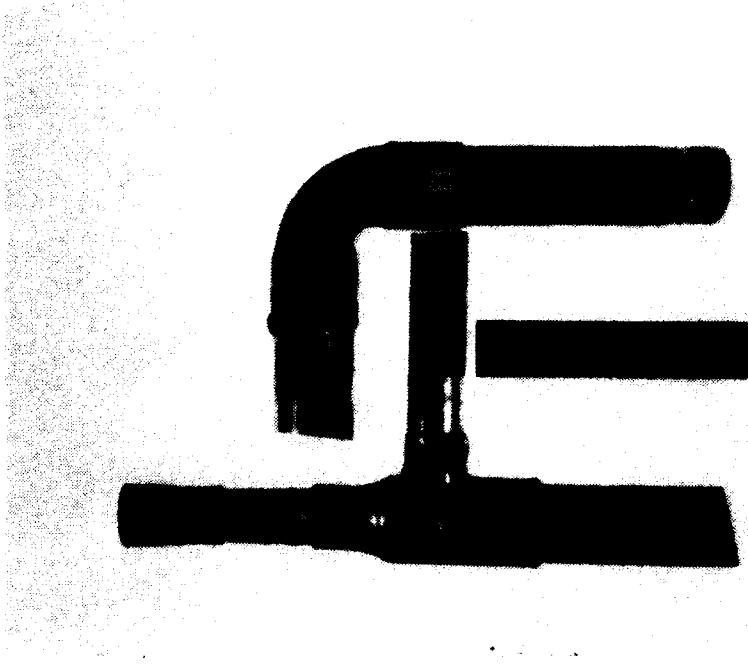
Examination of the outside surfaces of the copper tube/fitting specimens that were removed before and after the flushing revealed no significant deterioration by the external environment (Figures 29 through 32). Some chloride-containing, copper corrosion products were present, but only superficial corrosion of the underlying copper had taken place. This external corrosion had occurred, undoubtedly, because soldering flux residue had not been wiped from the outside surfaces of the tubes and fittings after the soldered connections had been made. The outside surface examination further revealed that several of the specimens had been overheated when the tubes were originally soldered to the fittings. The overheating was indicated by the near-black appearance of the tubes and fittings.

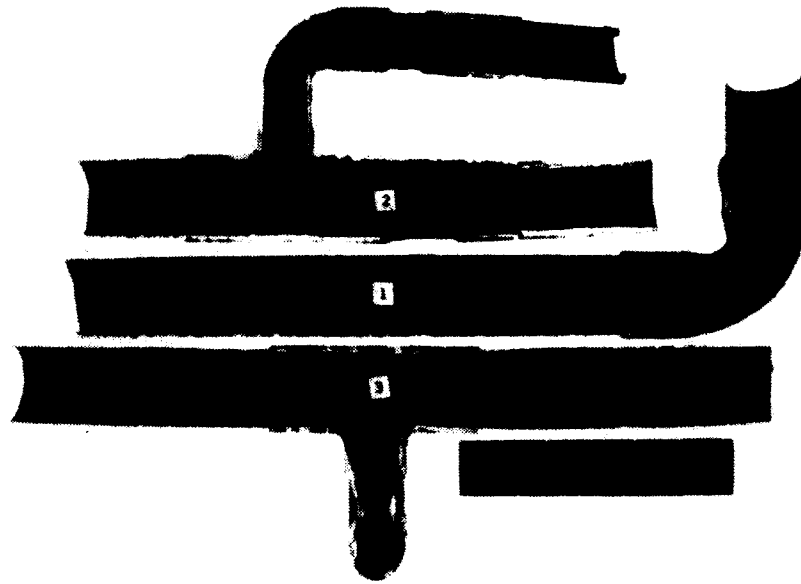
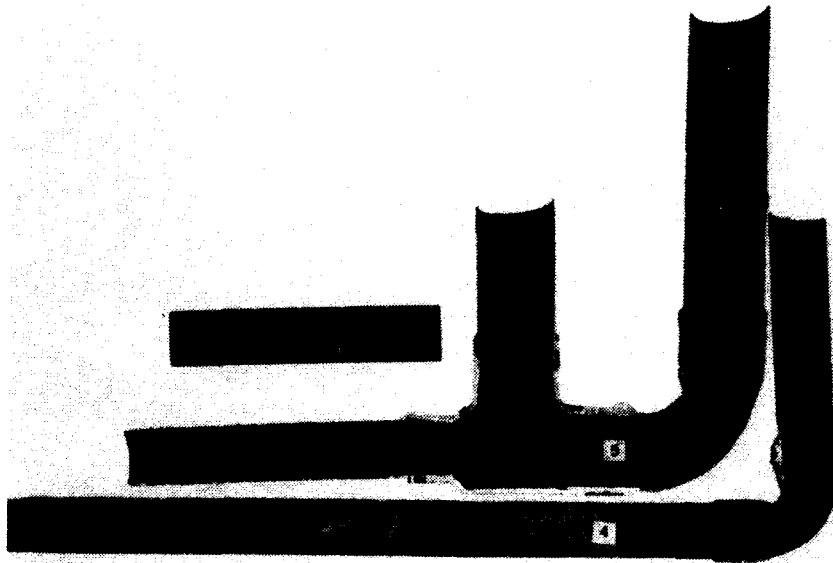
Examination of the inside surfaces of the tubes and fittings that had been removed before hot water flushing revealed that flux-induced corrosion had occurred inside four of the five specimens (Figures 33 and 34). The corroded areas contained porous, reddish brown, cuprous oxide, which was typically overlaid with friable, greenish-colored mounds (i.e., tubercles) of copper corrosion products.

Inside surface examination further revealed that very poor workmanship had been involved when the copper tube systems were originally installed. Evidence of this included: (1) tubes had not been fully inserted into fittings before soldering, (2) sticky, petroleum-base, soldering flux residue was on the inside surfaces in addition to the flux residue associated with the water-side corrosion, (3) solder was present on the water-side surfaces, (4) one tube from 7202A Baker Street was inserted too deeply into a fitting before soldering, and (5) soldered connections appeared black, which confirmed that the tubes and fittings had been overheated during the original soldering.

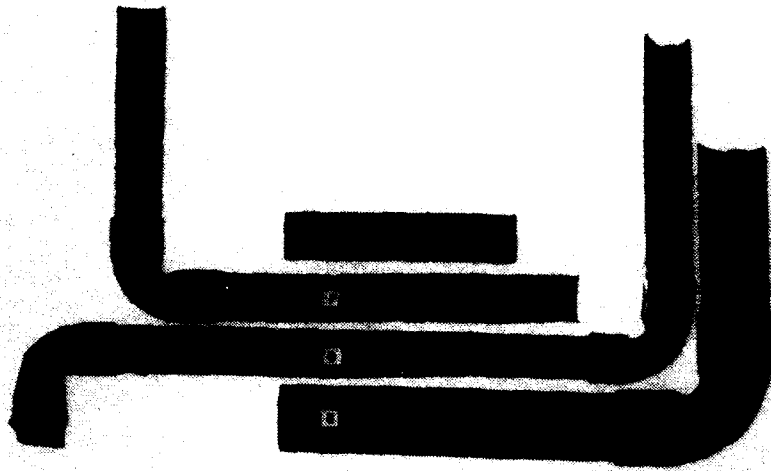
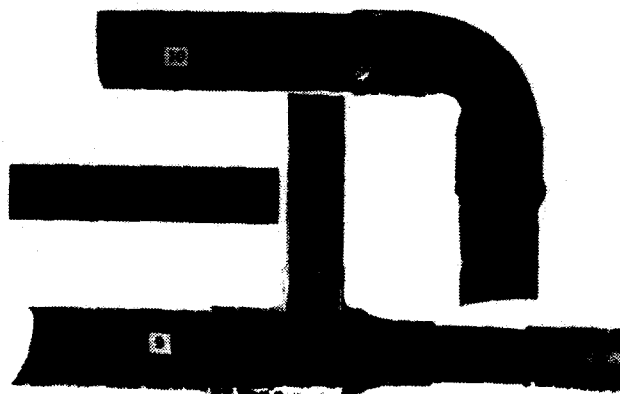
Examination of the inside surfaces of the tubes and fittings that had been removed after hot water flushing revealed that solder flux-initiated, localized corrosion had occurred on the water sides of all five samples (Figures 35 and 36). The samples looked similar to those taken before the hot water flushing with one exception: the specimen taken from 7315A Alexander Circle showed significant removal of the greenish-colored corrosion products.

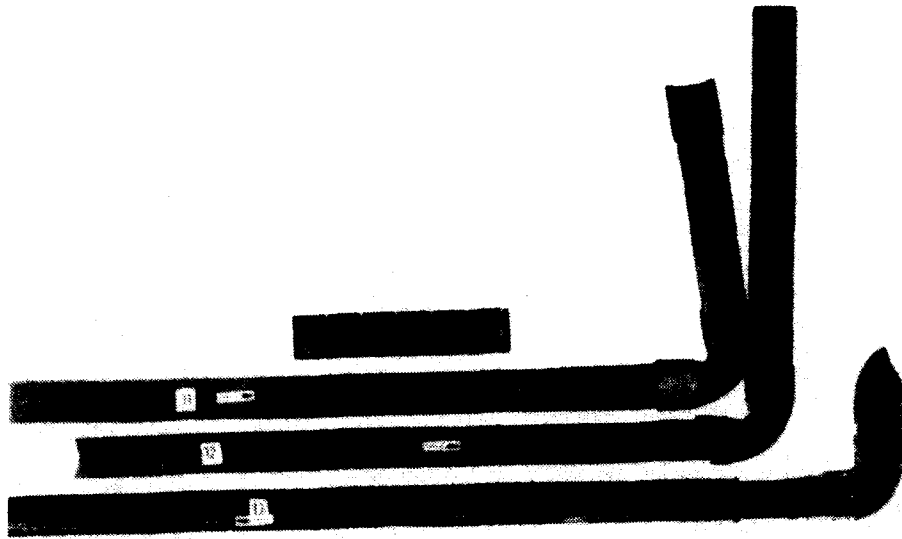
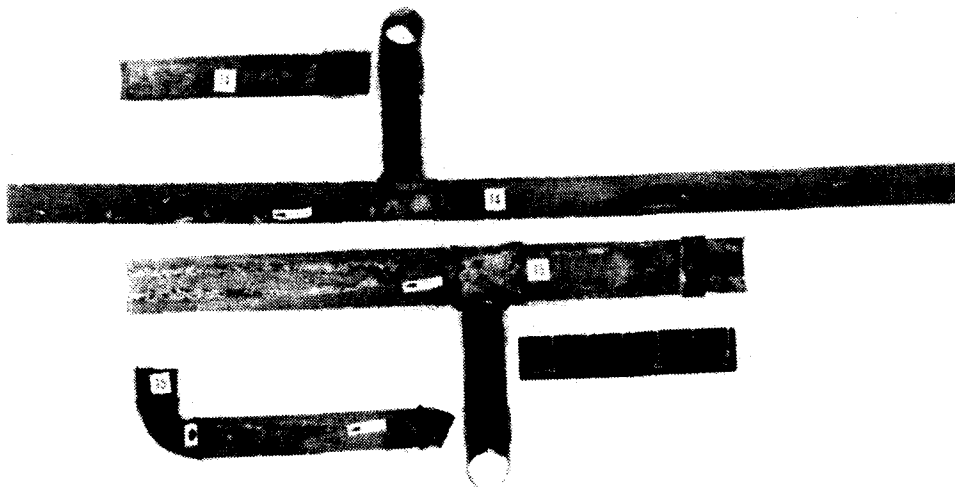
The outside surfaces of the pipes were examined first and no major deteriorations were discovered; the surfaces were either covered with solder or a protective tarnish film of reddish-brown, cuprous oxide. However, some outside surfaces were covered with chloride-containing, greenish-colored, copper corrosion products. Superficial corrosion had occurred at these locations that was most likely due to excess solder flux residue that had not been wiped off the outside surface of the pipes. The pipe specimens were then sectioned lengthwise to study the inside surface. The examination showed that some soldering flux-induced corrosion and greenish-colored copper corrosion products were present on the inside of all five specimens. The corrosion had occurred where the solder flux runs were located. The corrosion was most severe on the specimens from 7375B Mindanao Court and 7379C Mindanao Court. These two samples had pinhole perforations that contained reddish-brown, cuprous oxide in the pits. It was evident that the pits had occurred on the water-side because the diameters of the pits were larger on the water side than on the outside surface and because of the presence of the porous, reddish-brown cuprous oxide. None of the other specimens had pits that had propagated through the tube walls.

After examining the inside surfaces, it was again seen that poor workmanship existed when the copper pipe system was installed. Cut tube ends that had not been reamed/deburred before soldering, solder flux runs as long as 6 in., tubes that had not been fully inserted before soldering, and the black appearance of the soldered connection were some of the faults found in the pipe specimens. EDS was also performed on the five specimens collected. The EDS and microchemical analysis (MCA) showed that the copper corrosion products contained major quantities of copper, very minor to semi-major amounts of sulfur and iron, minor to semi-major quantities of silicon, and undetectable to minor amounts of chloride. The presence of the undetectable to minor amounts of chloride shows that the hot-water flushing has been at least somewhat successful in removing the chloride, which is primarily responsible for the

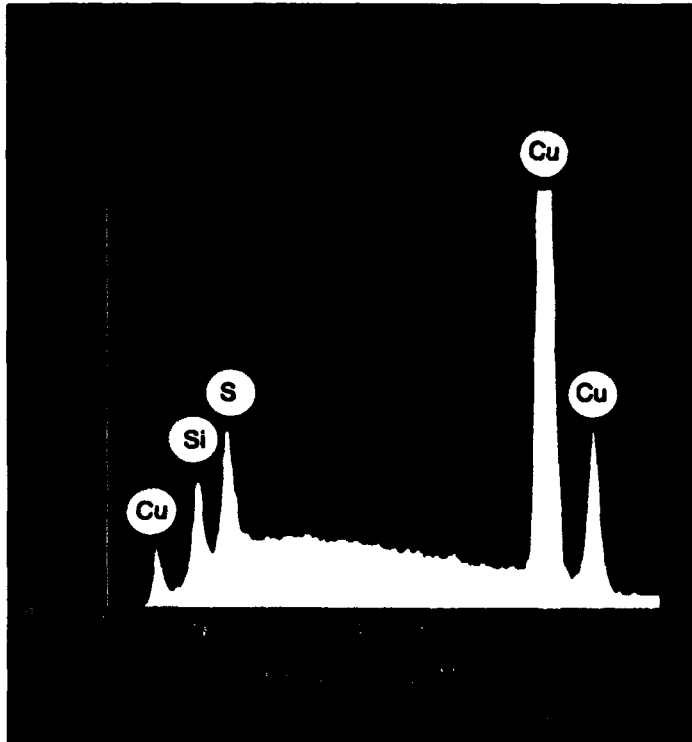
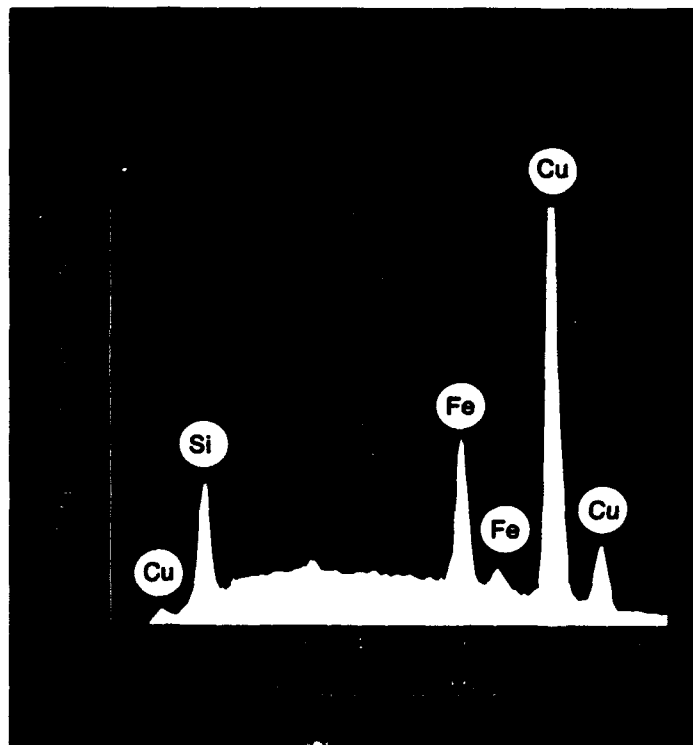
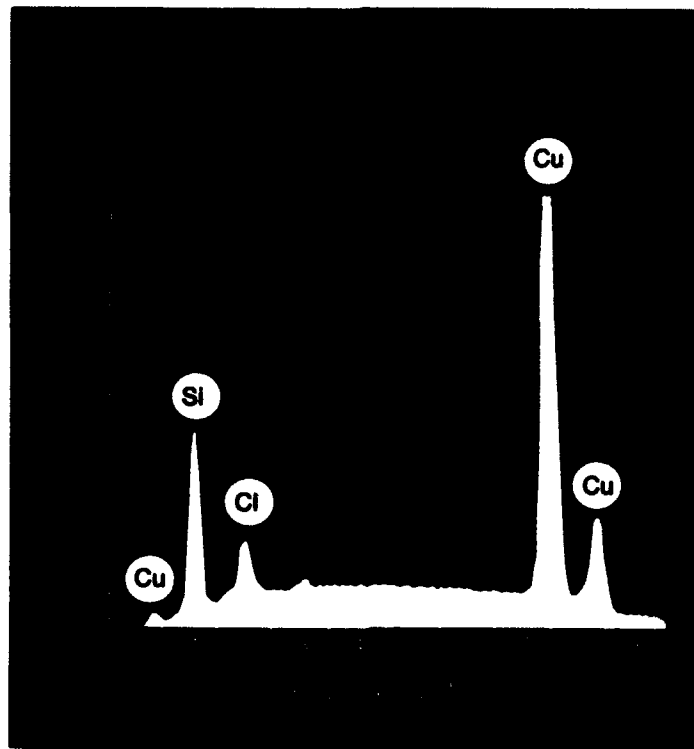
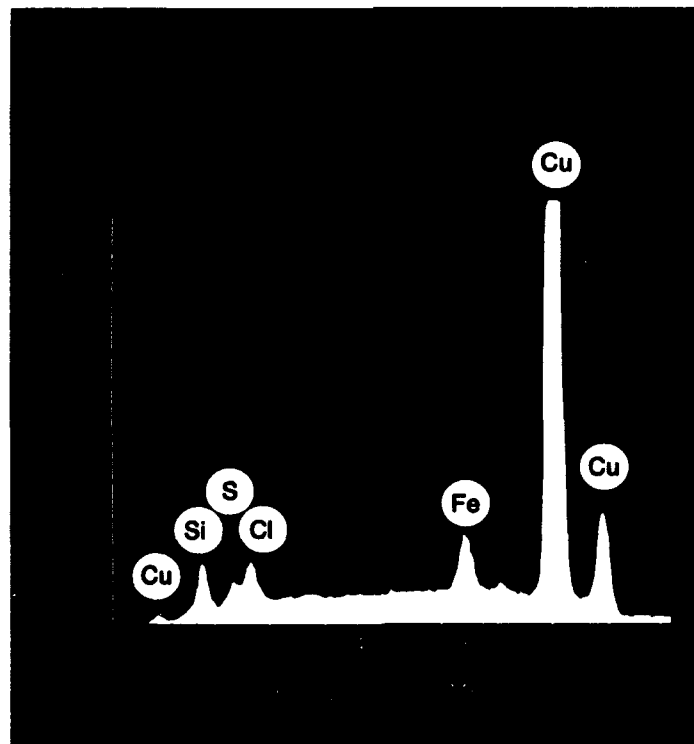
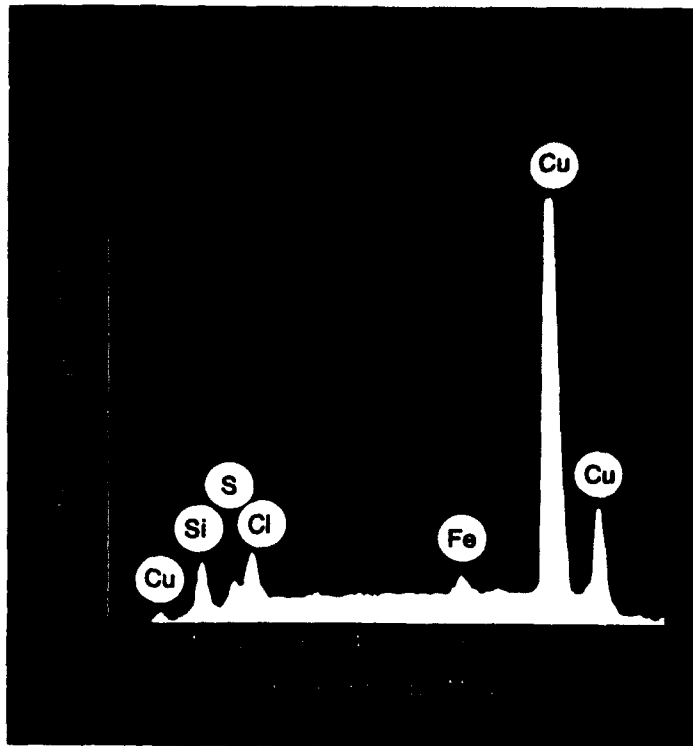
pitting. It was also seen from the EDS that no chlorides were detected in the corrosion-induced pits that are associated with the greenish-colored, copper corrosion products. The X-ray spectra for corrosion products removed (Figures 40 through 44), shows how much chloride was removed due to the hot-water flushing and the following 20 1/2 months of water flow through the pipes. See Table 11 for the summary of the percentages of chloride ions removed.
