MEMORANDUM REPORT

SANITARY SEWERAGE SYSTEM REPAIRS

ROCKY MOUNTAIN ARSENAL-COMMERCE CITY, COLORADO

BLACK & VEATCH
CONSULTING ENGINEERS
KANSAS CITY, MISSOURI

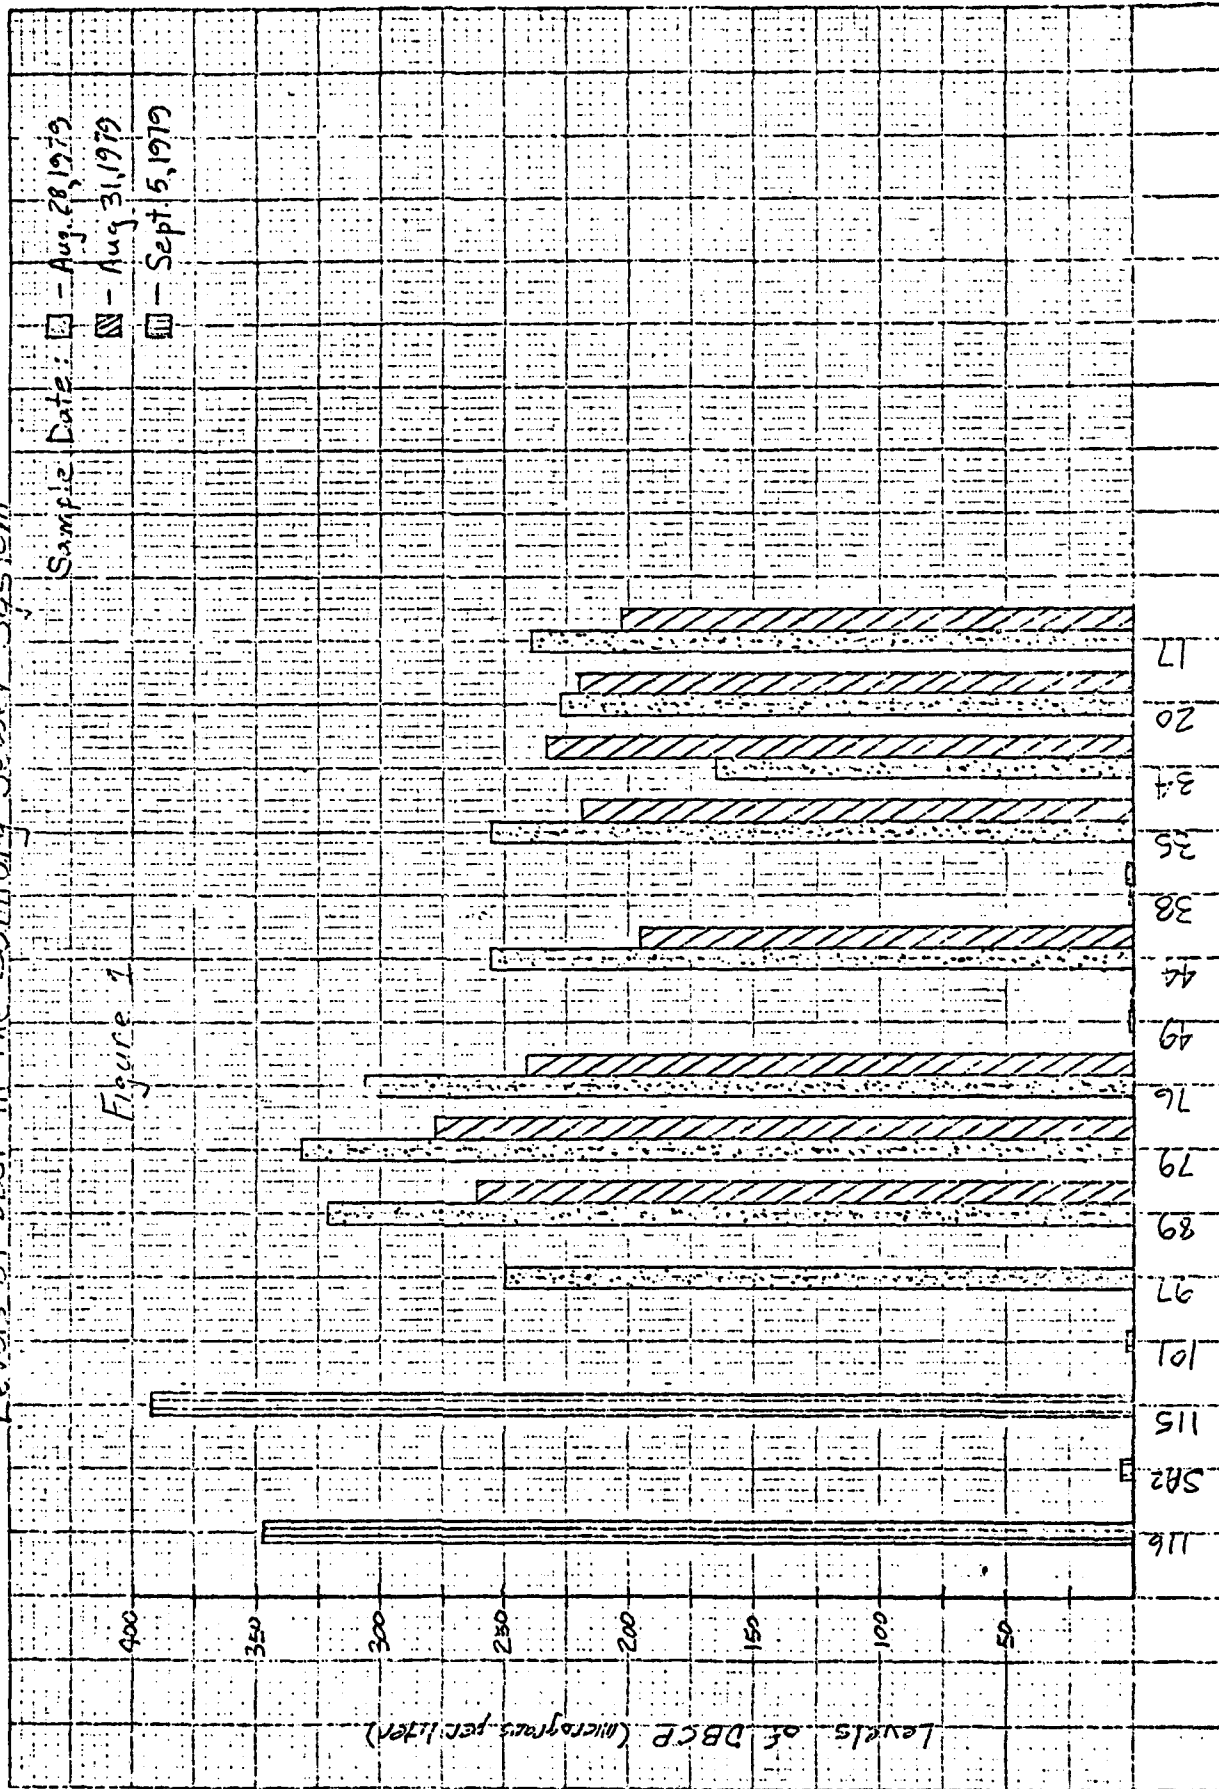
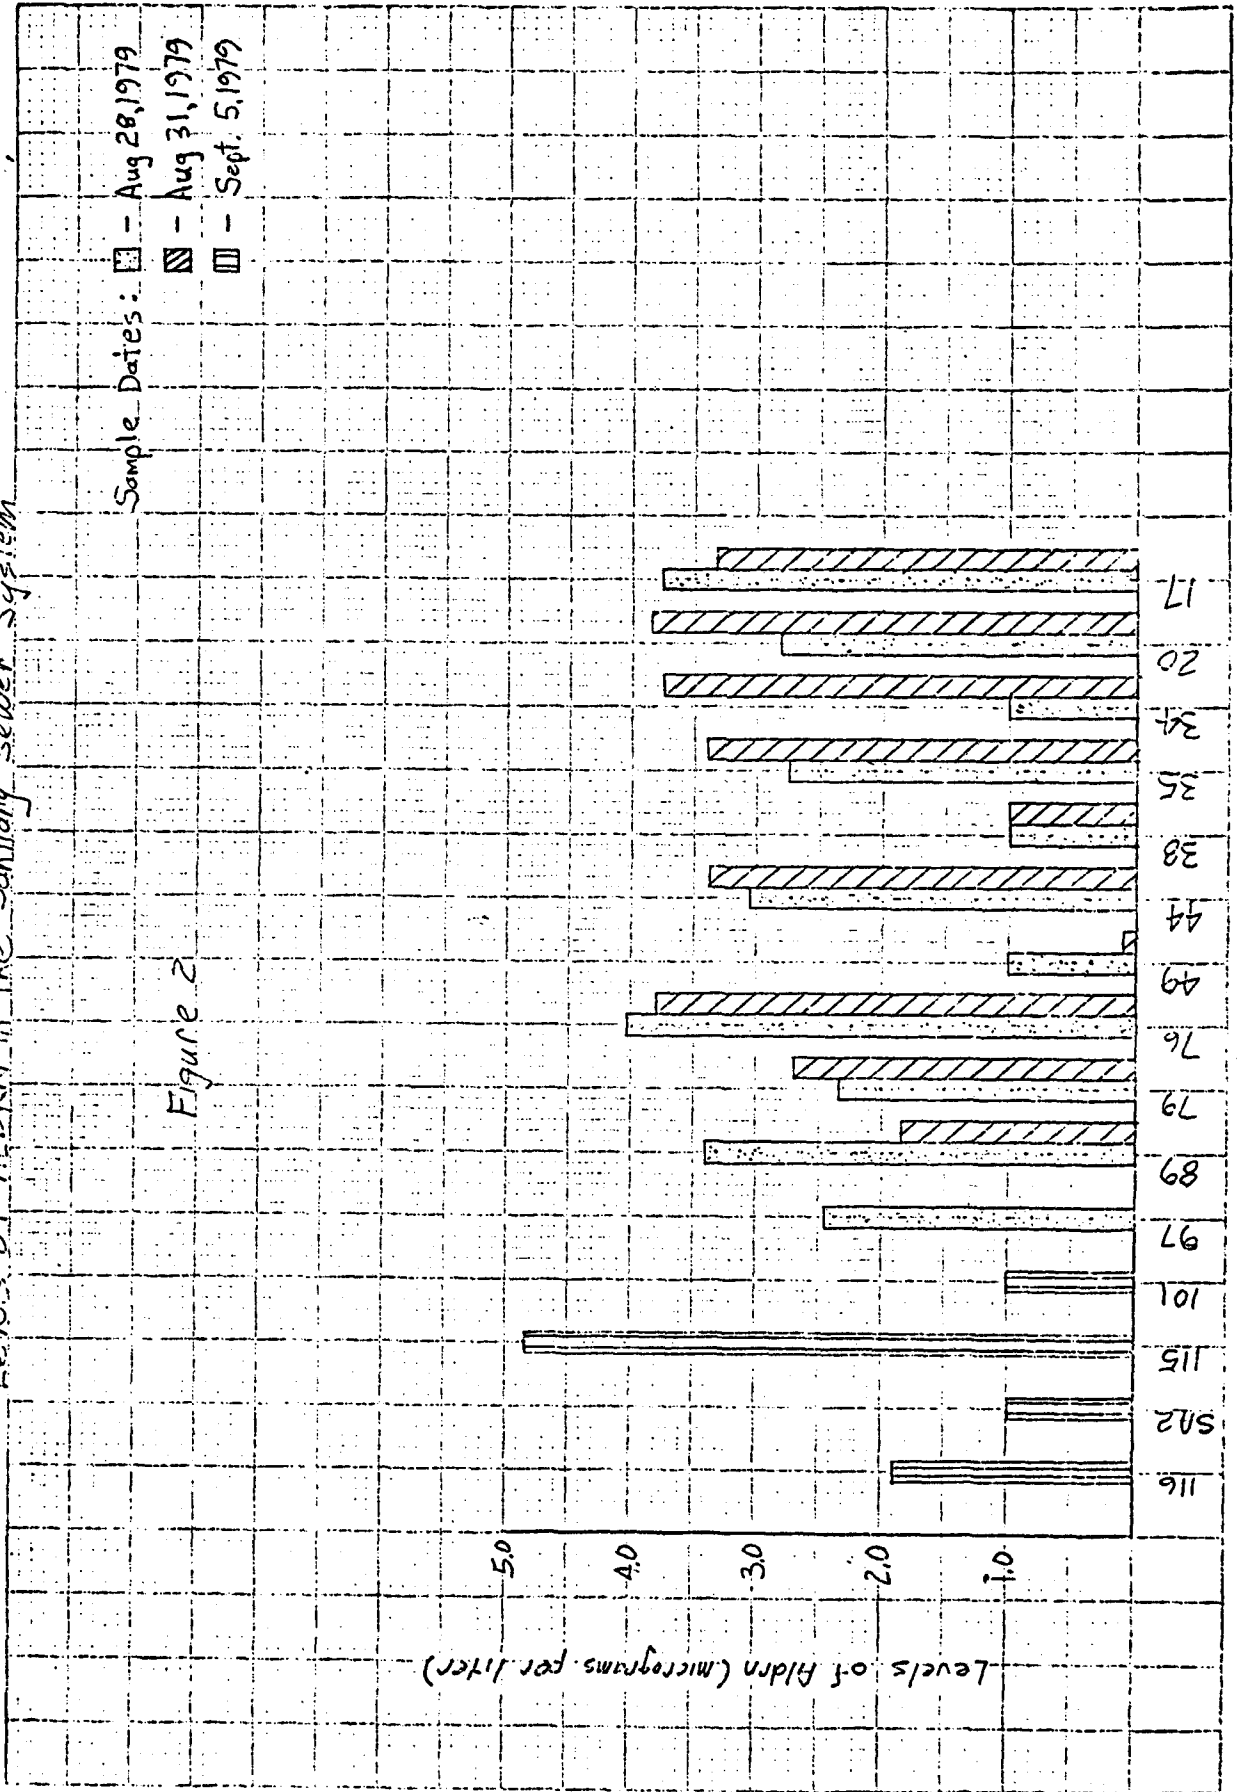
Figure 2

Levels of DBCP in the Sootary Sewer System

Levels of ALDRN in the Sanitary Sewer System

13. Chemical samples indicate contaminant leakage into the sanitary sewer system is occurring, particularly in the South Plant Area.
14. Dilution of the contaminants observed in South Plant sewage flows is occurring downstream in the system as evidenced by the chemical sampling program.

15. Sampled levels of DBCP, Aldrin, Dieldrin, and Endrin exceed recommended levels. These contaminants are a probable cause of the death of bacterial growth necessary for proper operation of the trickling filters.
