DOT/FAA/CT-90/10

Fuselage Burnthrough from Large Exterior Fuel Fires

July 1994

Final Report

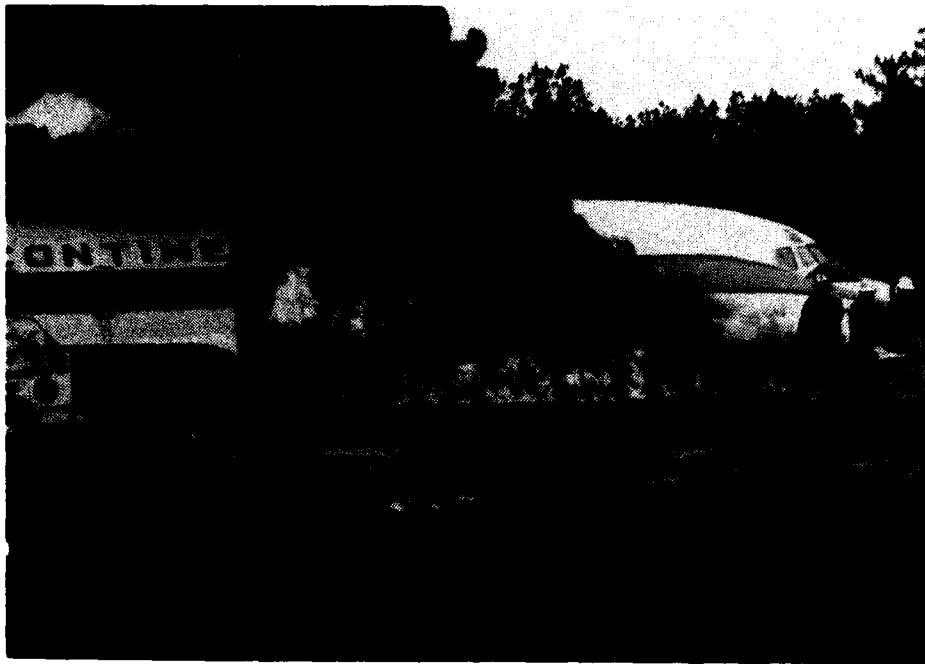
FIGURE 5. TEST 2 DC-8 FLAME EXPOSURE

FLAME IMPINGEMENT. The flame plume was blown against the fuselage and aft by a light wind that measured a steady 3 knots. This shifted the fire towards the rear of the compartment. The exterior baffles prevented the flame from damaging the center compartment. The fuselage was exposed to flame that extended from station 440 forward to station 284 at which point the flame trailed off toward the cockpit (figure 5). Instrumentation locations are shown in figure B-1. The fire temperatures measured at the windows (station 287 and 241) ranged from 1500 to 1800 °F (figures B-2 and B-3). The fire temperature measured at station 226 peaked at 1800 °F, while the fuselage skin at this location only reached 600 °F (figure B-4). The forward calorimeter located at station 228 registered a peak heat flux of 5.8 BTU/FT²-second and the aft calorimeter registered a peak value of 16.8 BTU/FT²-second foot (figures B-5 and B-6).

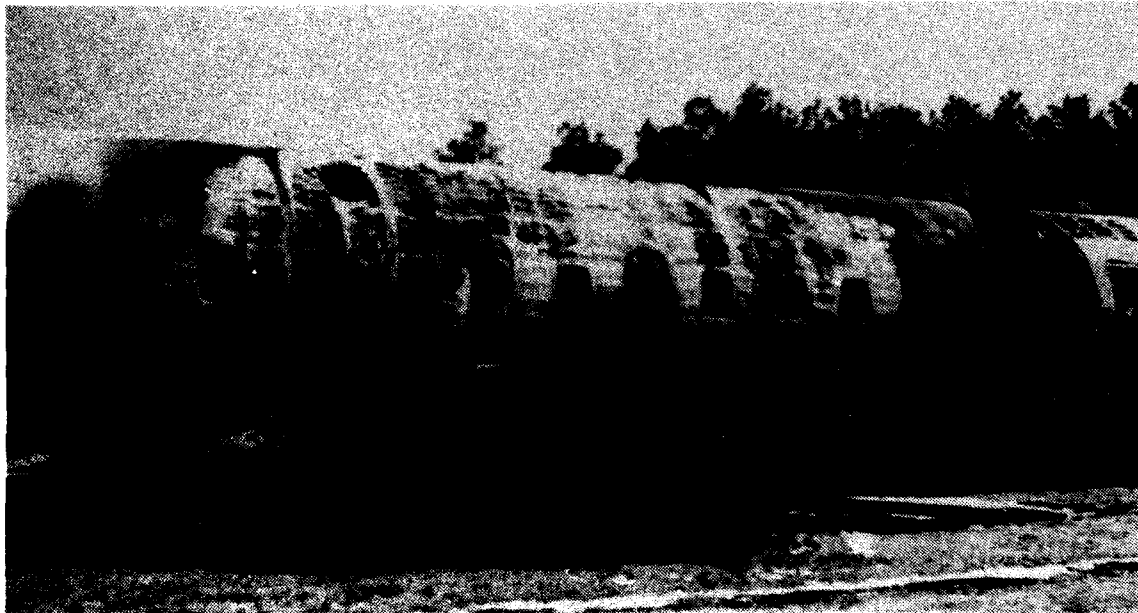
FIGURE 6. TEST 3 DC-8 CENTER SECTION FIRE DAMAGE

Skin Penetration. The skin aft of the wing (enclosing the wheel well) was completely melted away up to the top of the well (figures 6 and C-7). There was a small hole above the wheel well that went through the skin between the top of the wheel well and the cabin floor. Forward of the wing root the skin in the cheek area was melted through and the cargo liner was exposed. The liner was heavily charred but not penetrated. The window located directly above the trailing edge of the wing was completely consumed, allowing flame penetration into the cabin. The other windows exhibited varying degrees of damage but did not allow penetration. The skin both forward and aft of the wing above the melted sections was wrinkled and perforated. Both overwing exits were operable after the test. There was a 2- by 2-foot section above the trailing edge of the wing into the overhead section of the aircraft where the skin completely melted away.

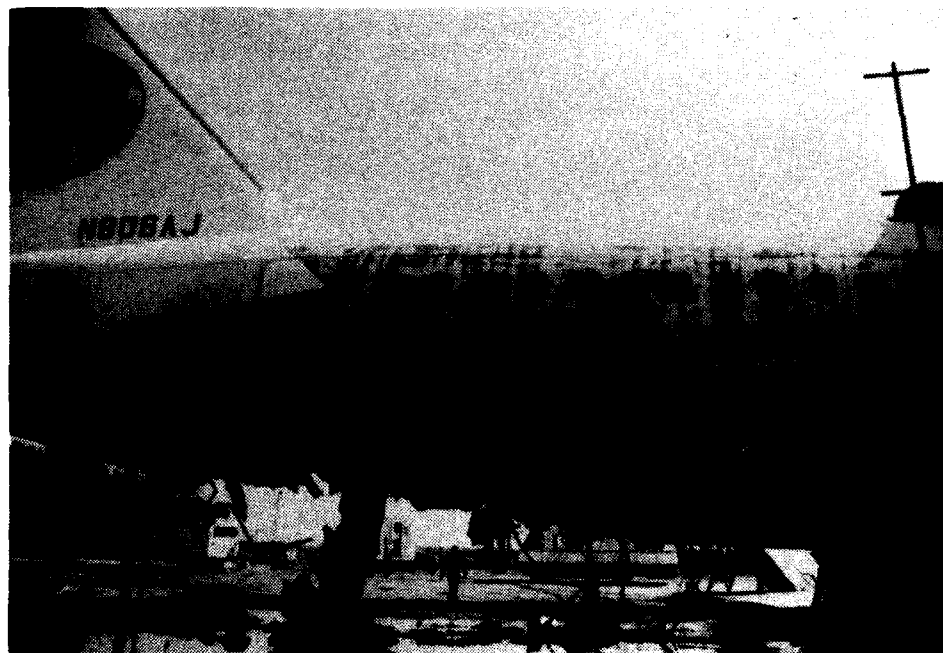
FIGURE 10. TEST 4 CV-880 STARBOARD SIDE FIRE DAMAGE

destroyed as well as 50 percent of the cabin floor above it. The forward bulkhead remained undamaged due to the protective steel partitions. The starboard cargo hatch was scorched on the inside but undamaged on the exterior. The hatch was inoperable after the test. The air temperature in the cargo compartment measured at station 1182 remained ambient for approximately 4 minutes at which time it rapidly rose to 1100 °F, dropped off to 700 °F and then peaked at 1600 °F at the conclusion of the test (figure D-18). The temperature in the cheek areas and between the floor and the top of the cargo compartment measured at station 1182 remained close to ambient for 4.5 minutes and then peaked at 1600 °F near the end of the test (figure D-19).

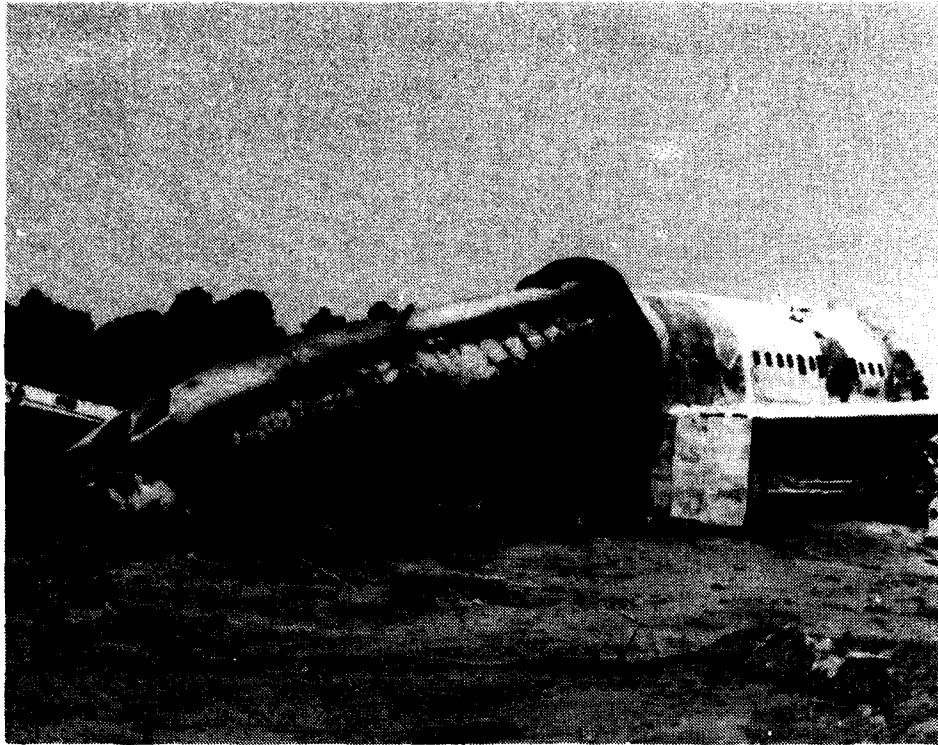
FIGURE 12. TEST 5 CV-880 PORT SIDE FIRE DAMAGE

FIRE PATHS. Initial smoke penetration came from the cockpit area. The cockpit, however, did not receive the most extensive damage. The fire may have come into the cabin through the electronics bay and up through the crew access tunnel. The electronics bay was not insulated.

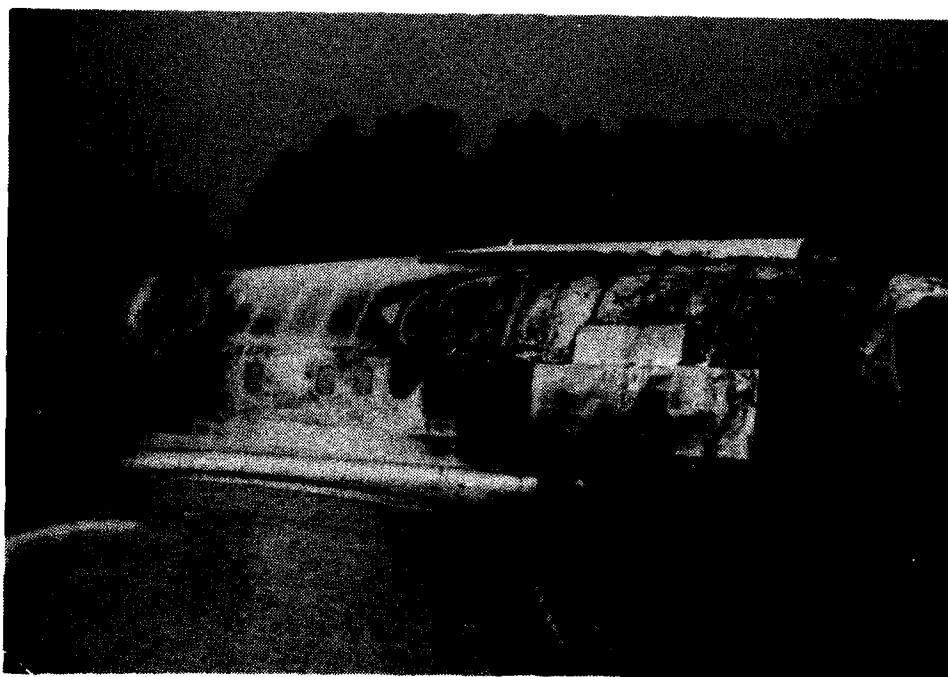
FIGURE 15. CV-880 PORT SIDE FIRE DAMAGE

Skin Penetration. The port side skin that was forward of the leading edge of the wing was completely burned away up to the top of the fuselage (figures 15 and F-7). The windows in this area (station 584) were completely burned through. The windows over the wing were charred but not penetrated. The skin aft of the wing was also burned away with damage extending forward to station 884. The exposed ribs at the aft end were buckled. The windows aft of the wing had their outer pressure panes completely burned away, but the inner fail-safe panes were

not penetrated. The insulation exposed by the melted skin on the fire side was charred but intact. The skin on the belly of the aircraft was heavily charred and buckled but not penetrated except forward and aft of the wing. The starboard side sustained damage similar to the port side (figures 16 and F-8). The skin aft of the wing was completely melted away exposing the insulation. The windows aft of the wing were burned through to the interior. The section forward of the wing also had the skin completely melted. The windows in this section had the pressure panes burned away with the fail-safe panes charred but not penetrated. The insulation throughout was heavily charred but intact.

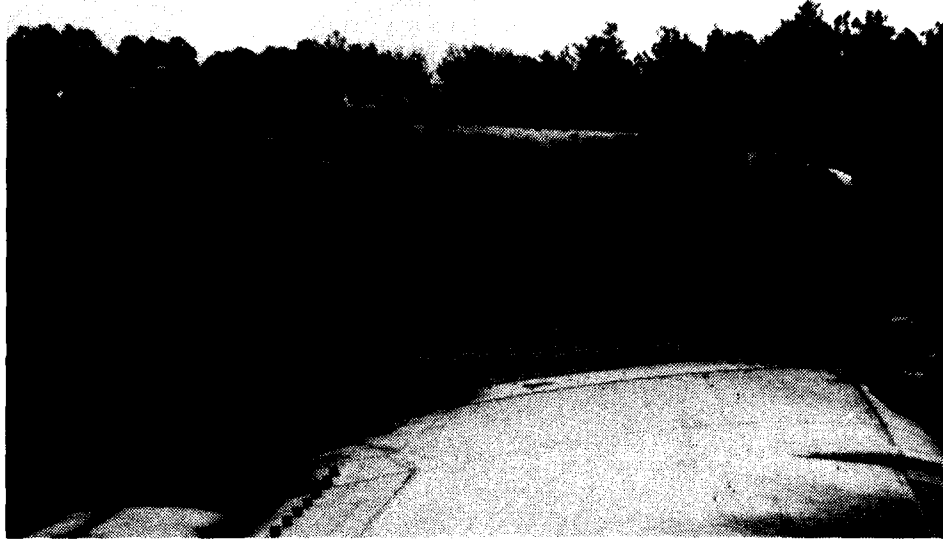
FIGURE 16. TEST 6 CV-880 STARBOARD SIDE FIRE DAMAGE

Wings. The leading and trailing edges of the wings were heavily damaged by the fire. In each case the skin was melted away up to the wing spars. The upper surfaces of the wings were clean and undamaged. The lower surface was heavily charred and sooted but not penetrated except in the wheel well area. Here, the fire penetrated up into the landing gear mounting points where the structure was completely burned away. When the fuselage collapsed to the ground, the gear assembly punched through the top of the wing. It should be noted that the wing fuel tanks were filled with water to lessen the possibility of explosion. This provided a heat sink effect that protected the wings in the tank areas.

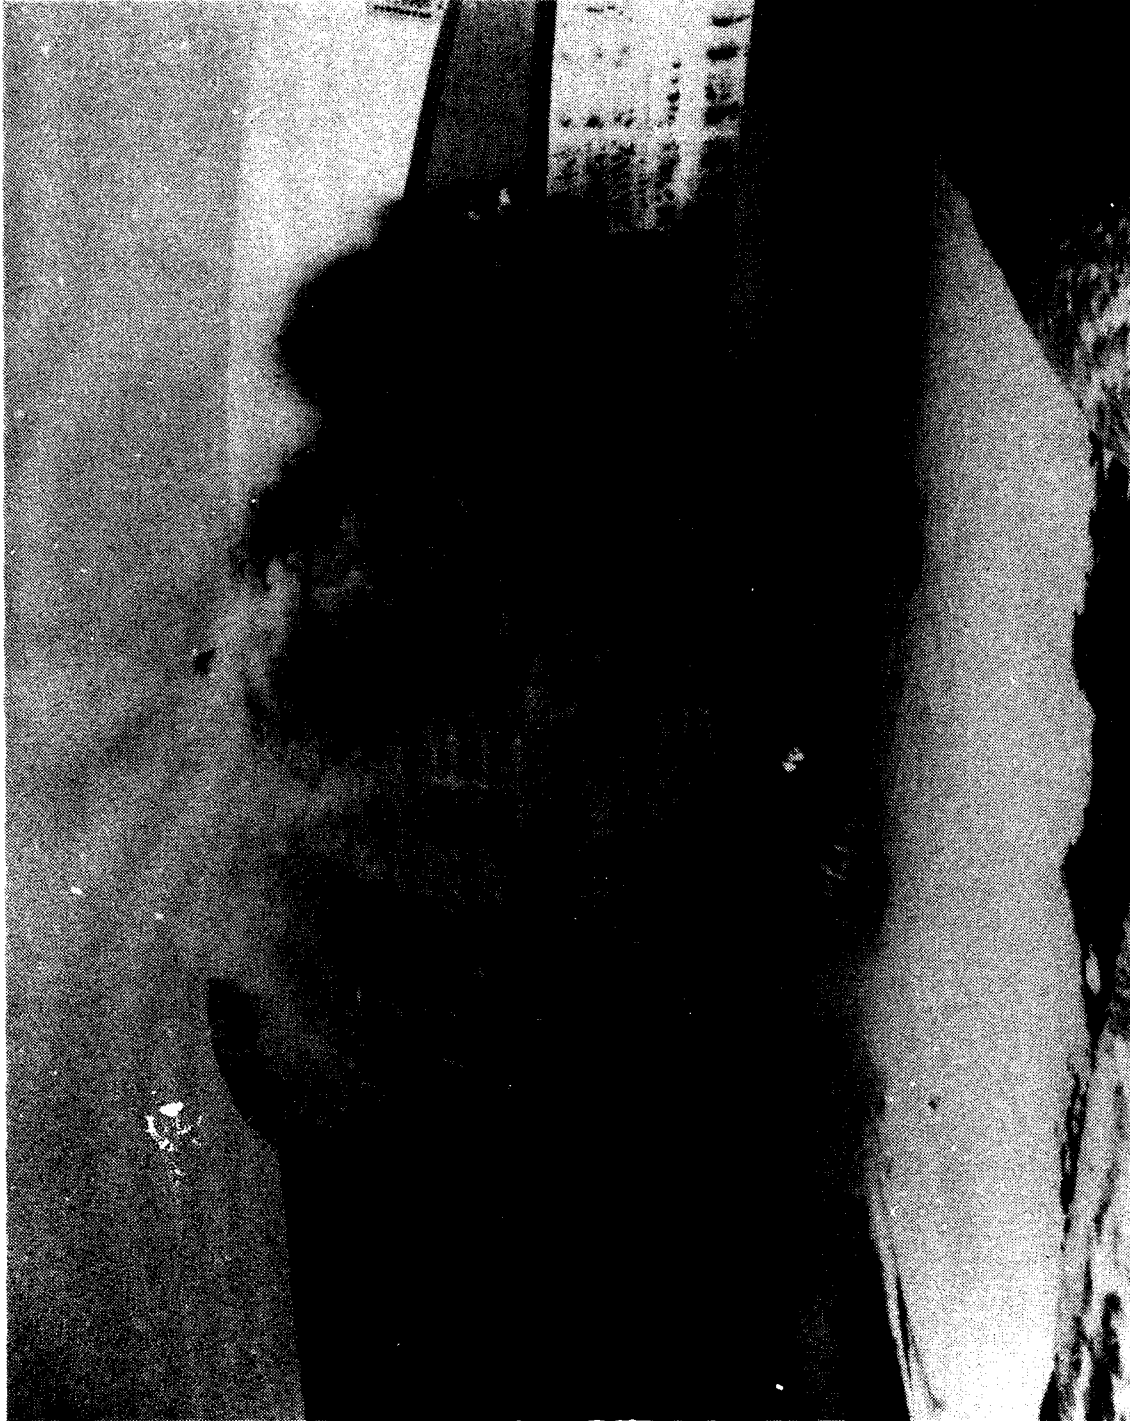
FIGURE B-7. TEST 2 EXTERNAL FIRE DAMAGE, DC-8 FORWARD SECTION

Skin Penetration. The aluminum skin was extensively destroyed from the fire barrier, located at the compartment partition, to approximately 16 feet forward as shown in figure B-7. The damage extended from ground level up to the center or the top of the aircraft (figure B-8). The skin on the service door was completely melted away. The cargo door skin was also melted away. Nearly all of the skin below the floor level was melted. The two windows on the starboard side were checkered but were still in their frames.

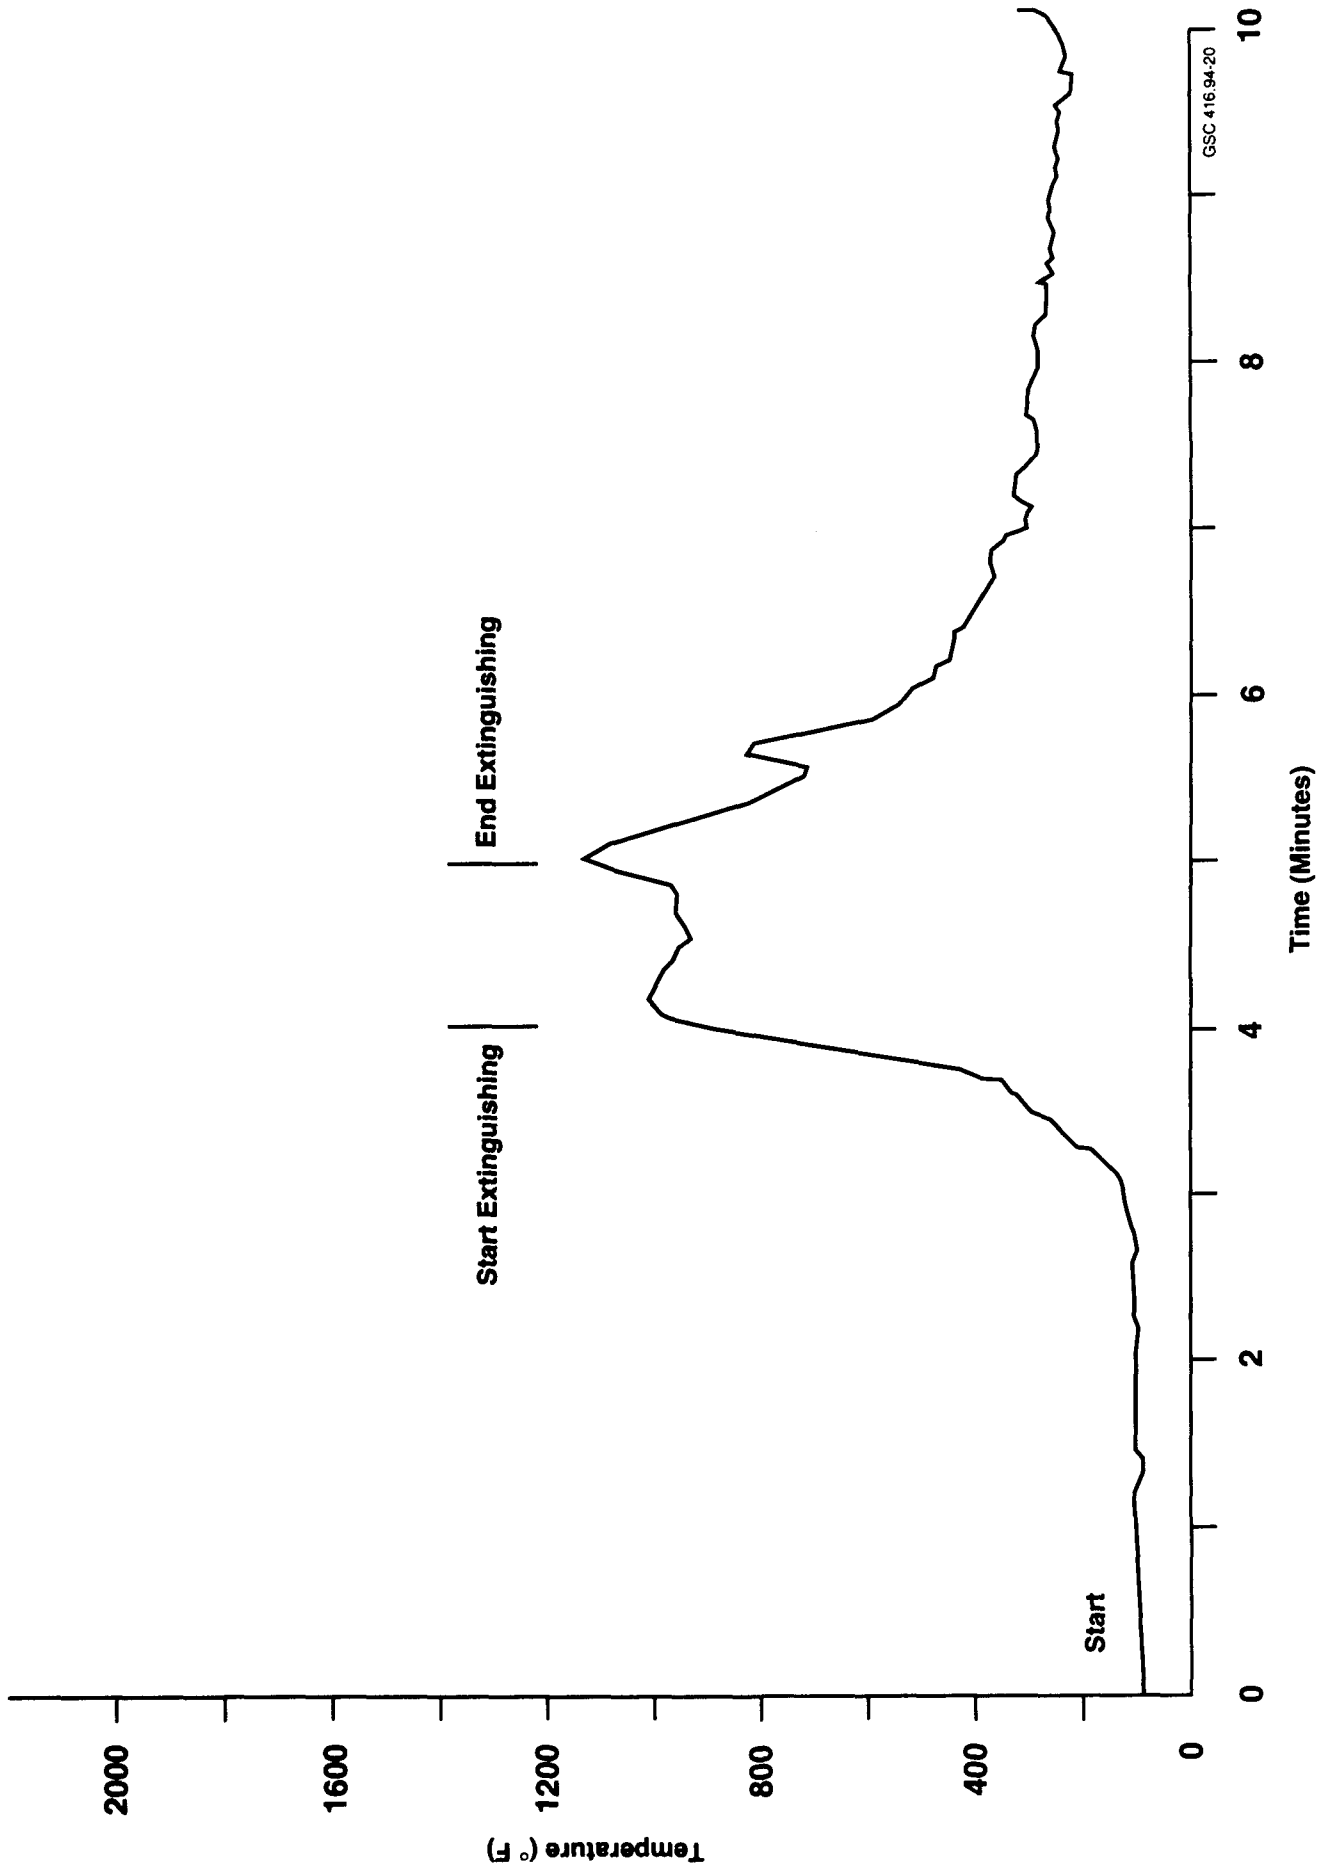
FIGURE B-9. TEST 2 AIR TEMPERATURE BETWEEN CABIN FLOOR AND THE CARGO COMPARTMENT AT STATION 270

Cargo Compartment. The fire breached the cargo compartment through the cargo door. The liner was blackened but not cracked where it was exposed in the cheek area. The interior of the compartment was sooted but undamaged. The area between the upper liner and the cabin floor was heavily sooted and the insulation charred but still intact. The temperature above the upper liner at station 270 reached a peak of 1100 °F (figure B-9). The cargo door was completely destroyed.
