1. AGENCY USE ONLY (Leave blank)	2. REPORT DATE 09/00/55	3. REPORT TYPE AND DATES COVERED	
4. TITLE AND SUBTITLE REPORT ON GROUNDWATER CONTAMINATION, ROCKY MOUNTAIN ARSENAL, DENVER, COLORADO		5. FUNDING NUMBERS

ROCKY MOUNTAIN ARSENAL
DENVER, COLORADO

GROUND WATER CONTAMINATION

CORPS OF ENGINEERS, U. S. ARMY
OFFICE OF THE DISTRICT ENGINEER
OMAHA DISTRICT
OMAHA, NEBRASKA
SEPTEMBER 1955

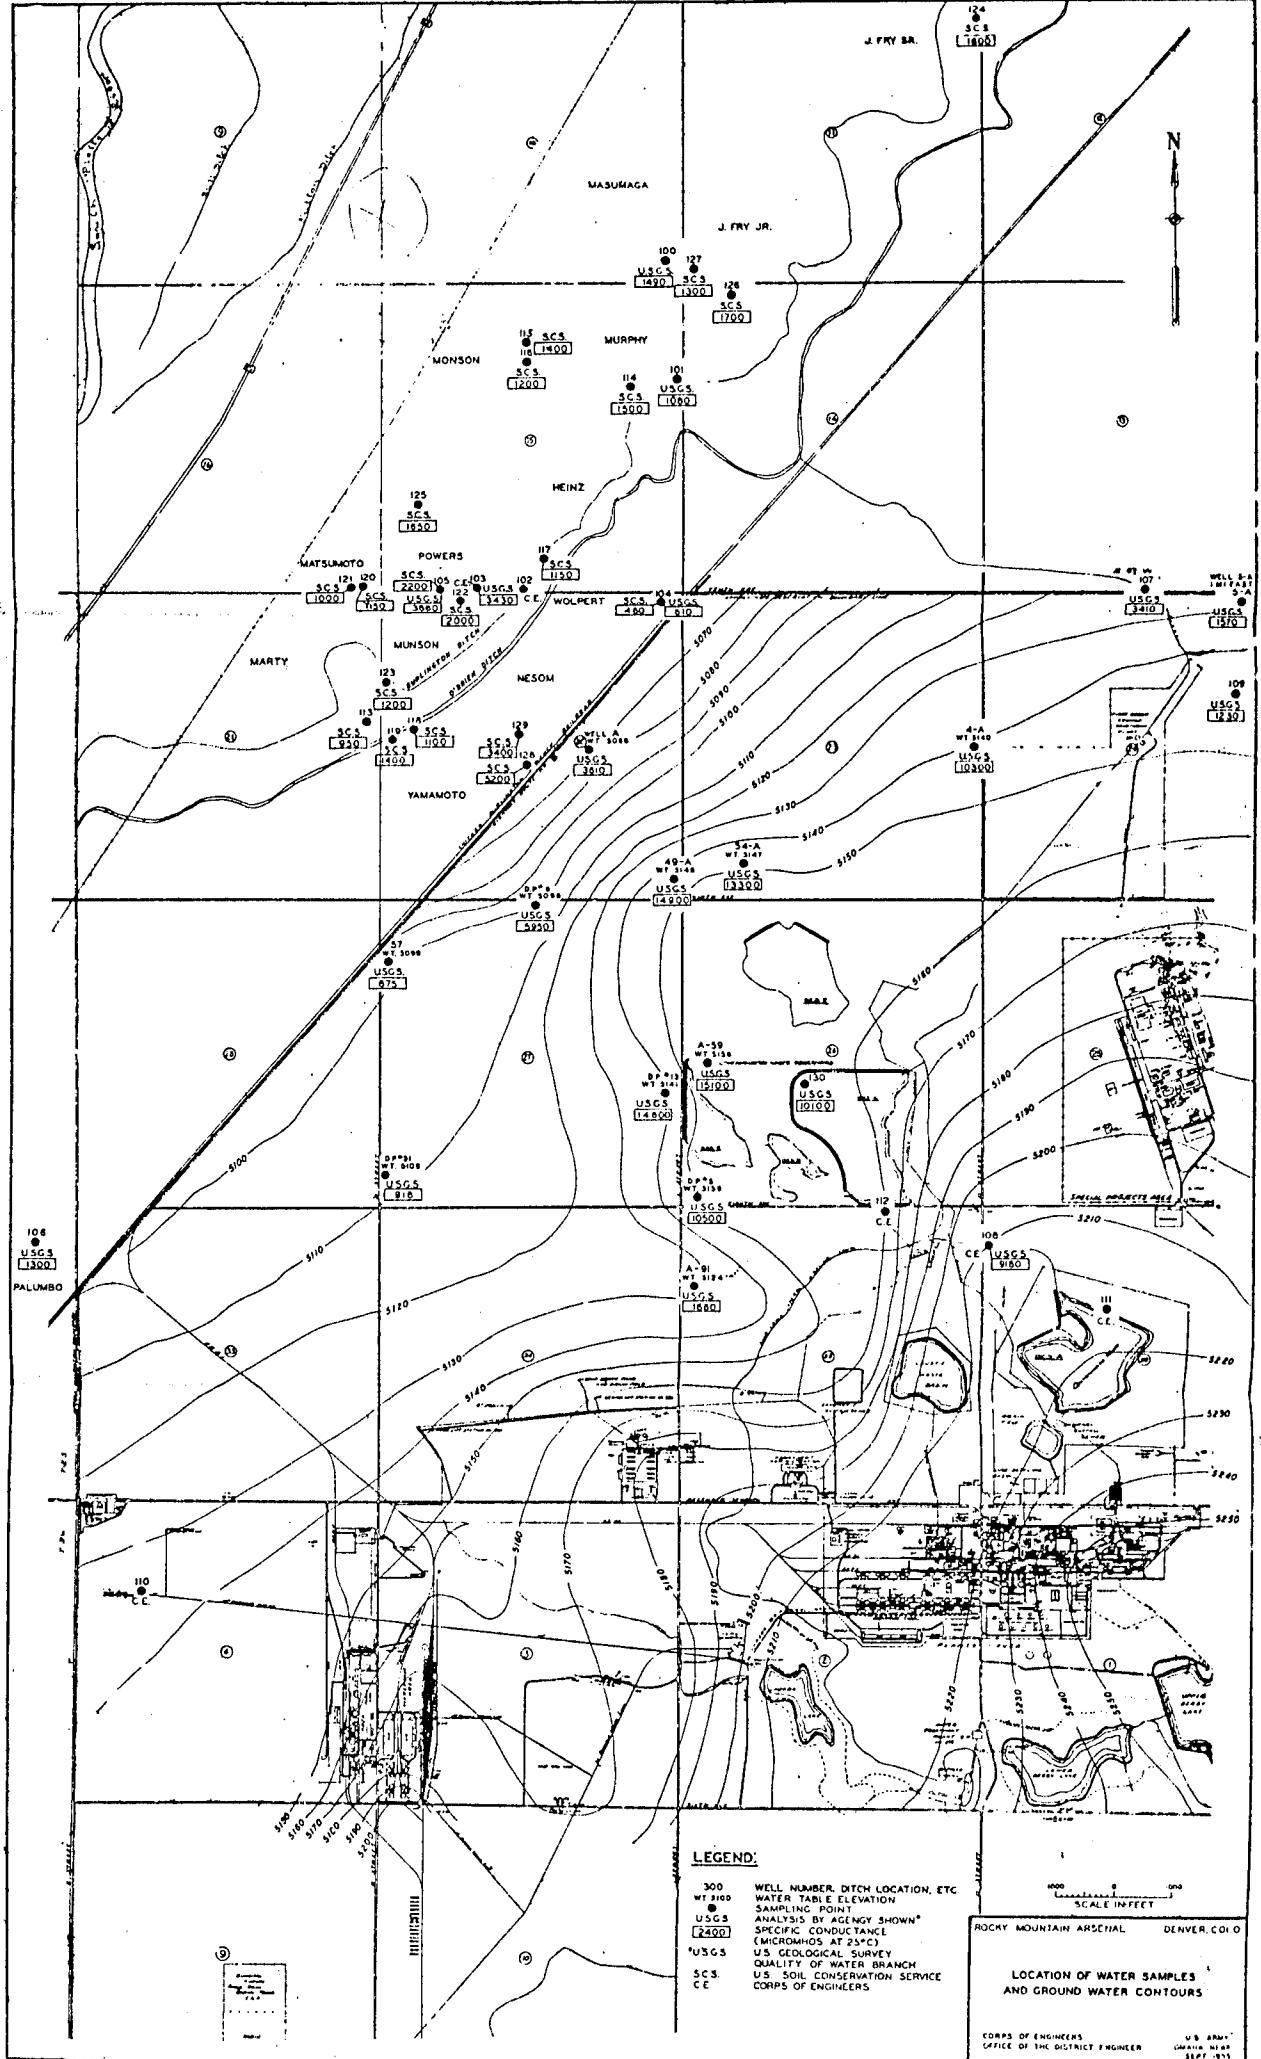
LOCATION OF WATER SAMPLES AND GROUND WATER CONTOURS

Samples were collected by the Quality of Water Branch and by the Corps of Engineers at locations shown on Plate 1. Results of the analyses are shown on Tables 2 and 3. In all, 22 samples were collected in November and analyzed by the U. S. Geological Survey Laboratory. These included four samples of waste, two from First Creek which is reported to carry only treated sanitary sewage, and two of industrial plant waste. One of these represents outflow from an acid neutralization system and the other the ponded material resulting from all waste outflows. The tabulations include five chemical analyses performed by the Corps of Engineers Laboratory on samples collected in October.

A study of the ground water conditions in the Arsenal area and also in the area reporting contamination indicated that the ground water contours slope in a general northwest direction as shown on Plate No. 1.

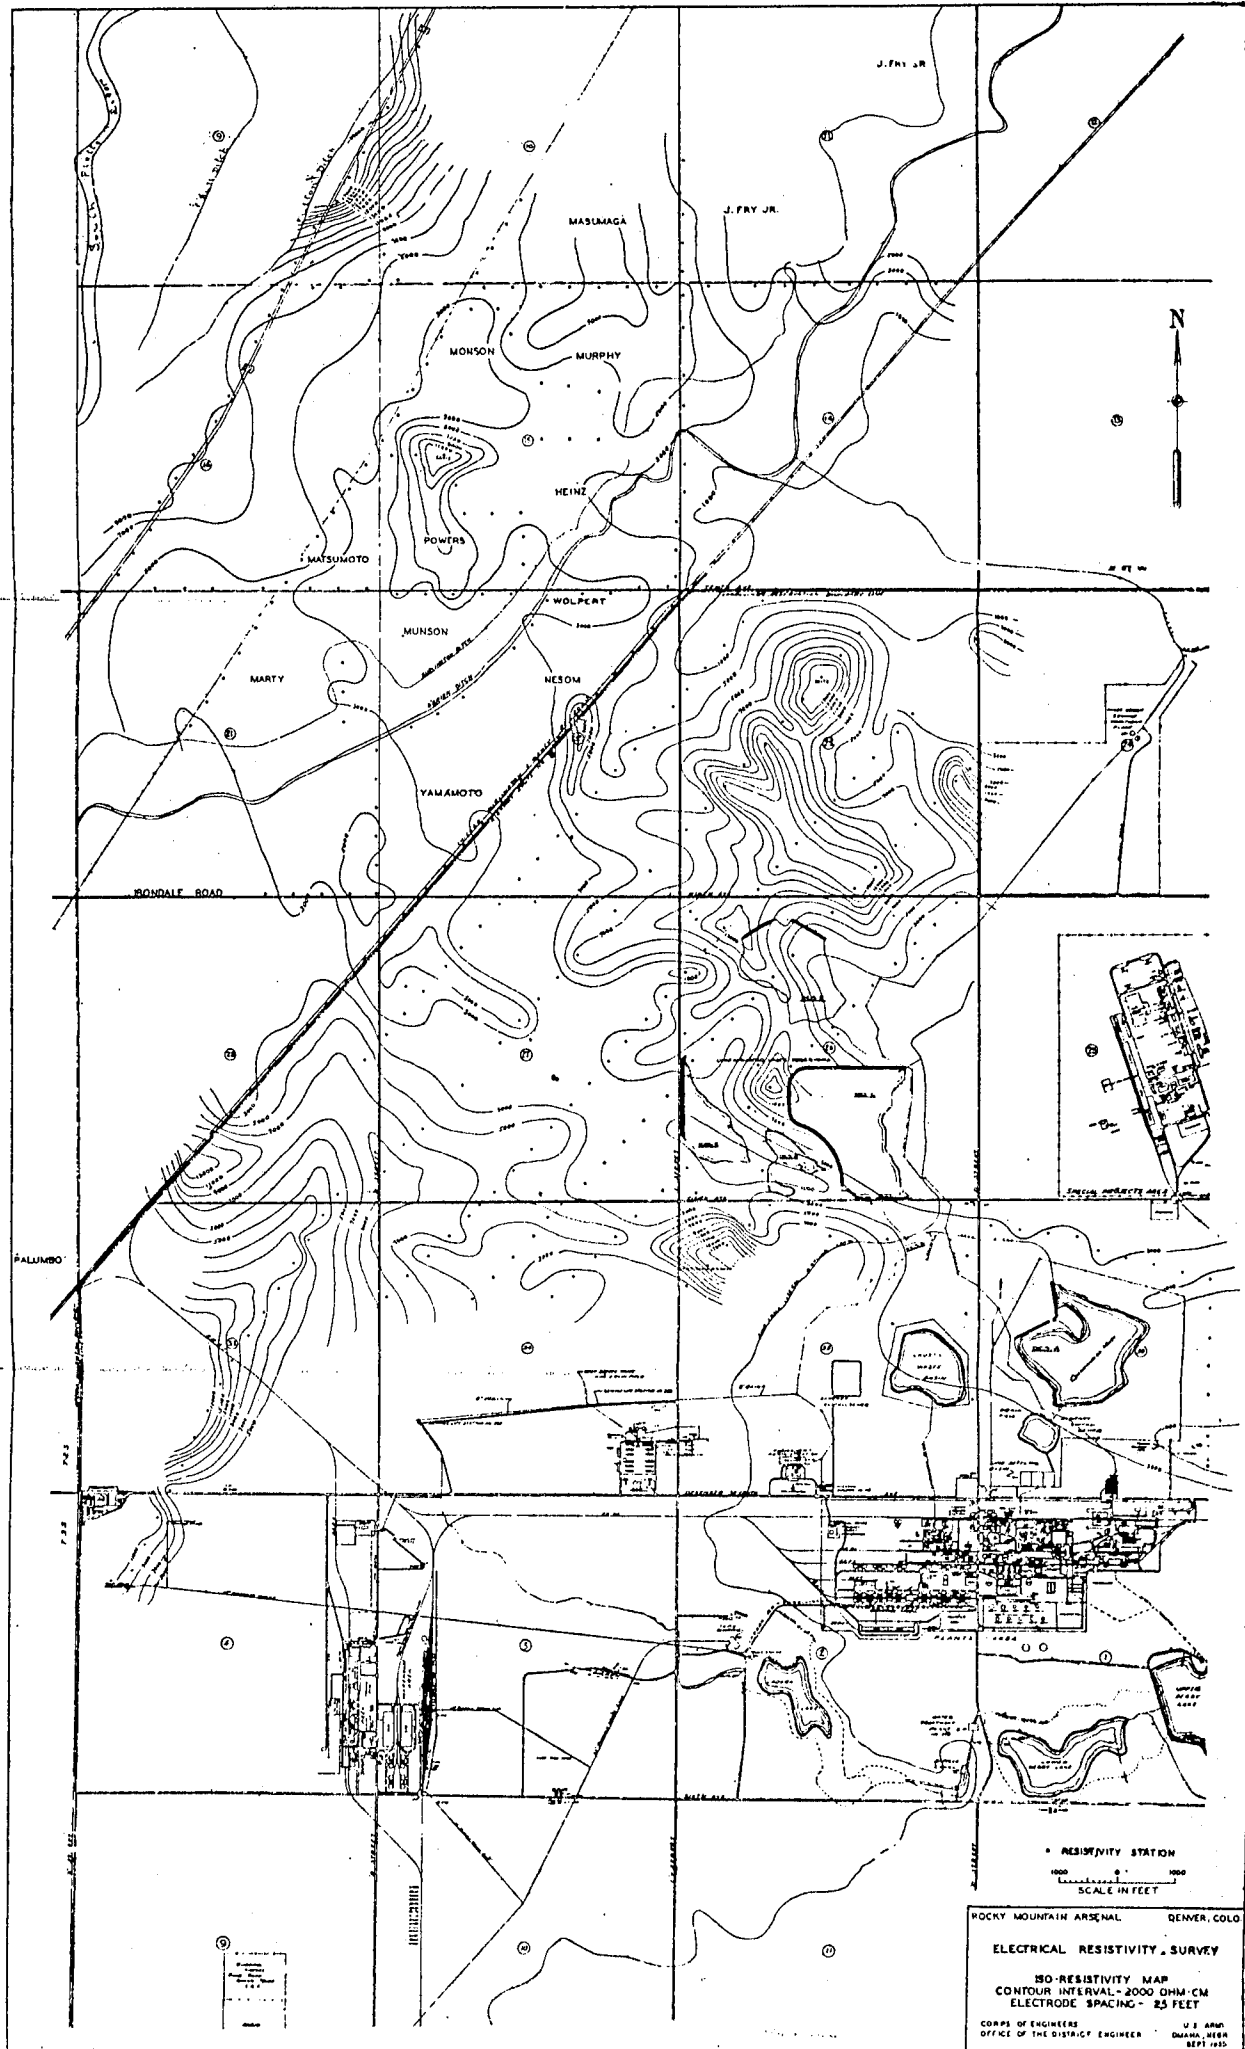
* RESISTIVITY STATION
 1000 0 1000
 SCALE IN FEET
 ROCKY MOUNTAIN ARSENAL DENVER, COLO.
ELECTRICAL RESISTIVITY SURVEY
 ISO-RESISTIVITY MAP
 CONTOUR INTERVAL - 2000 OHM-CM
 ELECTRODE SPACING - 25 FEET
 CORPS OF ENGINEERS U.S. ARMY
 OFFICE OF THE DISTRICT ENGINEER QUADRA, SEEN
 SEPT 1955

The electrical resistivity survey revealed two areas which have pronounced low resistivity values. The general trend of these "low" areas is in a northwest direction. The limits of the "low" area near the northern boundary line have not been delineated as thoroughly as the "low" area northwest of the Contaminated Waste Reservoir A. It may be noted that the "low" areas follow a trend toward the area being contaminated, namely the Powers property, as shown on the iso-resistivity maps, Plates Nos. 2, 3, 4, and 5.

There appears to be a general correlation between the low resistivity values with the high saline concentrations and high conductance values.

If the source of contamination is from the infiltration of disposal wastes into the ground water, it is reasonable to assume that the "low" areas may be the limits of the contamination.
