WL-TR-94-2092

RECIRCULATING CAVITY CASING  
TREATMENT FAILURE

PAUL T. KERNEY  
TEST & EVALUATION SECTION  
TECHNOLOGY BRANCH  
TURBINE ENGINE DIVISION

AUG 1994

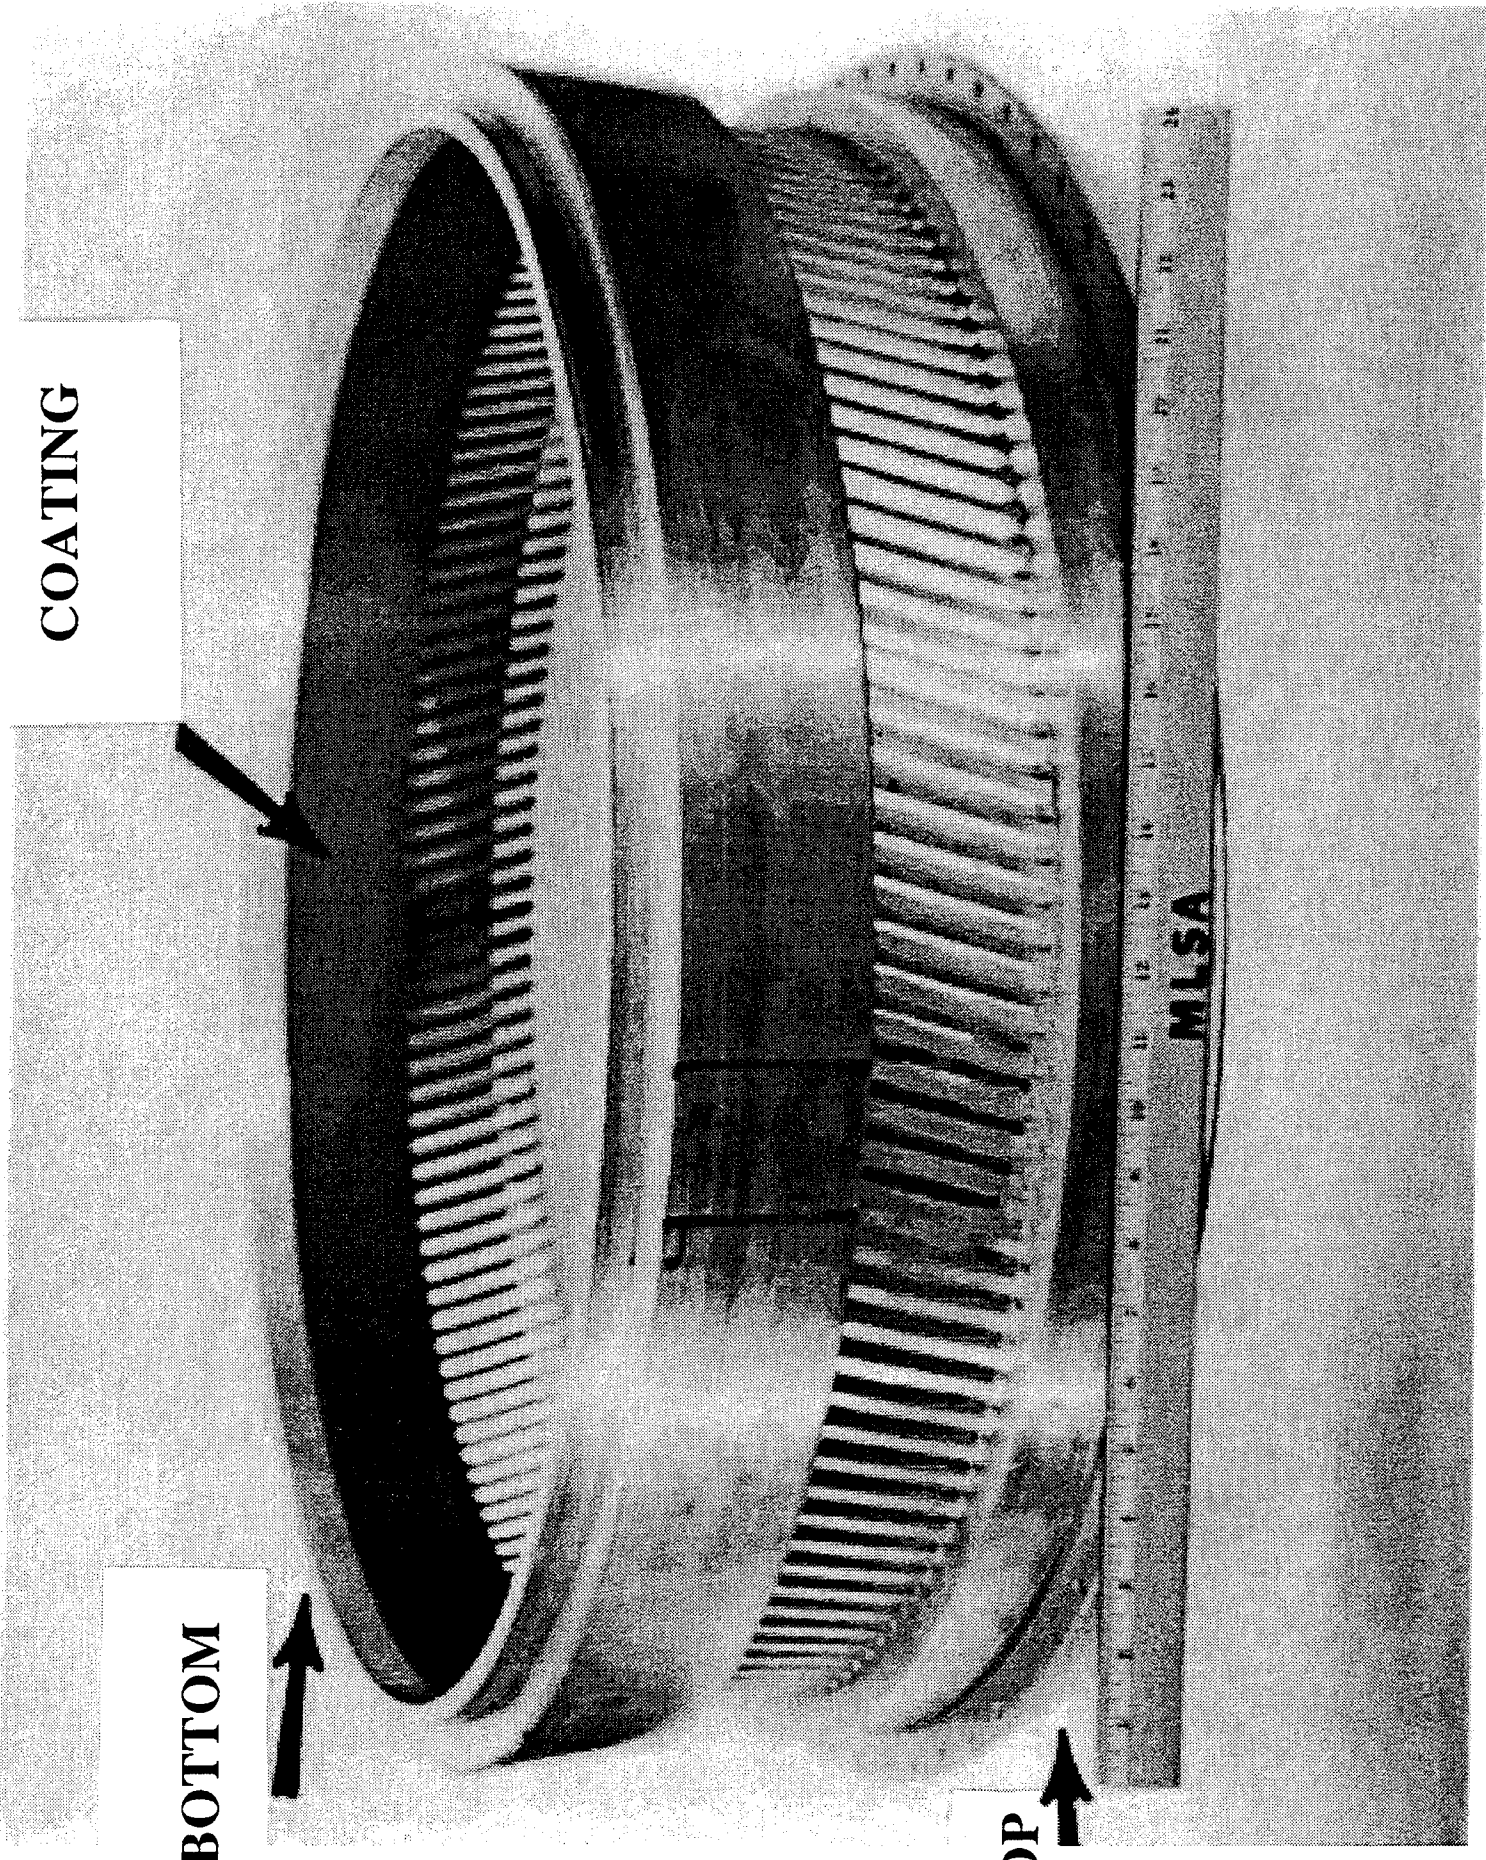
On 19 May 1993, the Test Article was boroscoped. The Recirculating Cavity Casing Treatment was found to be extremely discolored from the heat and some of the fingers were cracked. The casing treatment was removed and an overall view of the 6061-T6 aluminum alloy casing treatment can be seen in Figure 1.

Figure 1 Overall View of the 6061-T6 Recirculating Cavity Treatment

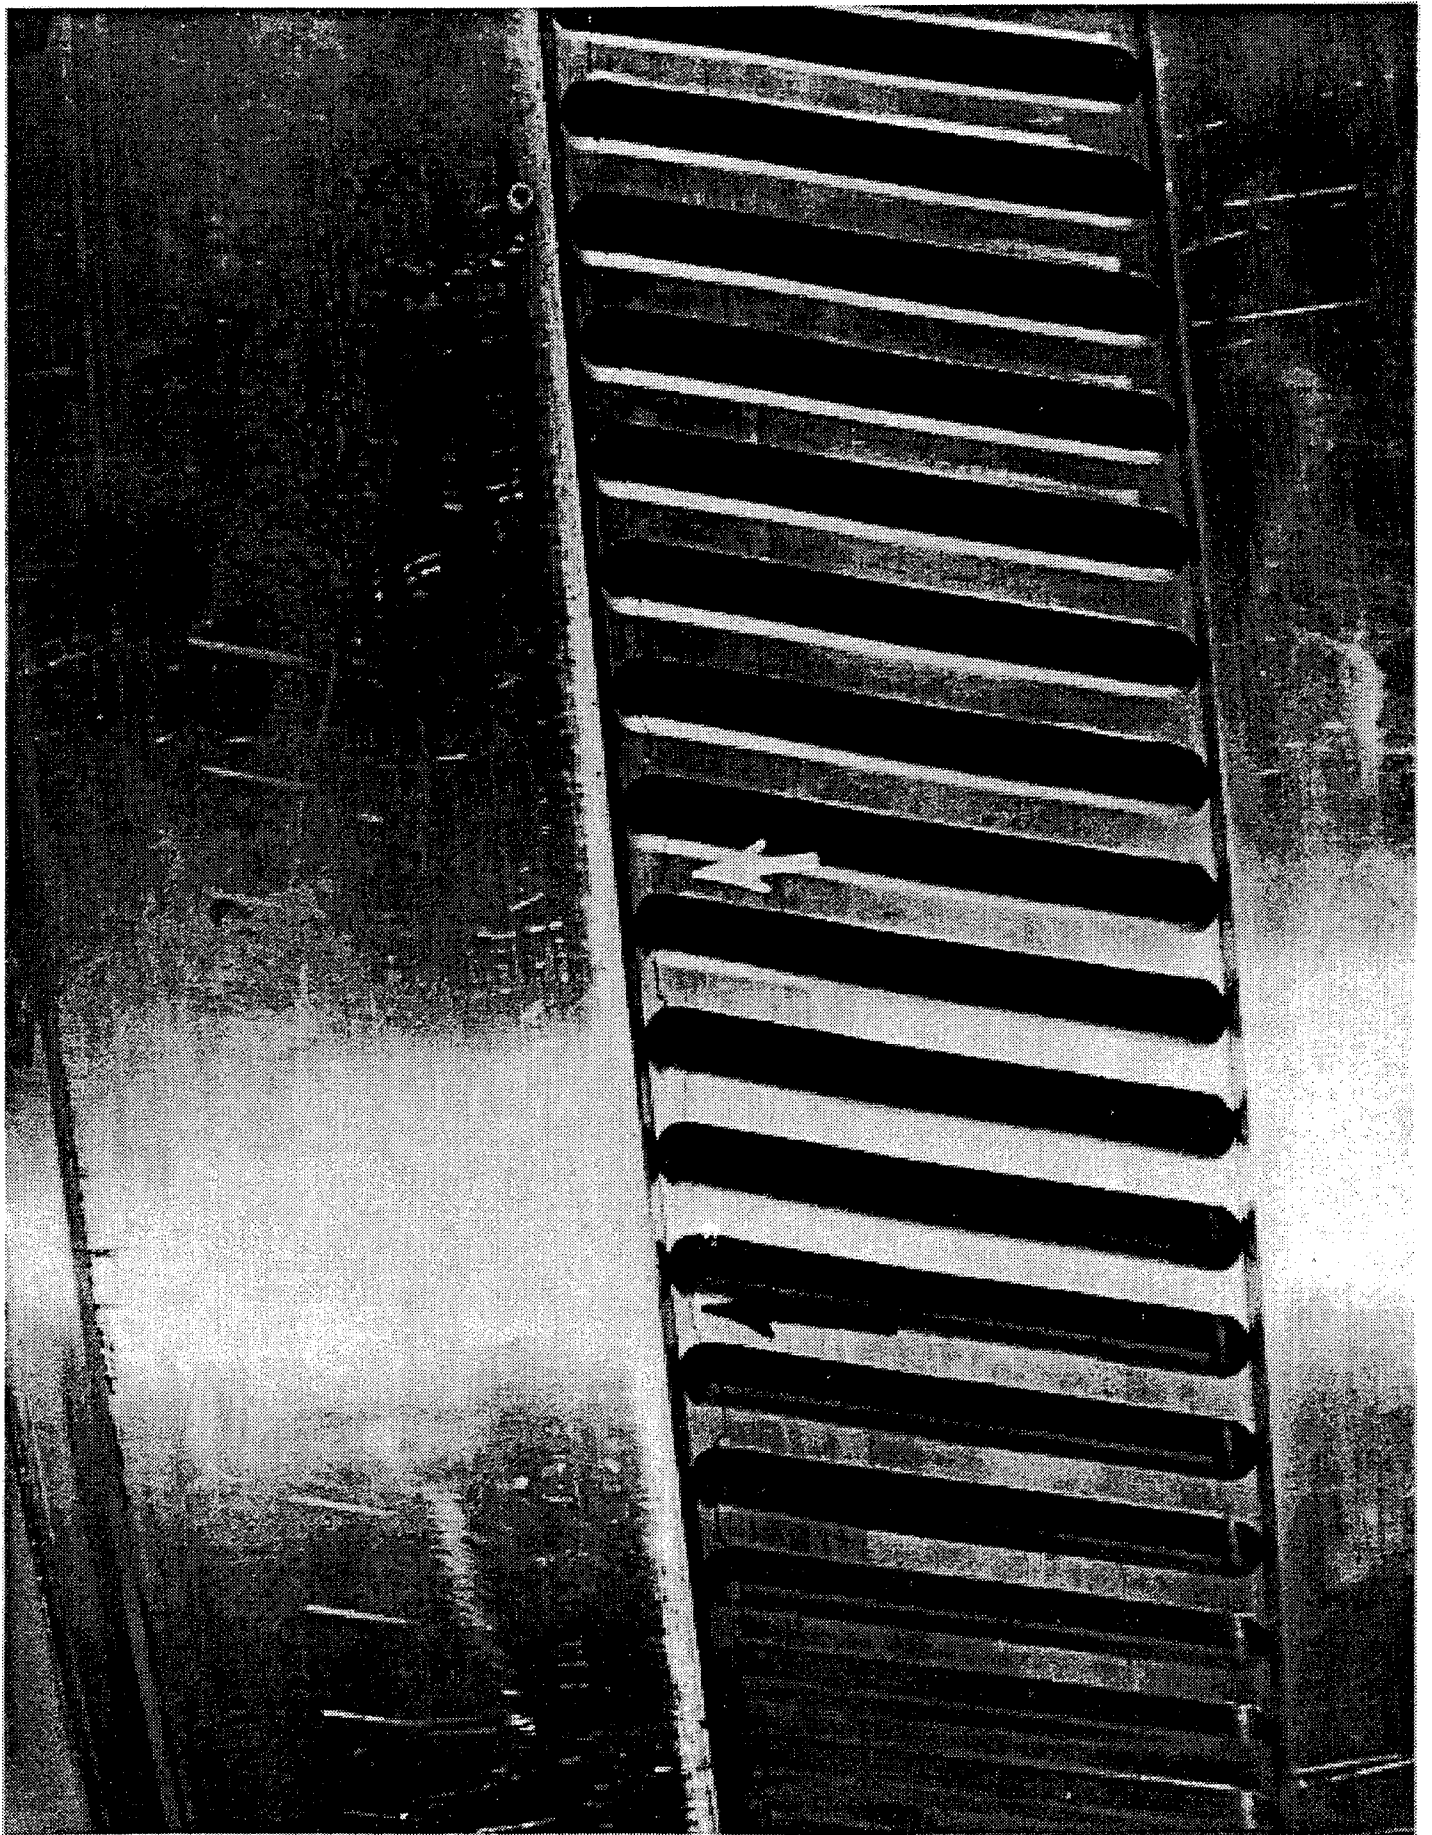
On 19 May 1993, the Test Article was boroscoped to find cracked fingers on the Recirculating Cavity Casing Treatment. See Figure 4. The casing treatment was then removed and failure analysis was started.

Figure 4 Photograph of the Cracked Fingers

After reviewing Figure 4, it can be seen only one end of the fingers developed cracks. This end is the downstream end of the casing seeing the hottest air flow. Cracks appear to originate from the two corners of the fingers, the corner being the intersection of the width and the thickness dimension of a finger. A close-up view of a crack in the finger can be seen in Figure 5. Scanning electron microscopy, Figure 6, determined these corner cracks to be due to mechanical fatigue. Scanning electron micrographs show fatigue striations indicative of mechanical fatigue, Figures 7 and 8.

Since fatigue cracking of the fingers is related to softening of the aluminum alloy, it is recommended 6061-T6 aluminum alloy not be used for this application.

Aluminum alloys 2219 and 2618 have better fatigue crack growth resistance under prolonged exposures between 300°F and 600°F and should be considered as alternate materials.

Although the suggested replacement aluminum alloys would work under the conditions specified and are lightweight, they are expensive and not readily available to a test program already on a tight time constraint. Since weight is not important in a ground test, the plain carbon steel 4041 will handle the rugged test environment, is available in stock at most metal distributors, and is easily machined.

It is also the recommendation of the paper to fully instrument the new casing treatment with thermocouples to analyze the effect of the elevated temperatures. Since the cracks occurred in the corners, it was suggested to increase the radius of the corners. This will also shorten the total machining time.

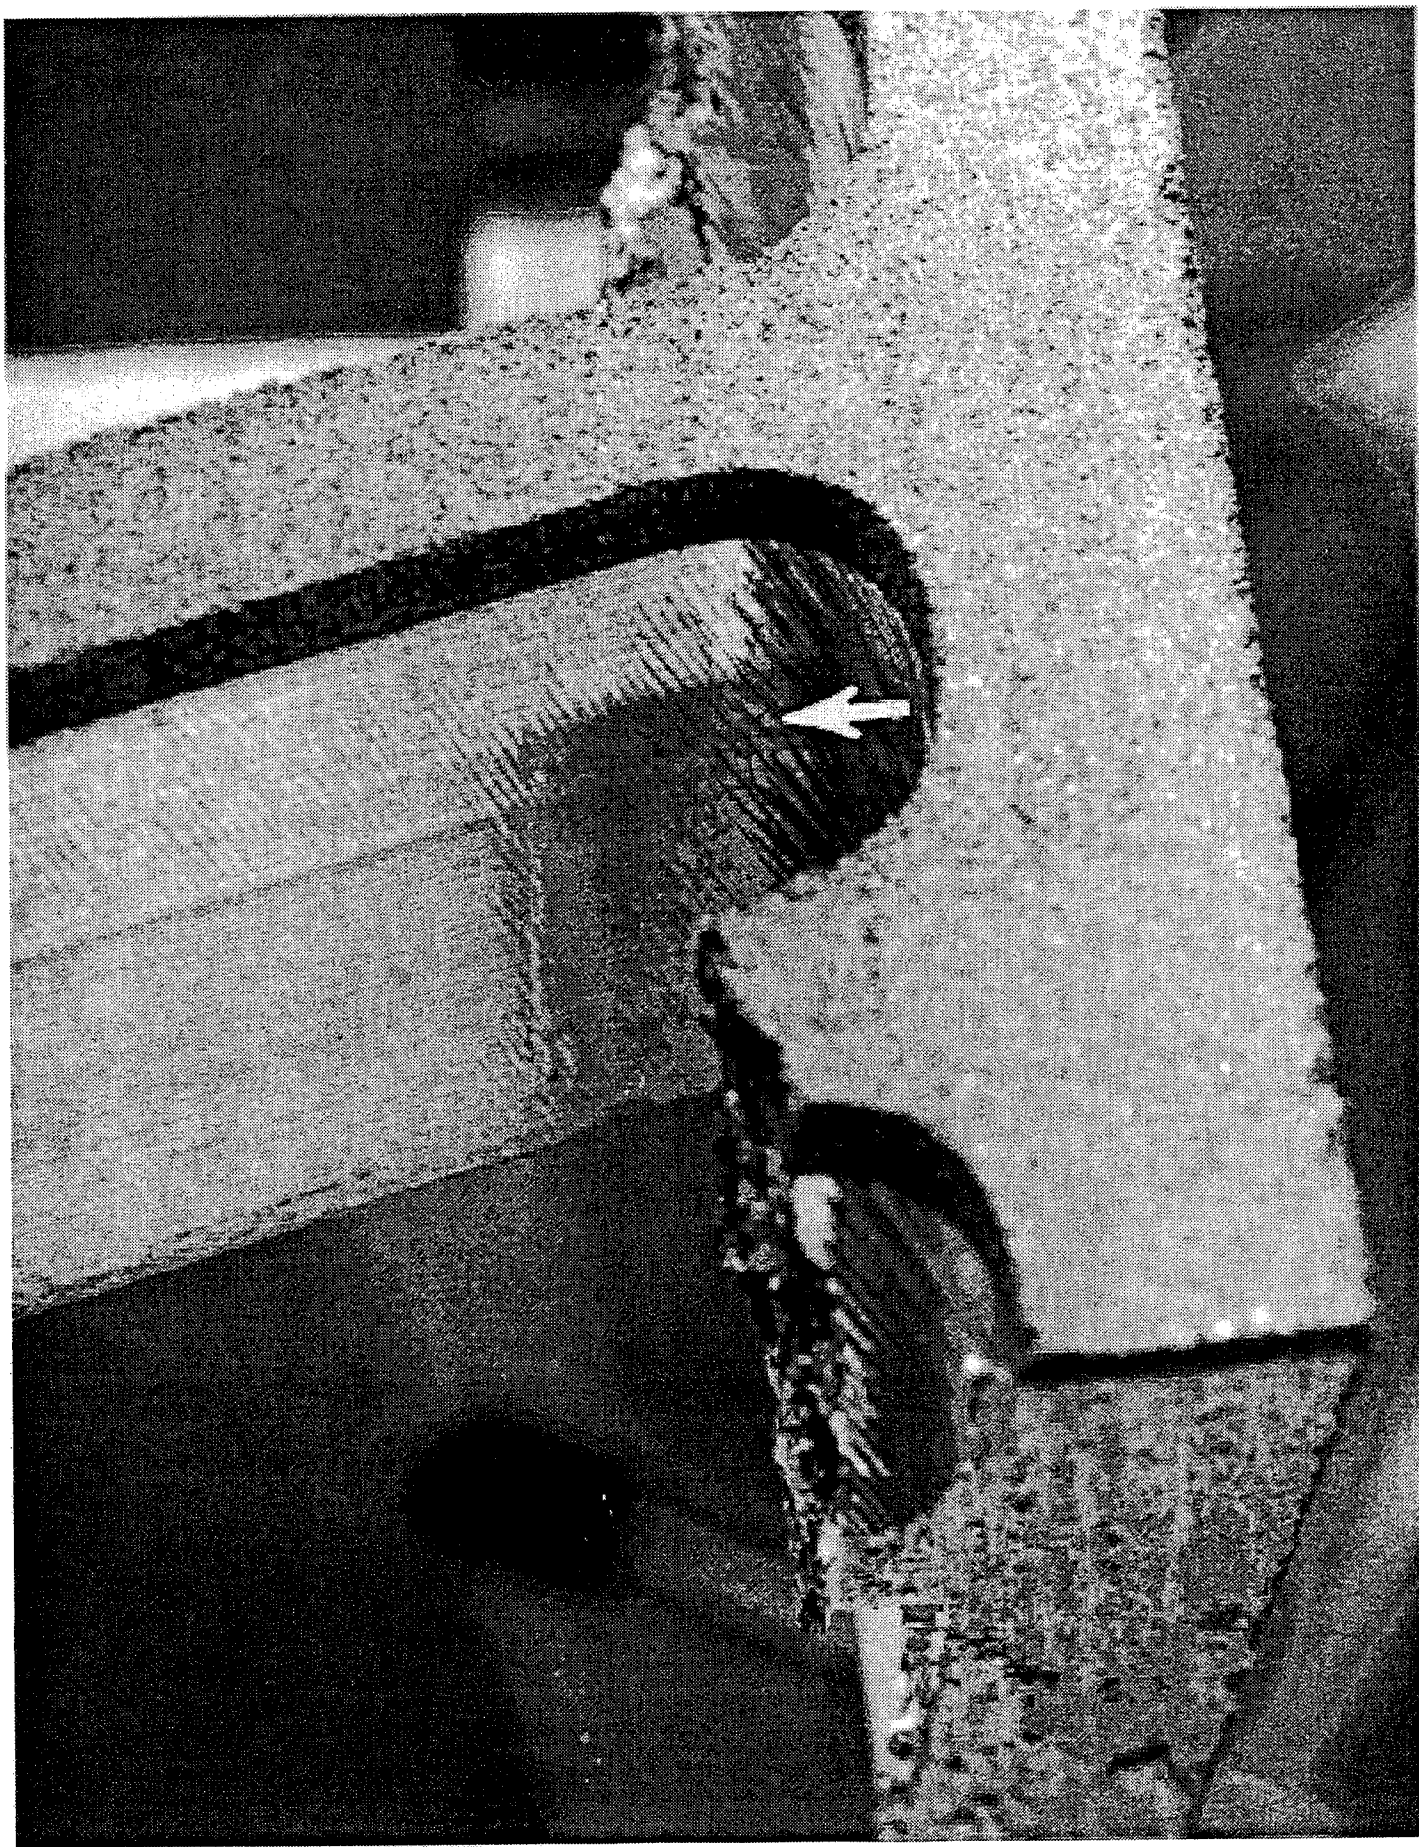
Hardness measurements on the cracked fingers showed substantial variation along the length of the finger. In the area where the fracture occurred, the hardness is Rockwell E ( $R_E$ ) 67. In the middle of the finger, the hardness is  $R_E$  63. The area at the bottom of the finger farthest from the fracture site is  $R_E$  78. The minimum recommended hardness according to the American Society for Testing Materials Specification 2658 for 6061-T6 is  $R_E$  85. The original design specifications did not call out a minimum desired  $R_E$  hardness value. The decreased hardness numbers are due to the extreme temperatures seen by the casing treatment.

Figure 5 Close-Up View of a Cracked Finger

All of the hardness numbers along the finger length were lower than the minimum recommended number of  $R_e$  85 for 6061-T6. This would suggest the aluminum alloy softened due to exposure to high temperatures. Aluminum 6061-T6 will soften when exposed to temperatures greater than 300°F. Although the hardness in the middle portion of the finger is lowest, cracks did not originate in this region. The presence of a sharp radius at the junction and a low hardness caused the failure.

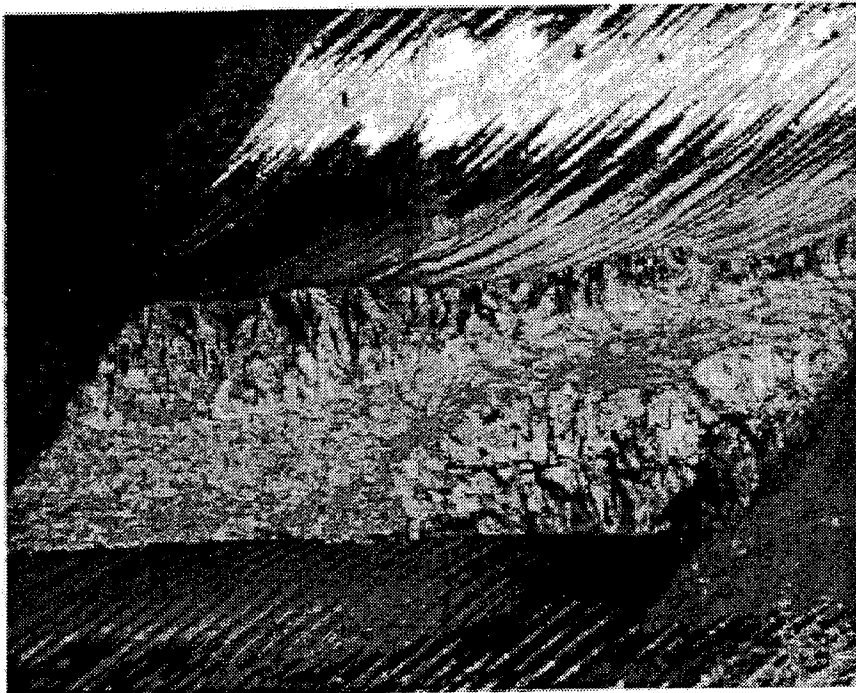
Figure 6 Optical Micorgraph Depicting Two Corner Cracks  
Mag: 7.2X

Almost all of the cracked fingers exhibited corner cracks. The corner cracks were initiated and propagated by fatigue. Fatigue crack propagation data for 6061-T6 are available only for room temperature and 300°F temperatures. These data show at 300°F, fatigue crack growth rates are twice as fast as at room temperature. This suggested exposure to higher temperatures would only be further detrimental to crack propagation. Data on yield strength show 30 minutes exposure to 300°F decreases the yield strength from 42 Ksi to 36 Ksi. This would also imply reduced hardness.

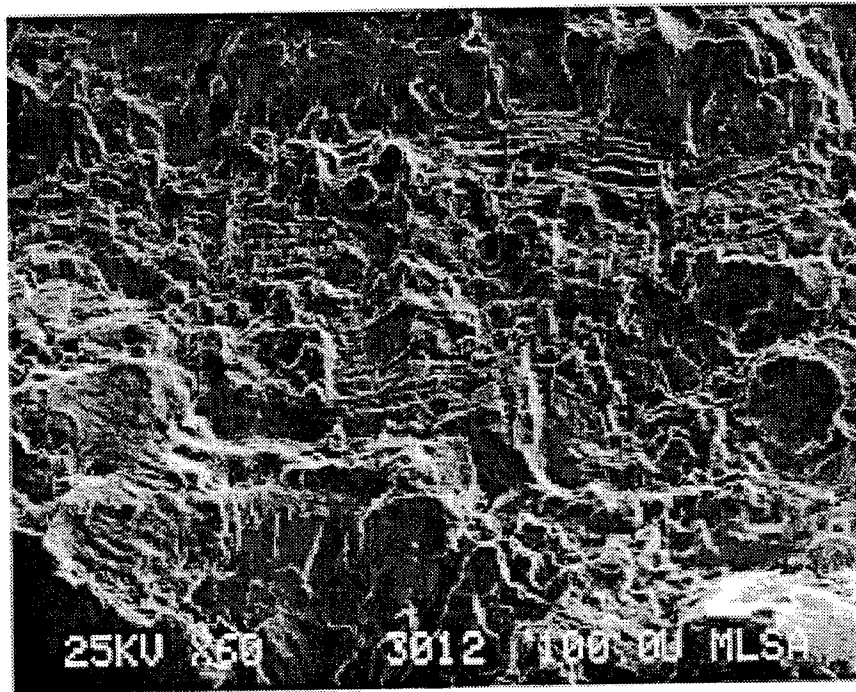
Figure 7 Scanning Electron Micrograph Fatigue Striations  
Mag: 60X

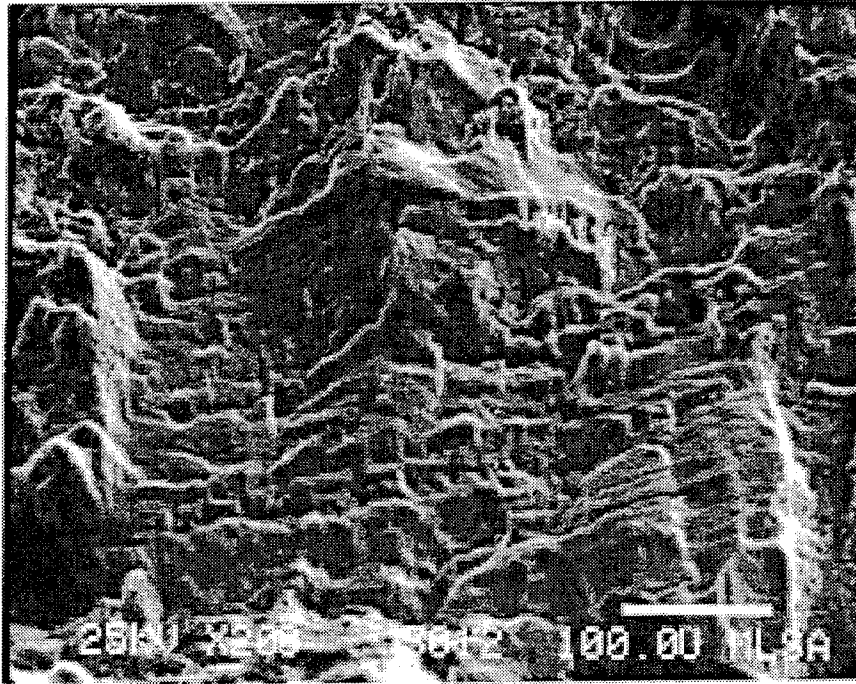
Figure 8 Higher Magnification View of Figure 7  
Mag: 200X
