USACERL Technical Report FE-95/04  
November 1994

# **Improving Central Heating Plant Performance at the Defense Construction Supply Center (DCSC)**

## **Advanced Operation and Maintenance Methods**

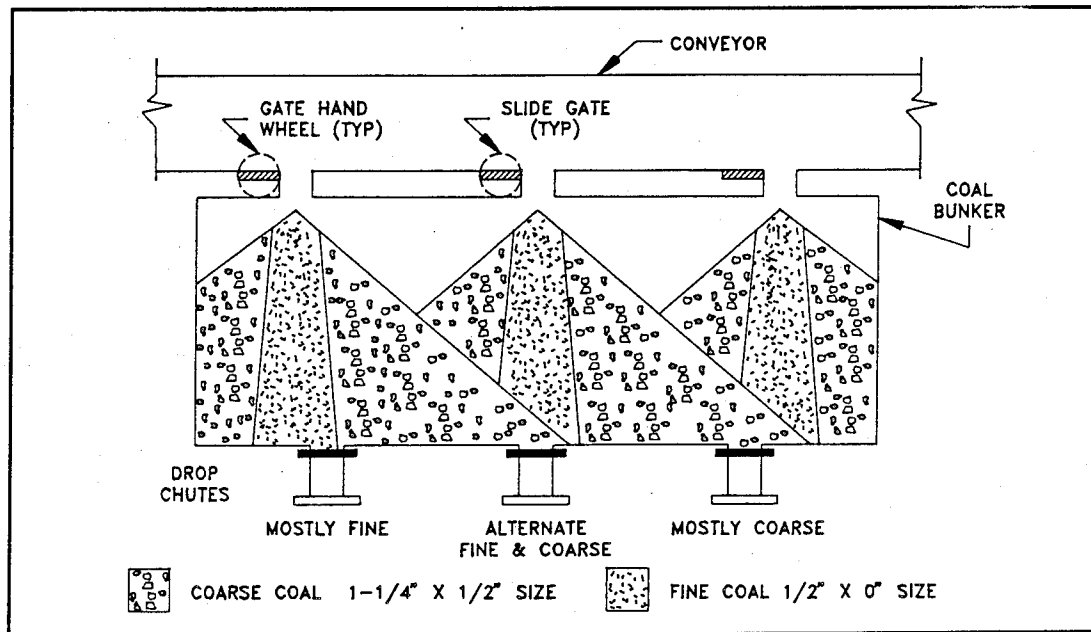
Figure 6. Schematic showing coal segregation.

The DCSC standard operating procedure for filling the bunkers was to leave all the slide gates on the flight conveyor open. This procedure causes segregation to occur in the overhead bunker. Figure 6 shows a schematic representation of this segregation. The bunker area under the first slide gate was filled first, creating a cone shaped pile up to the slide gate. With the first slide gate closed off with coal, coal would fill the area under the second slide gate. This procedure was continued until the bunker was filled.

This segregation causes slugs of fines and large coal to be sent to the HTWG feeders instead of the required homogenous size distribution. This will cause poor distribution of coal on the stoker grates, resulting in poor combustion and high particulate emissions. As discussed earlier, poor size distribution at the stoker feeders was identified during the USAEHA tests.

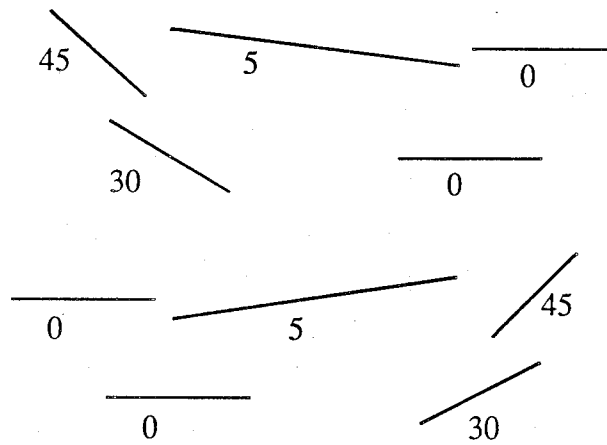
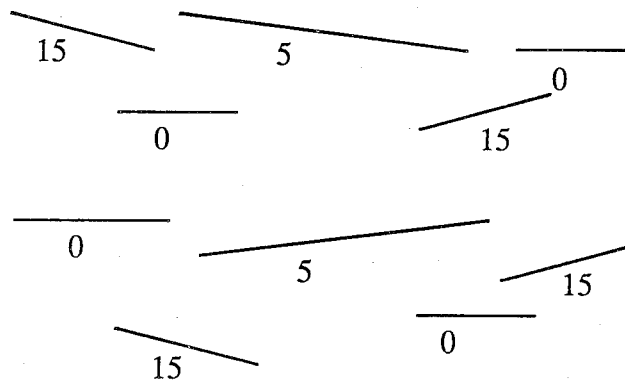
PADDLE ANGLE ARRANGEMENT  
(ALL FEEDERS)

**Coal feeders.** All three HTWGs have Model B Riley Spreader Stoker feeders. A careful inspection of HTWG no. 2 and 3 feeders showed that they were in excellent mechanical condition. No replacement of parts was necessary. However, observation of the lateral coal distribution on units no. 1 and 3 indicated that modification of some of the distributor paddle angles was needed to improve lateral coal distribution over the grate area. Figure 10 shows the existing paddle angles followed by the suggested arrangement. The improvement in coal distribution over the grate area will permit complete combustion of the fuel with less excess air.

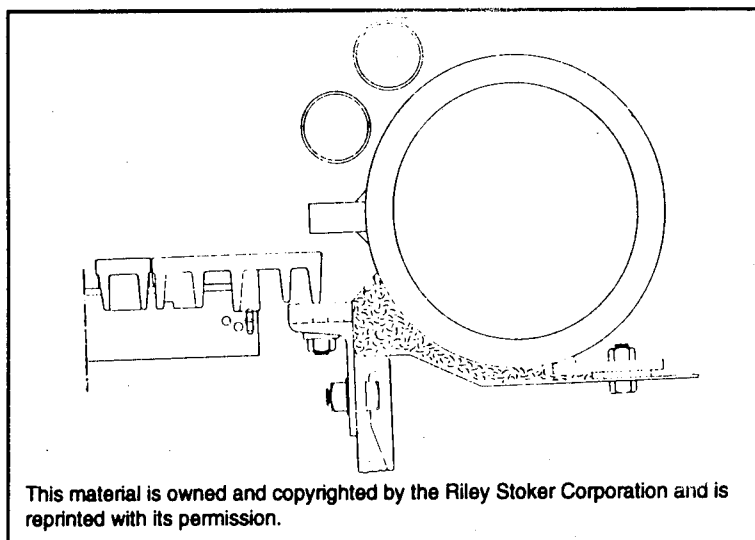
Figure 11. Travel grate details—sealing clips.

The grate clips on HTWG no. 3 showed definite overheating distress. The clips were humped and beginning to bind on the "TEE" bars (grate racks). To alleviate this, one 1-in. grate clip was removed from each rack (1 in. = 25.4 mm). The grate clip growth was undoubtedly due to operating with too thin an ash bed on the grate surface or running "clinkers" (inadequate excess air). If there is any further deterioration due to overheating, this grate surface will have to be replaced within 1 year. The rear overgrate air seal castings on this unit were similar to those on HTWG no. 2. The castings were wearing and subject to heat deterioration, but were still sound.

The side air seals were adequate and the stationary castings were in excellent condition. The sealing clips were in very good condition. However, the clips did not

make firm contact with the stationary castings due to the "TEE" bars being bent upward slightly. To correct this, the bars could be bent downward the next time the grate clips are replaced.

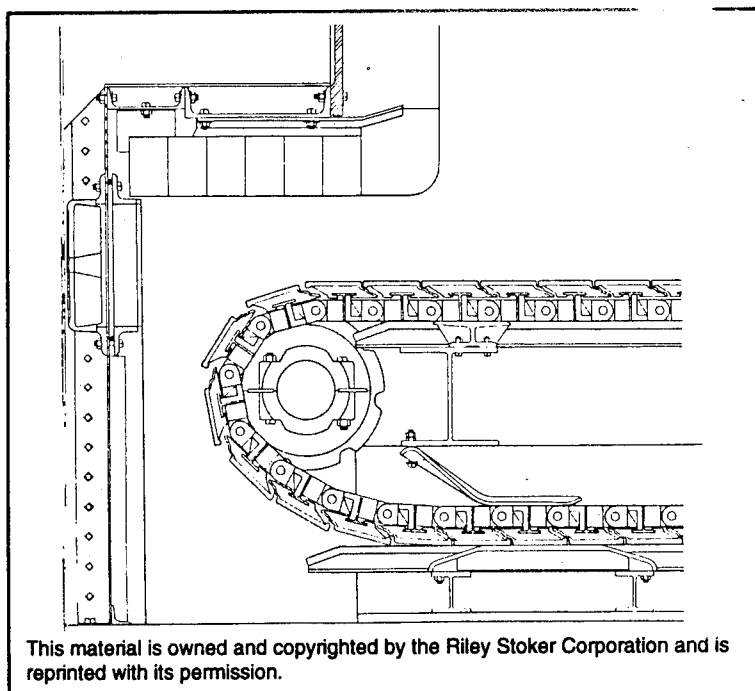
Figure 12. Travel grate details—cast iron air seals.

The castings forming the rear overgrate air seal showed some slight distress due to heat and wear but did not require replacement at the time of inspection.

The front air seals were in good condition. There are no broken or missing castings and contact between moving and stationary members was correct.

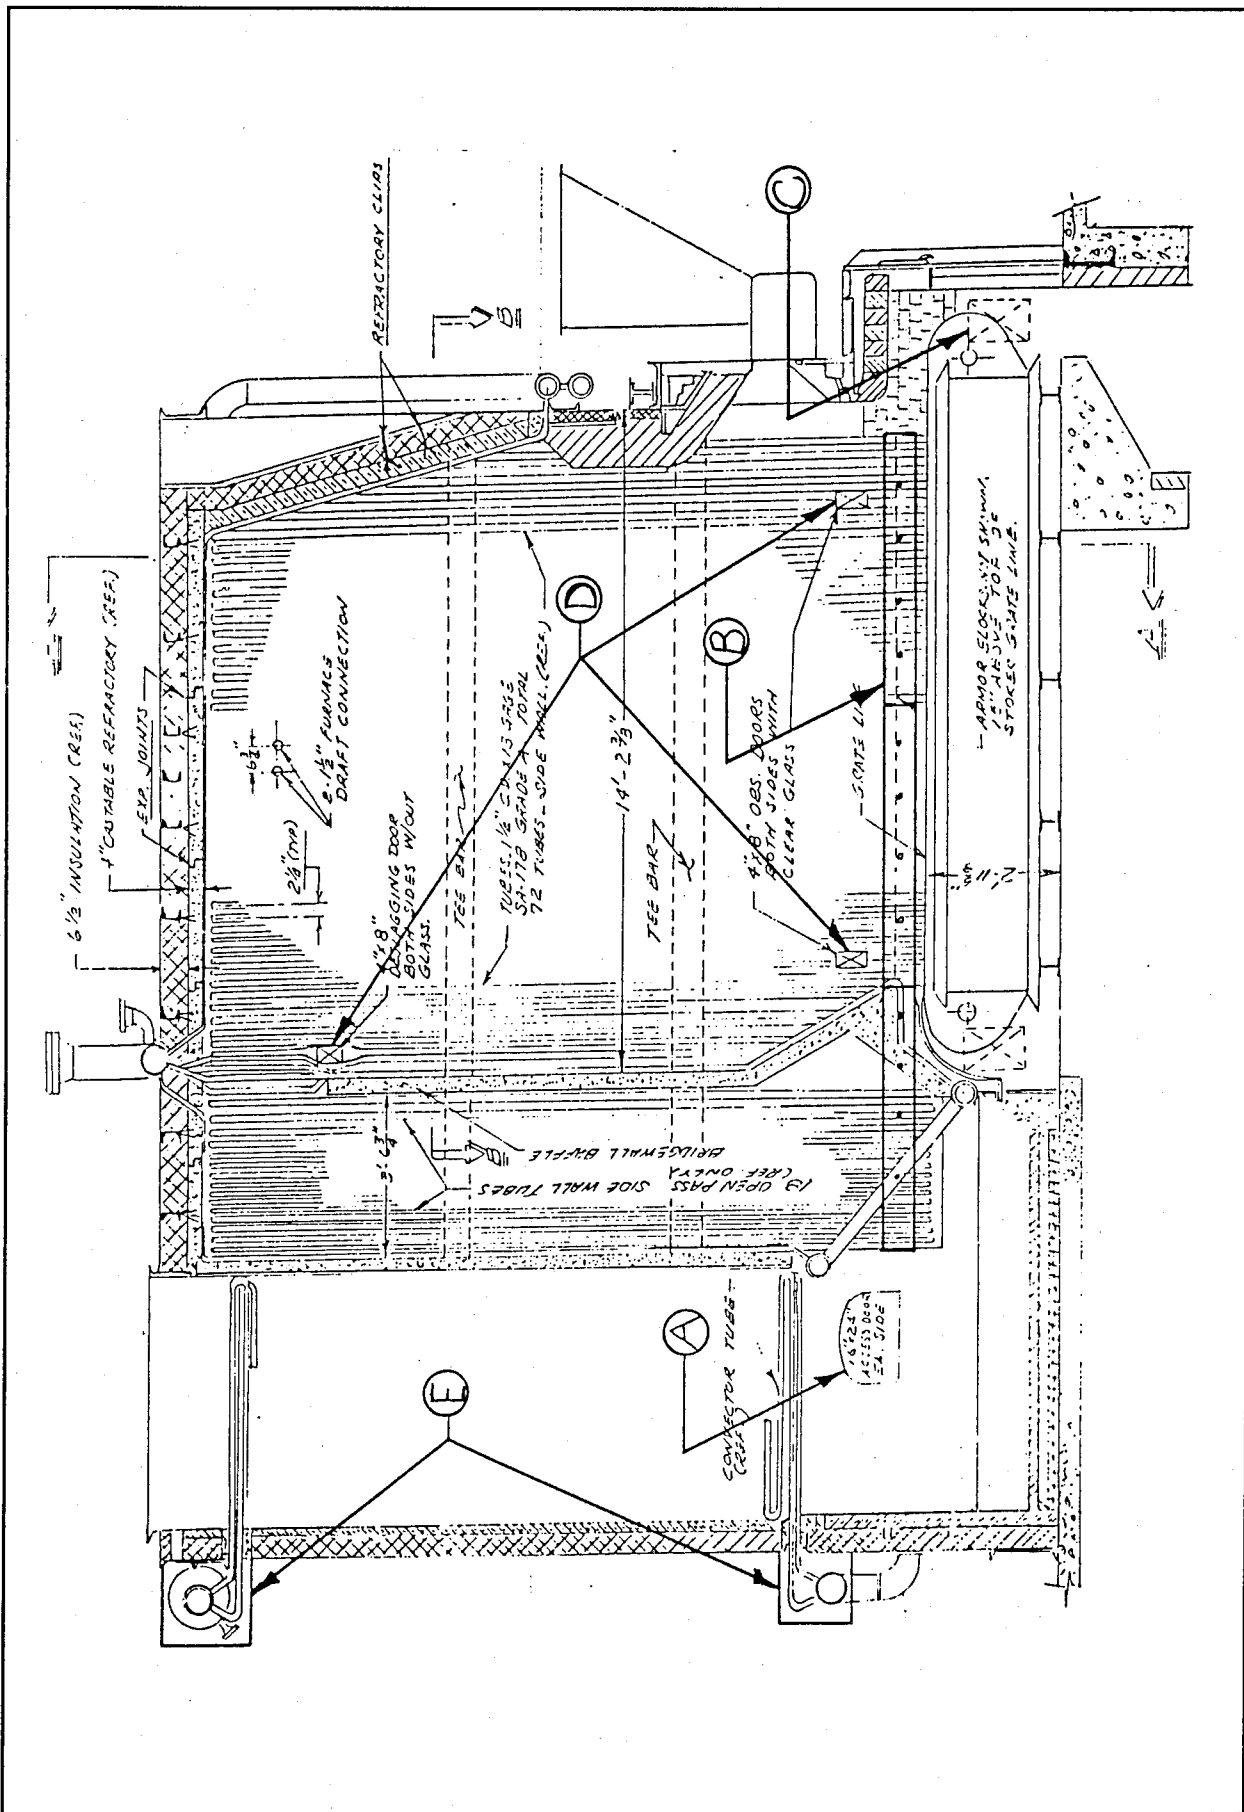
Figure 15. Location of HTWG leaks.

On HTWG no. 2, one of the overfire air lines passing through the hopper was defective. The 2-1/2 in. pipe was broken at a pipe flange and was separated by about 2 in. Because of this leak, about 50 percent of the air supplied by the fan was escaping into the last pass hopper.

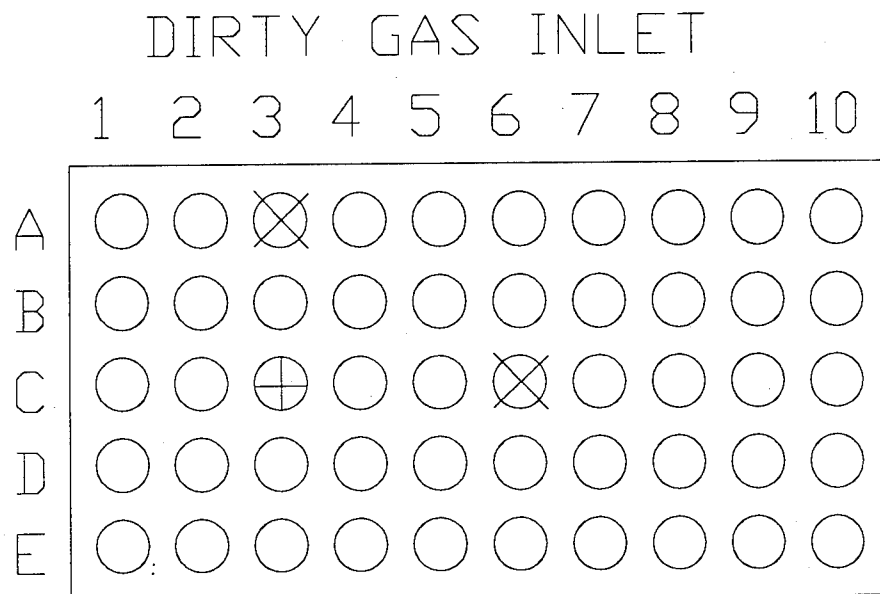
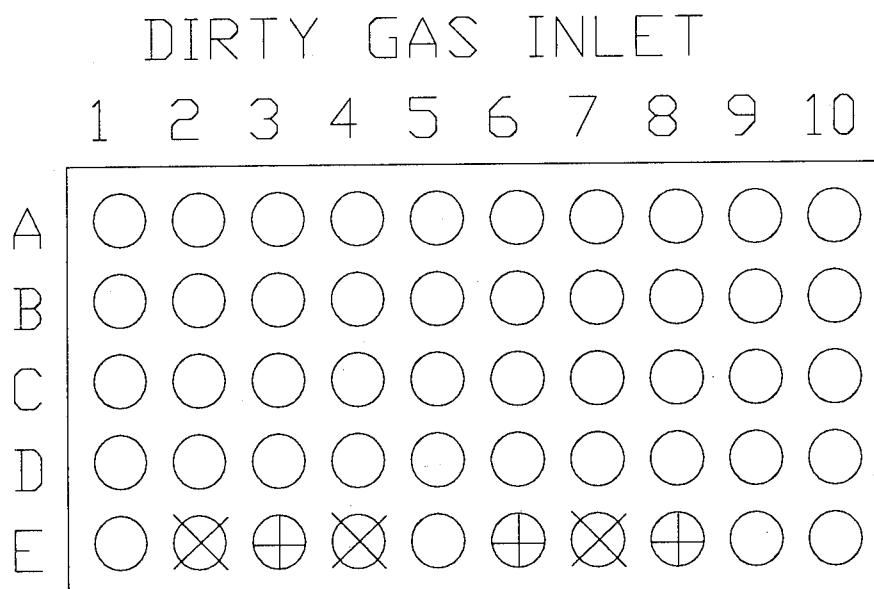
Figure 18. Mechanical collector inspection.

⊕ WORN CAST IRON  
COLLECTING TUBE.

⊗ WORN BOOT

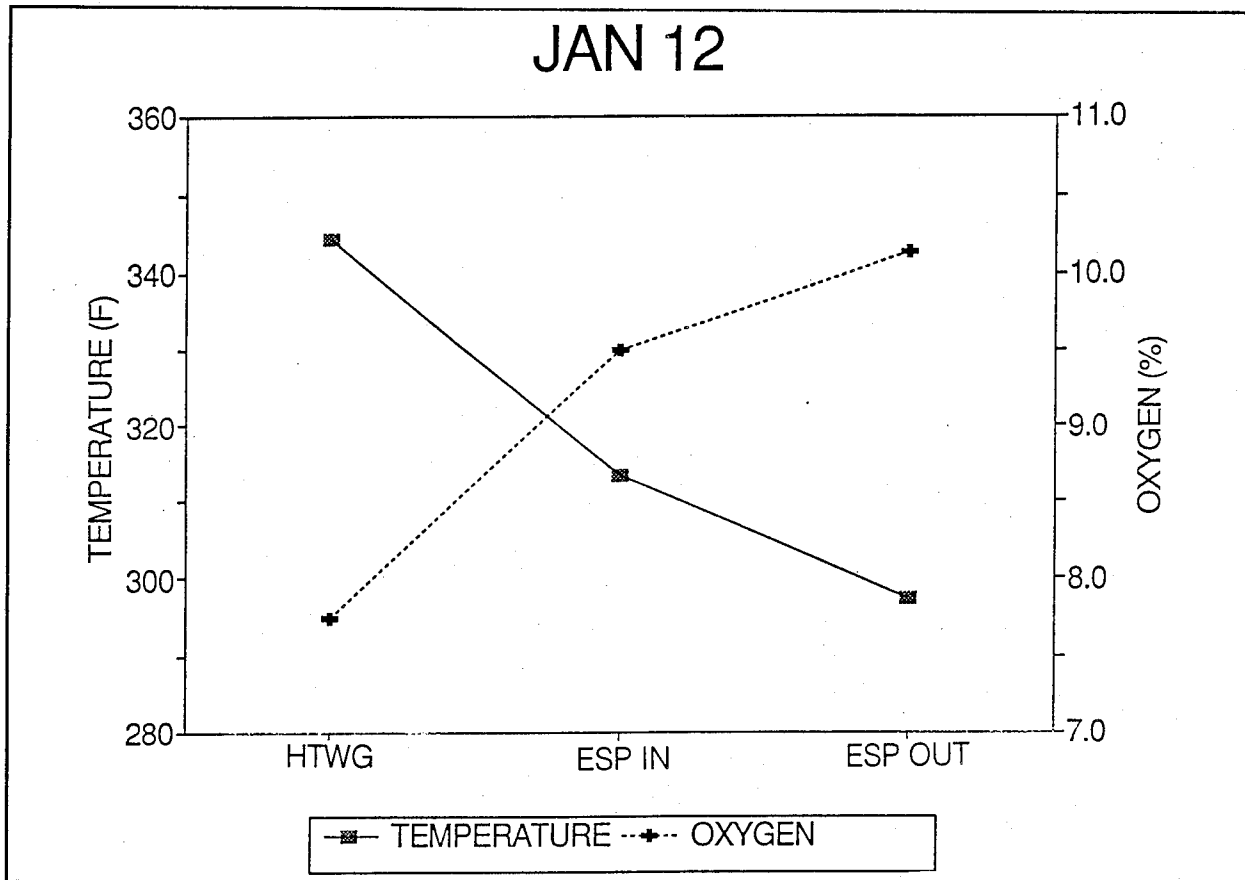
Figure 23. Pre-compliance test air infiltration.

level was 0.0248, based on measured coal input. This was about one-sixth of the Ohio EPA allowable emission level of 0.16 lb/MBtu for these operating conditions.

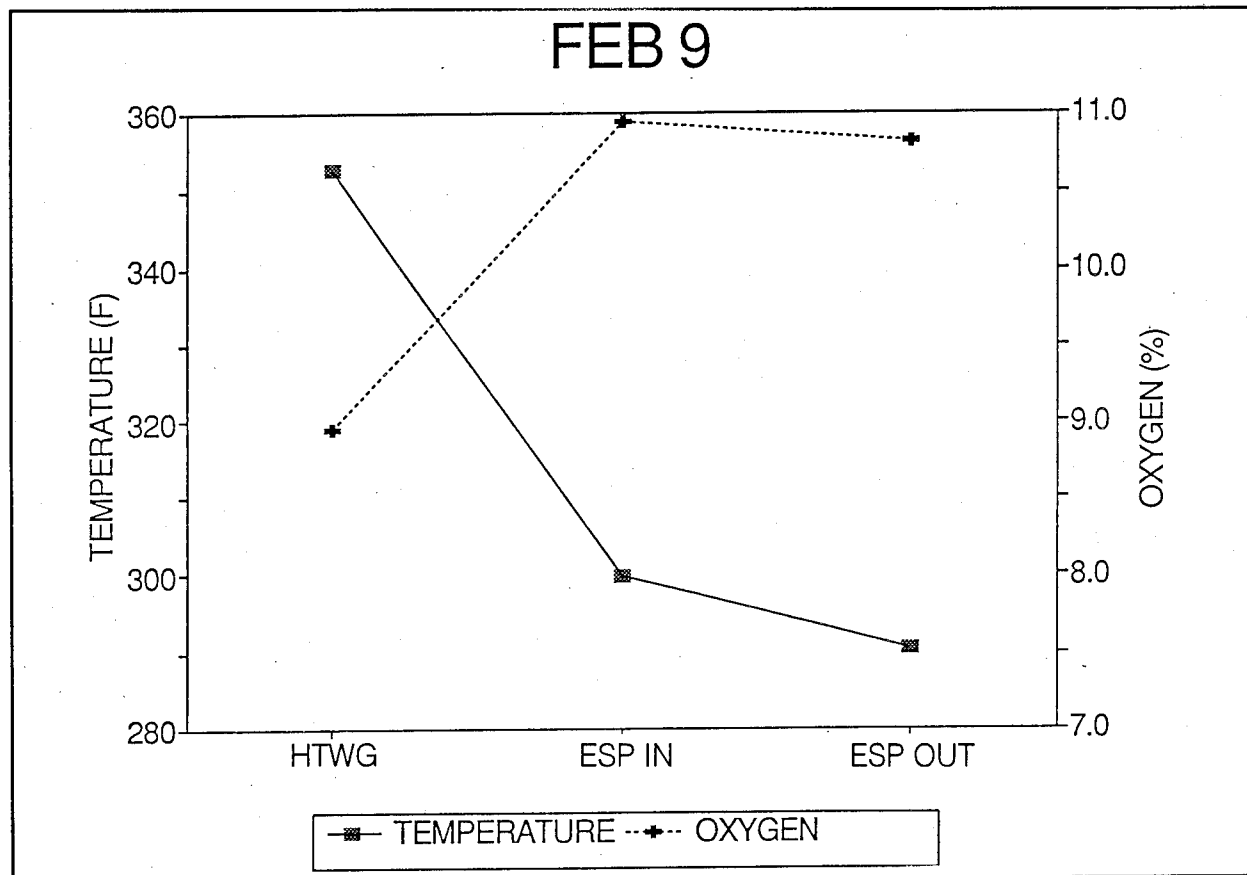
Figure 24. Pre-compliance test air infiltration.

was probably due to operation by plant personnel instead of the stoker expert. The average emission level was 0.0445, based on measured coal input. This is still less than one-third the Ohio EPA allowable emission level of 0.16 lb/MBtu for these operating conditions.
