Monitoring of the Yaquina Bay Entrance North Jetty at Newport, Oregon; Summary and Results

by *Steven A. Hughes, Terri L. Prickett,
Michael W. Tubman, William D. Corson*

Final report

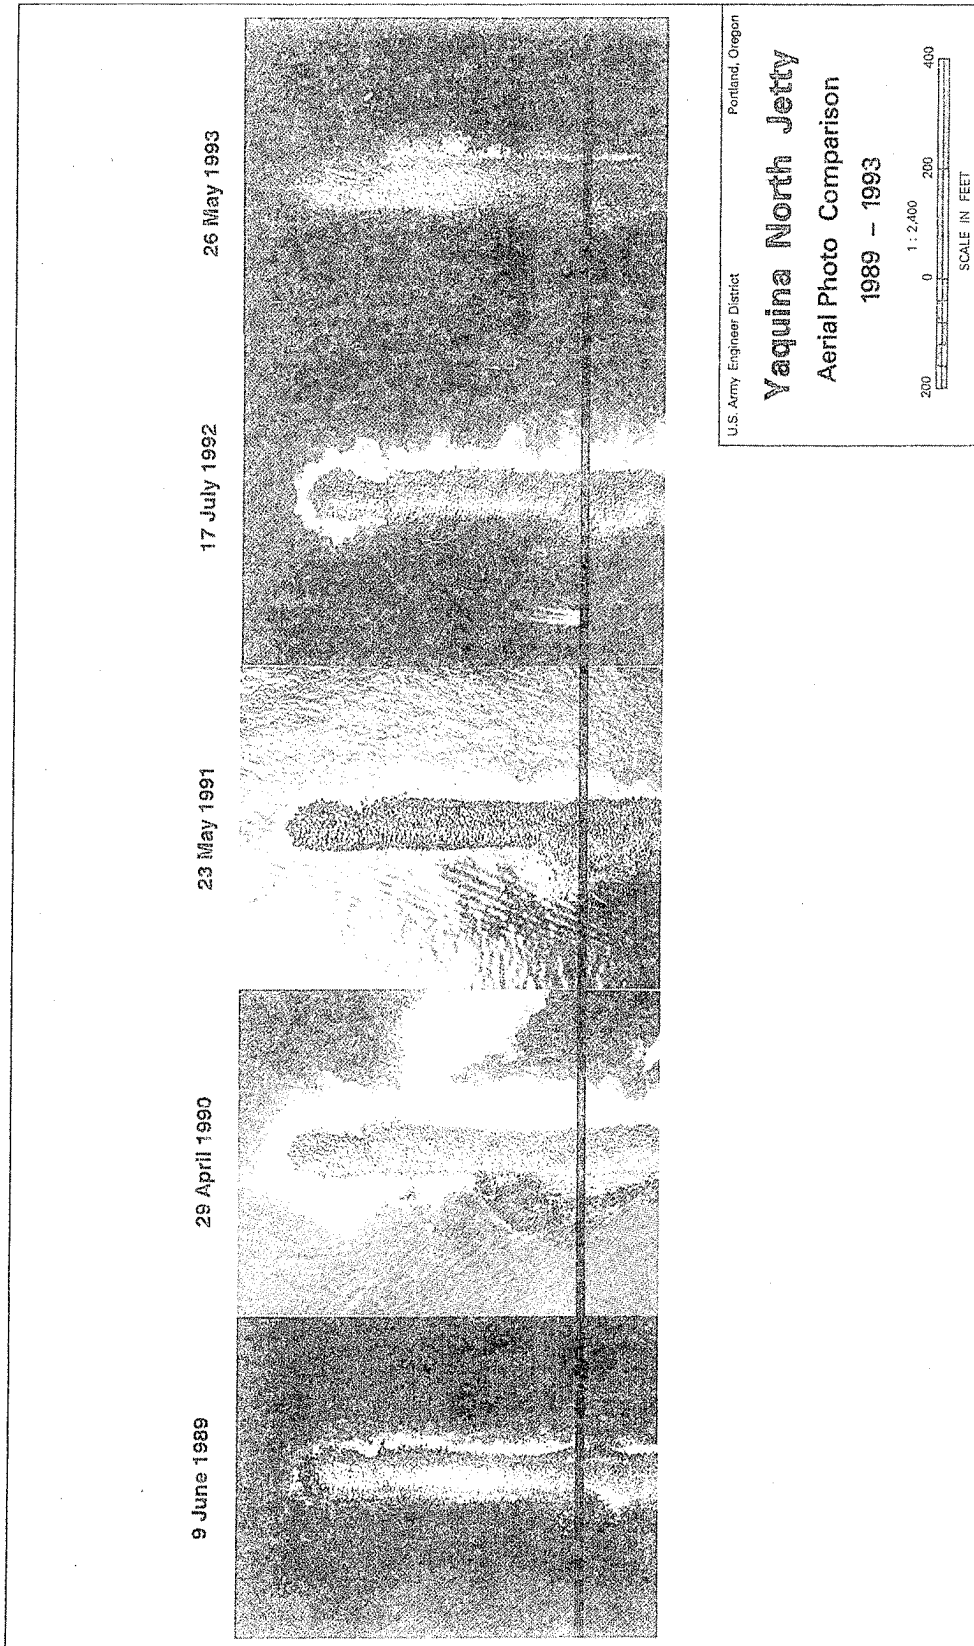
Originally, damage that occurred after the north jetty was extended out to the offshore reef in 1966 was thought to have been caused by increased water currents resulting from the proximity of the jetty tip to the reef. It was hypothesized that these currents produced scour at the toe of the structure, thus causing the armor layer to slough off into the scour hole. Under this scenario it was concluded that the remains of the degraded tip of the structure would serve as a stable foundation for the repair performed in 1978. This premise was supported by experience at other jetty structures which had undergone similar rehabilitation. However, the rehabilitated north jetty at Yaquina Bay proved to be unstable, which led to a widening of the possible damage hypotheses to include foundation failure, wave focusing by local

Figure 2. Yaquina Bay north jetty aerial photographs, 1989-1993

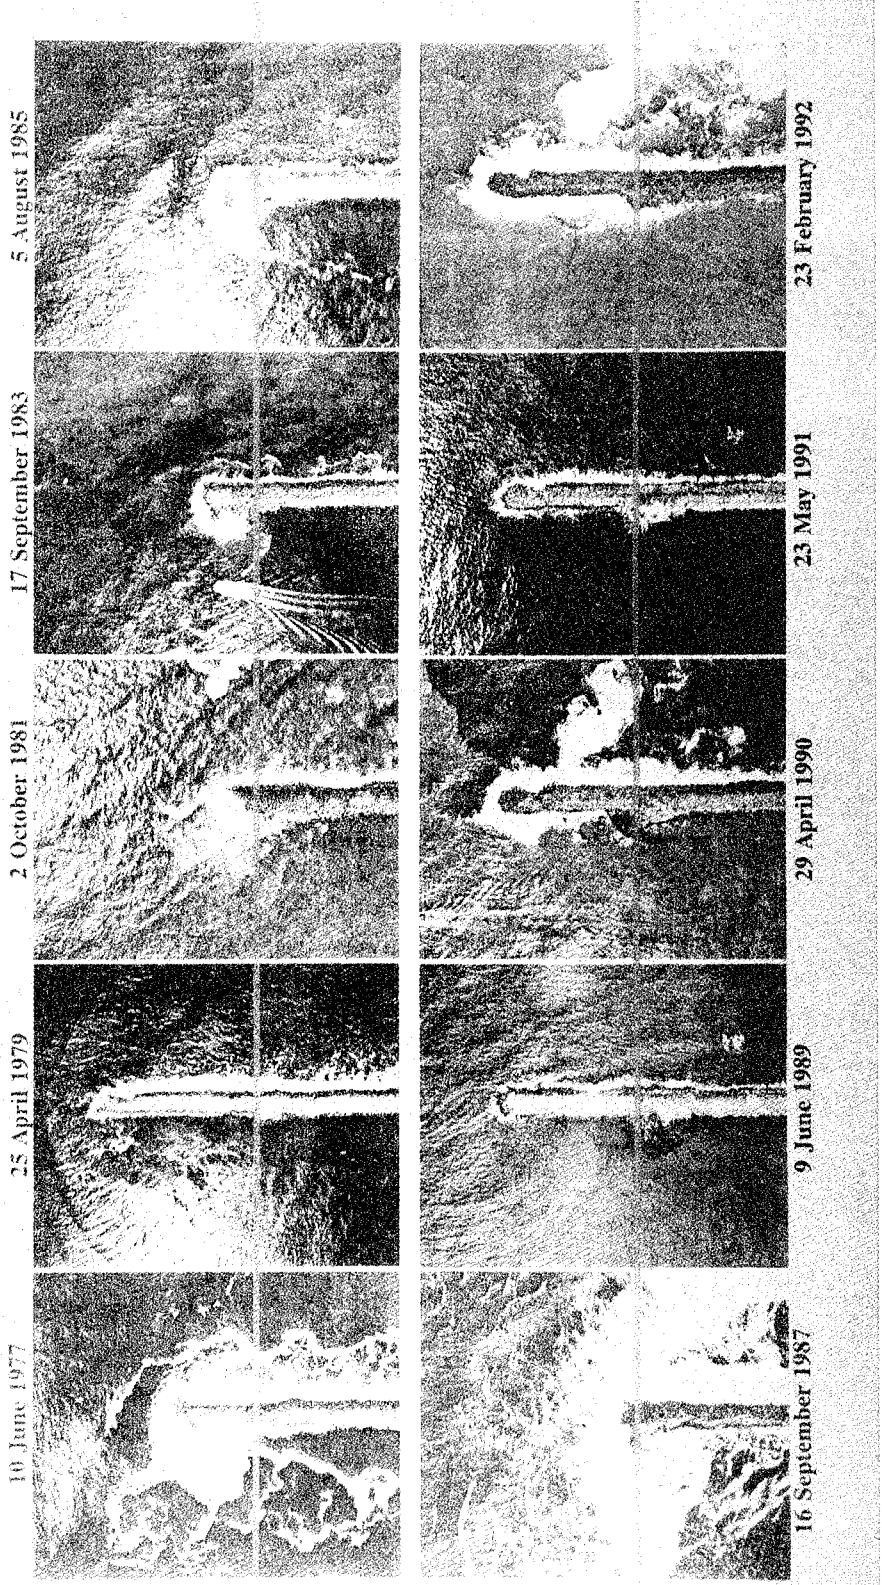
Almost immediately after completion of the north jetty rehabilitation, damage started to occur on the seaward tip of the structure. Aerial photographs indicated that 12 m (39 ft) of the tip was submerged by April 1979, with subsequent total submerged lengths of 68 m (224 ft) by October 1981, 115 m (379 ft) by September 1983, 124 m (406 ft) by August 1985, and 137 m (450 ft) by September 1987. This sequence of deterioration is shown by the aerial photographs in Figure 6 (the solid horizontal line on the figure is a common line of reference).

Figure 6. Yaquina Bay north jetty history from aerial photographs, 1977-1992

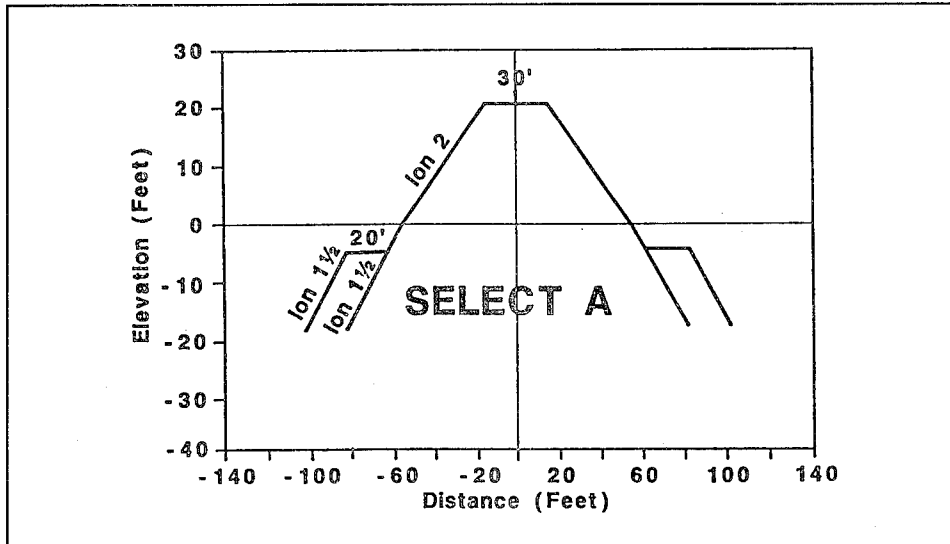
Figure 7 shows the nominal design cross section for rehabilitation of the seawardmost 30 m (100 ft) of the north jetty. The key differences of this design from the 1978 repair were elimination of the class "A" stone core and an increase in the size of the select class "A" armor stone. Thus, the entire end cross section of the jetty was constructed of select class "A" stone having an average weight of 29.5 tonnes (32.5 tons) with a minimum weight specified as 26.9 tonnes (29.7 tons). In addition, a 6-m-wide (20-ft-wide) bench was now included on both sides of the jetty. Behind the select class "A" stone repair section, the next 30-m (100-ft) repair length was armored using class "A" stone with an average weight of 23.4 tonnes (25.8 tons) (minimum 18.7 tonnes (20.6 tons)). The landwardmost portion of the rehabilitation was performed using class "B" stone having an average weight of 16.3 tonnes (18.0 tons) (minimum 12.2 tonnes (13.5 tons)). Details of the 1988 rehabilitation plan are shown on Figure 8. (Note that jetty stations given on Figure 8 do not correspond to jetty stations as labeled for this monitoring study.)

Figure 7. Yaquina Bay north jetty cross section, 1988 rehabilitation

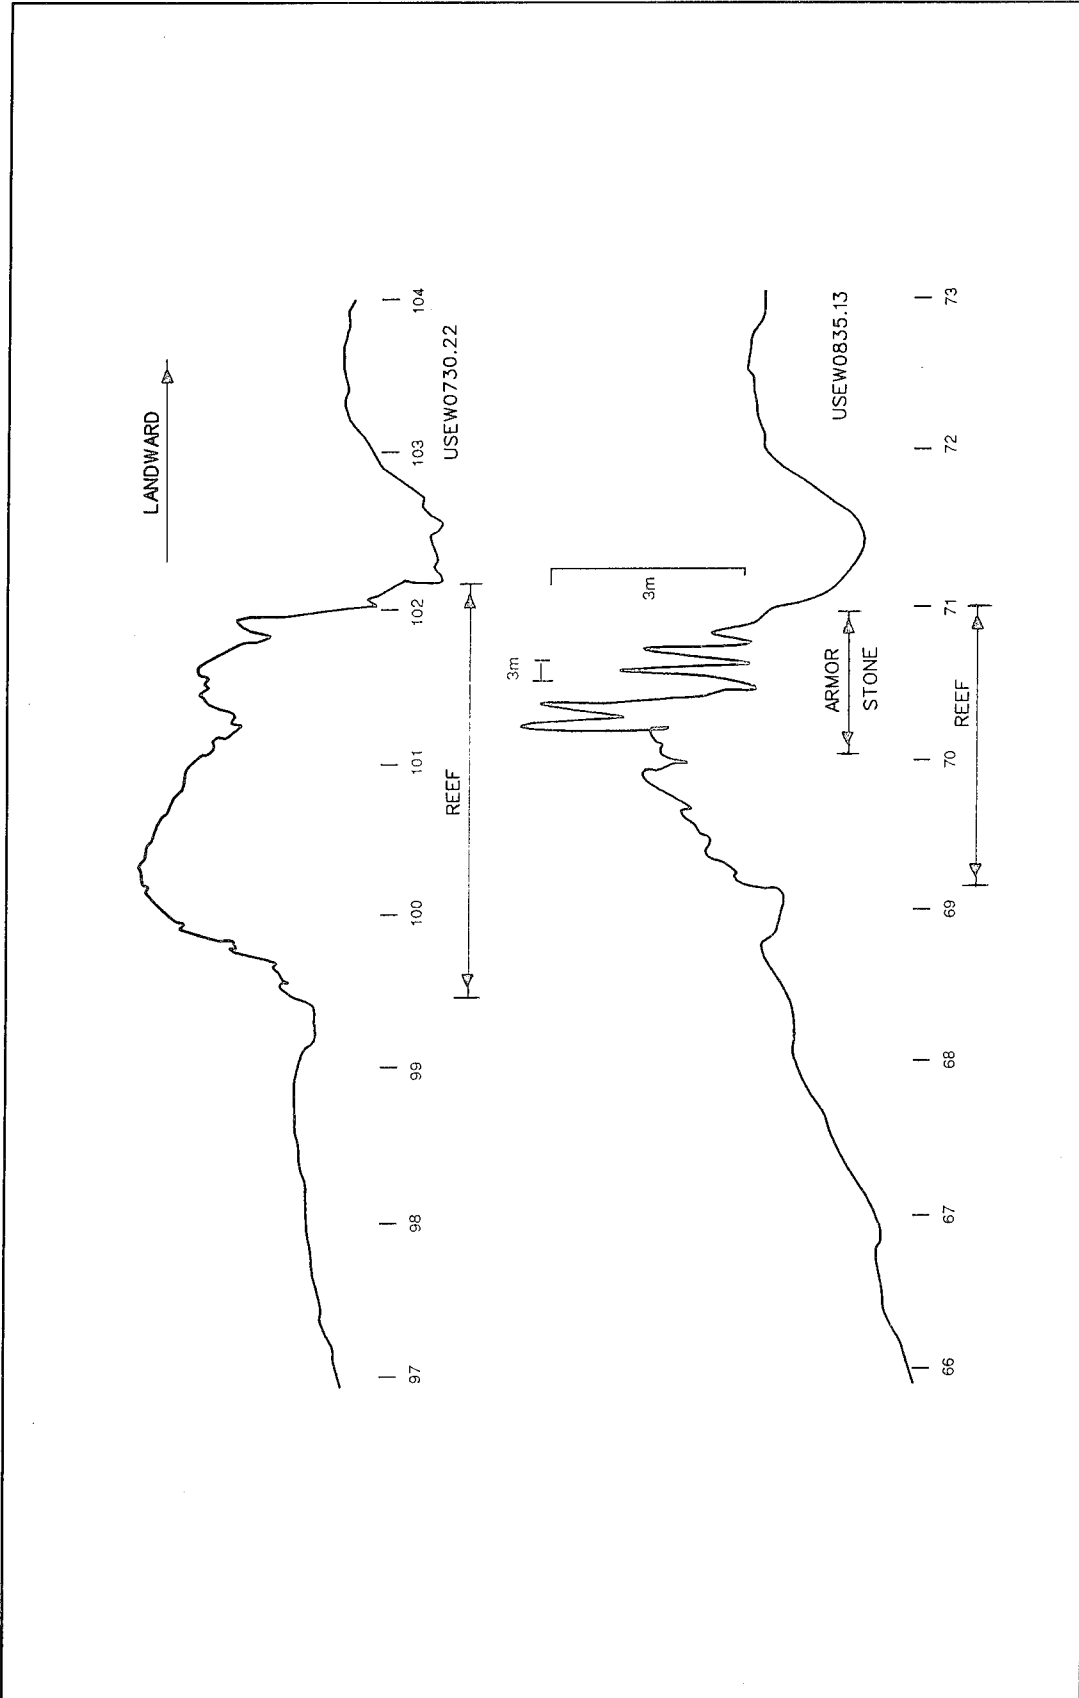
Aided by the side-scan sonar record shown in Figure 27, the bottom echo-sounder trace of Figure 26 was interpreted to be a section of the Yaquina Reef with jetty armor stones resting on the reef, whereas the top trace of Figure 26 shows a section of the Yaquina Reef without jetty stones. The noticeable dip

Figure 26. Examples of echo sounder traces transecting the Yaquina Reef

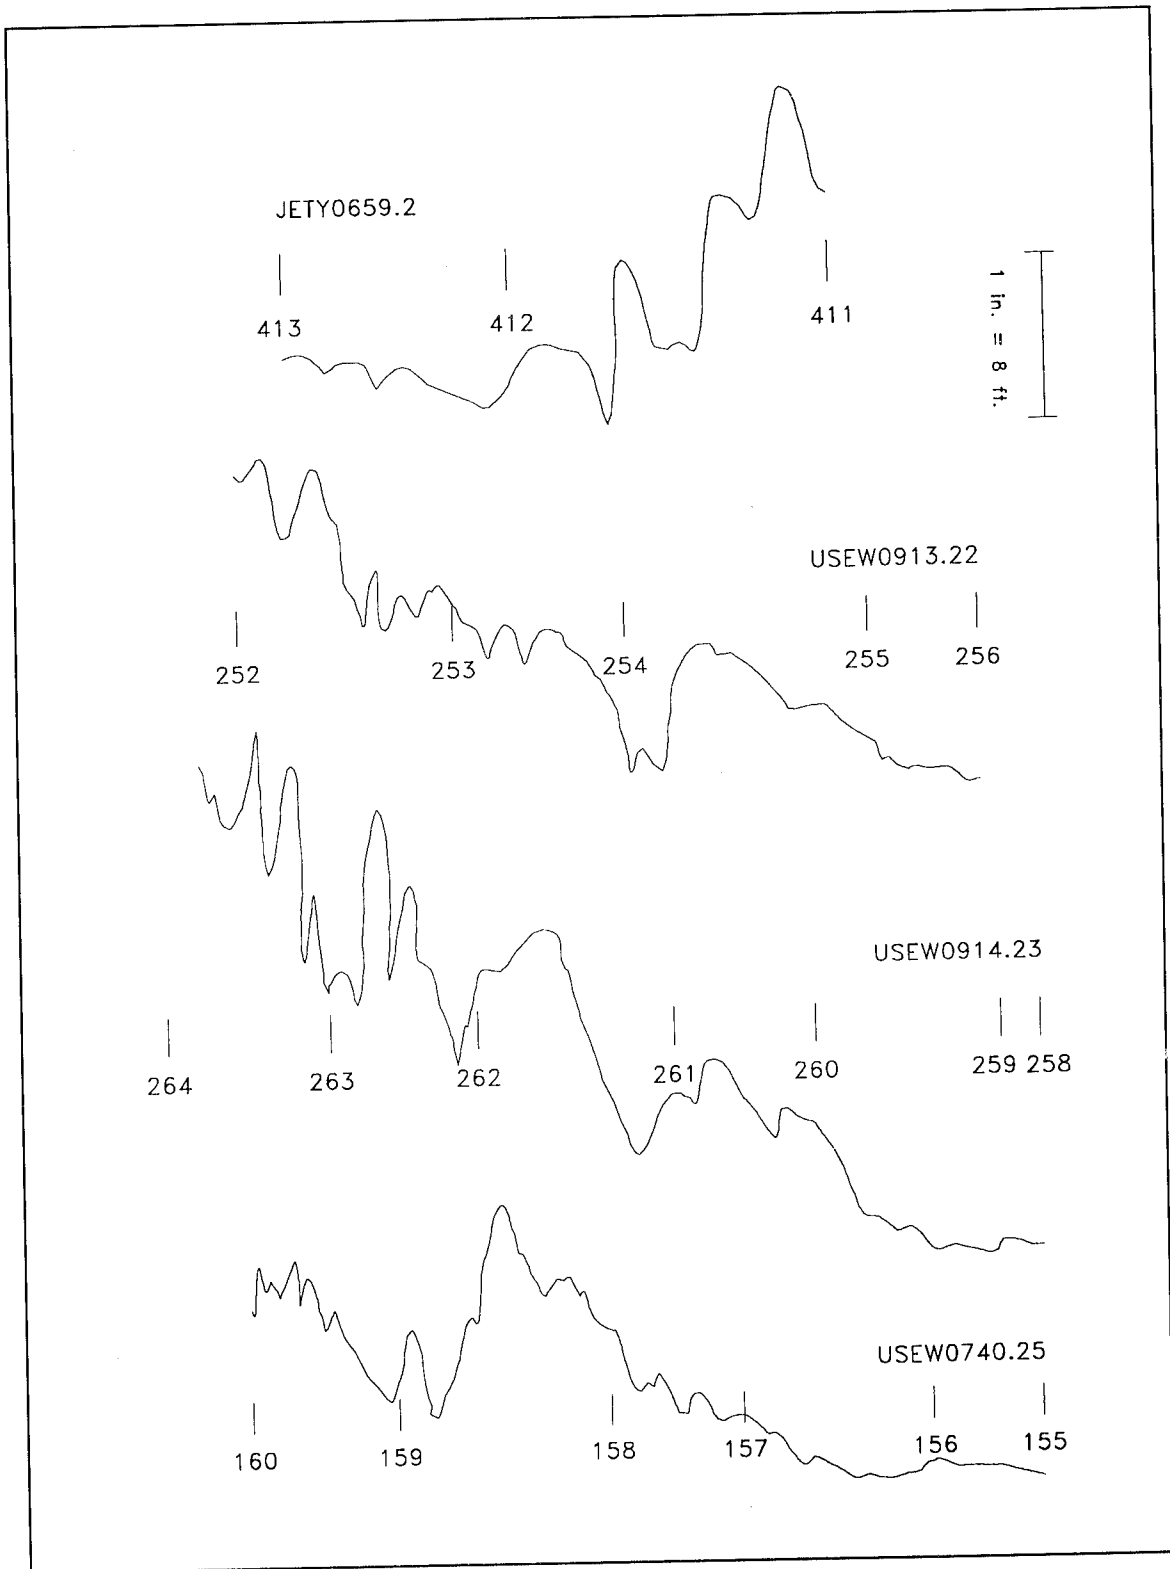
The bathymetric profile for track line JETY0659.2 shown on Figure 34 is relatively smooth, and the large roughness elements are generally wider in the horizontal and shorter in the vertical than those of individual jetty stones. The

Figure 34. Echo sounder profiles for "west side of jetty" region

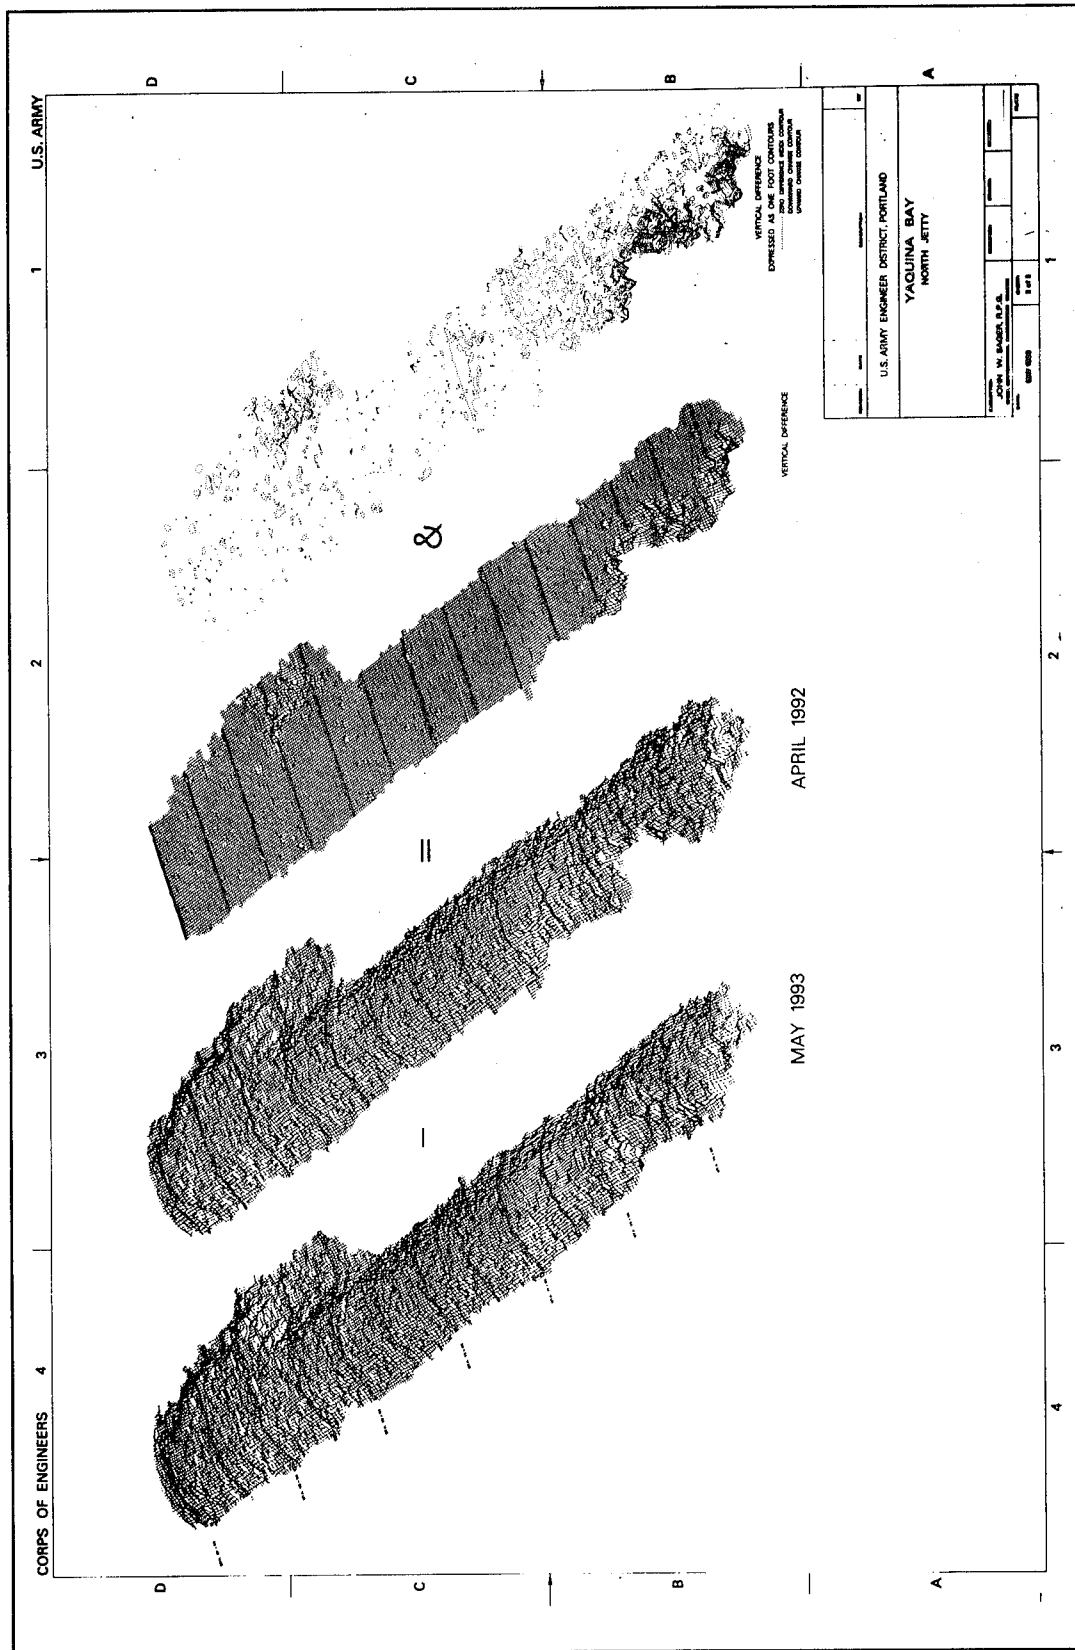
Figure 53. Yaquina Bay north jetty stone loss between 1992 and 1993

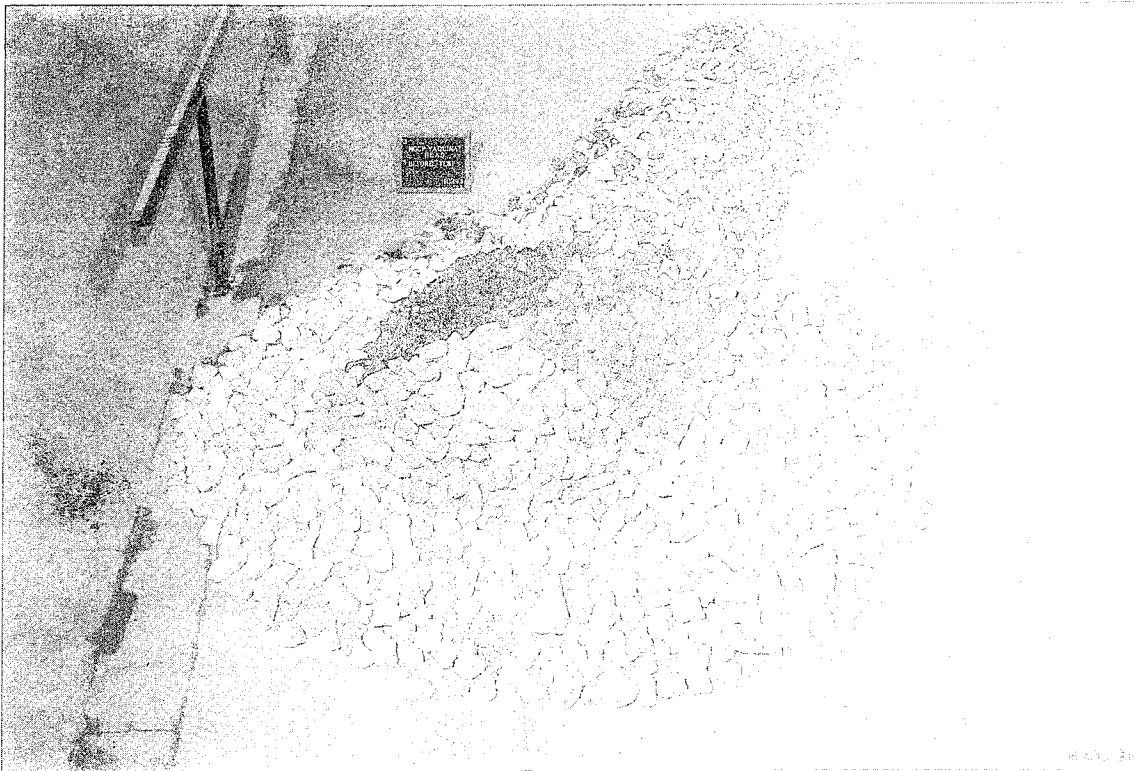
Figure 65 shows the reconstructed Yaquina Bay north jetty head prior to testing. The armor stones in different shaded regions of the structure had been painted so that damage would be easier to spot. Figure 66 shows the condition of the jetty head at the end of Test 6. Although it is difficult to see in the photograph, the armor underlayer had been exposed in an area that

Figure 65. Wave/current stability model prior to Test 6

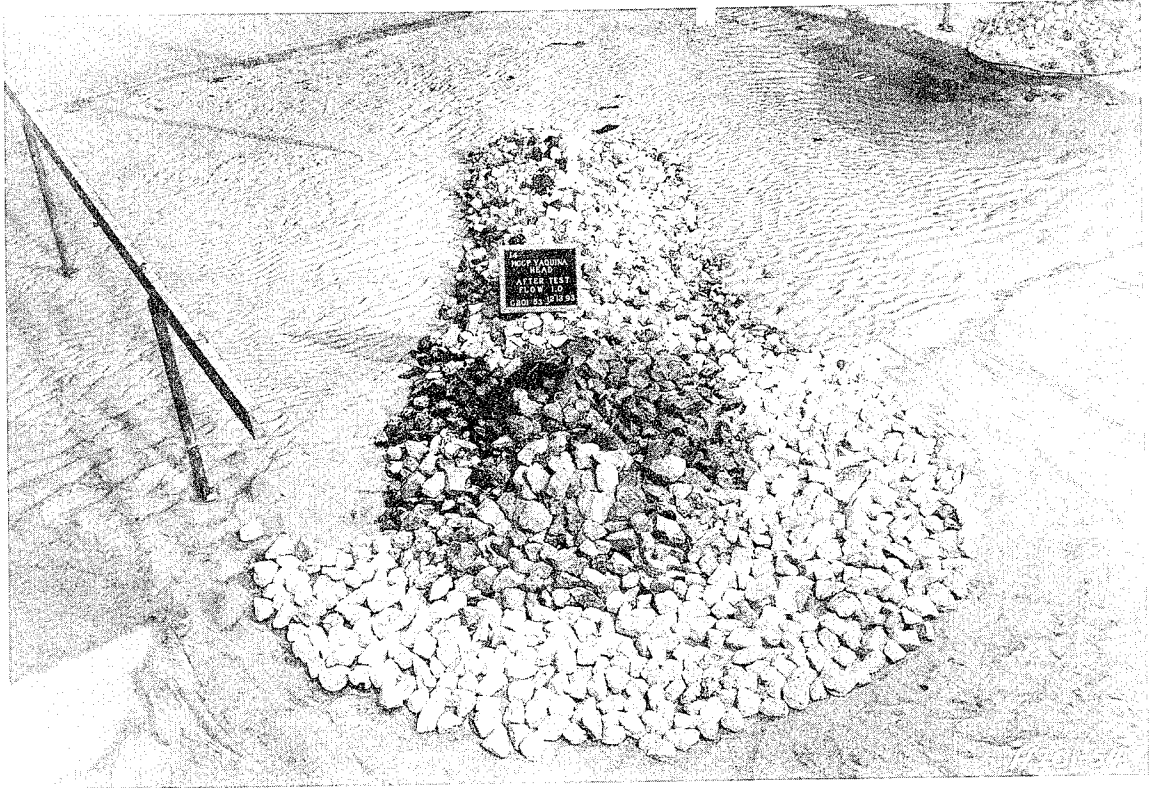
Figure 66. Wave/current stability model showing damage after Test 6
