1. AGENCY USE ONLY (Leave blank)		2. REPORT DATE 04/00/86	3. REPORT TYPE AND DATES COVERED	
4. TITLE AND SUBTITLE PHASE I OF ROCKY MOUNTAIN ARSENAL SEWER INVESTIGATIONS, INTERIM REPORT			5. FUNDING NUMBERS

INTERIM REPORT:  
PHASE I OF ROCKY MOUNTAIN ARSENAL  
SEWER INVESTIGATIONS

Prepared by  
Morrison-Knudsen Engineers, Inc.  
Denver, Colorado 80290

April, 1986

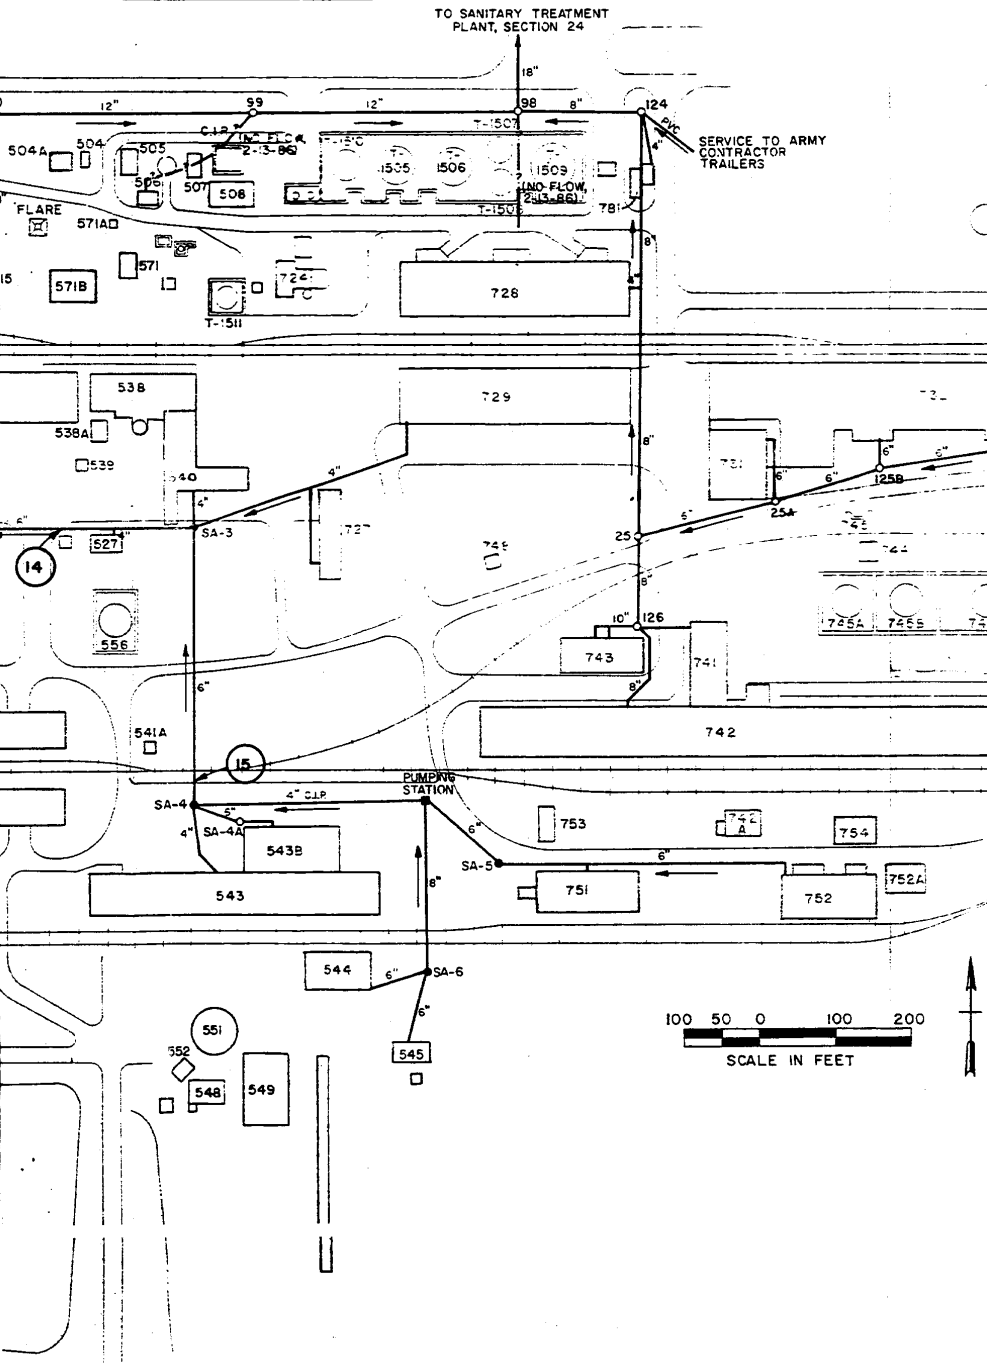
**ROCKY MOUNTAIN SEWER INVEST**  
FIGURE 3.7 SAMPLING AND INVESTIGATION SITES, EAS PLANTS SANITARY SEWER

The segments of the RMA sewer systems that were air pressure tested are shown on Figures 3.6, 3.7 and 3.8. All test sites failed to pressurize when air was introduced into the line. The conclusion was reached in the field that further air testing would not produce results that would enable the investigators to distinguish between the relative condition of the various sites tested, and therefore the air testing was halted and the investigating team proceeded with jet cleaning and televising of the lines. Refer to Appendix B for the Air Testing Standard Operating Procedure.
