NASA Technical Memorandum 83786

# Fracture Surface Characteristics of Notched Angleplyed Graphite/Epoxy Composites

Carol A. Ginty and Thomas B. Irvine  
*Lewis Research Center  
Cleveland, Ohio*

Prepared for the  
International Symposium—Composites: Materials and Engineering  
sponsored by the Center for Composite Materials, The University  
of Delaware  
Newark, Delaware, September 24-28, 1984

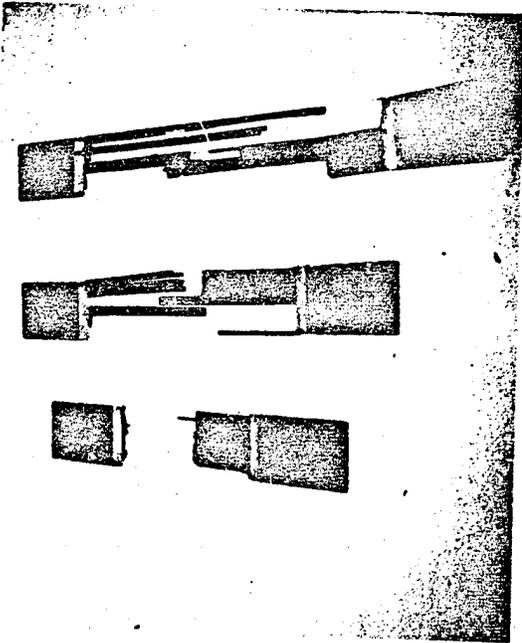
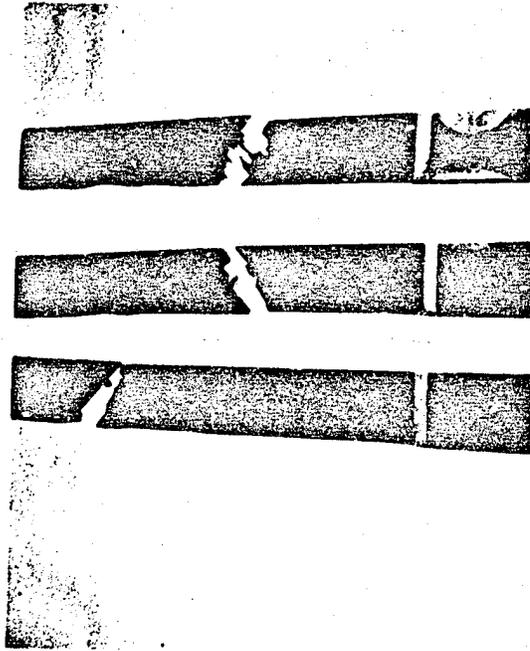
Uniaxial tension testing of the specimens was conducted in an incremental load-to-fracture manner using a 50 kip load frame with a prescribed load increment size. Fracture was catastrophic for the lower angle ( $0^\circ$  to  $15^\circ$ ) G/E specimens leaving very little of the composite intact (fig. 1(a)). The remaining angleplied specimens ( $30^\circ$  to  $90^\circ$ ) exhibited a brittle fracture process that produced puzzle-like pieces of the composite as the specimens broke apart (fig. 1(b)). Table I lists the fracture loads of the solid and notched specimens for each laminate configuration in the series.

Figure 1. - Fractured G/E specimens from left to right -- solid, notch/slit and notch/hole.

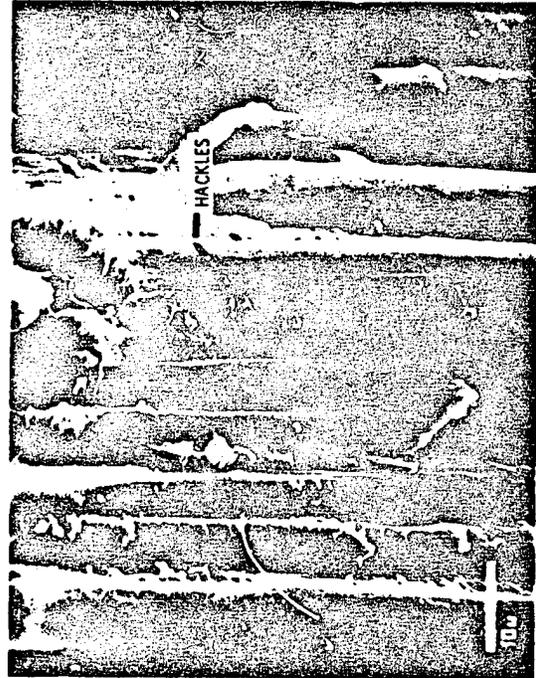
Irregular fracture surface and fiber pull-out are still the outstanding microstructural characteristics for the  $[\pm 10]_S$  laminate exhibited in figure 5(a). The photomicrograph in figure 5(b), however, reveals a cluster of fibers with relatively clean surfaces breaking at approximately the same place indicating a combination of longitudinal tensile and intraply shear modes respectively. Figures 5(b) and (c) show matrix hackles appearing in an established pattern between the fibers instead of the random occurrence which was previously observed.

Figure 5. - The fracture surface of the notch/slit ( $\pm 10$ ) $\mu$ s G-E laminate revealing matrix hackles between the fibers.

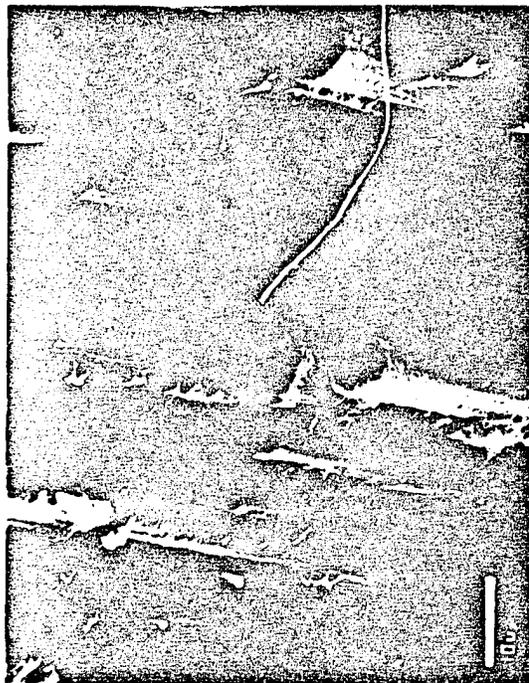
Photomicrographs of the  $[\pm 15]_S$  laminate fracture surface are presented in figure 6. The irregular surface (fig. 6(a)) and the clean fibers along with the fiber pull-out (fig. 6(b)) indicate a longitudinal tensile fracture mode. Figure 6(c) reveals not only an abundance of matrix hackles but also matrix debris on the surfaces of the fibers which are now forming a level surface, indicative of an intraply shear fracture mode.

Figure 6. - Photomicrographs revealing the microstructure of the [±15]s G/E fracture surface. Longitudinal tensile and intraply shear fracture modes are characterized by the fiber fracture and matrix hackles respectively.

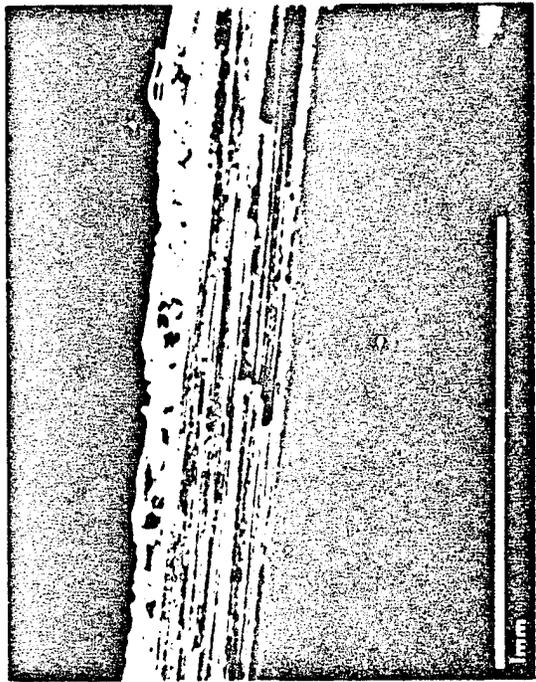
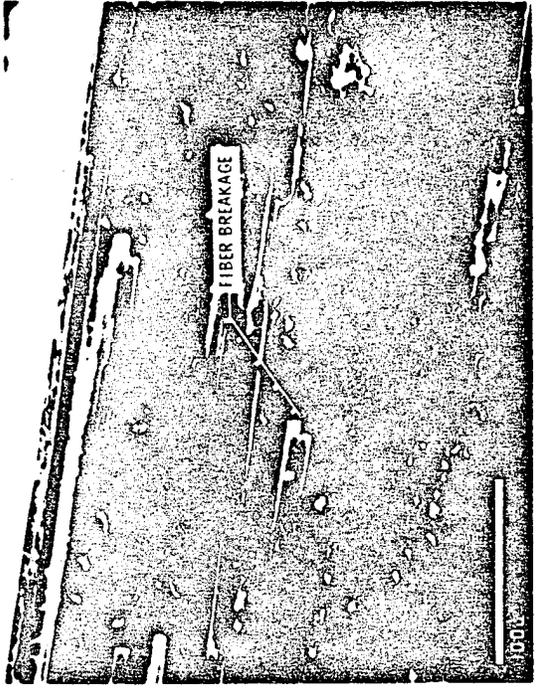
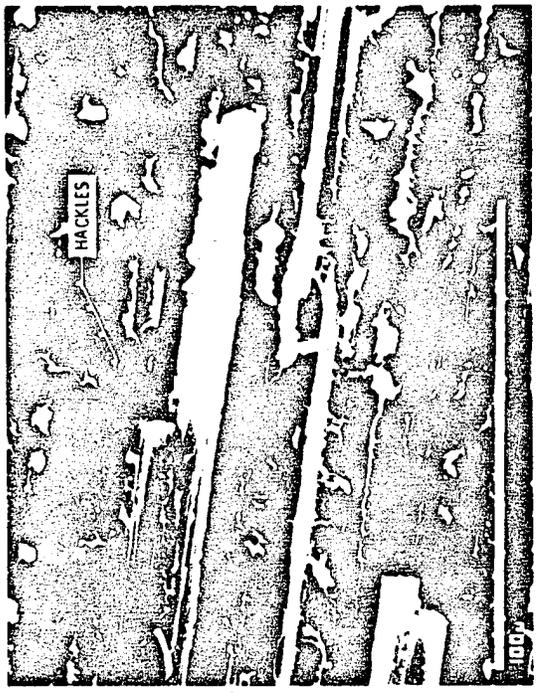
The fracture surface of the  $[\pm 60]_5$  G/E laminate in figure 9(a) is entirely flat with no sign of fiber pull-out. Some fiber breakage (fig. 9(b)) did occur but in the transverse direction. These microstructural characteristics are indicative of a transverse tensile fracture mode. The extensive presence of matrix hackles exhibited in figure 9(c) represents the intraply shear fracture mode which also induces final fracture in this laminate.

Figure 9. - Fracture surface characteristics of the [L<sub>4</sub>60] s G/E laminate. The flat surface is indicative of a transverse tensile mode of fracture.

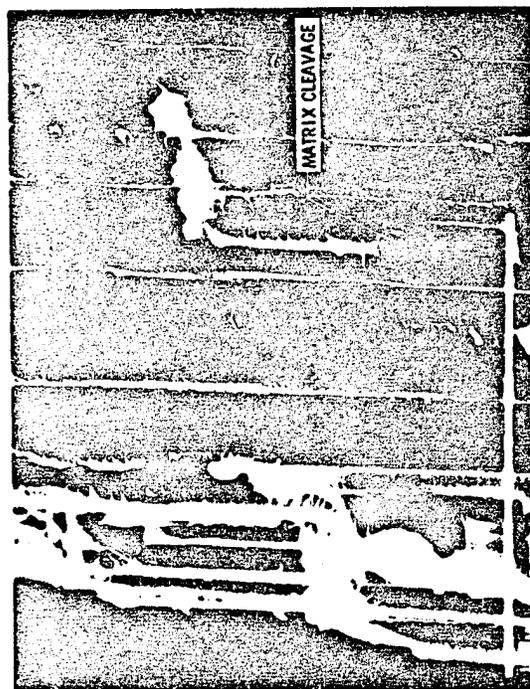
More fiber breakage occurring in the transverse direction on the flat fracture surface of the  $[\pm 75]_5$  laminate is shown in figures 10(a) and (b). A new characteristic, matrix cleavage, was observed on this surface and is illustrated in figure 10(c). Matrix cleavage resembles a cutting or hollowing-out of the matrix between relatively clean fibers. The microstructural characteristics of this laminate are the result of a transverse tensile fracture mode.

Figure 10. - In addition to the flat features, the [110]s G/E fracture surface consists of fiber fracture and matrix cleavage.

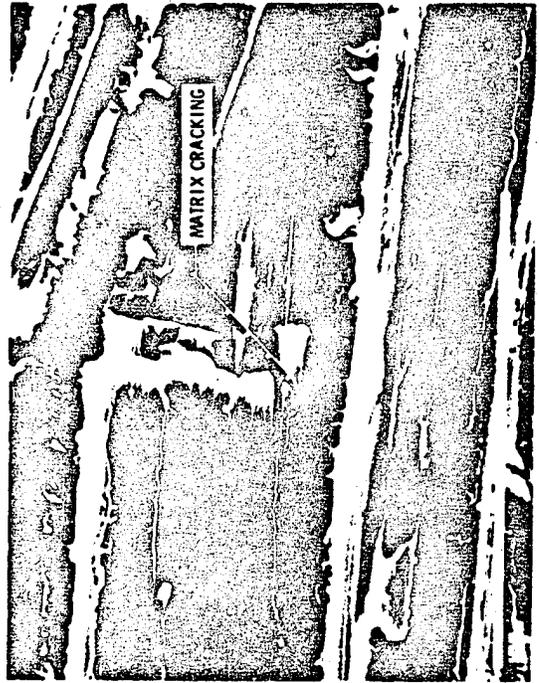
The final fracture surface to be examined is that of the  $[90]_4$  G/E laminate presented in figure 11. The flat fracture surface reveals some fiber breakage in figure 11(a). With the occurrence of extensive matrix cracking, the specimen is beginning to fall apart (fig. 11(b)). Magnification of the specimen's edge exposes the matrix cracking and cleavage which causes the fracture due to a transverse tensile fracture mode.

Figure 11. - The fracture surface of the notch is [90] G/E laminate consists of considerable matrix cleavage and cracking.

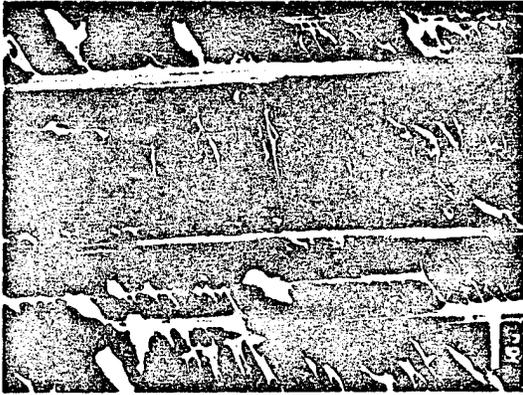
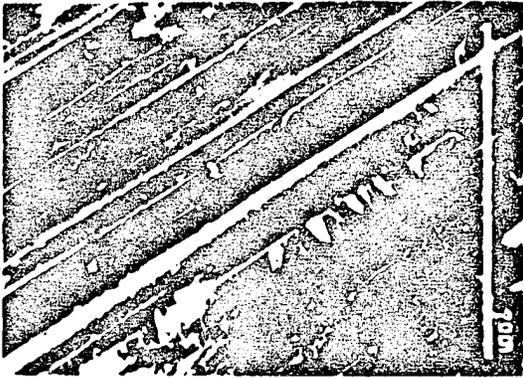
Through the microscopic analysis, it was revealed that neither the presence of a defect nor the type of defect had any effect on the fracture surface microstructural characteristics and thereby the fracture modes. This is illustrated in figure 13 for the unidirectional laminate and in figure 14 for the more complex fracture process of the  $[\pm 45]_s$  angleply laminate. As can be seen, the microstructural characteristics are identical for the solid and notched specimens for each laminate. This phenomenon was also present in the CODSTRAN predictions which are listed in table IV. Results for the unidirectional and  $[\pm 45]_s$  laminates, as well as all the other laminates, indicate that neither the presence of a defect nor the type of defect affect the primary mode of fracture in these G/E  $[\pm \theta]_s$  laminates. Therefore, use of the fracture surface of the notch/slit laminate to represent the microstructural characteristics of a particular laminate is valid.

Figure 14. - Fracture surface characteristics of the [± 45]s G/E laminate.
