Materials for Oxygenated Wastewater Treatment Plant Construction

(U.S.) Bureau of Reclamation, Denver, CO

July 1978

1. REPORT NO. EPA-600/2-78-136		2.		3. RECIPIENT'S ACCESSION NO.	
4. TITLE AND SUBTITLE MATERIALS FOR OXYGENATED WASTEWATER TREATMENT PLANT CONSTRUCTION				5. REPORT DATE July 1978 (Issuing Date)

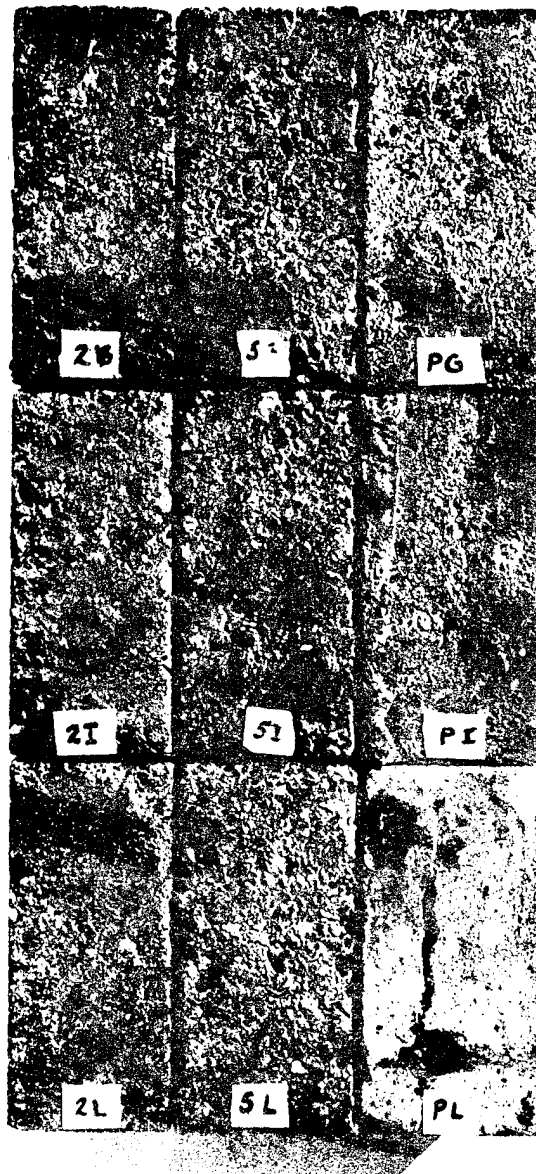
3. Surface conditions. - Generally, only minor changes in surface appearance have occurred at sites 1 and 2. At site 3, erosion of the surface was experienced as shown in figure 15.

a. Concrete made with Type V cement suffered the most severe erosion damage.

b. Less severe erosion damage was observed on concrete made using Type II cement.

Figure 15. - Concrete prisms exposed at site 3 for 28 months depict the damage due to surface abrasion. Prefix of specimen code denotes concrete type, i.e., 2-Type II, 5-Type V, and P-PIC; suffix indicates exposure, i.e., G-gas, I-interface, L-liquor.

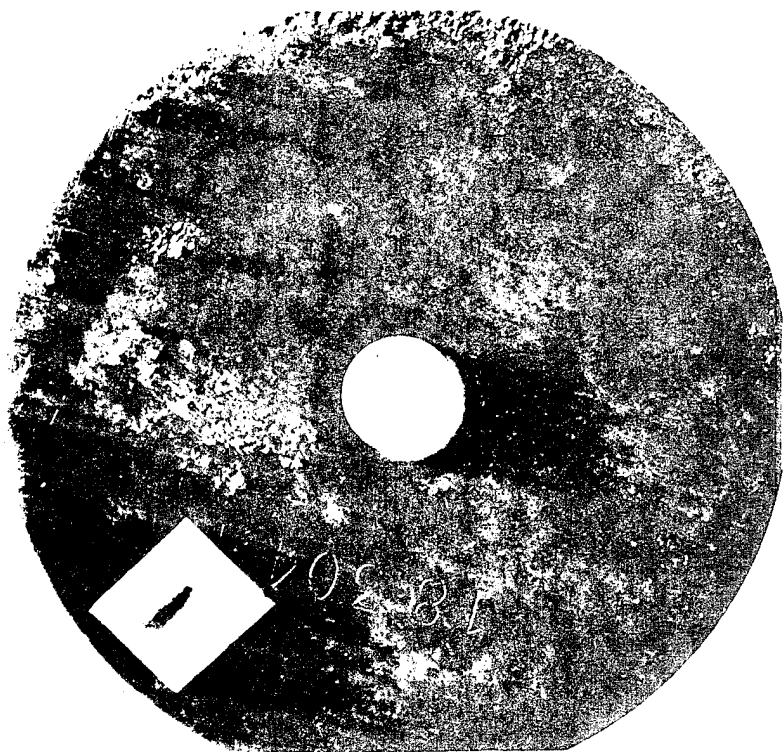
Figure 16. Sensitized Type 304 stainless steel specimen exposed in the gas zone at site 1 for 22 months. Note pitting due to sensitization.

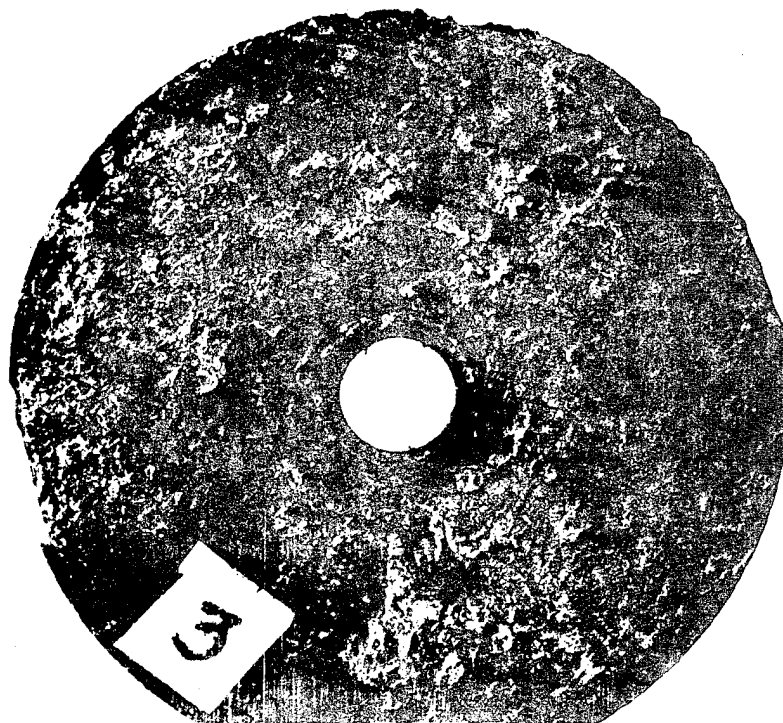
Figure 17. Mild steel specimen exposed in the gas zone at site 2 for 28 months. Surface is deeply pitted.

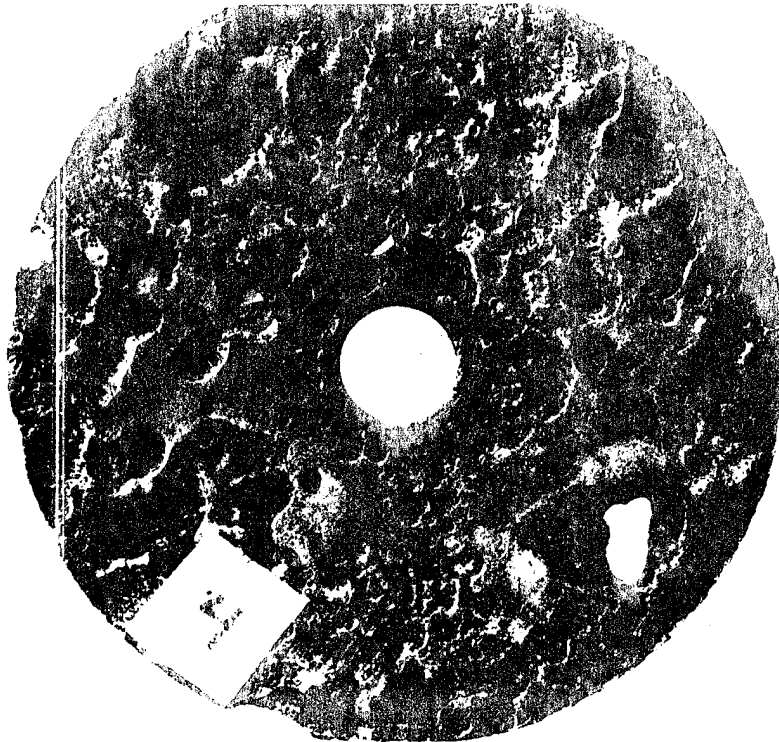
Figure 18. Low alloy steel specimen exposed in the liquor at site 2 for 28 months. Specimen is perforated.

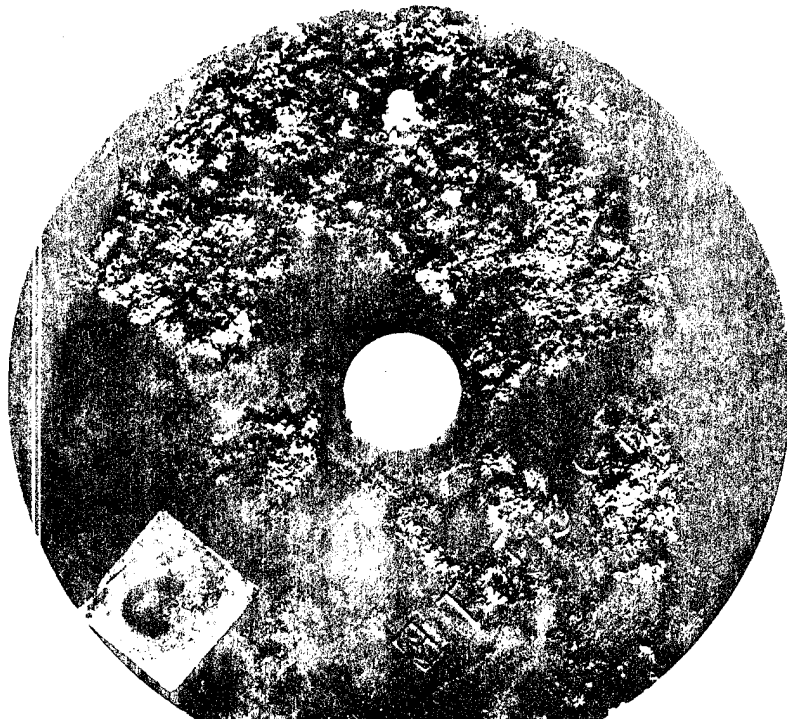
Figure 19. Aluminum alloy 6061 exposed in the gas zone at site 2 for 28 months. Sample is perforated.

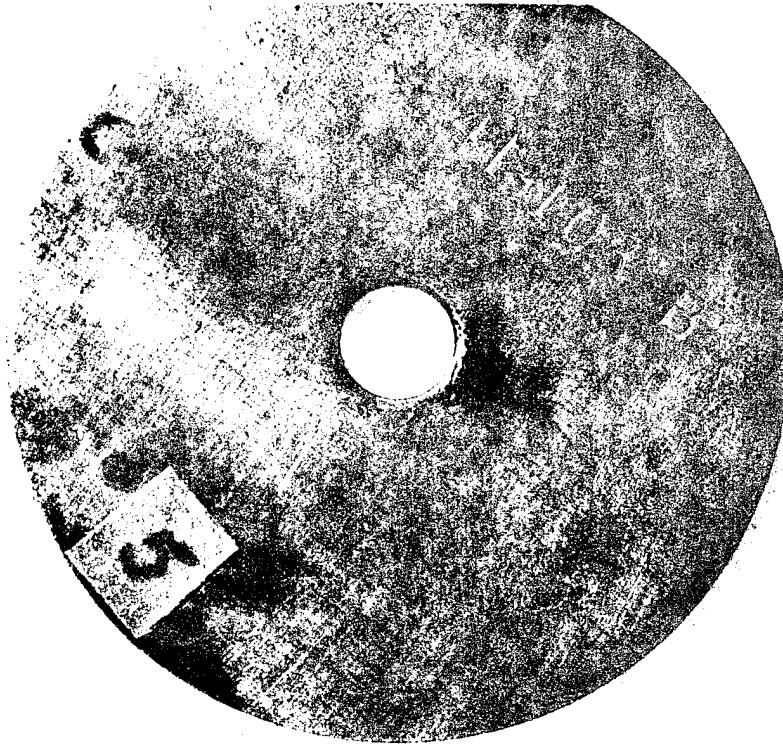
Figure 20. Copper specimen exposed in the gas zone at site 2 for 28 months. Sample is pitted in one localized area only.

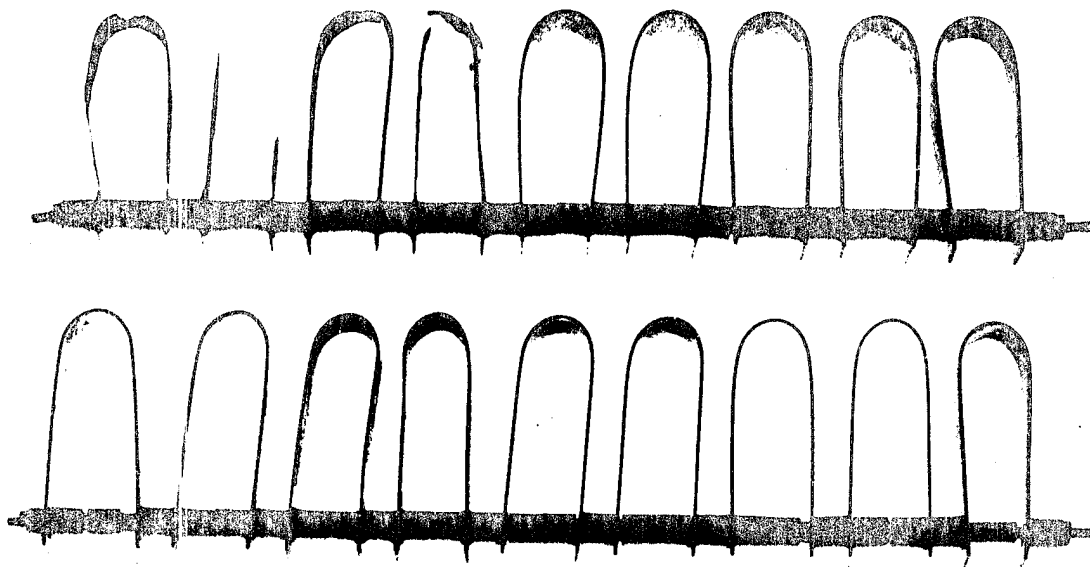
Figure 23. - Duplicate mild steel (first two samples, top row) and low alloy steel (second two samples, top row) stressed specimens failed after 28 months' exposure at the interface at site 3.

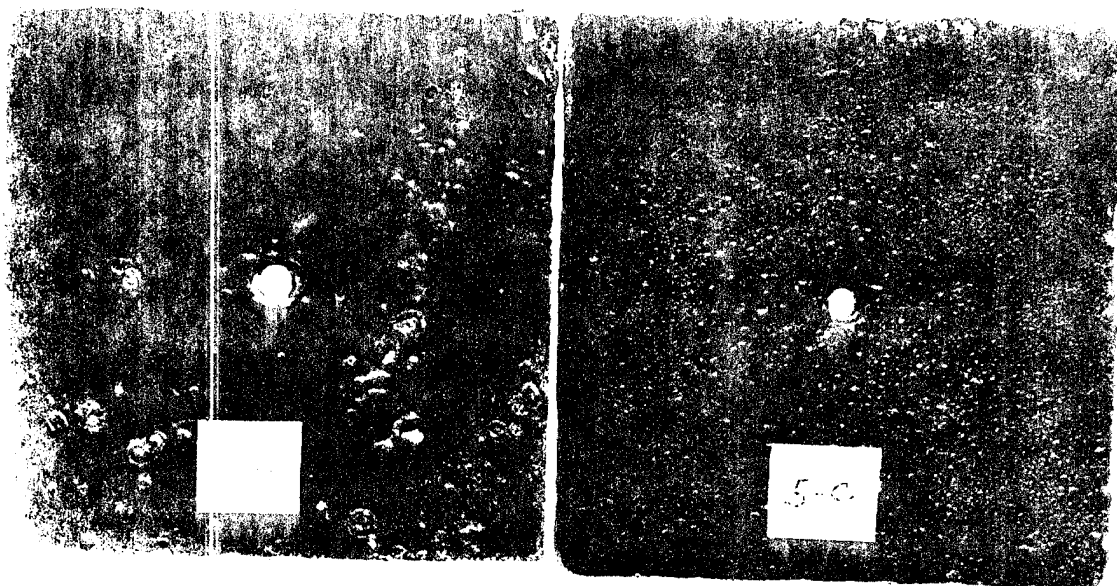
Figure 24. Blistering of proprietary butyl coating (No. C-6) on steel (left) and concrete substrates.

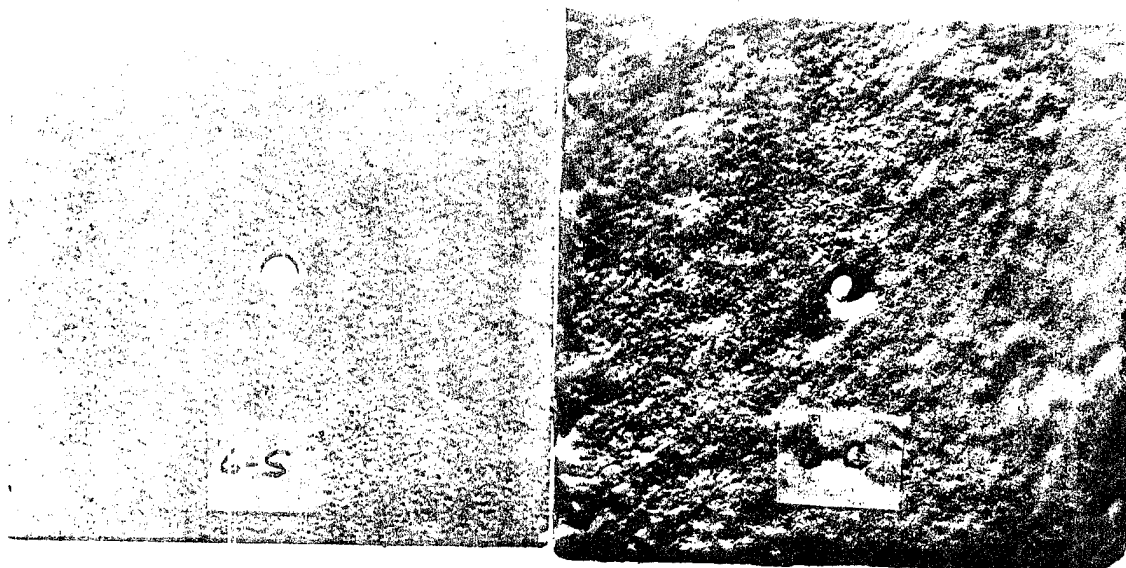
Figure 25. Defect-free proprietary urethane coating (No. C-9) on steel (left) and concrete substrates. Roughness is characteristic of application.

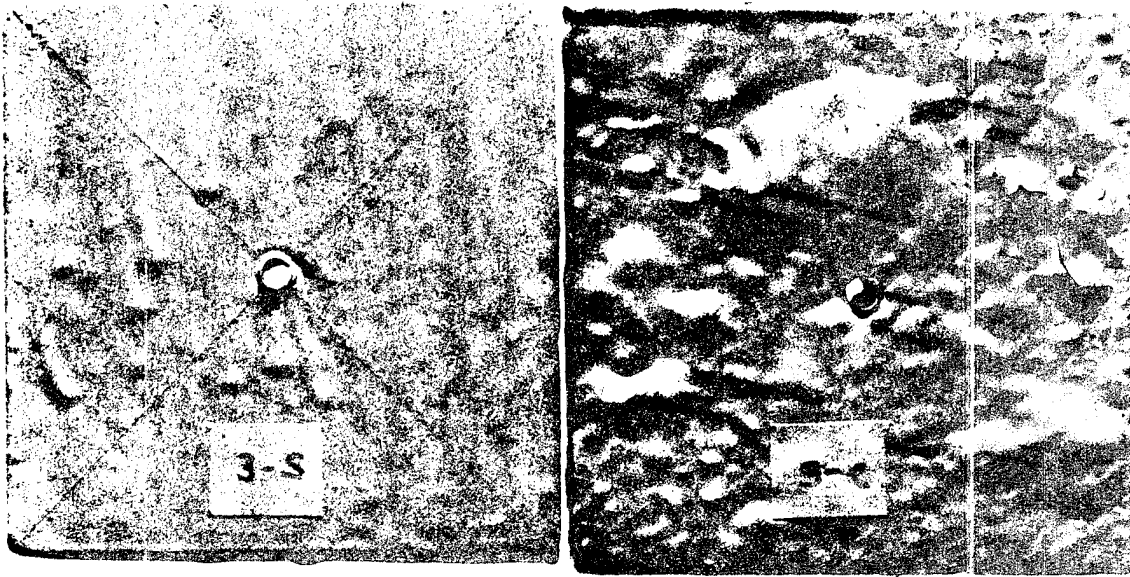
Figure 26. Blistering of proprietary, one-component urethane coating (No. C-13) on steel (left) and concrete substrates.

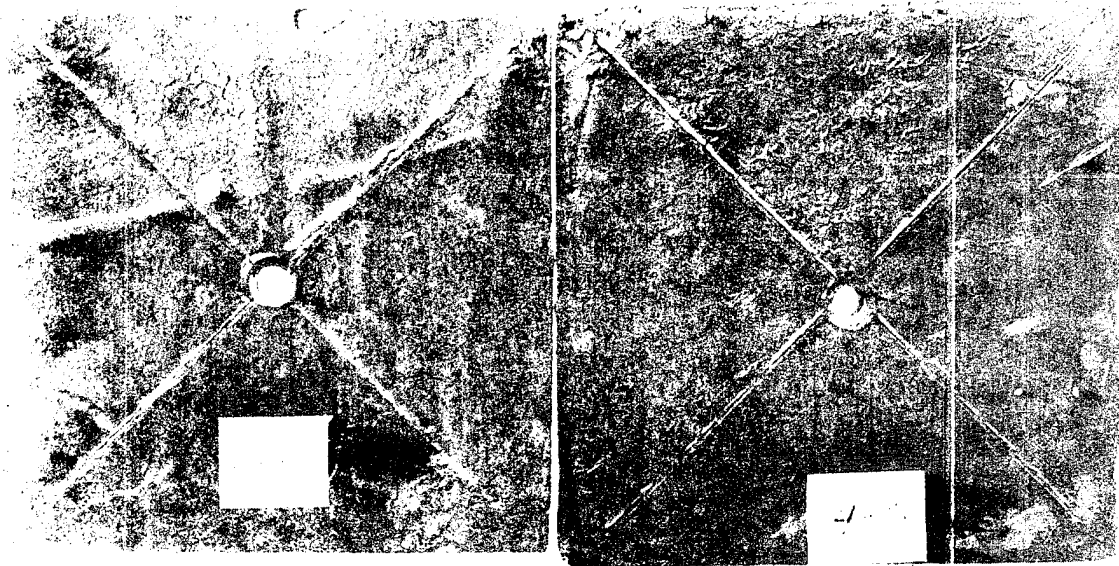
Figure 27. Cracking of coal-tar enamel coating (No. C-3) on steel (left) and on concrete substrates.

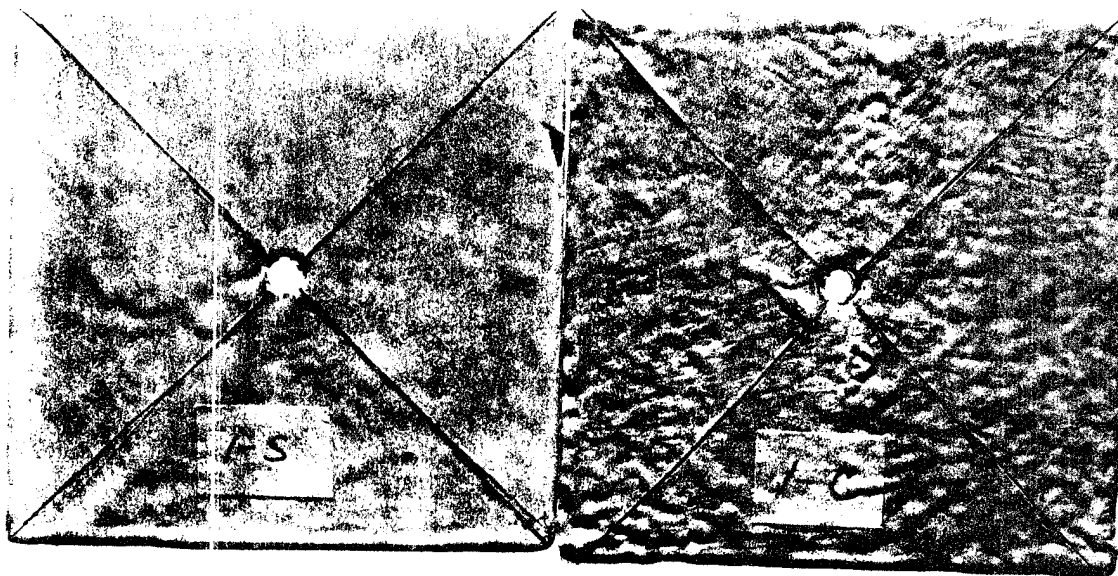
Figure 28. Defect-free phenolic-epoxy coating (No. C-12) on steel (left) and concrete substrates.

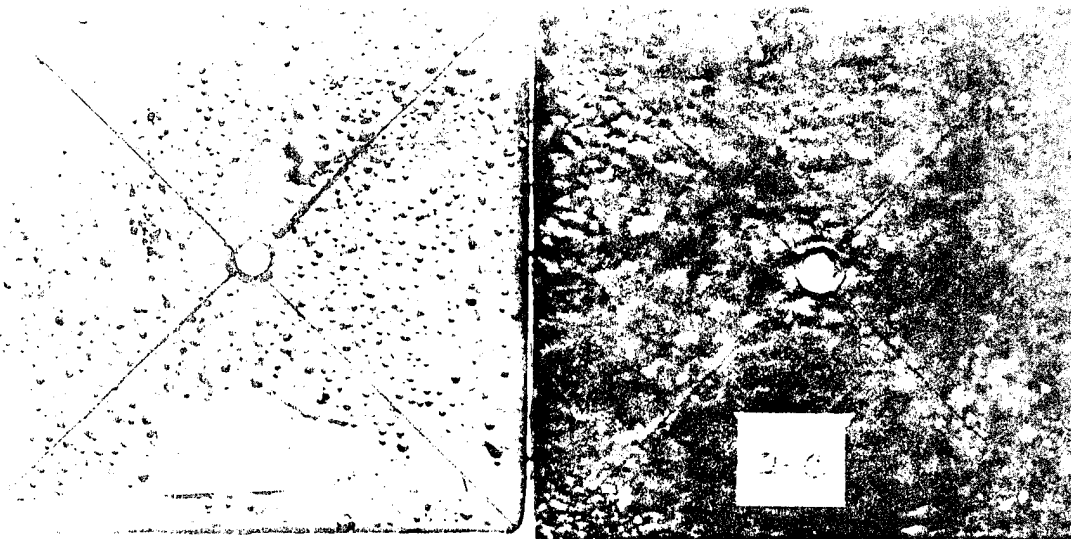
Figure 29. Severely blistered proprietary urethane coating (No. C-14) on steel (left) and concrete substrates.

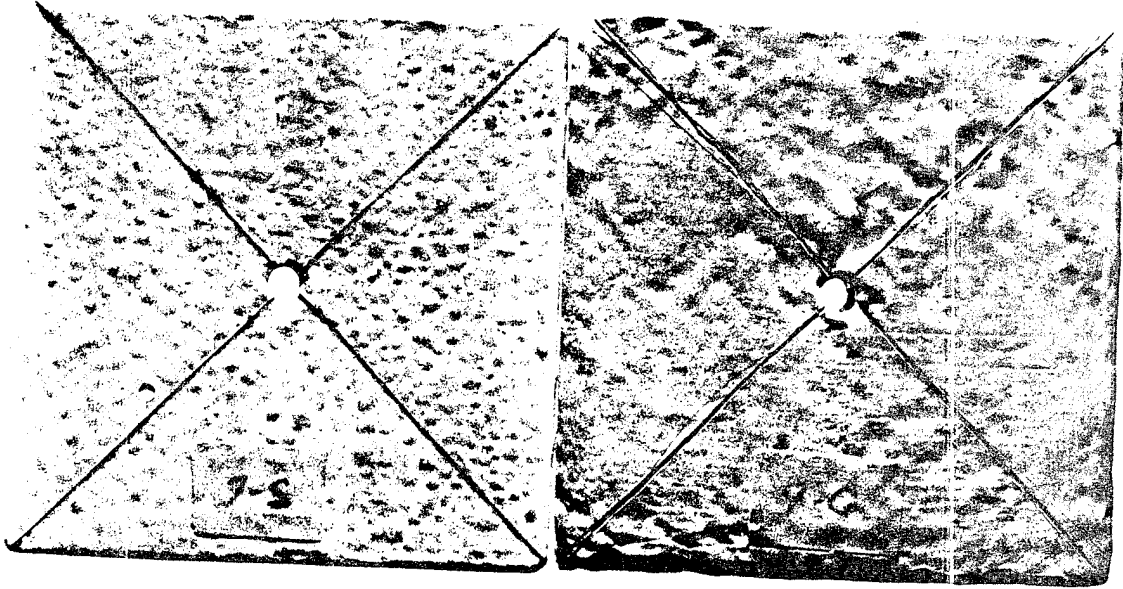
Figure 30. Blistering (topcoat only) of proprietary phenolic-epoxy coating (No. C-16) on steel (left) and concrete substrates.
