US Army Corps  
of Engineers  
Waterways Experiment  
Station

Miscellaneous Paper SL-96-1  
February 1996

## Forced Entry Testing of Five-Minute Walls

Prepared for U.S. Department of State,  
Office of Foreign Building Operations

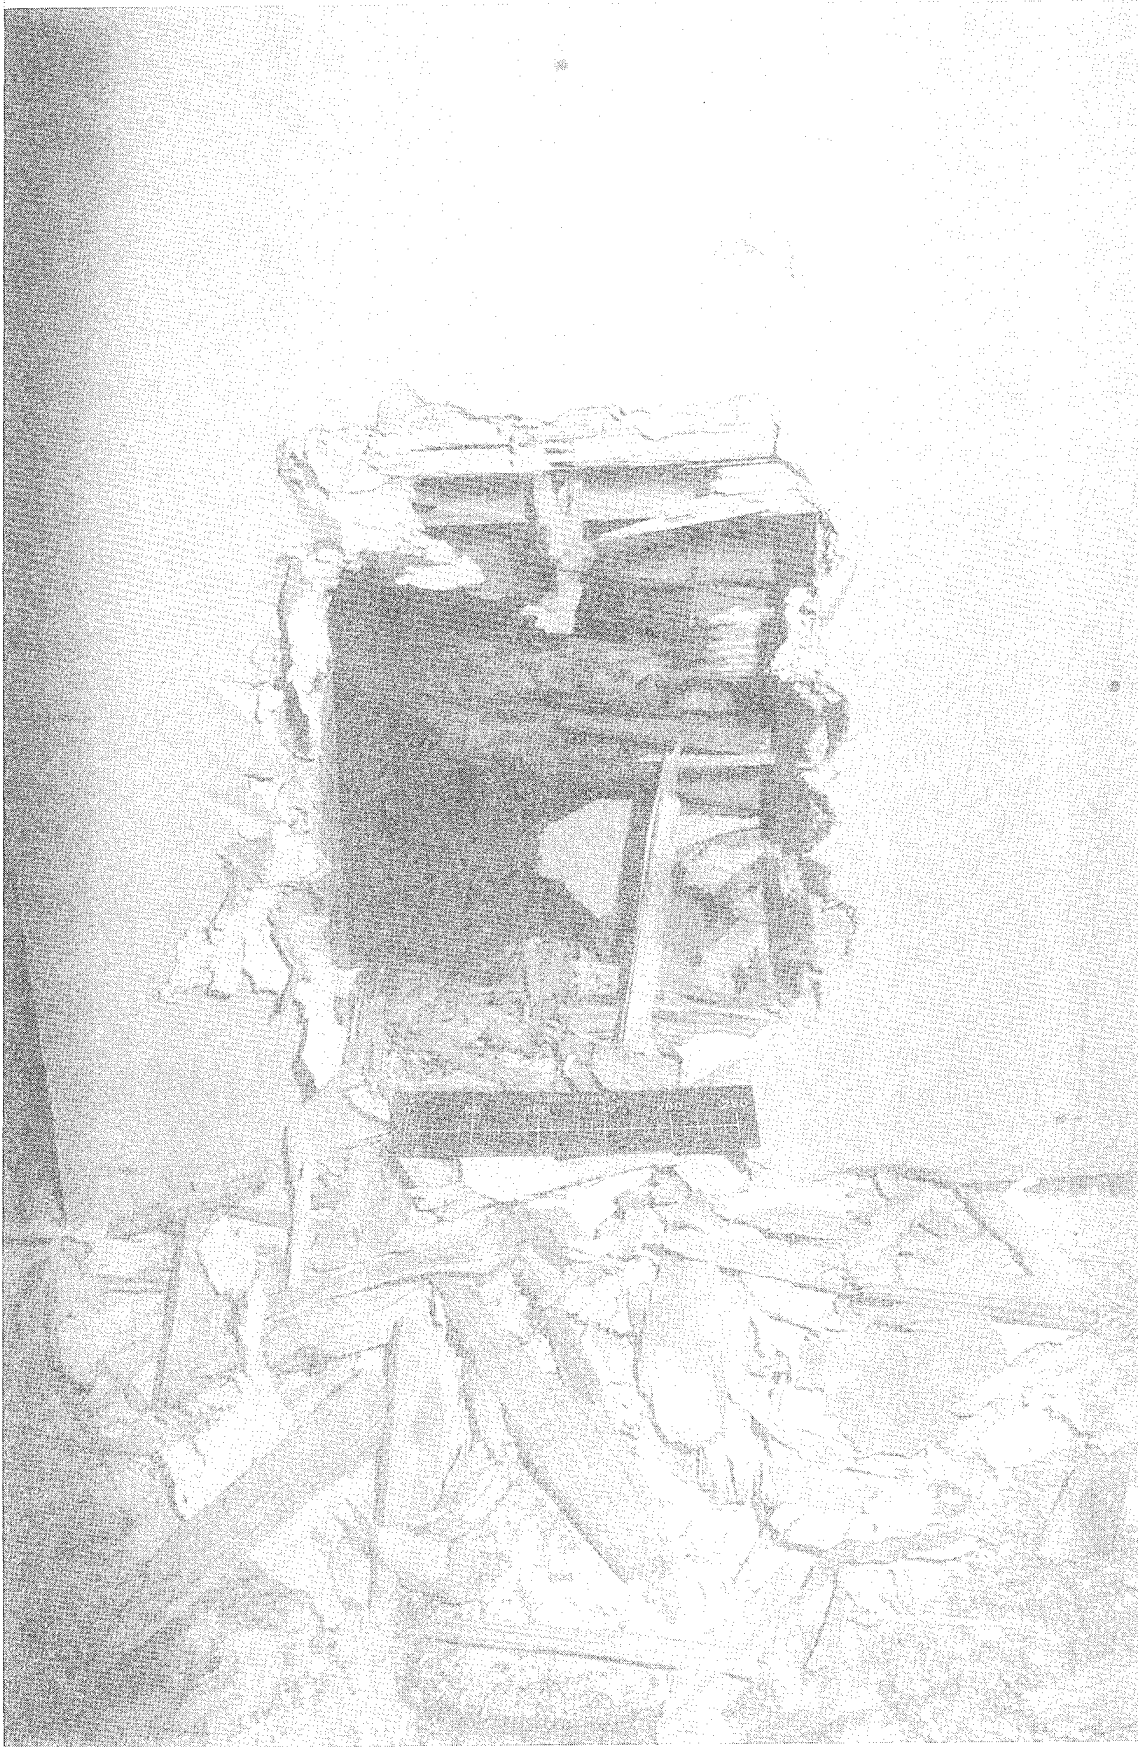
Figure 28. Assault side of panel XPK-05N-DOS-01 after test 1-1

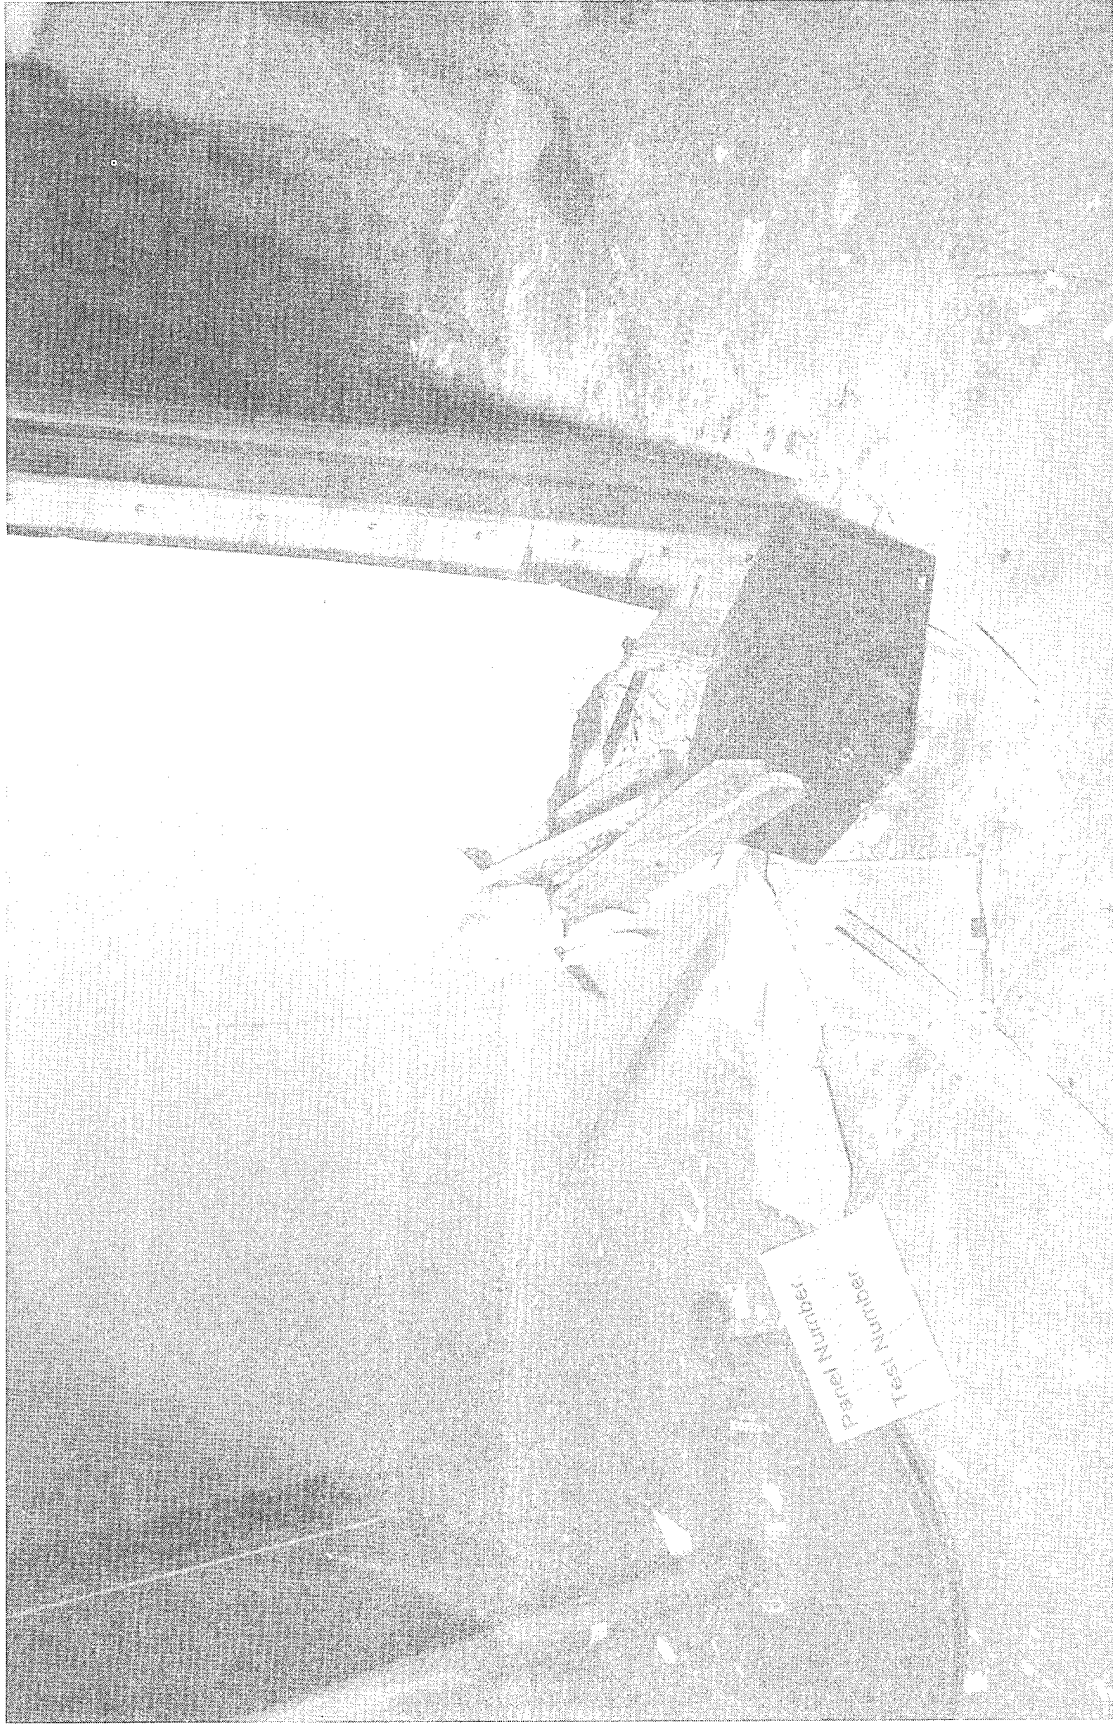
Figure 29. Protect side of panel XPK-05N-DOS-01 after test 1-1

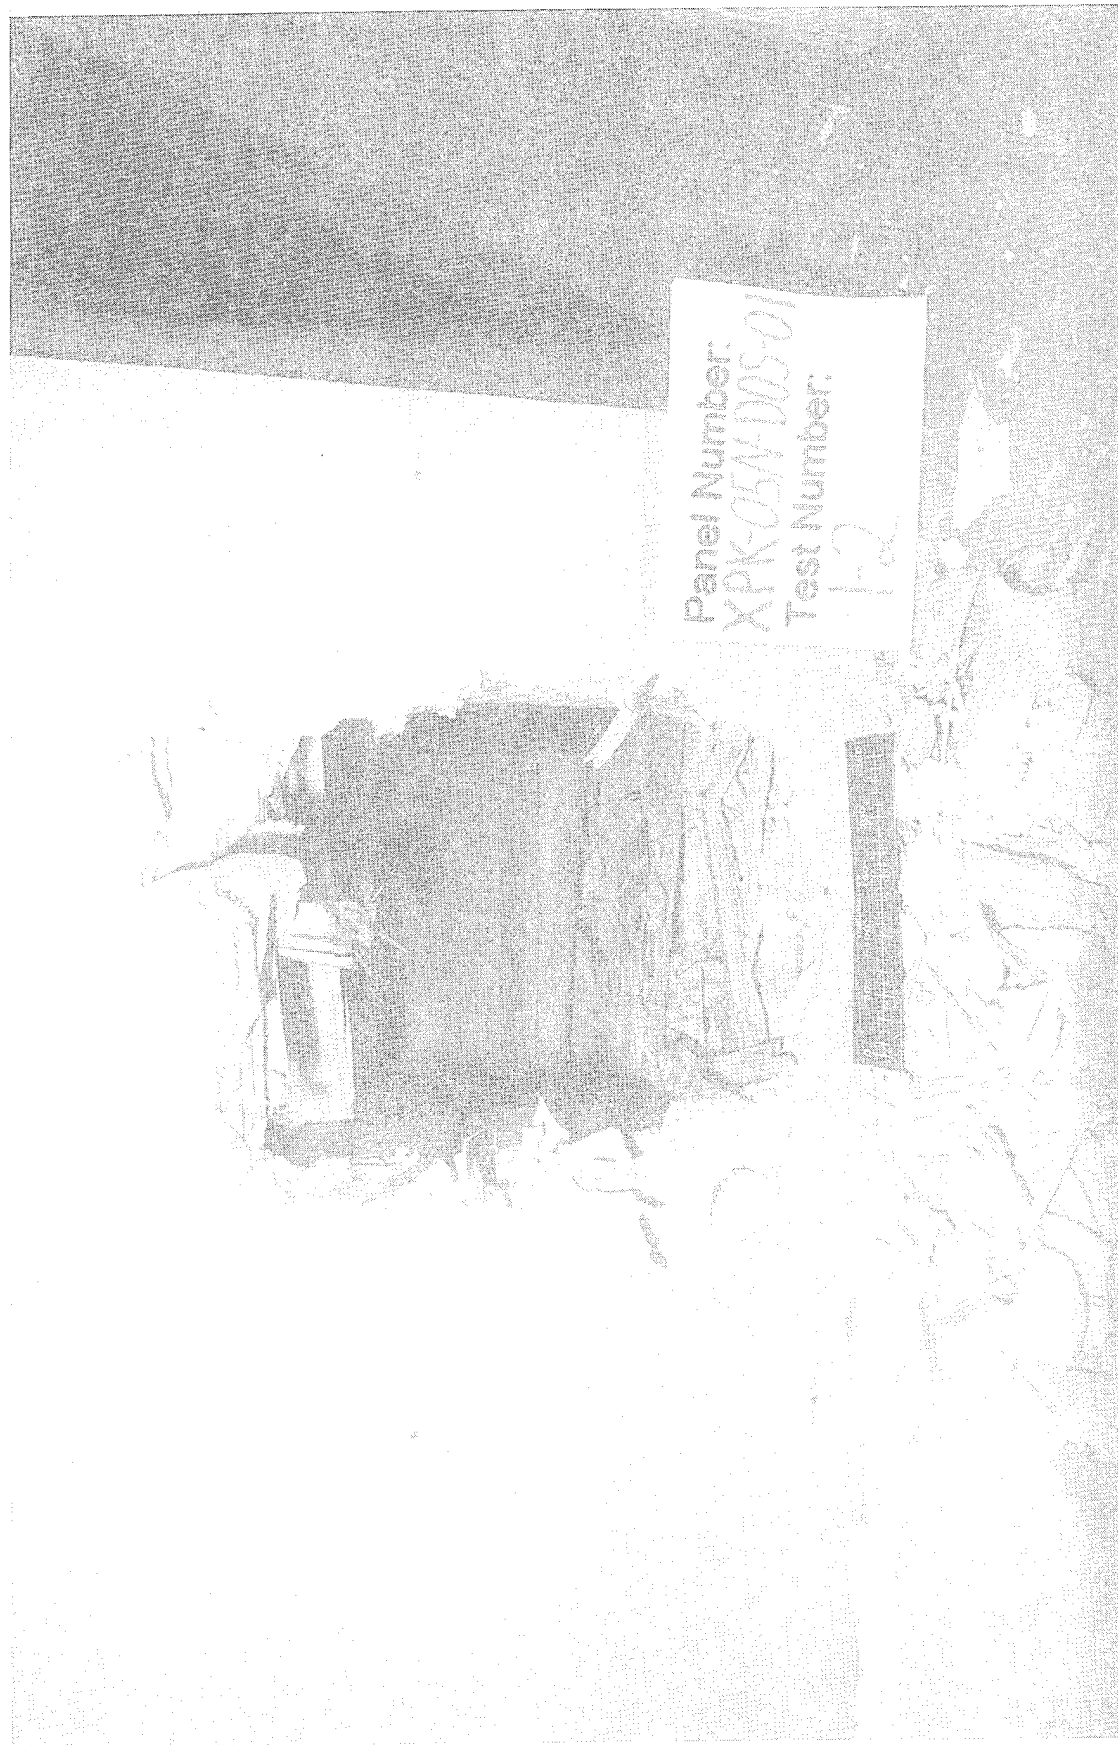
Figure 30. Assault side of panel XPK-05N-DOS-01 after test 1-2

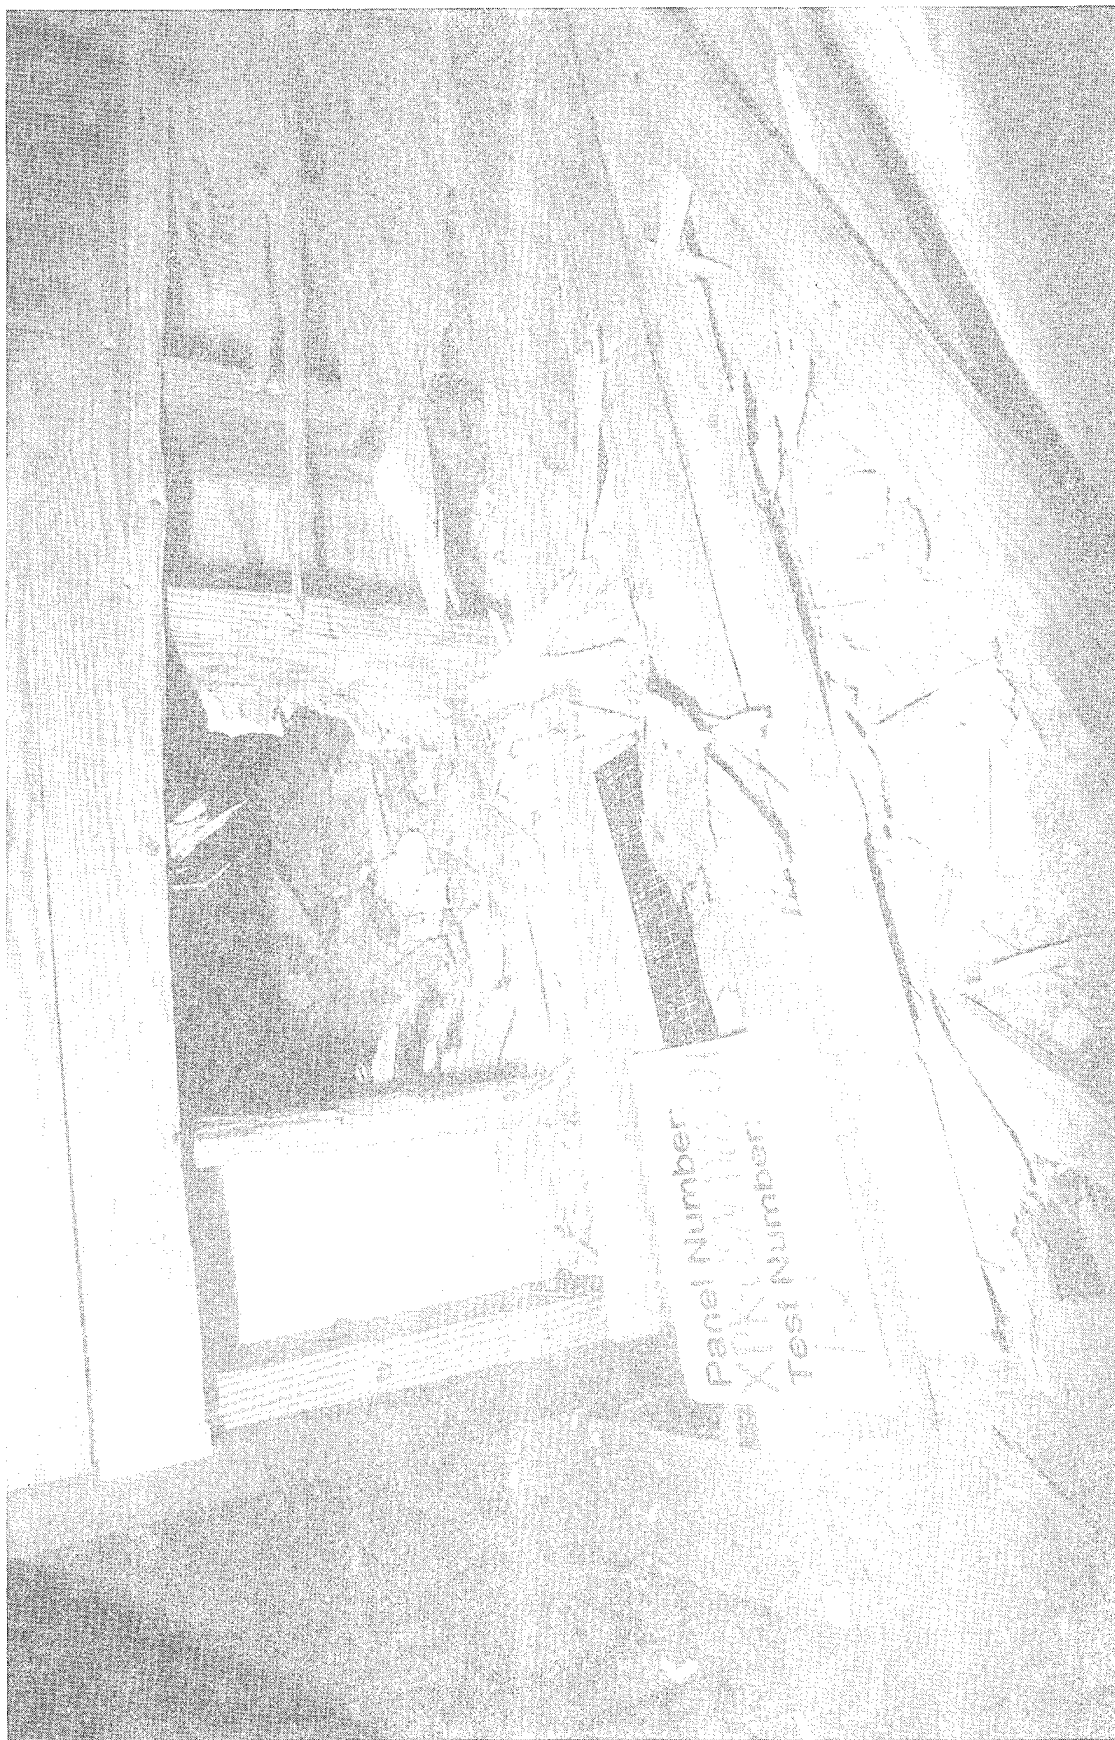
Figure 31. Protect side of panel XPK-05N-DOS-01 after test 1-2

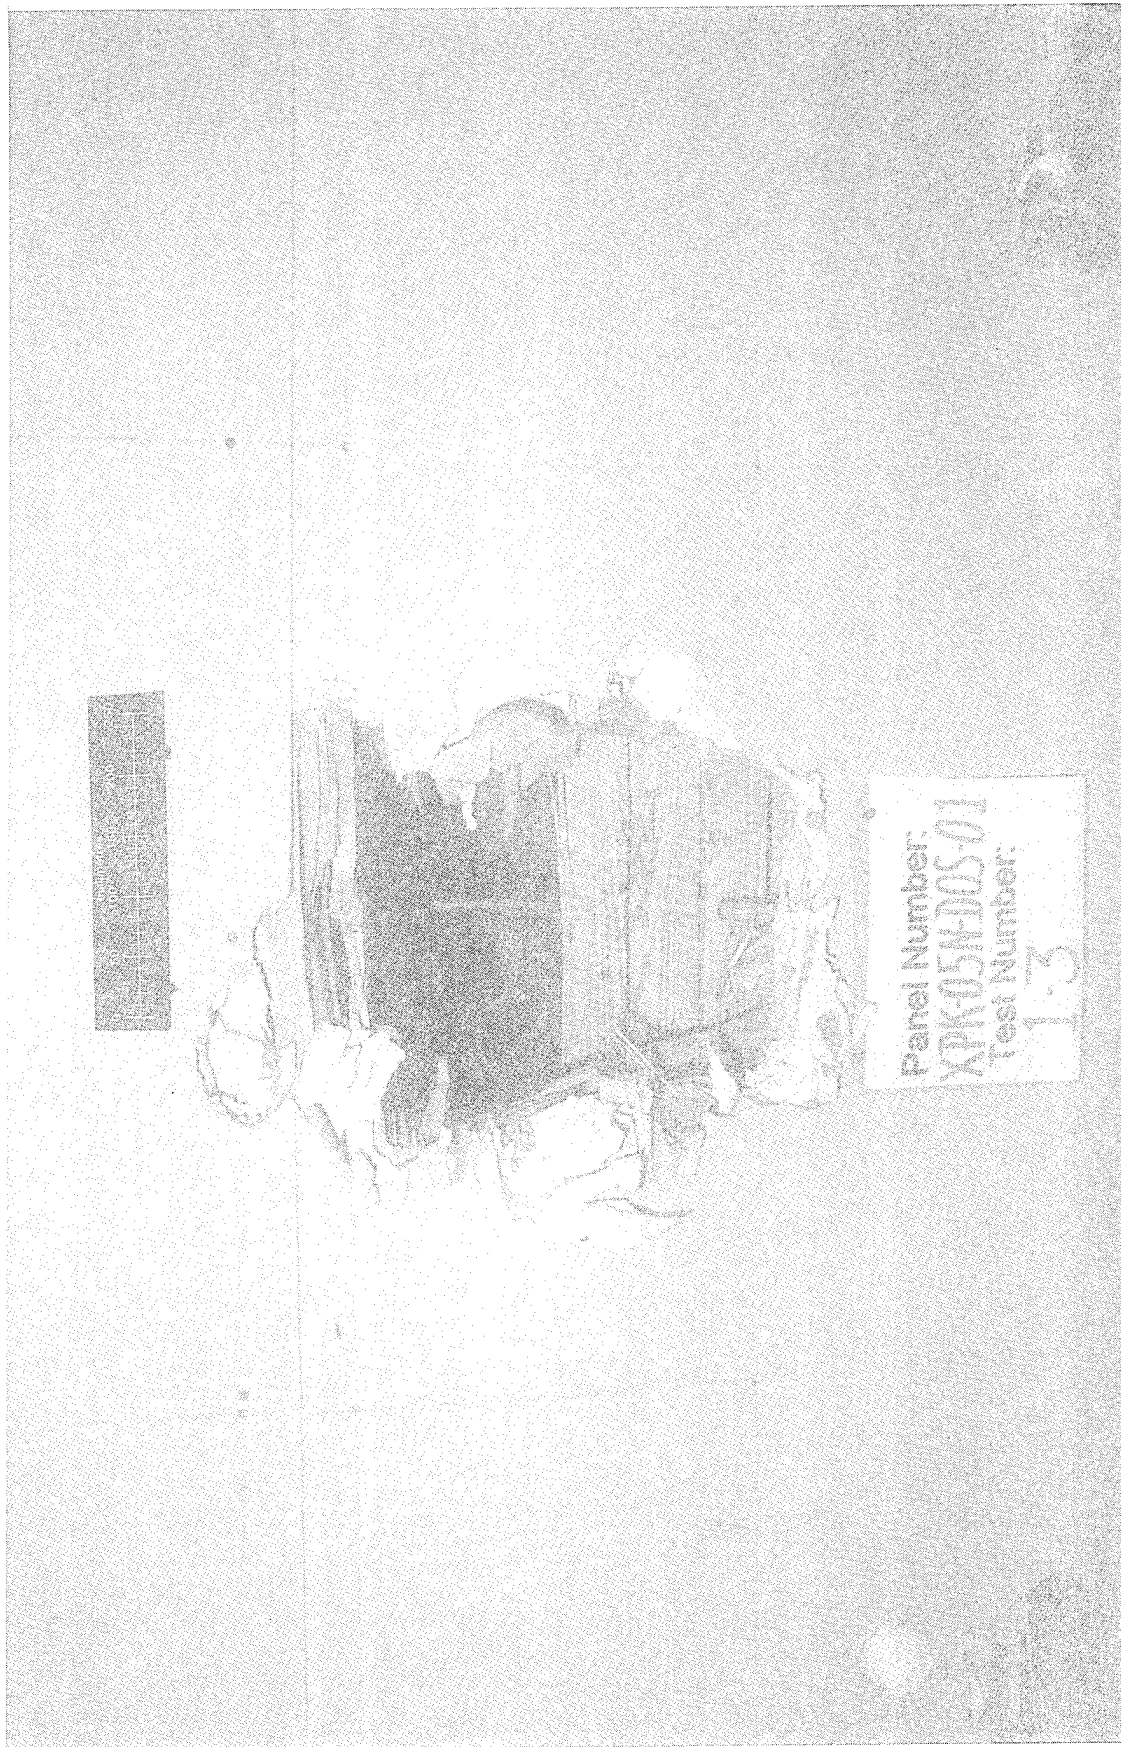
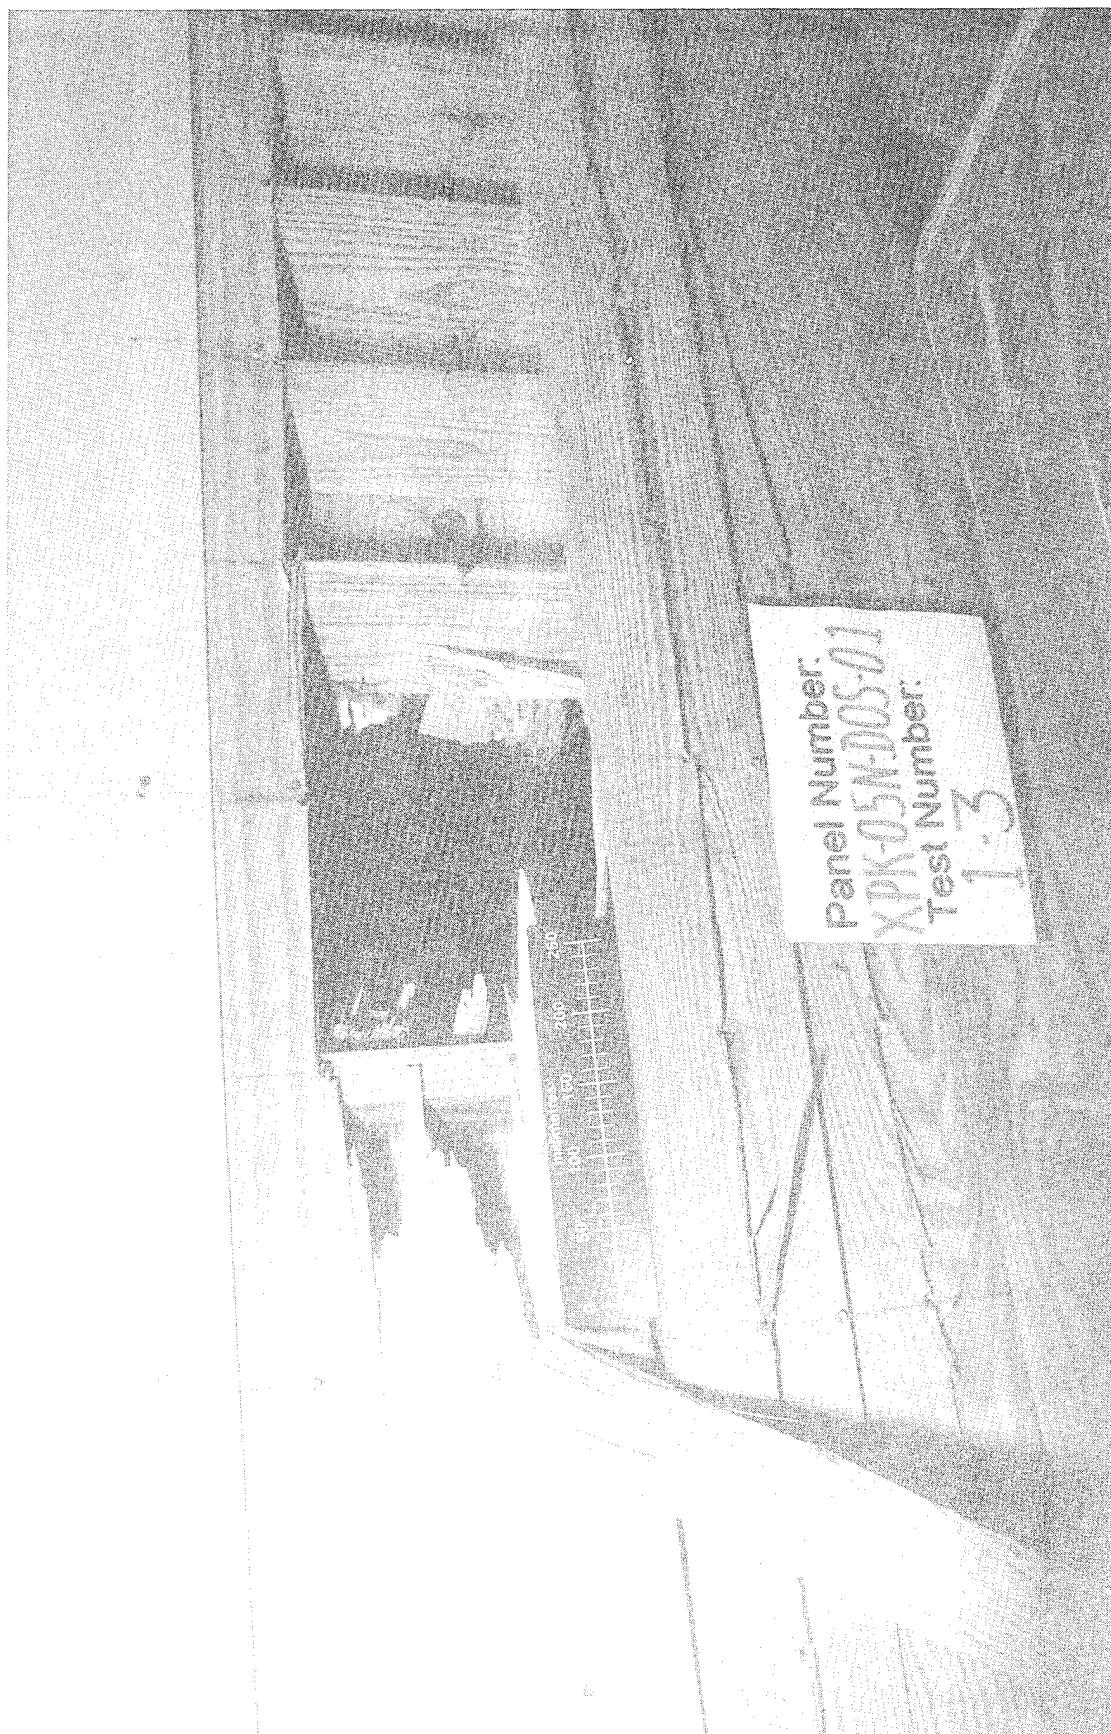
The assault began at 10:55:00 on 31 May 95 with the assault team using sledgehammers. The sledgehammer assault continued until 10:57:32 when the assault team began using the ram to break loose the wood board sheathing on the protect side of the panel. (The protect side is opposite the assault side of the panel.) After using the ram for approximately 8 seconds, the assault team returned to the sledgehammers which they used until 10:58:35 when they pushed the metal box completely through the opening in the panel. The total penetration time was 3 minutes and 35 seconds. Posttest photographs of the opening in the panel are presented in Figures 32 and 33.

Figure 32. Assault side of panel XPK-05N-DOS-01 after test 1-3

Figure 33. Protect side of panel XPK-05N-DOS-01 after test 1-3

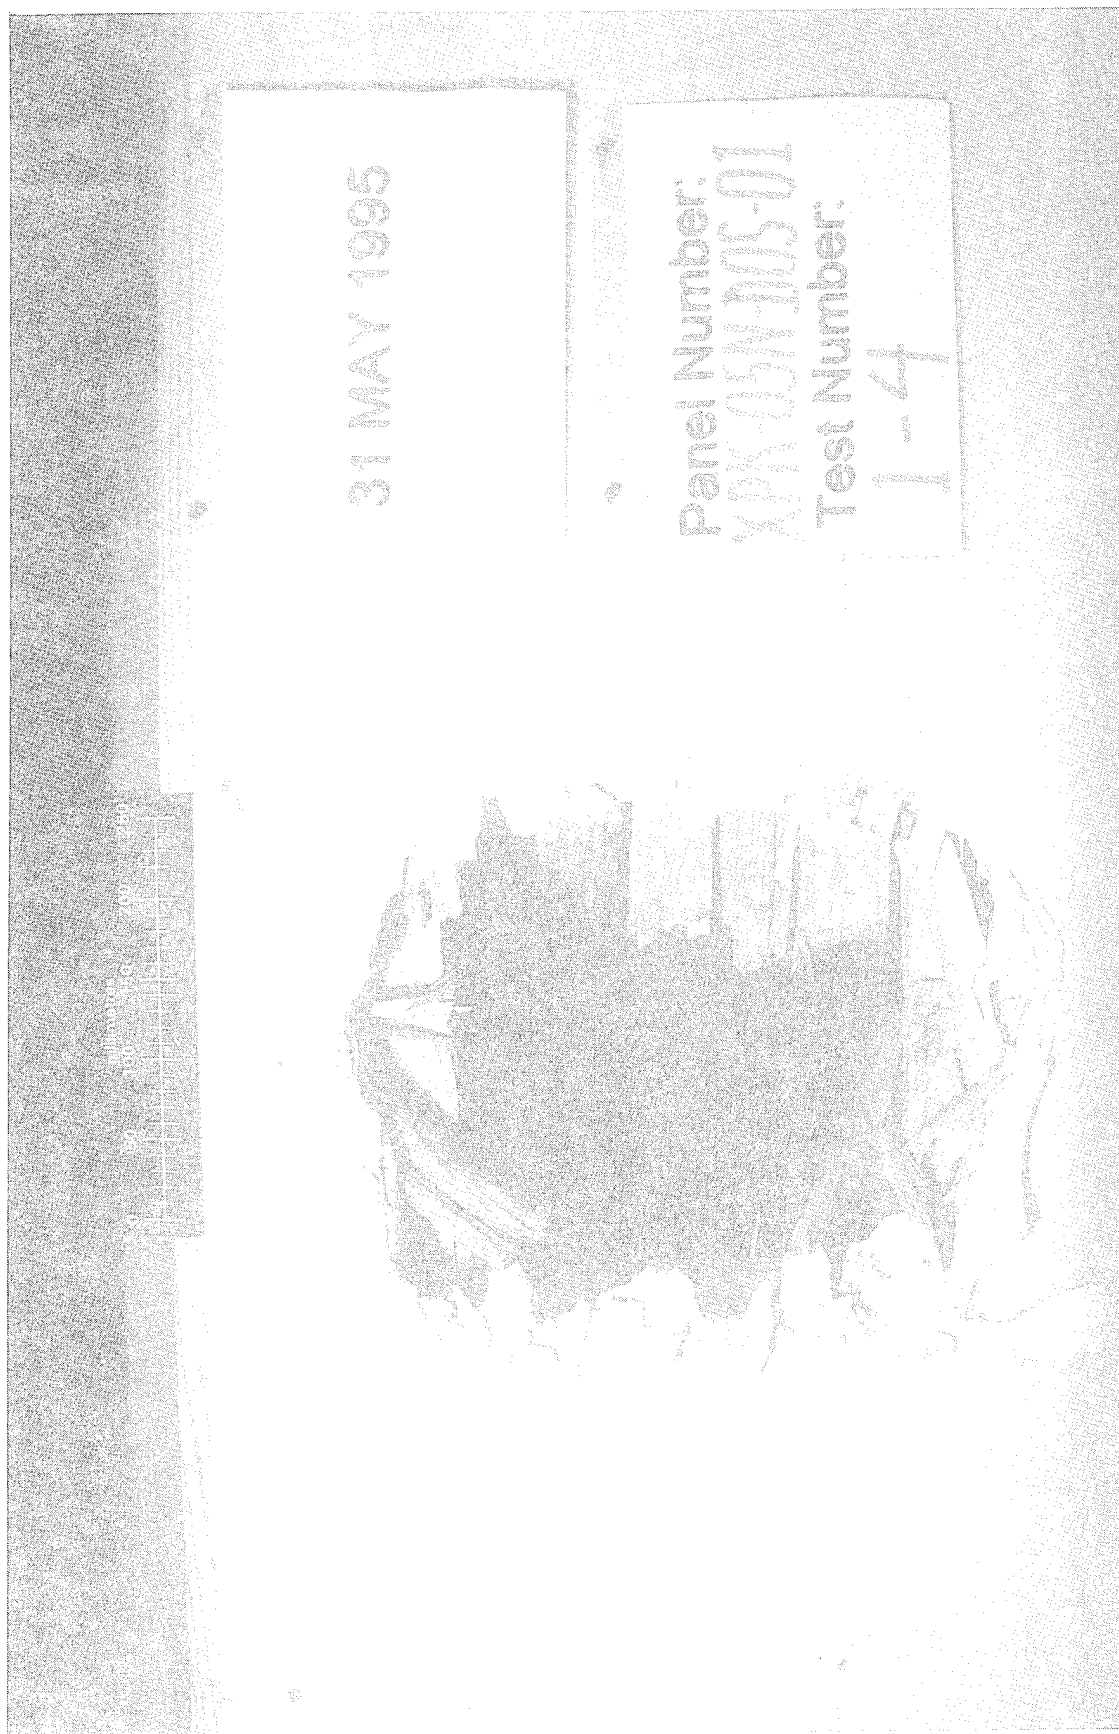
Figure 34. Assault side of panel XPK-05N-DOS-01 after test 1-4

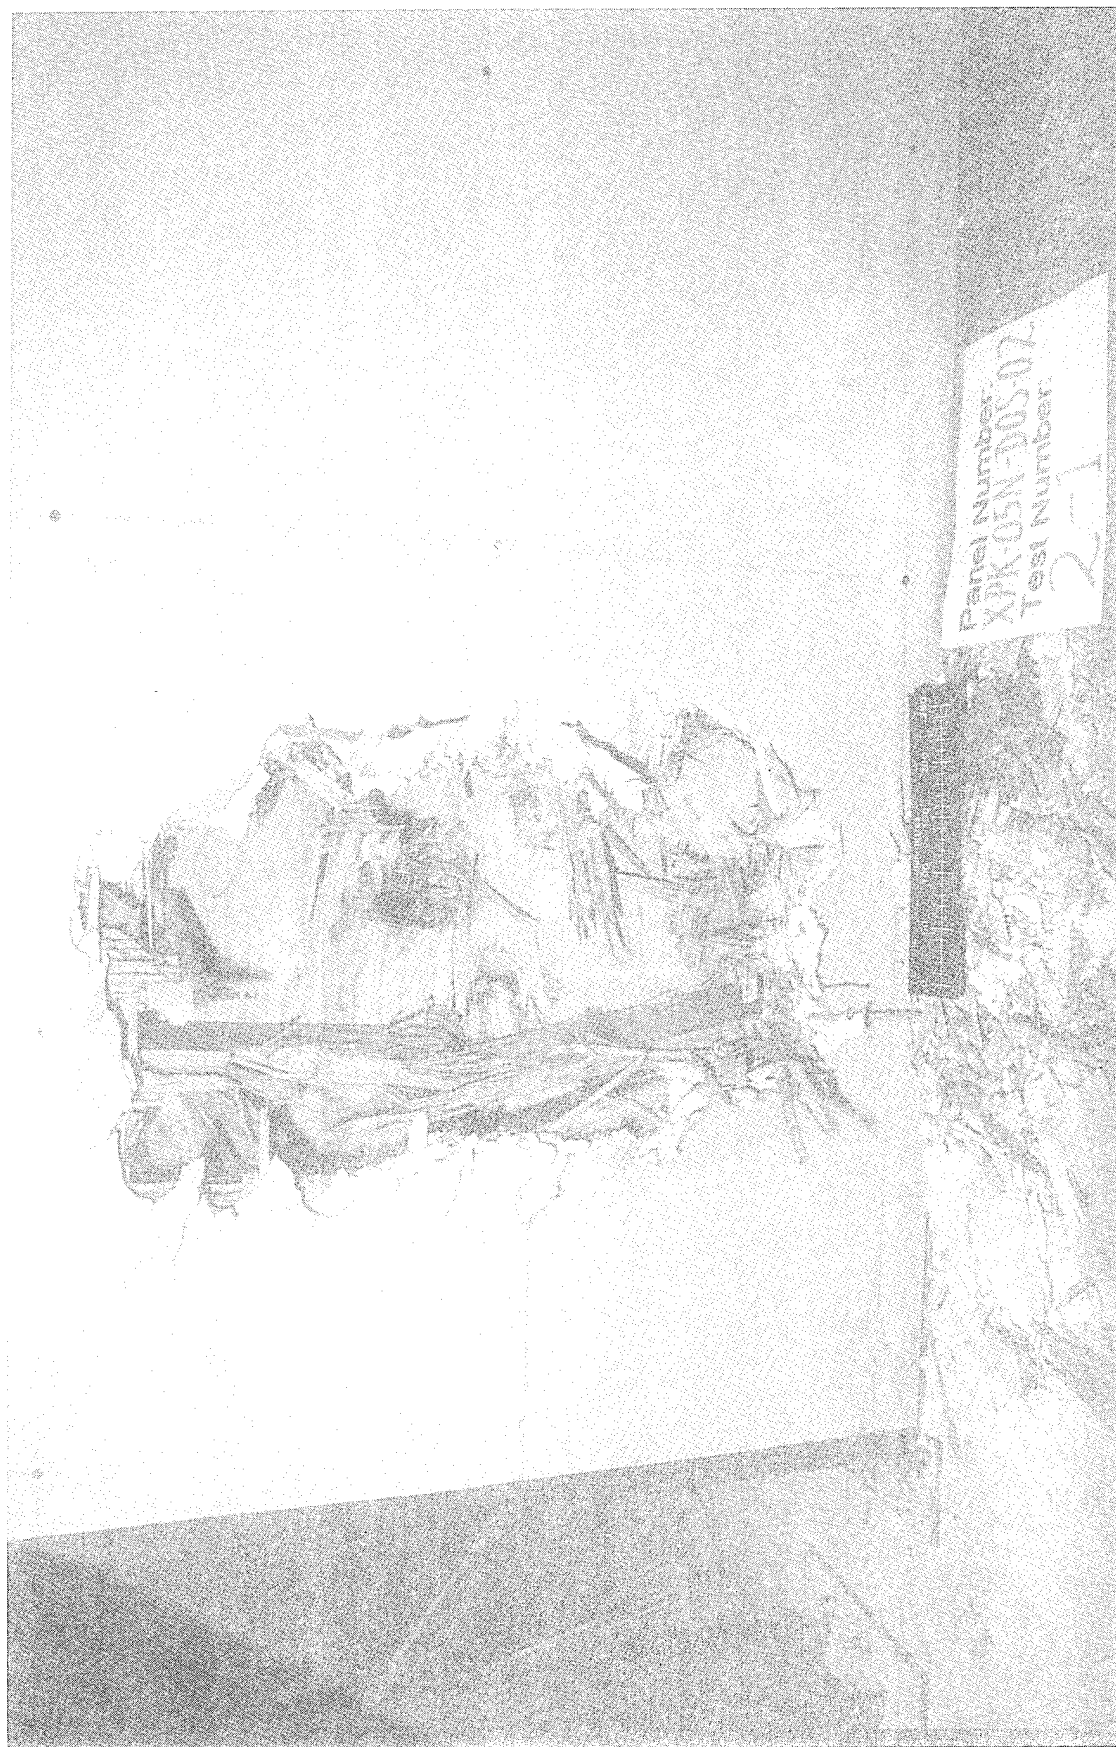
Figure 36. Assault side of panel XPK-05N-DOS-02 after test 2-1

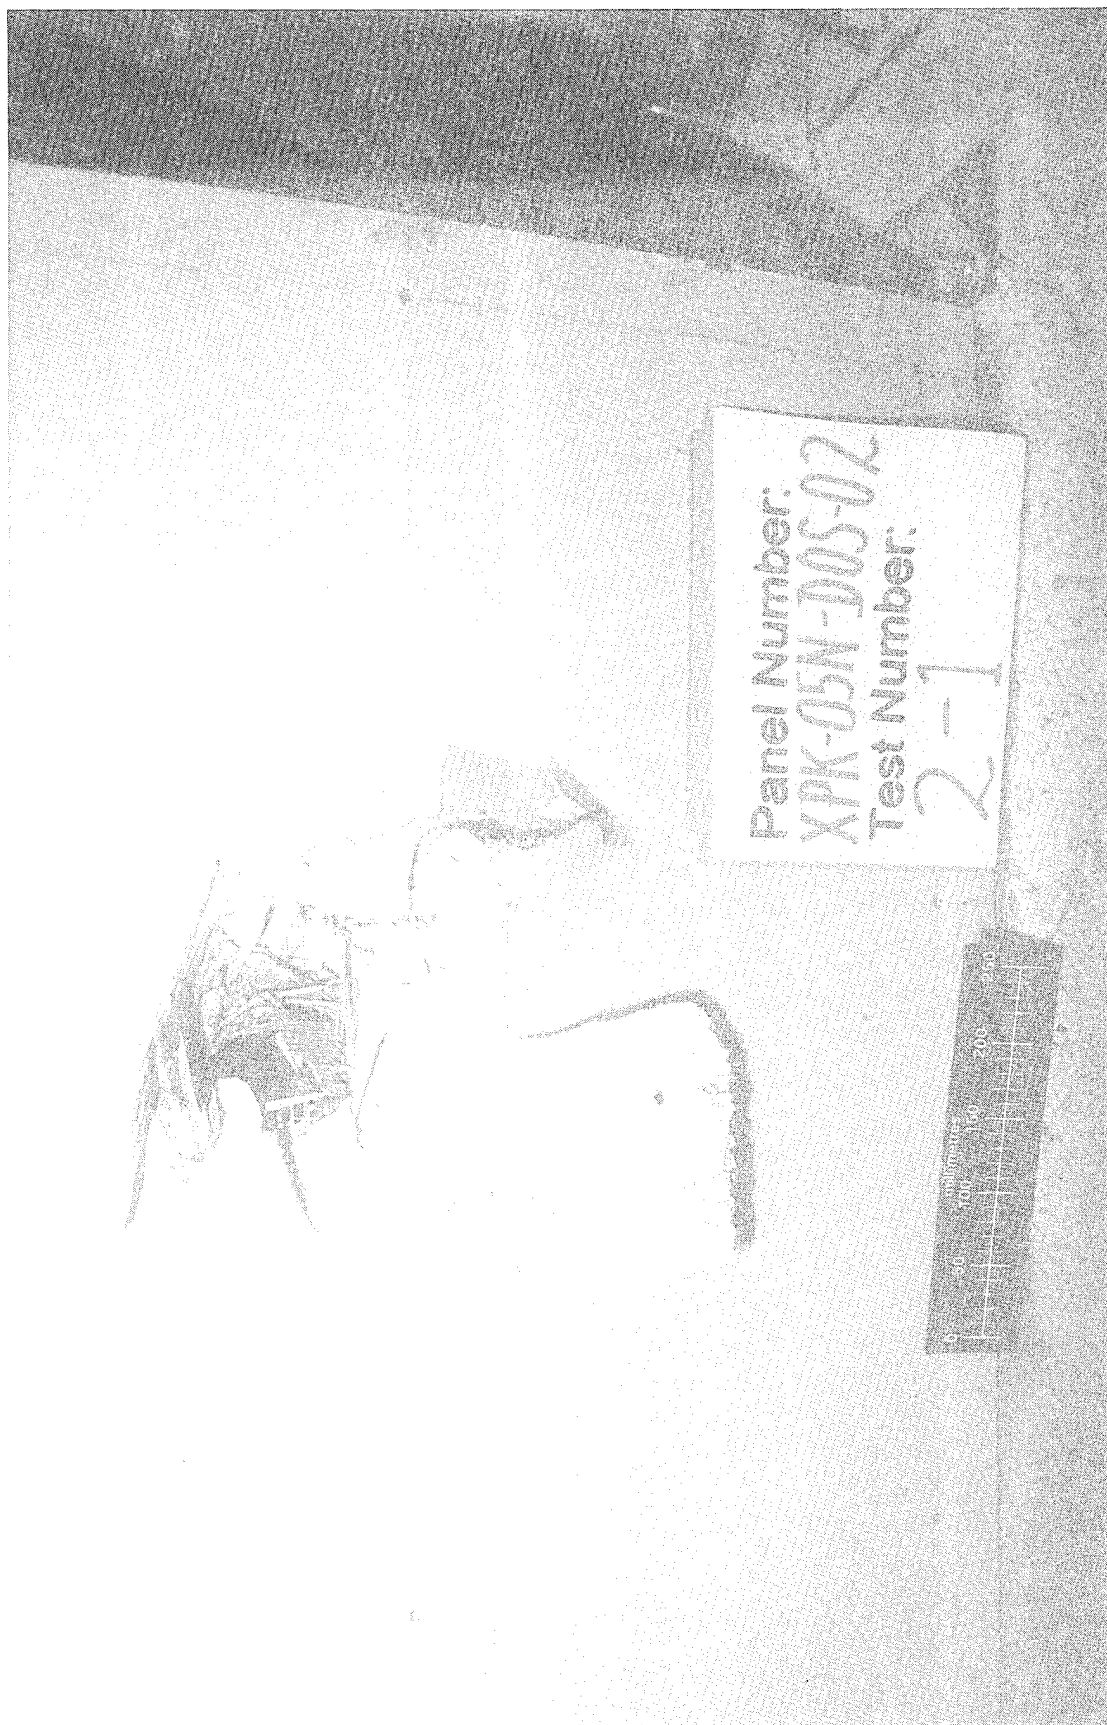
Figure 37. Protect side of panel XPK-05N-DOS-02 after test 2-1

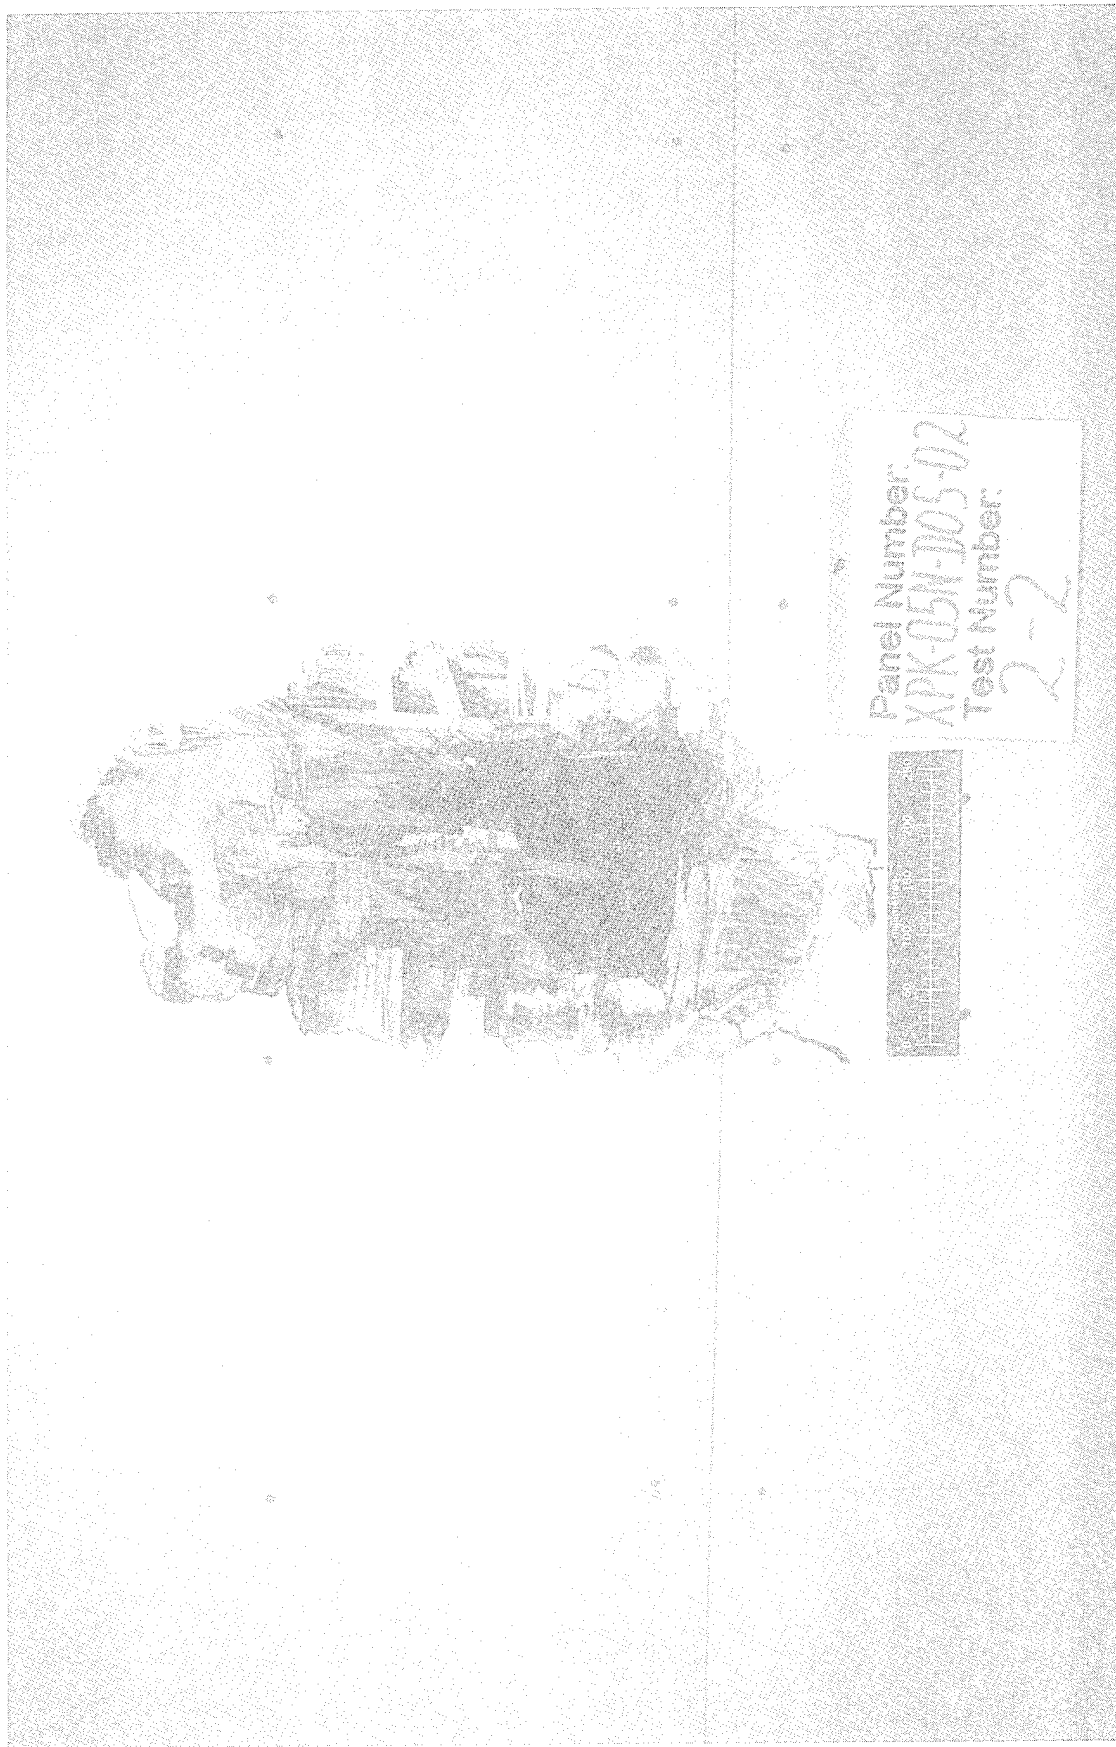
Figure 38. Assault side of panel XPK-05N-DOS-02 after test 2-2

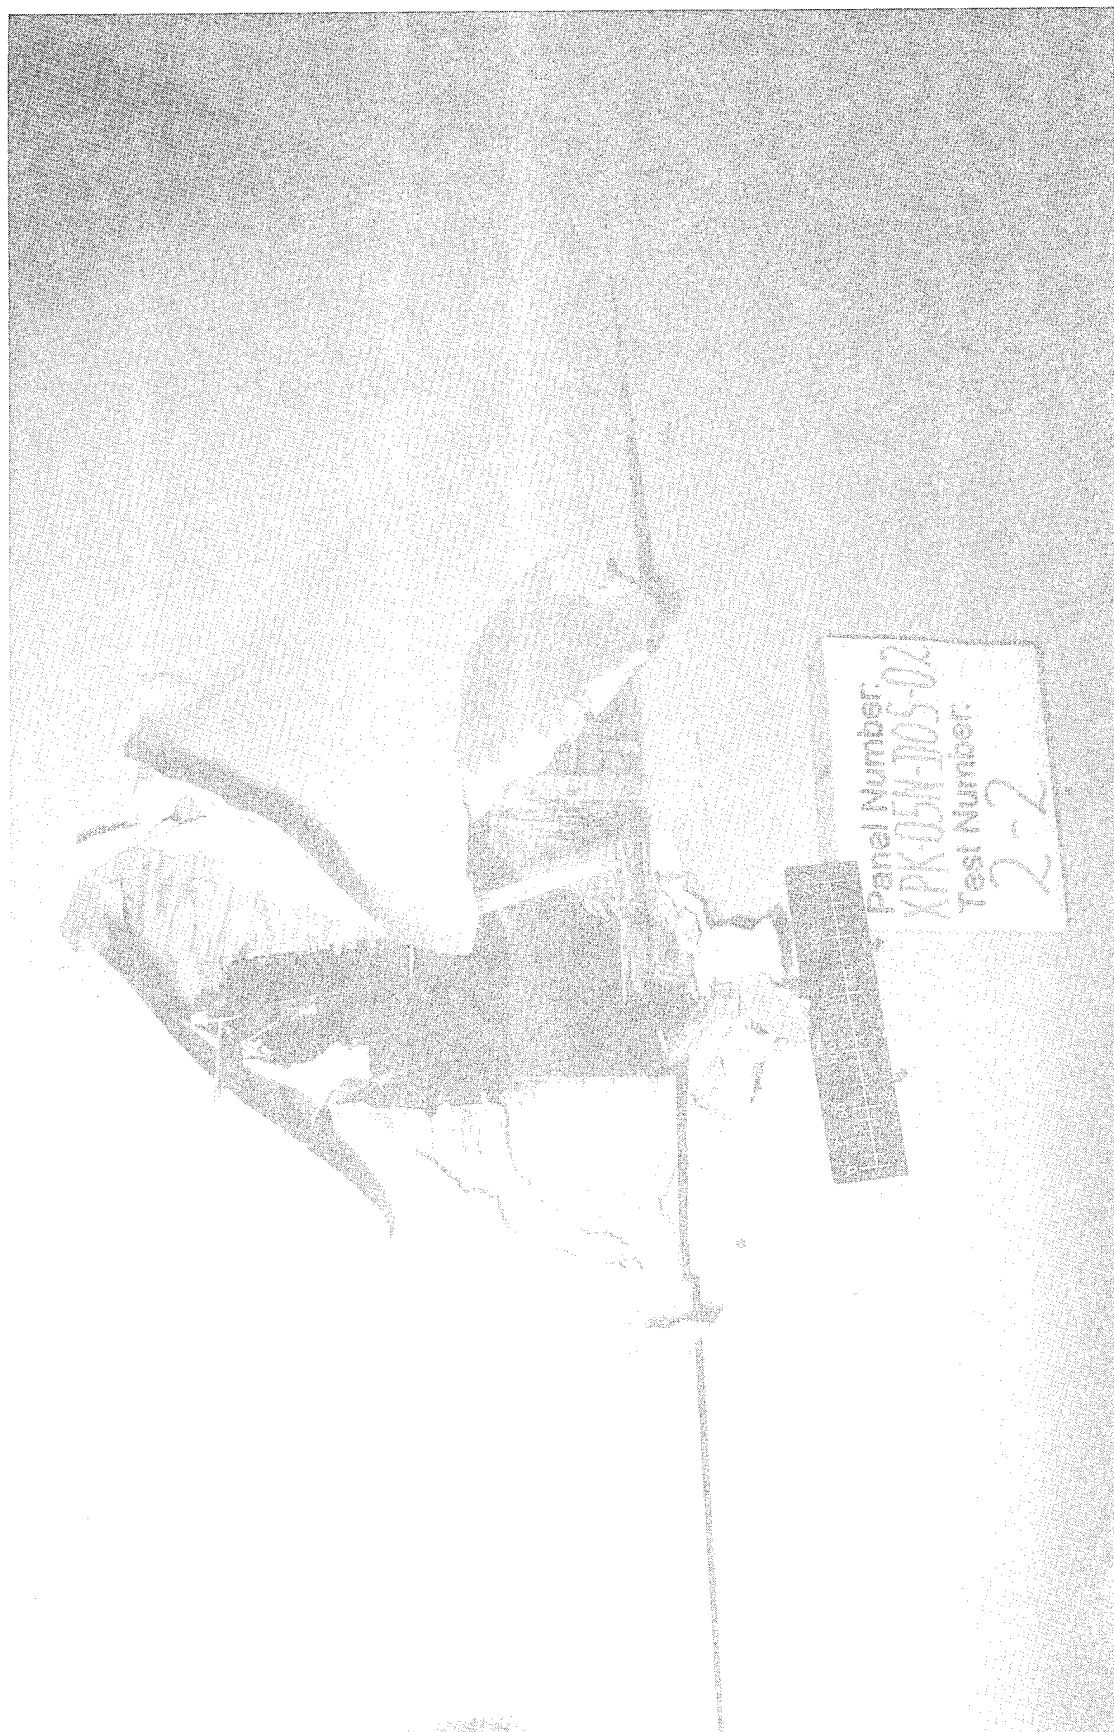
Figure 39. Protect side of panel XPK-05N-DOS-02 after test 2-2
