US Army Corps  
of Engineers  
Waterways Experiment  
Station

Miscellaneous Paper SL-96-1  
February 1996

## Forced Entry Testing of Five-Minute Walls

Prepared for U.S. Department of State,  
Office of Foreign Building Operations

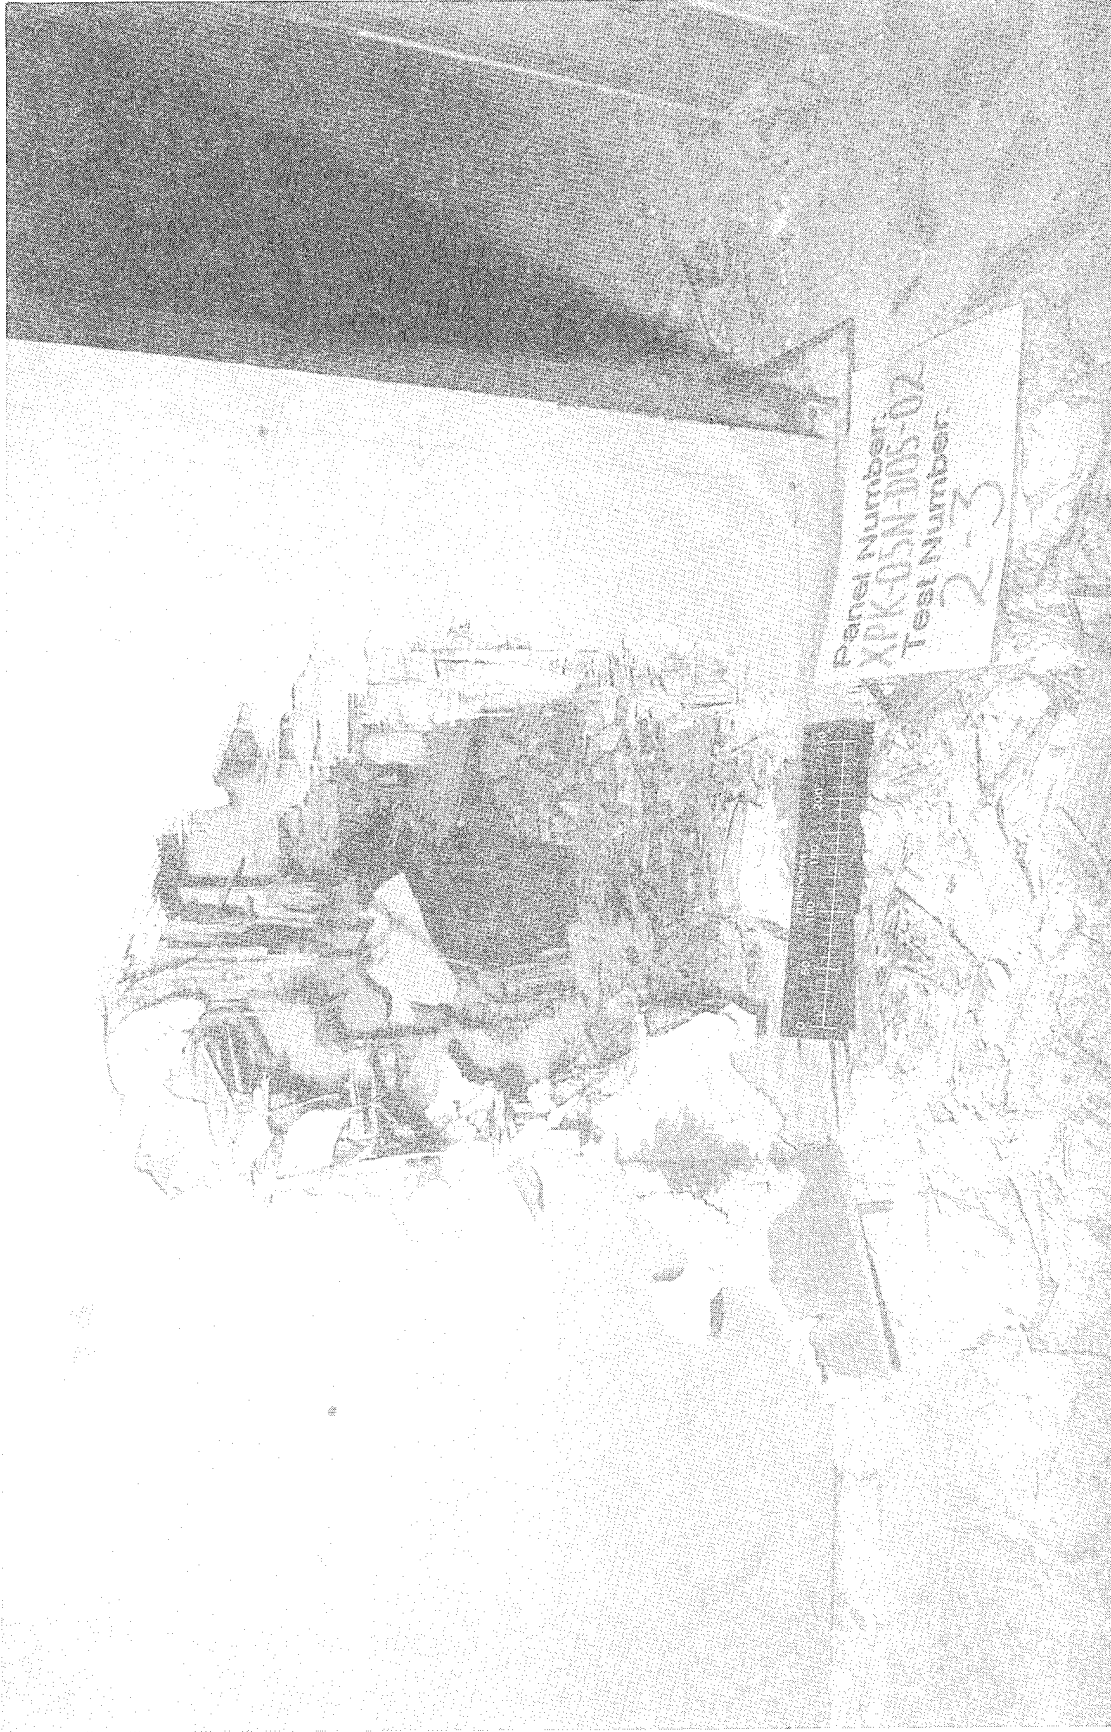
Figure 40. Assault side of panel XPK-05N-DOS-02 after test 2-3

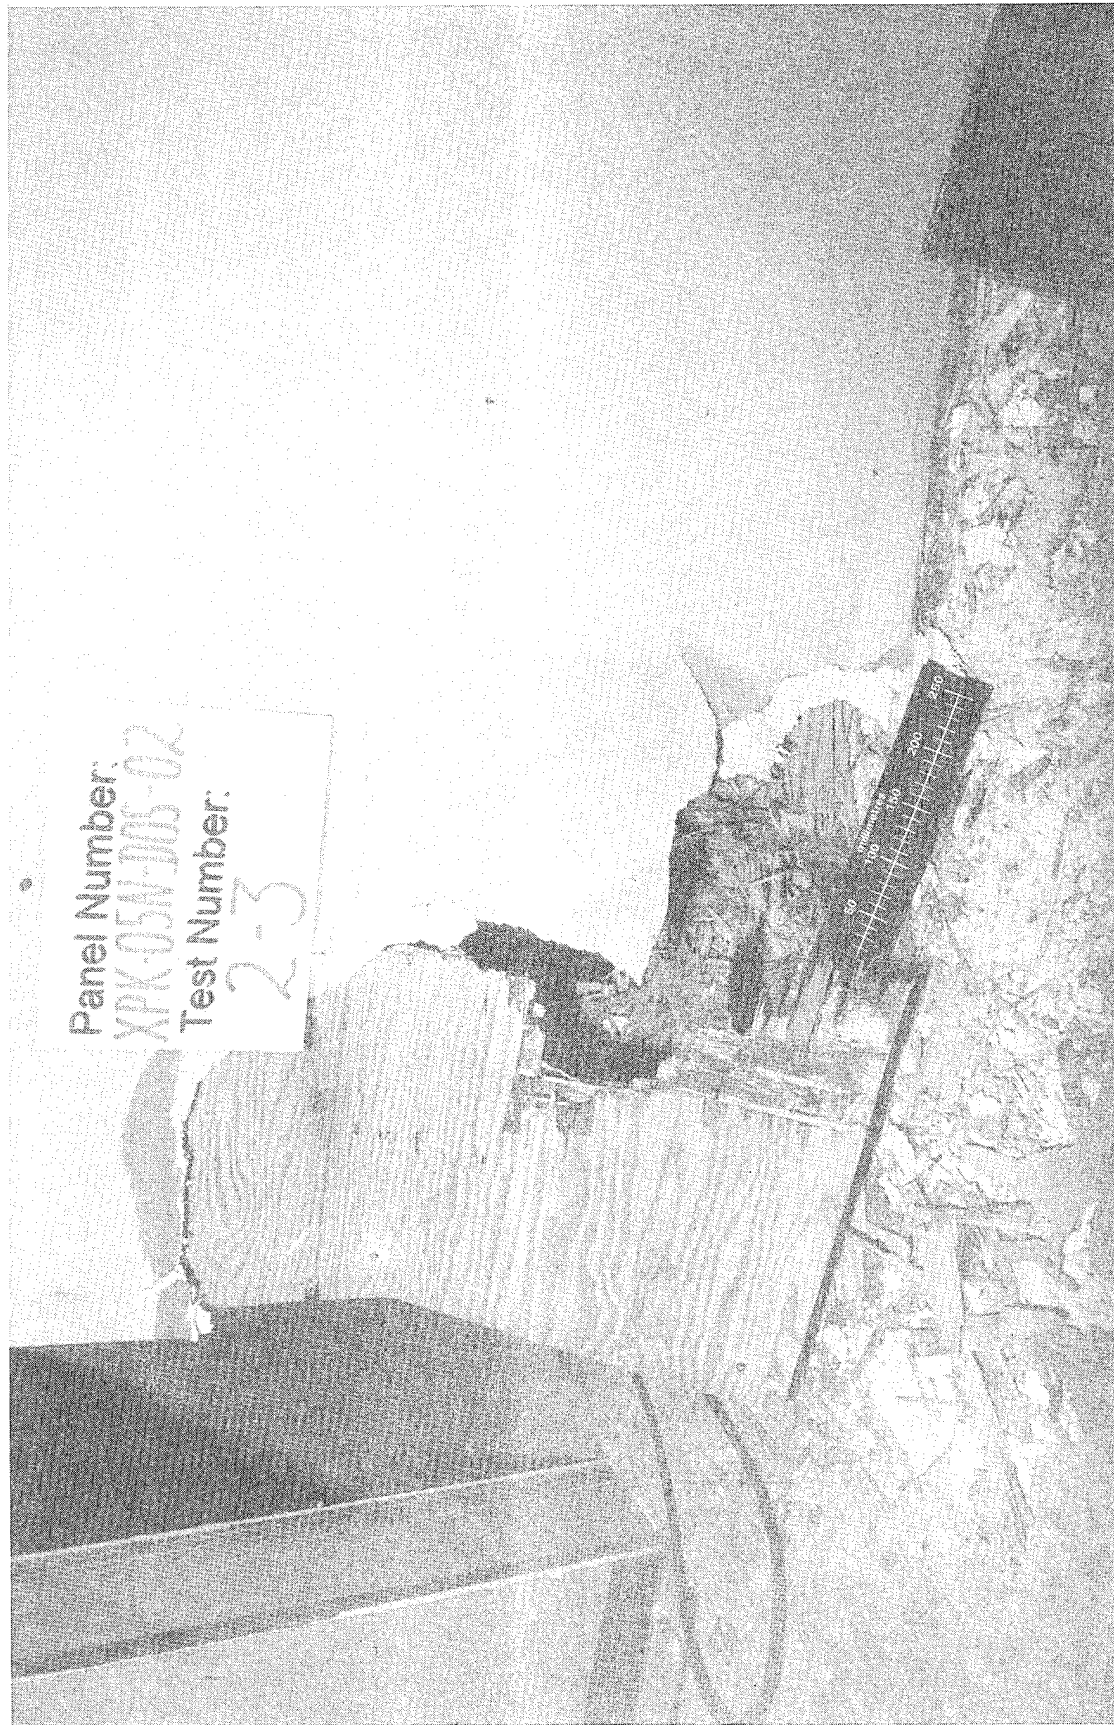
Figure 41. Protect side of panel XPK-05N-DOS-02 after test 2-3

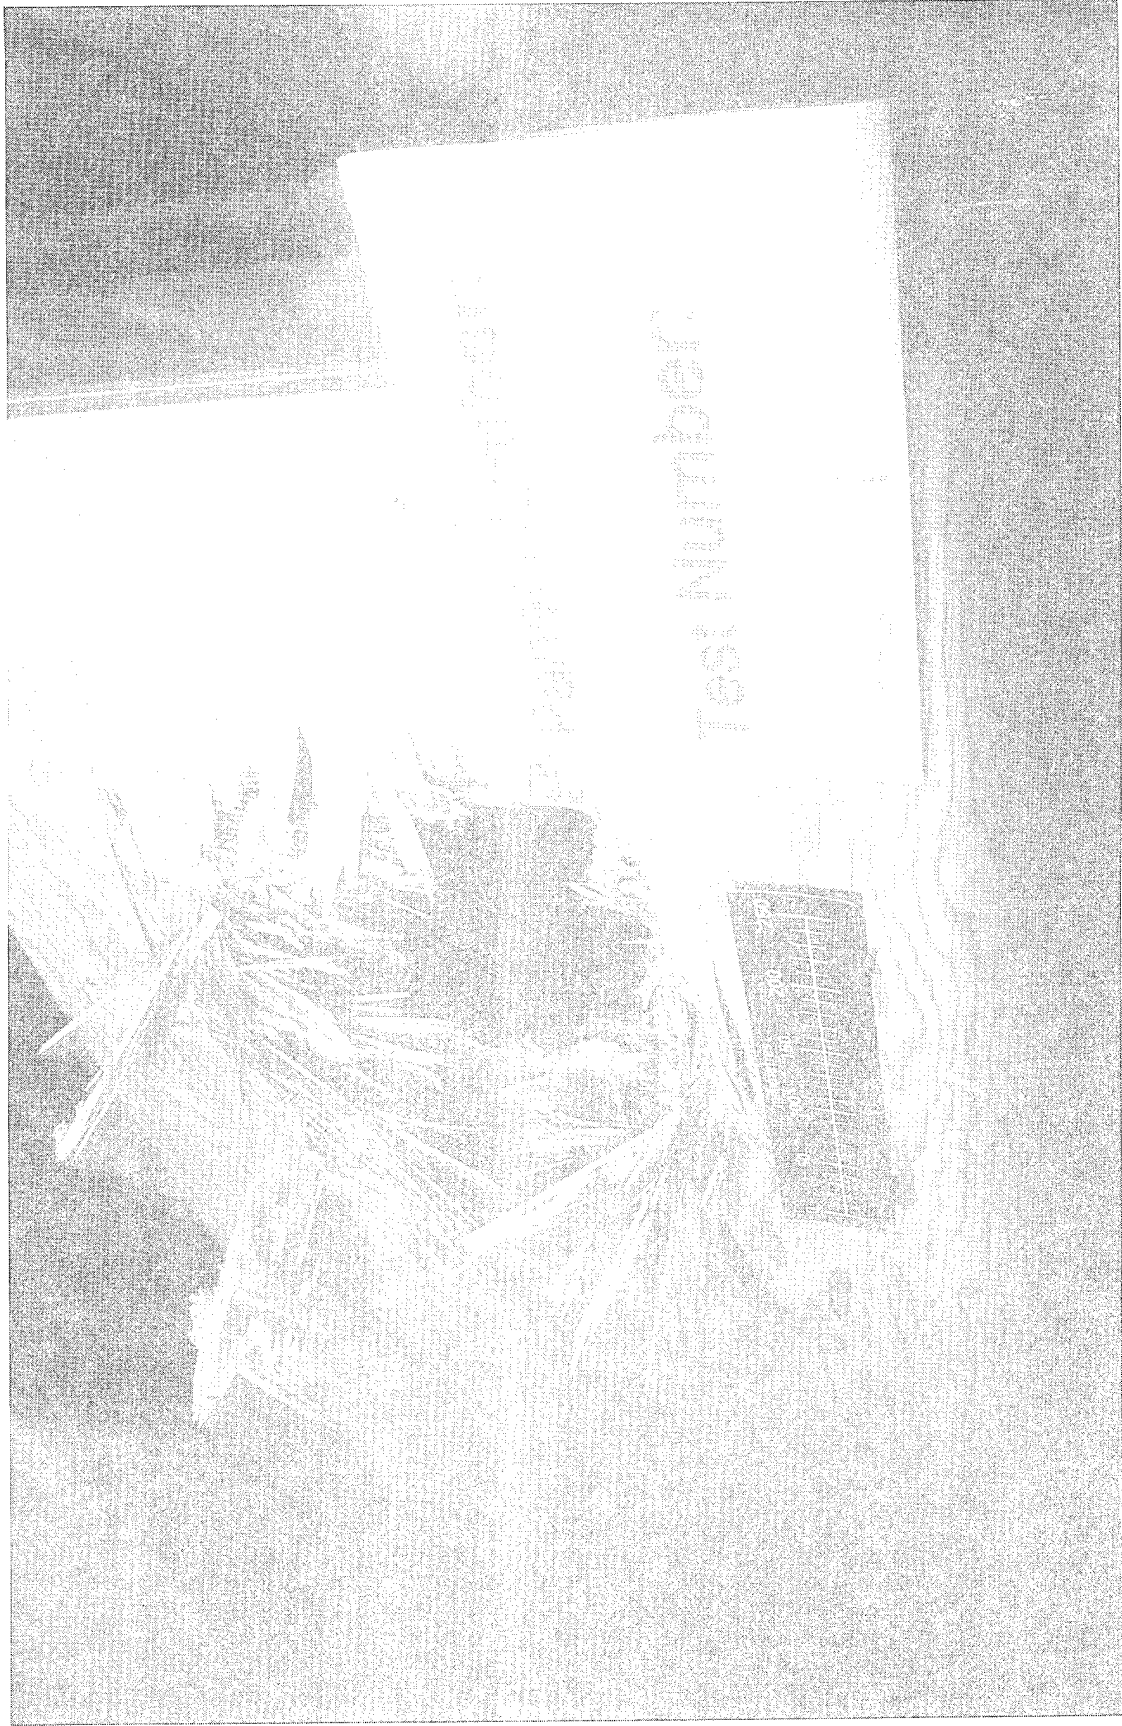
Figure 43. Protect side of panel XPK-05N-DOS-02 after the initial assault phase of test 2-4

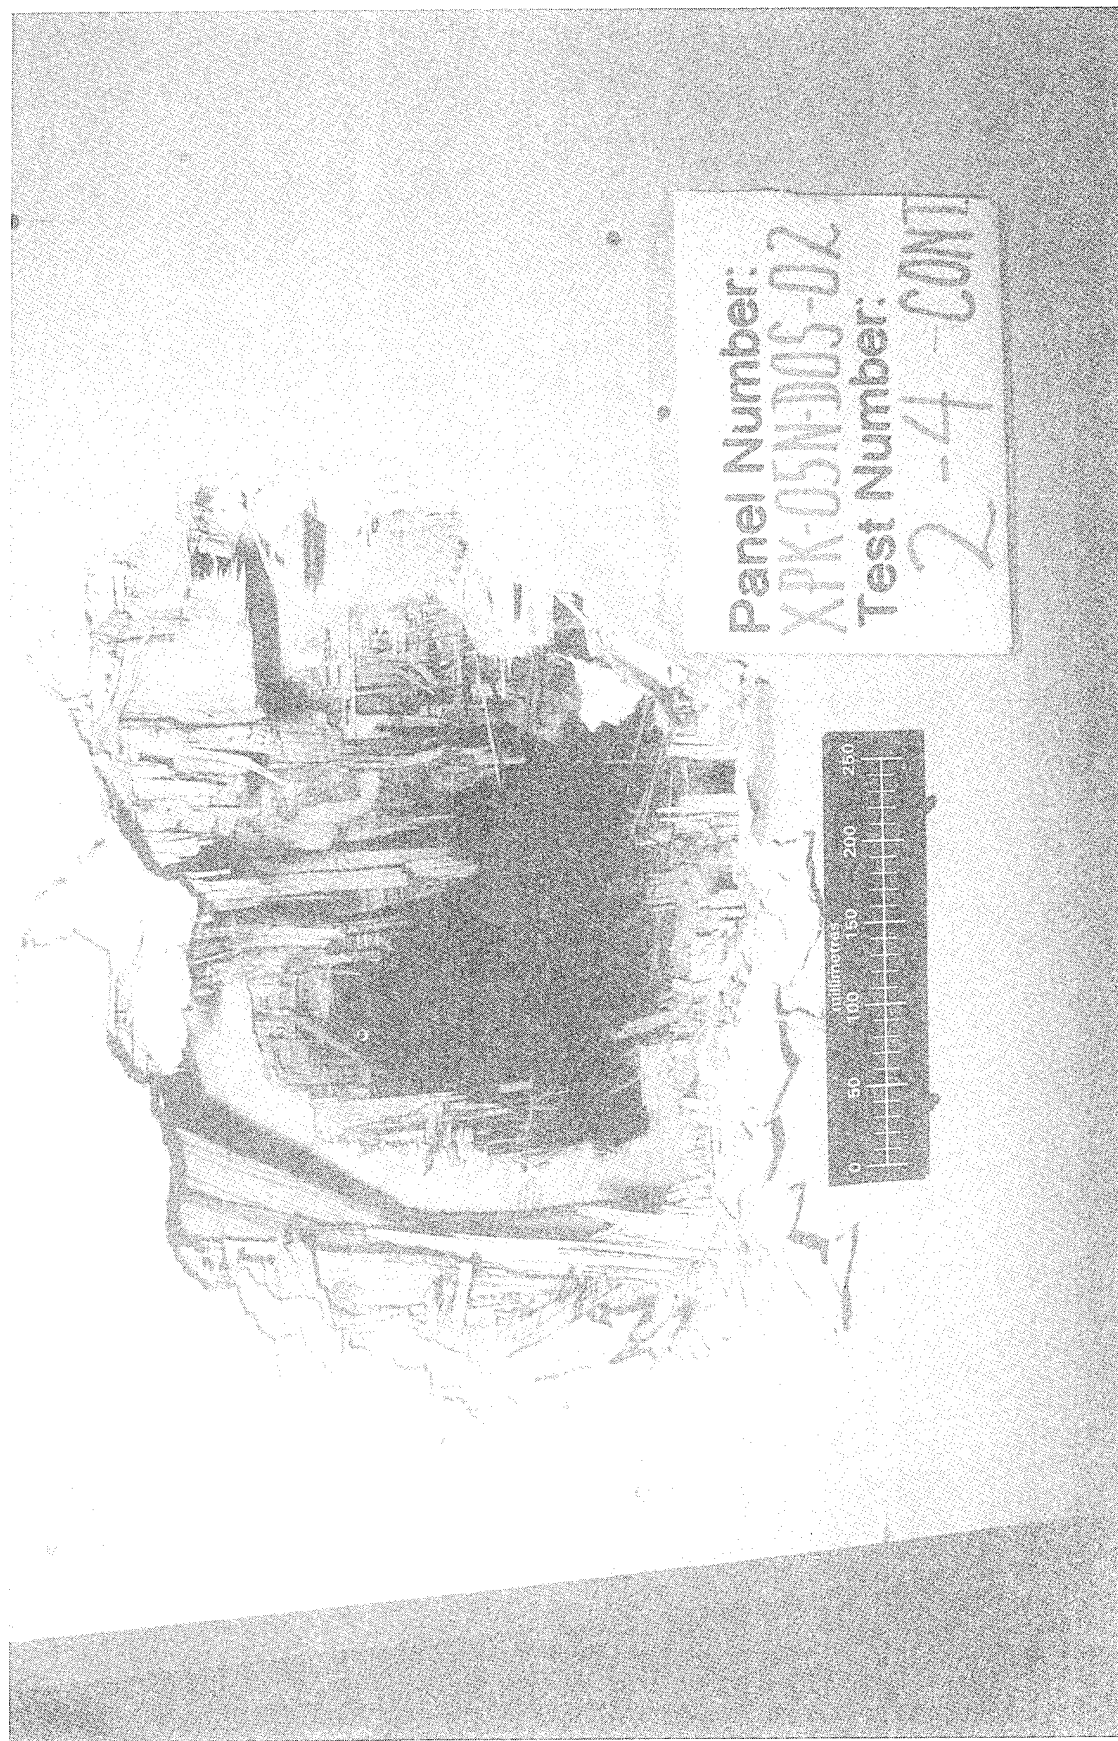
Figure 44. Assault side of panel XPK-05N-DOS-02 after the second assault phase of test 2-4

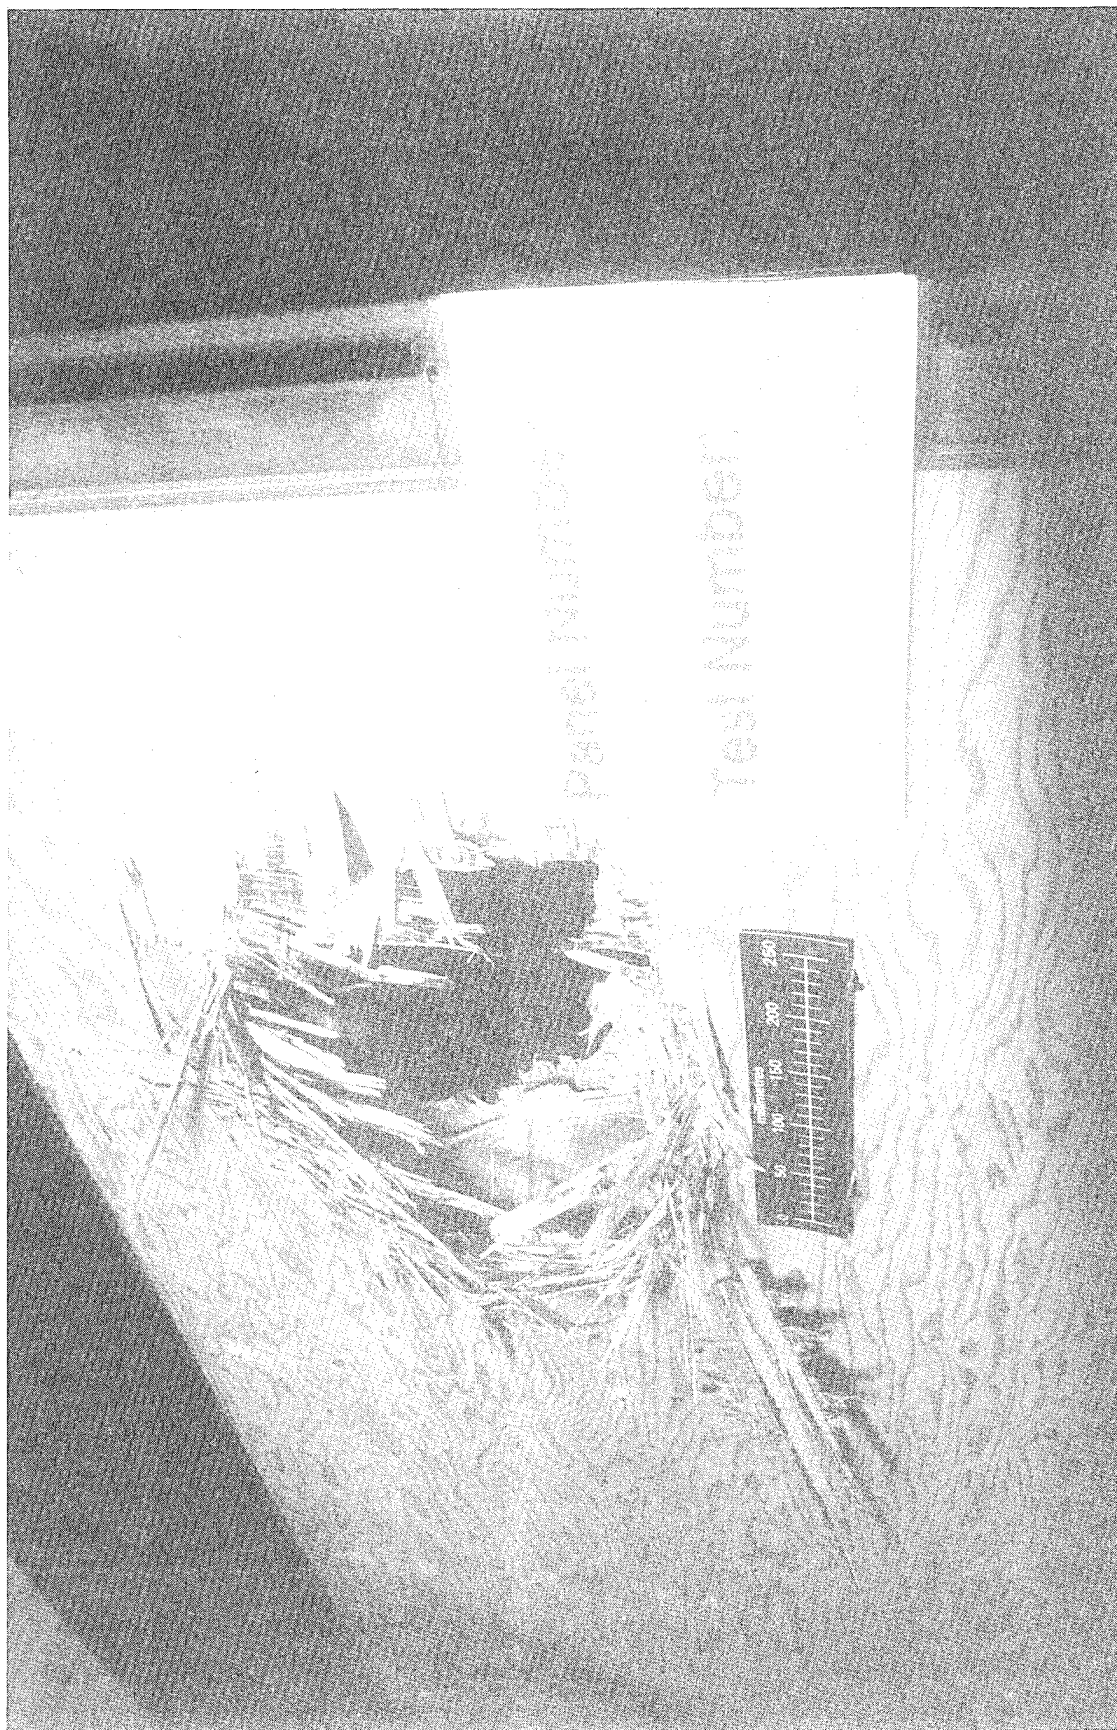
Figure 45. Protect side of panel XPK-05N-DOS-02 after the second assault phase of test 2-4

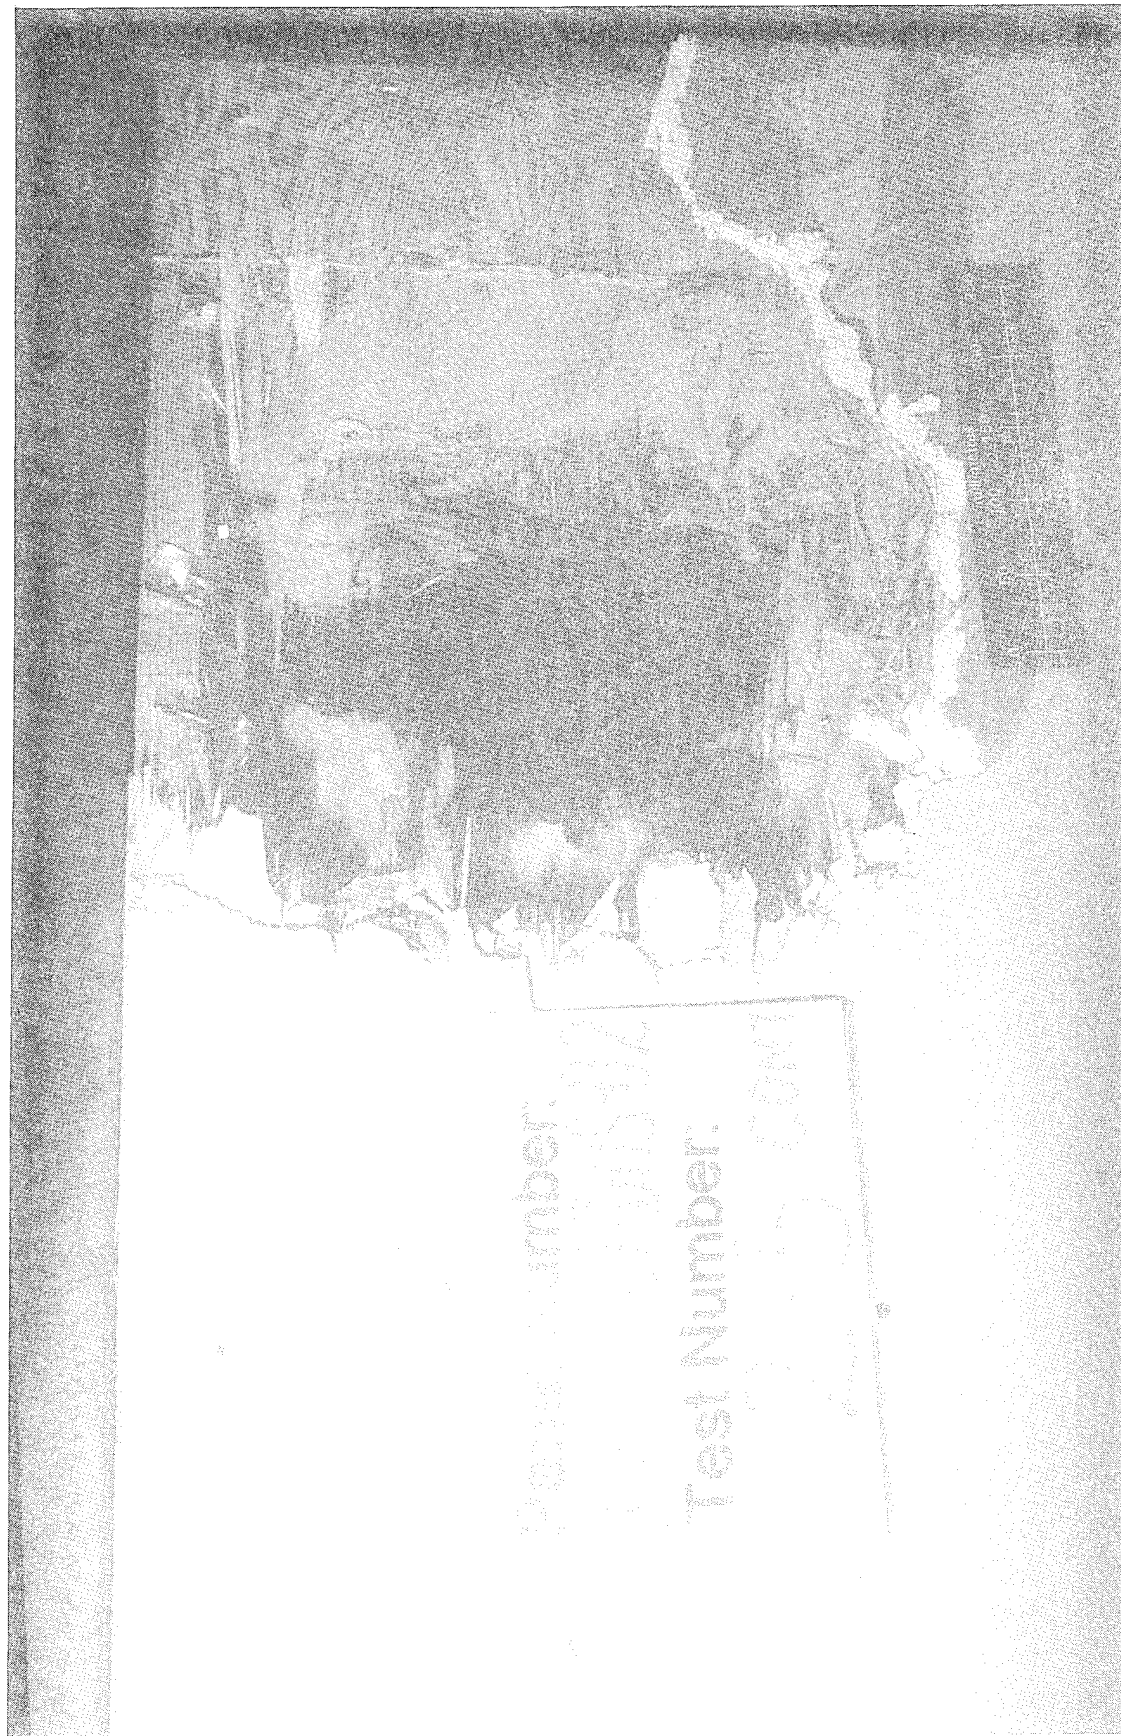
Figure 48. Assault side of panel XPK-05N-DOS-02 after the second assault phase of test 2-5

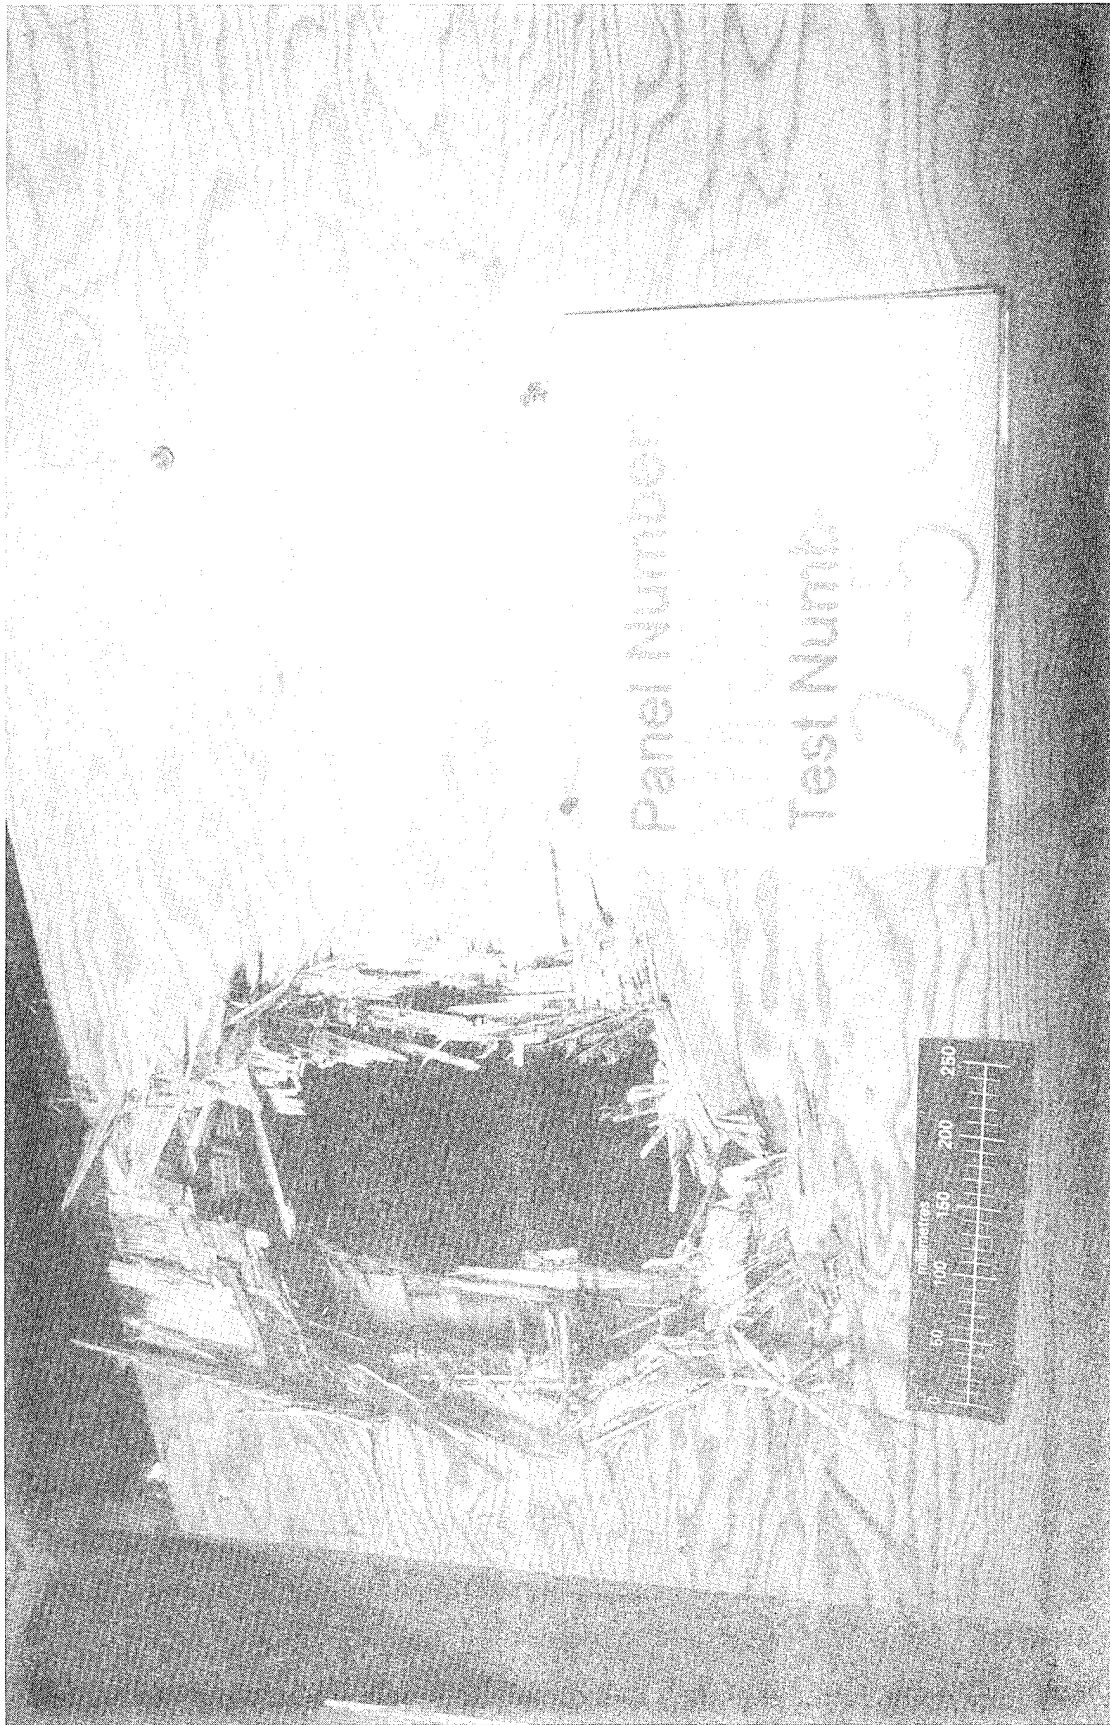
Figure 49. Protect side of panel XPK-05N-DOS-02 after the second assault phase of test 2-5

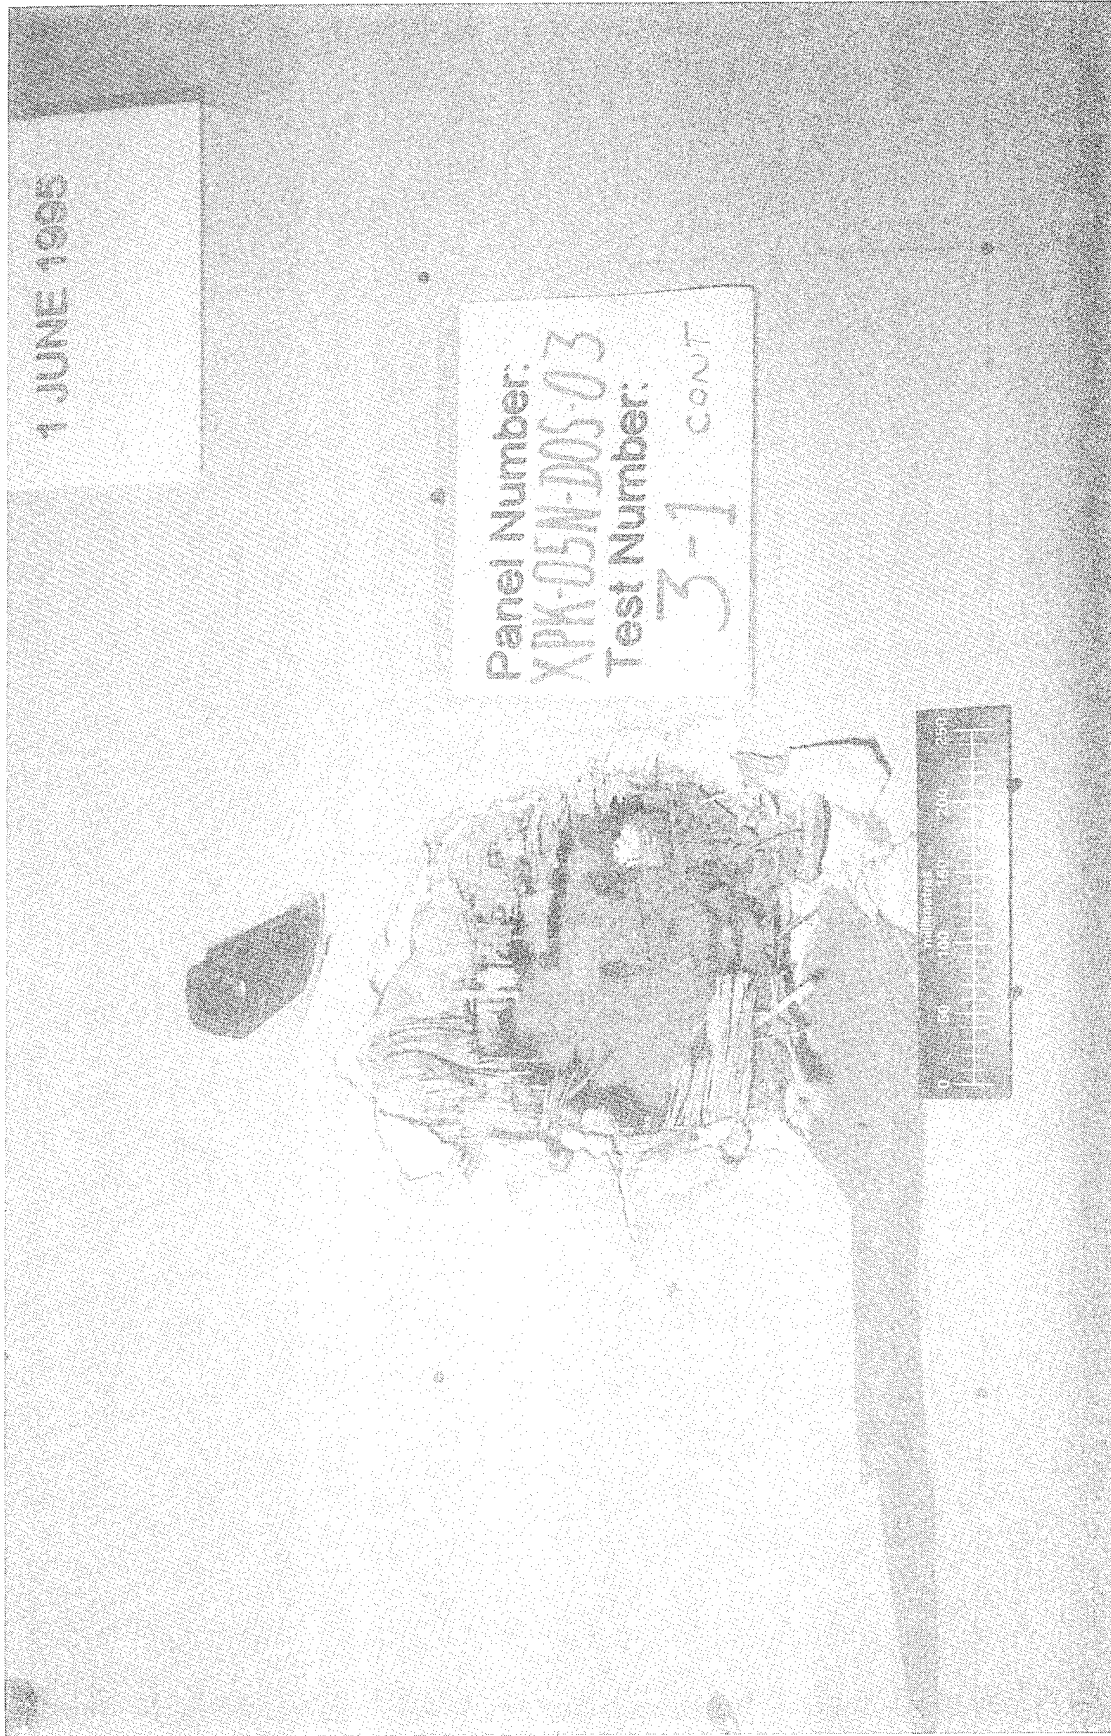
Figure 52. Assault side of panel XPK-05N-DOS-03 after the second assault phase of test 3-1

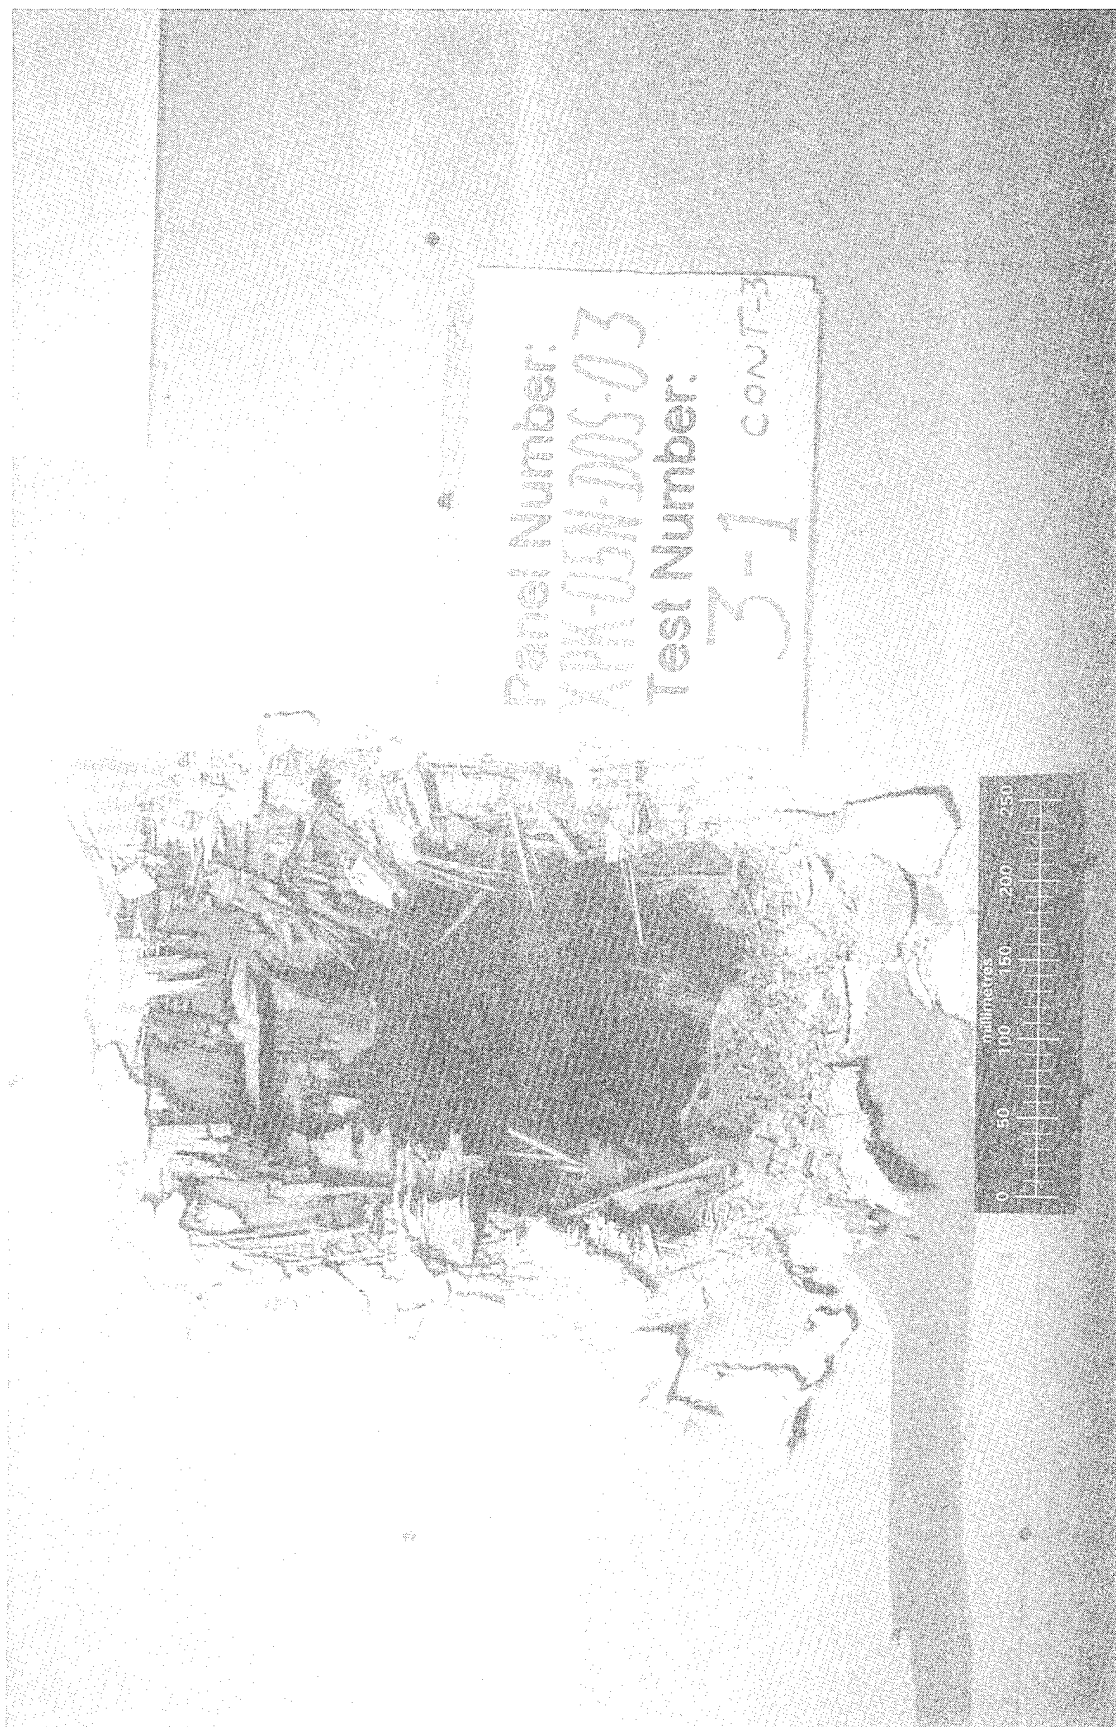
Figure 53. Assault side of panel XPK-05N-DOS-03 after the third assault phase of test 3-1

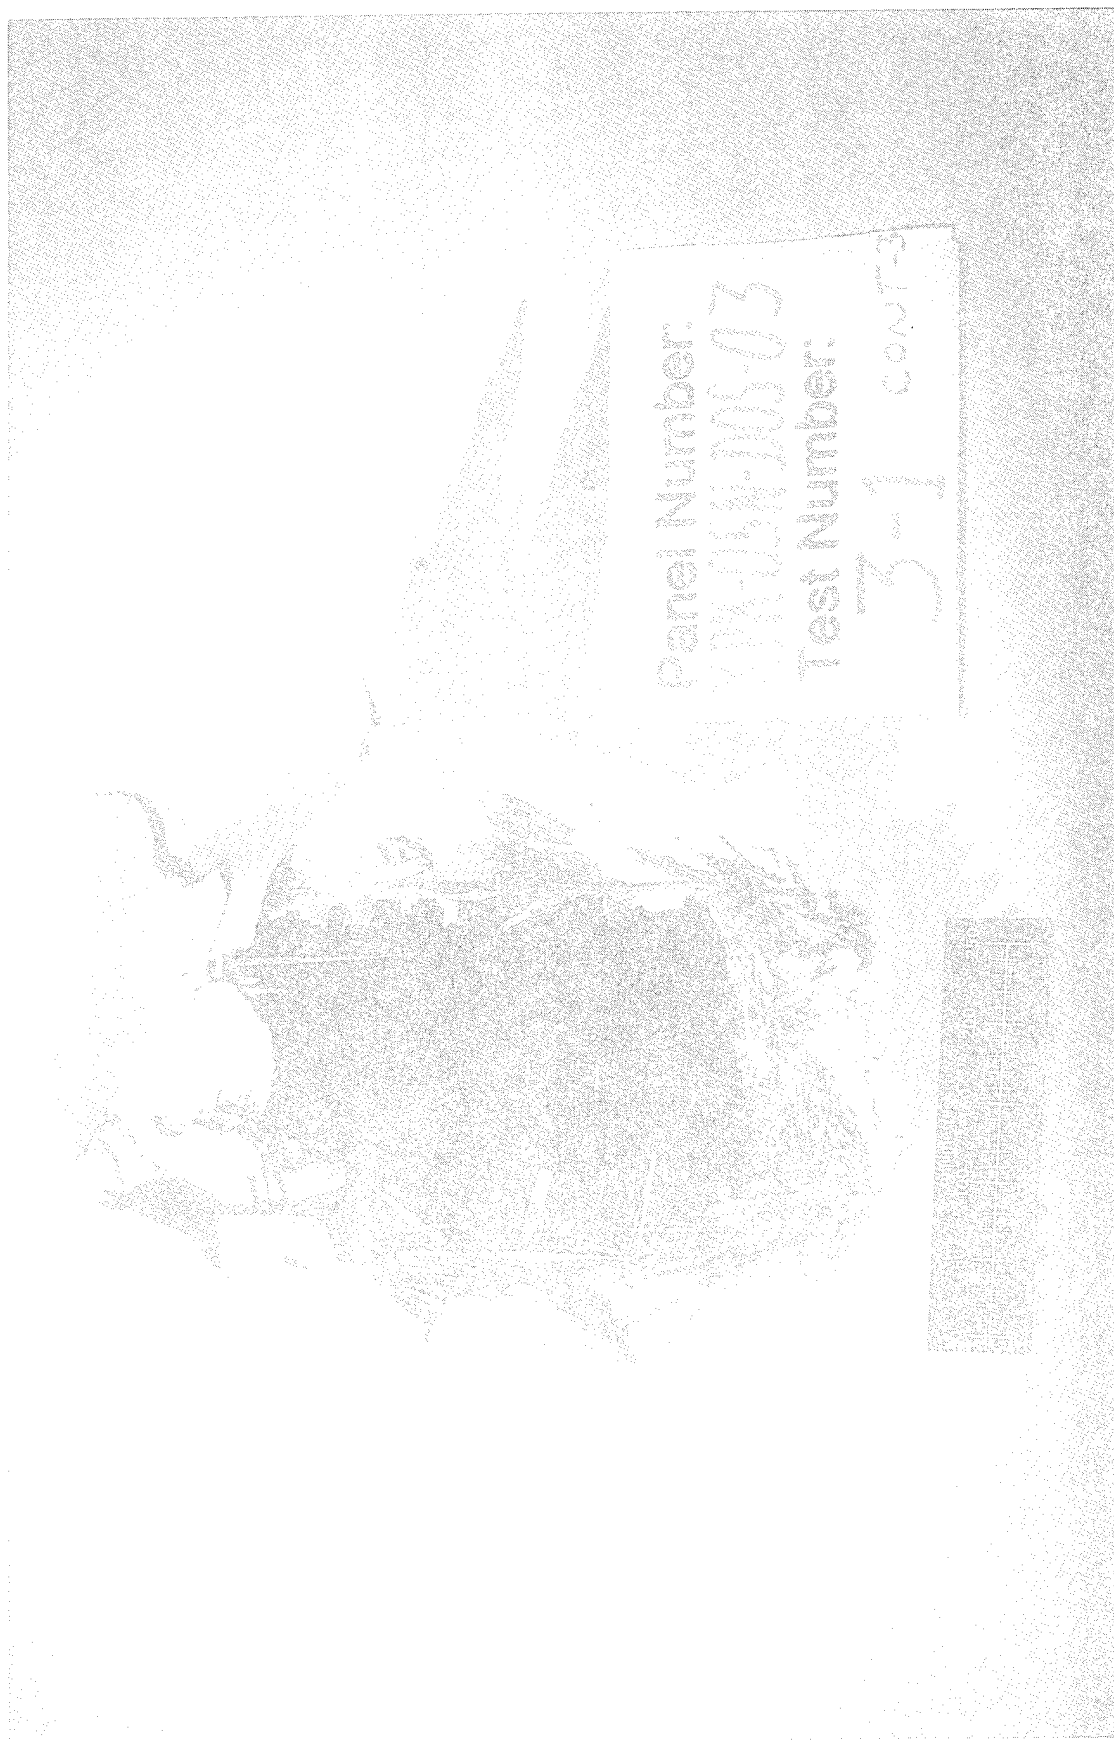
Figure 54. Protect side of panel XPK-05N-DOS-03 after the third assault phase of test 3-1

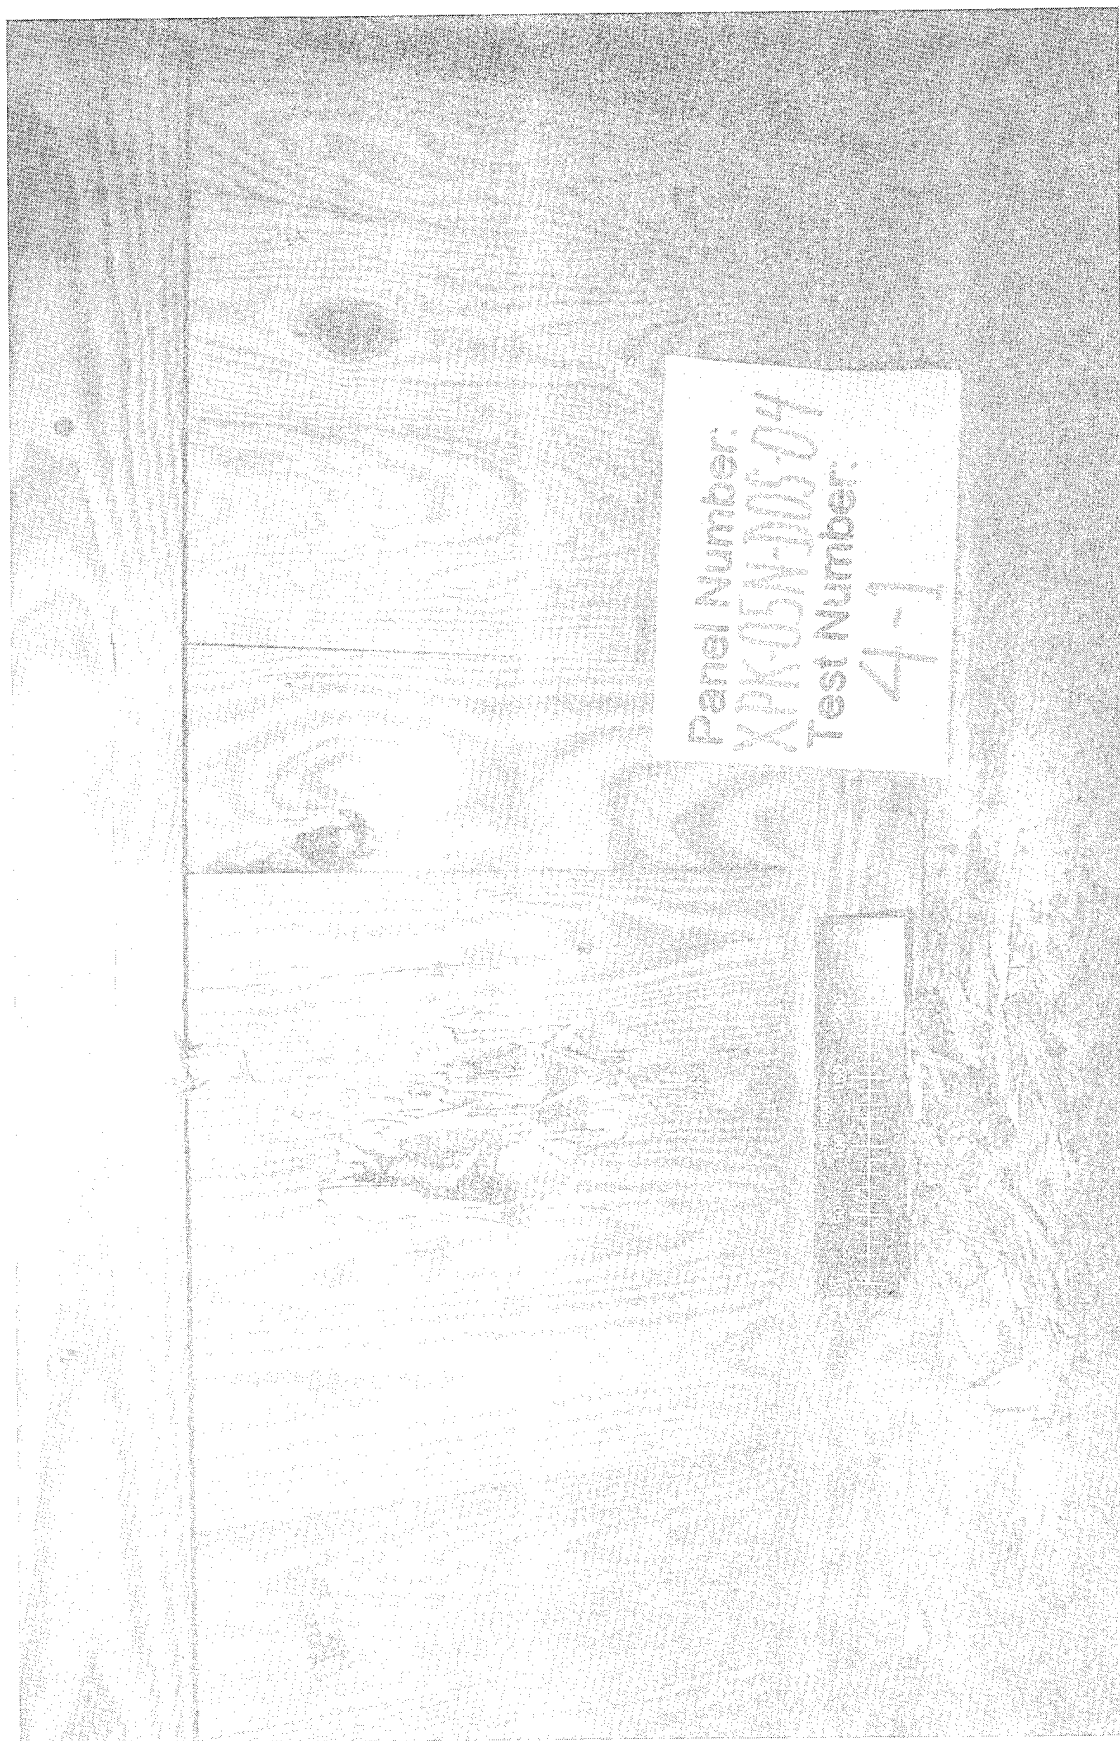
Figure 55. Assault side of panel XPK-05N-DOS-04 after test 4-1
