US Army Corps  
of Engineers  
Waterways Experiment  
Station

Miscellaneous Paper SL-96-1  
February 1996

## Forced Entry Testing of Five-Minute Walls

Prepared for U.S. Department of State,  
Office of Foreign Building Operations

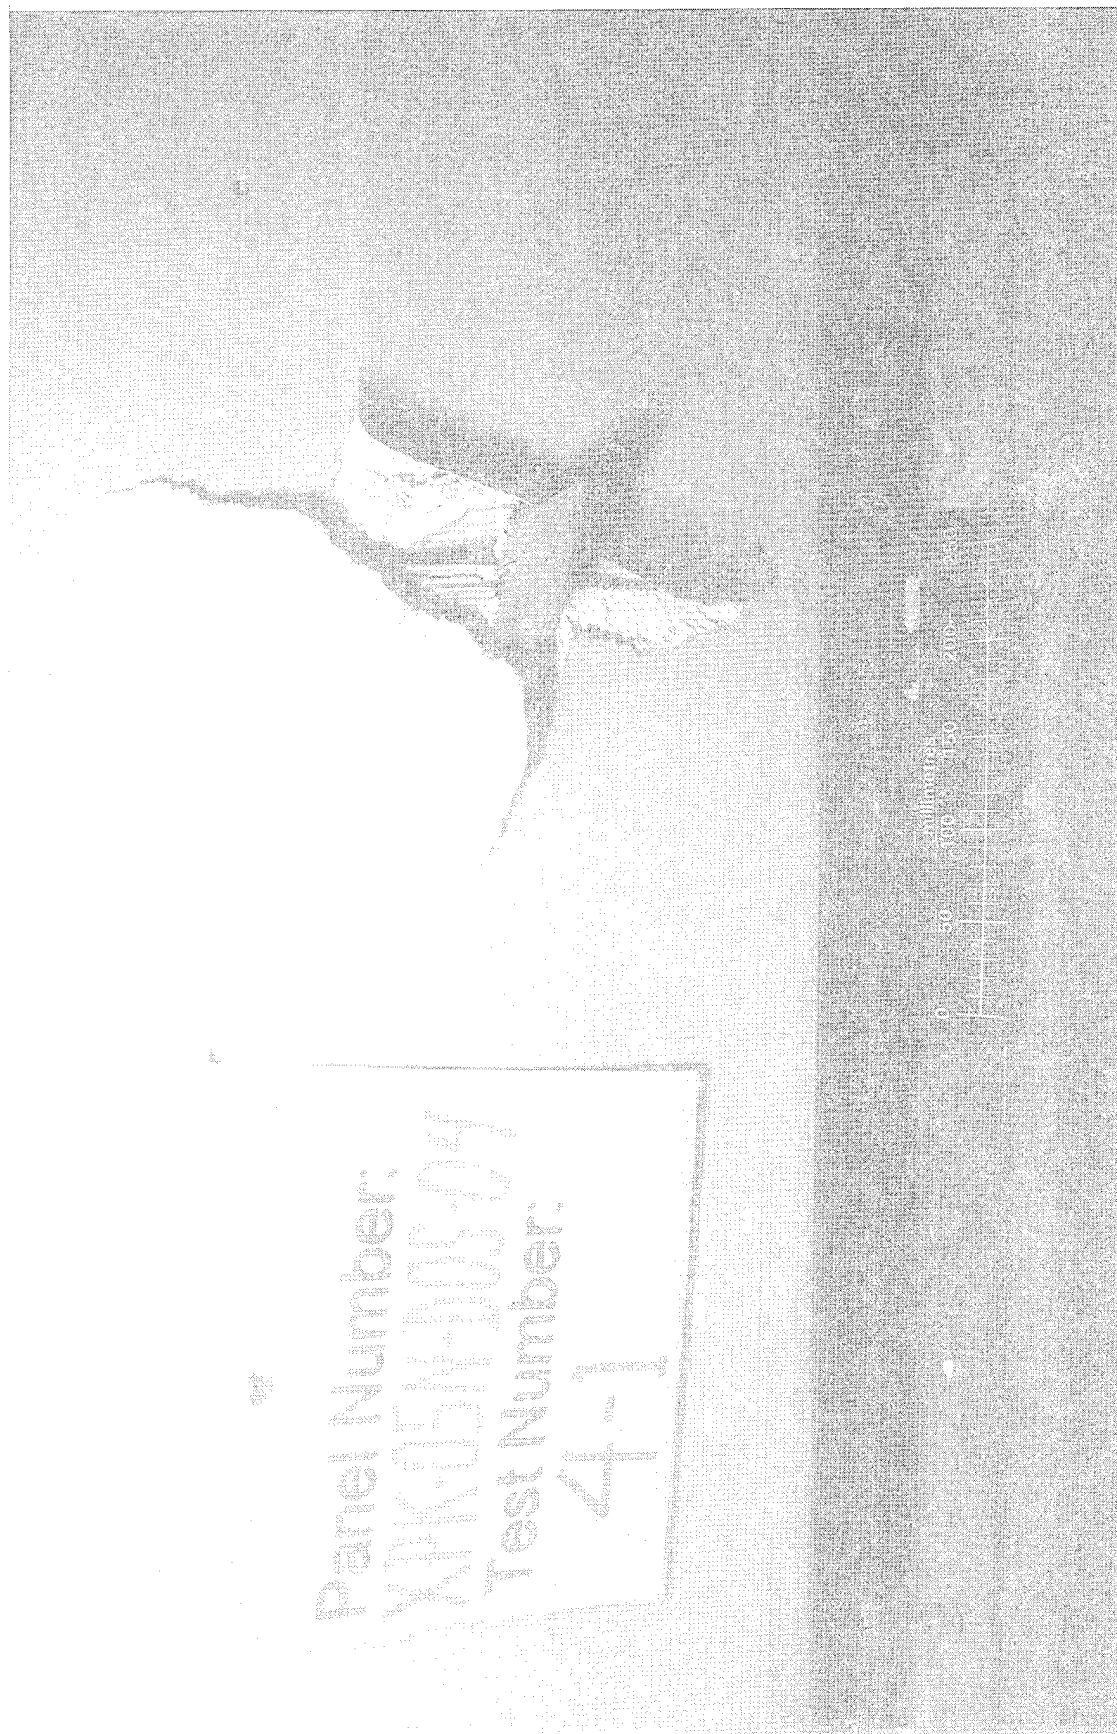
Figure 56. Protect side of panel XPK-05N-DOS-04 after test 4-1

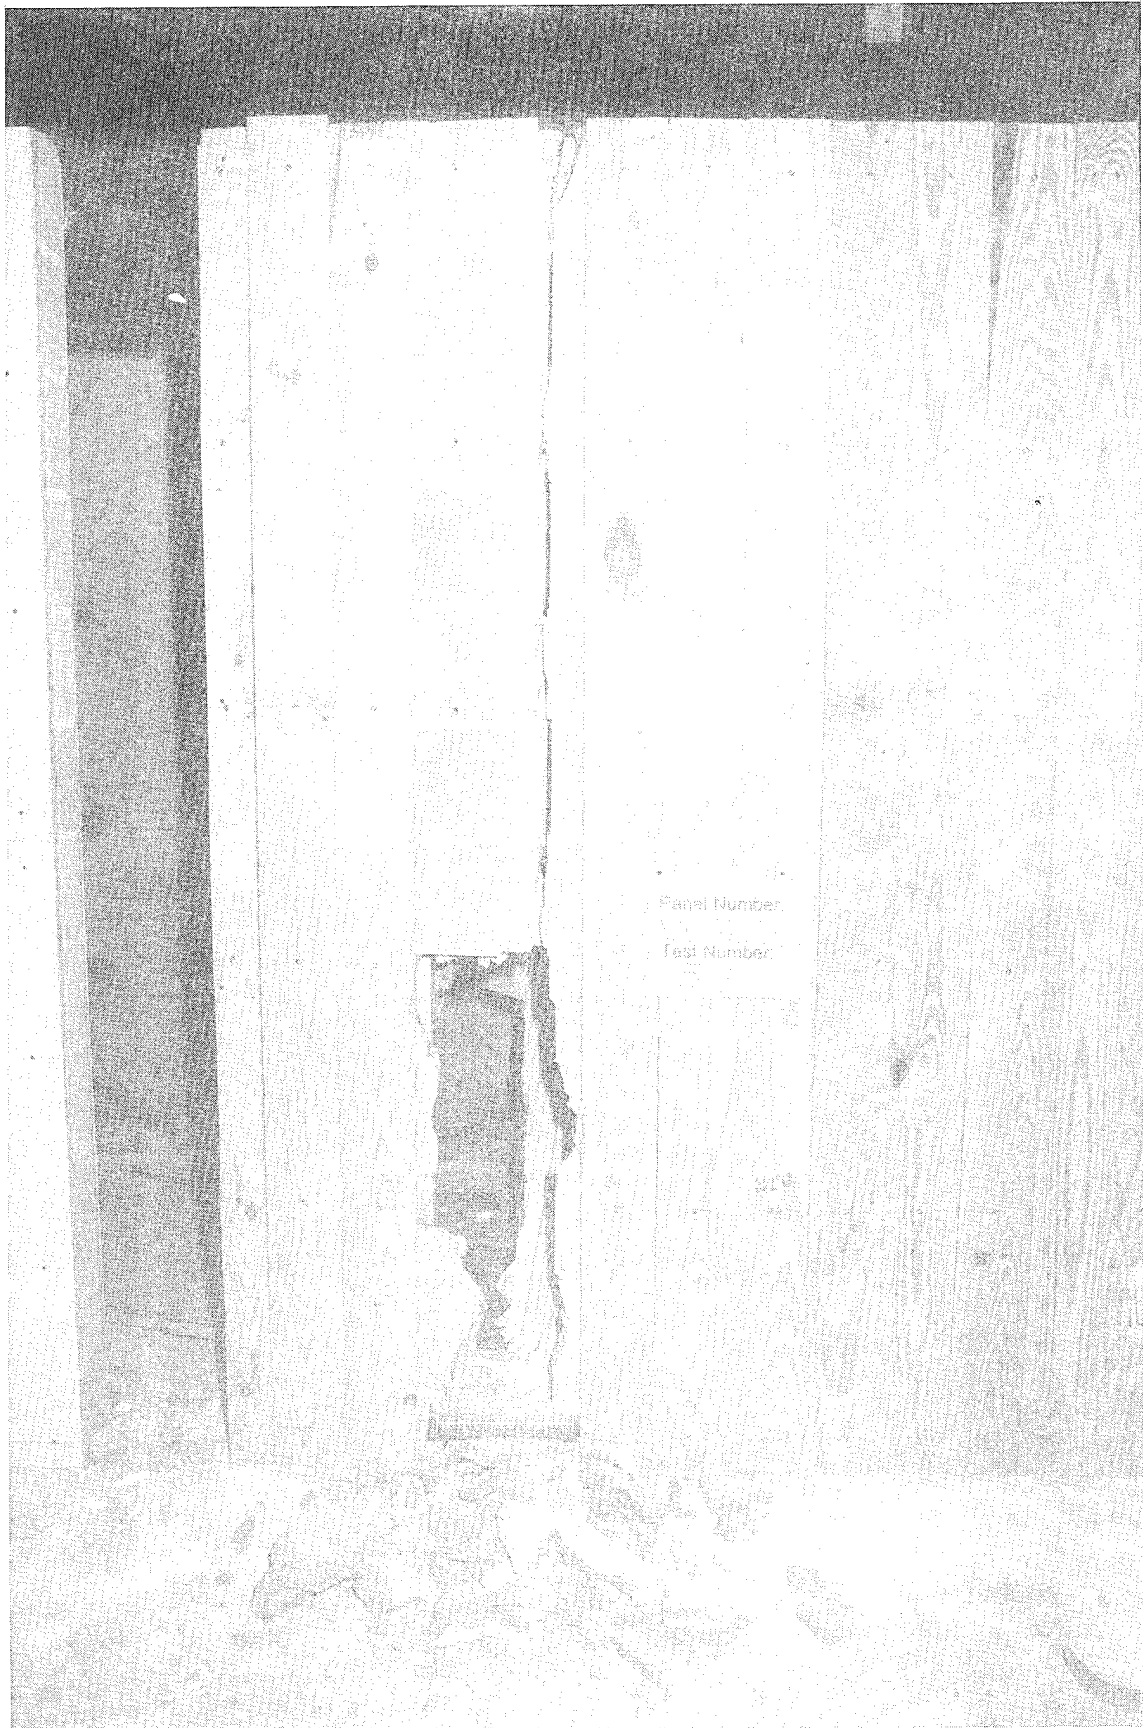
Figure 57. Assault side of panel XPK-05N-DOS-05 after test 5-1

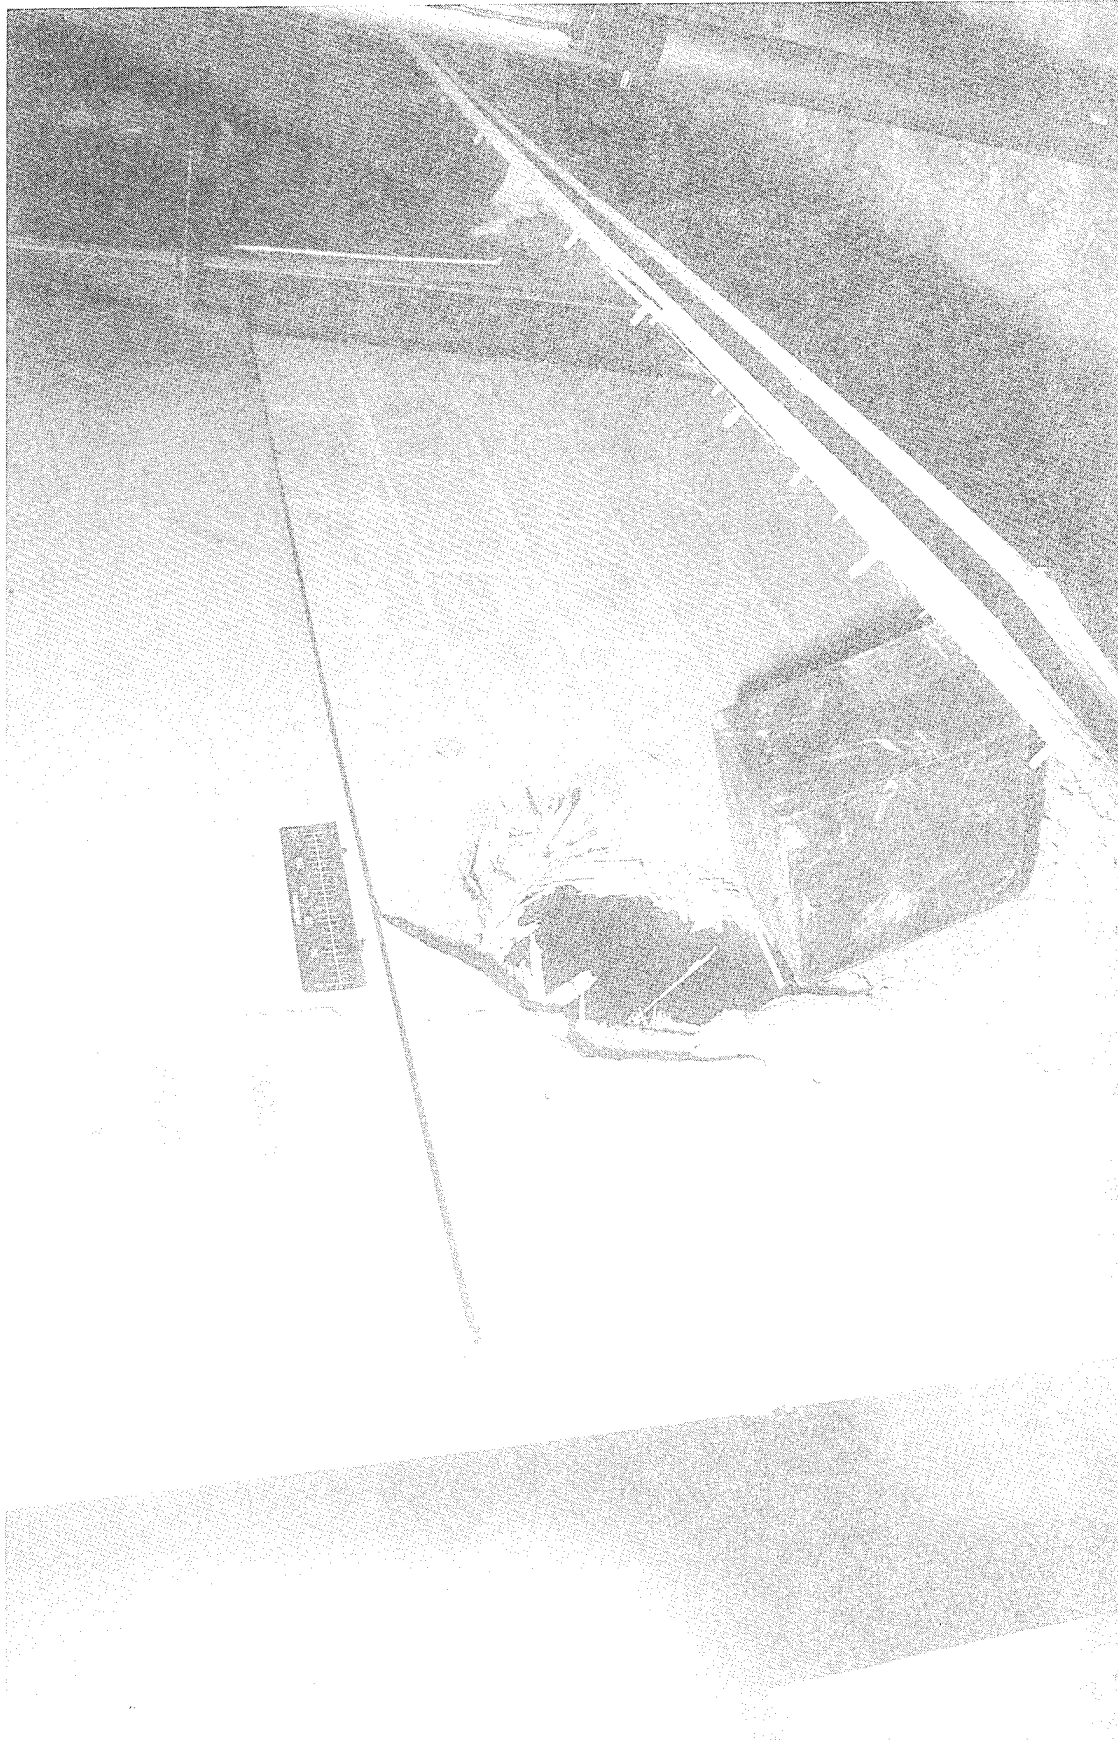
Figure 60. Protect side of panel XPK-05N-DOS-06 after test 6-1
