EFFECT OF MATRIX RESIN ON THE IMPACT FRACTURE CHARACTERISTICS
OF GRAPHITE-EPOXY LAMINATES

NASA Contractor Report 165784

P. E. Hertzberg, B. W. Smith, and A. G. Miller

Boeing Commercial Airplane Company
Seattle, Washington

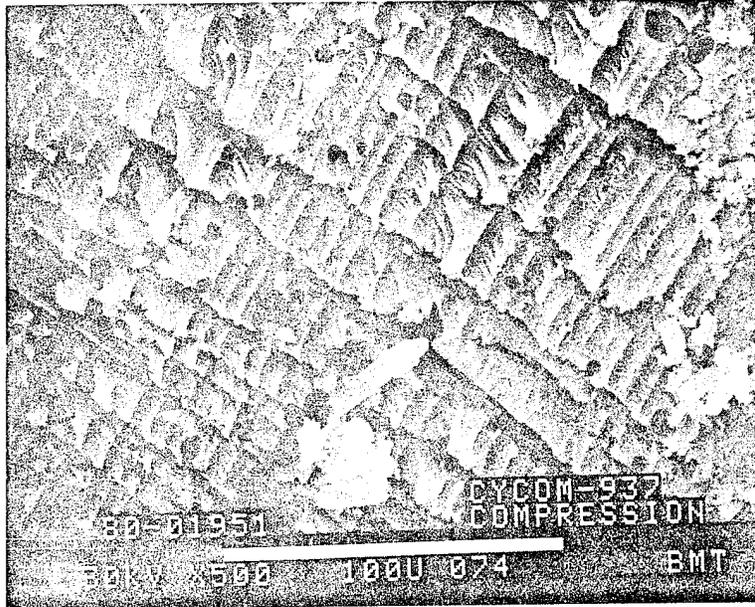
Figure 25. Static Notched Shear Failure, Propagation Zone, Cycom 937 (500X)

Note: Voids are not crack origins.

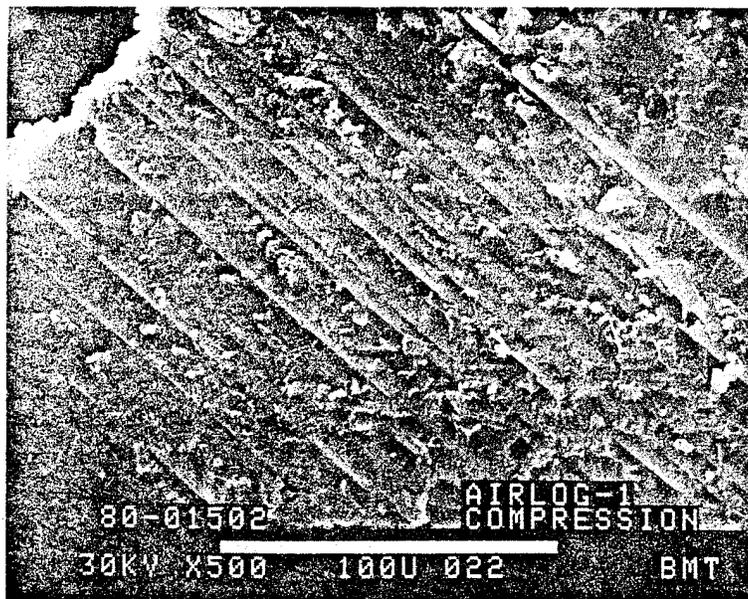
Note plastic flow between fibers.

Figure 36. Compression Shear, Air Logistics 1 (500X)

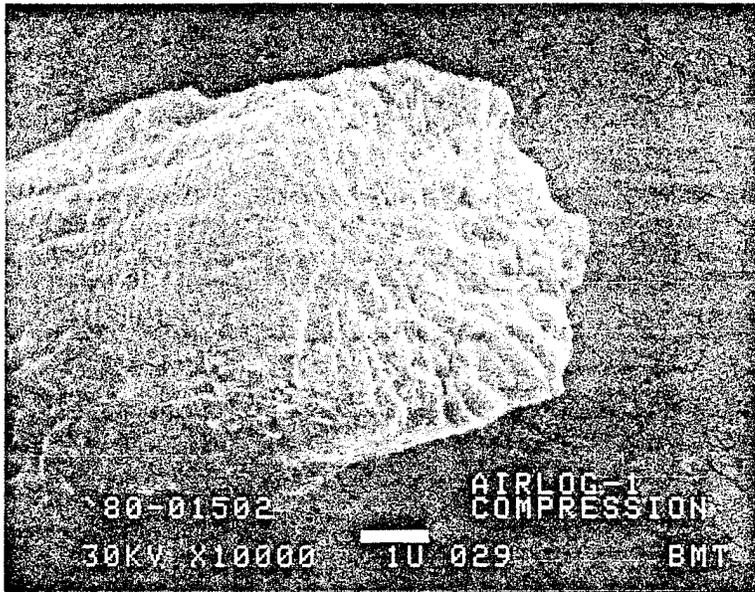
Figure 40. Fiber-Matrix Bond, Compression Side, Air Logistics 1 (10,000X)

Note cohesive failure.

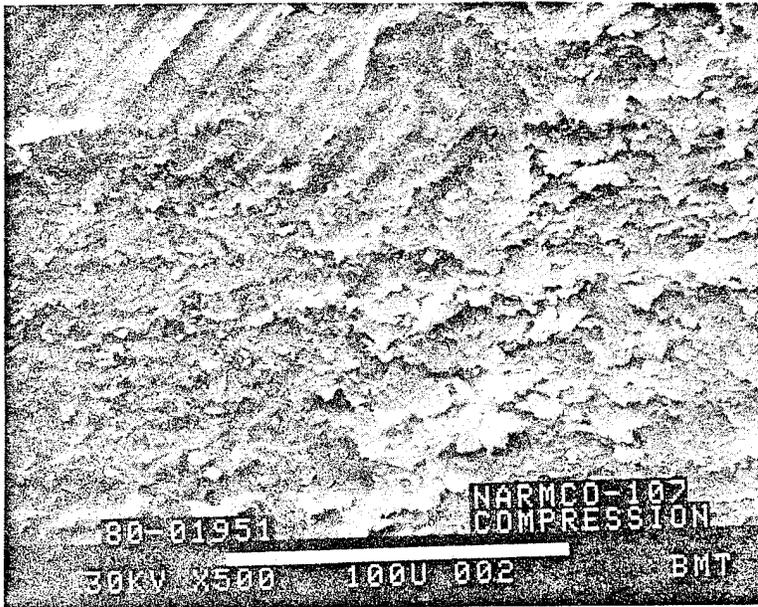
Note: Same area as figure 47.

Figure 49. Compression Shear, Narmco 107 (500X)

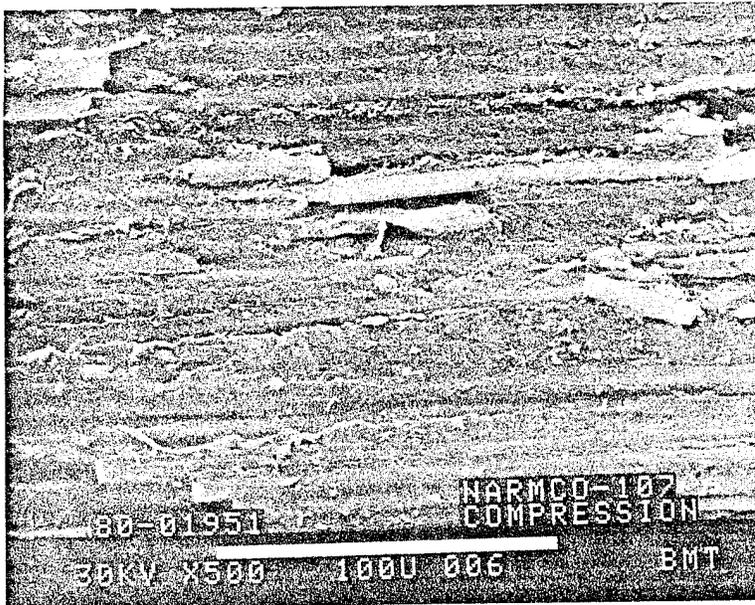
Note: Same area as figure 48.

Figure 50. Transverse Fracture of 90-deg Ply, Narmco 107 (500X)

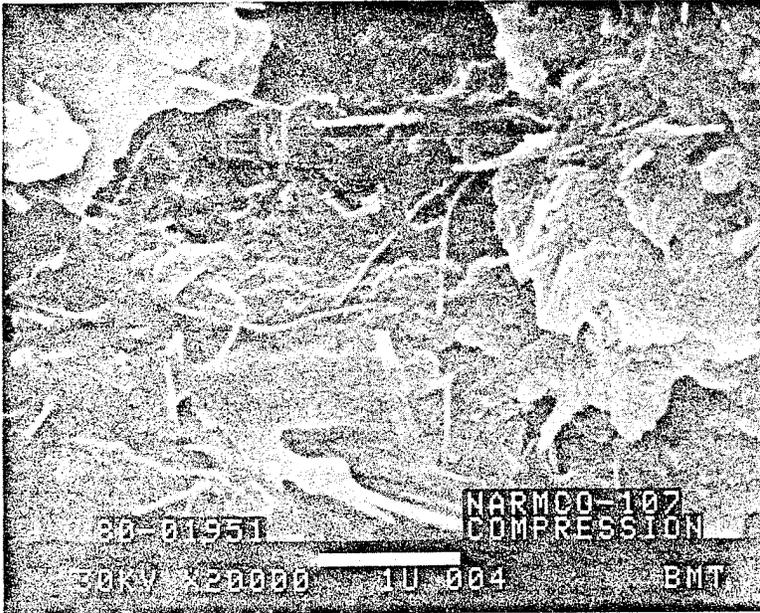
Note that hairs are part of larger resin blocks.

Figure 53. Compression Shear Hairs, Narmco 107 (20,000X)

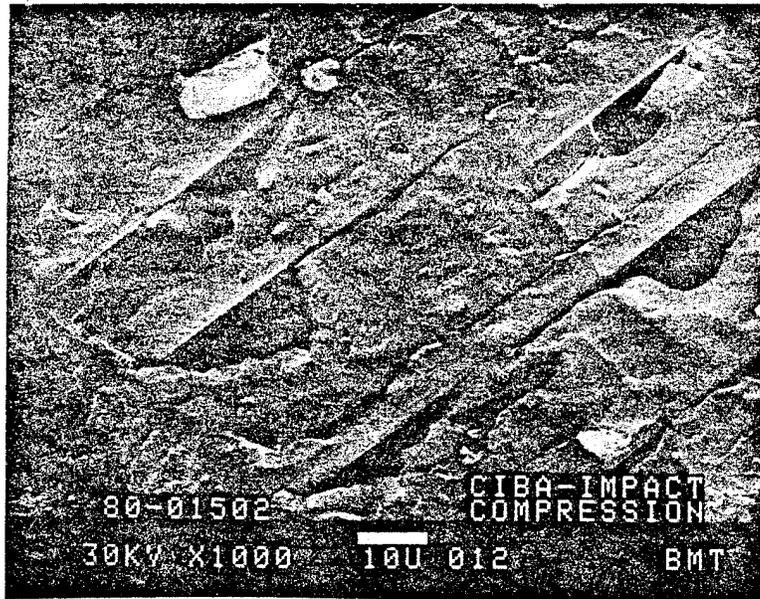
Figure 76. Influence of Voids on Fracture, Ciba 1M (1000X)

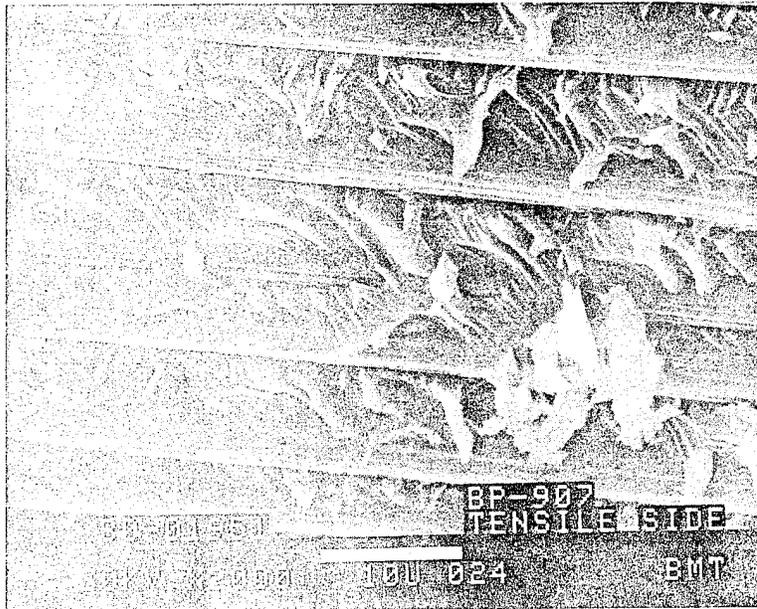
Figure 97. Ductile Resin Failure, BP-907 (2000X)

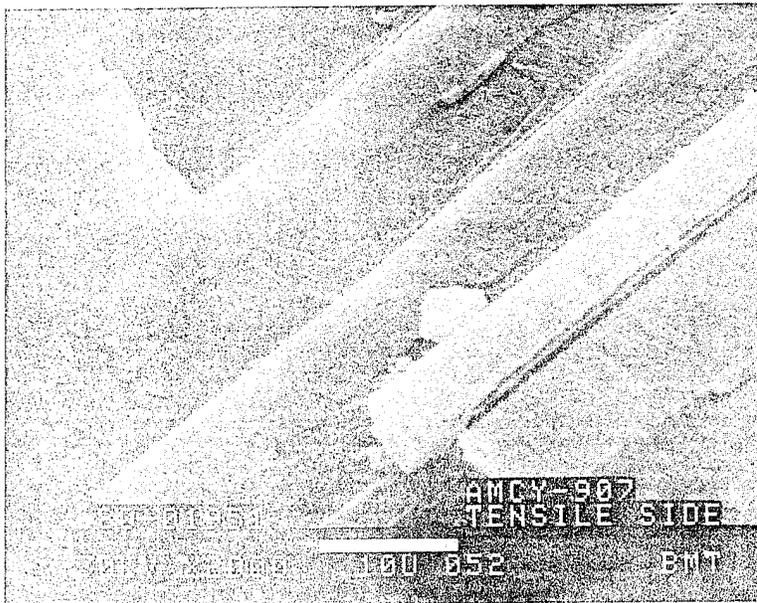
Figure 98. Brittle Cleavage Failure, BP-907-LR (2000X)

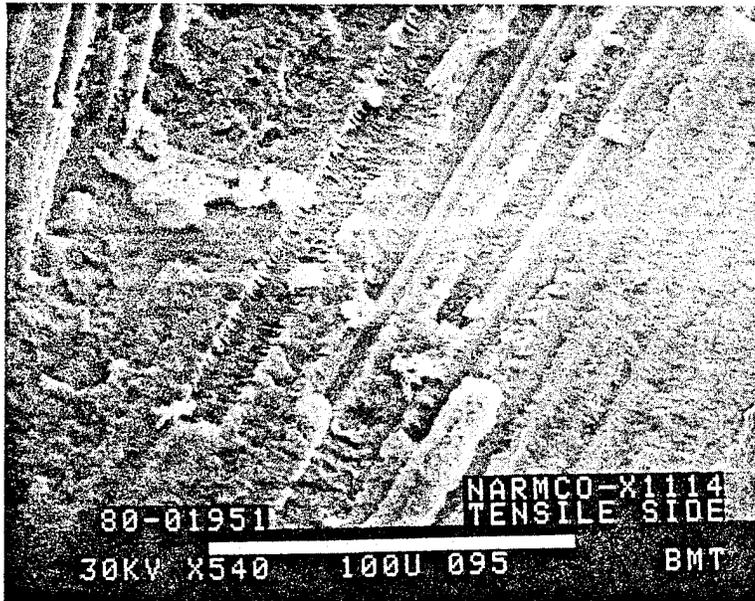
Figure 112. Tension Failure, 90-deg Ply, Narmco X1114 (540X)

Note stretched and collapsed resin.

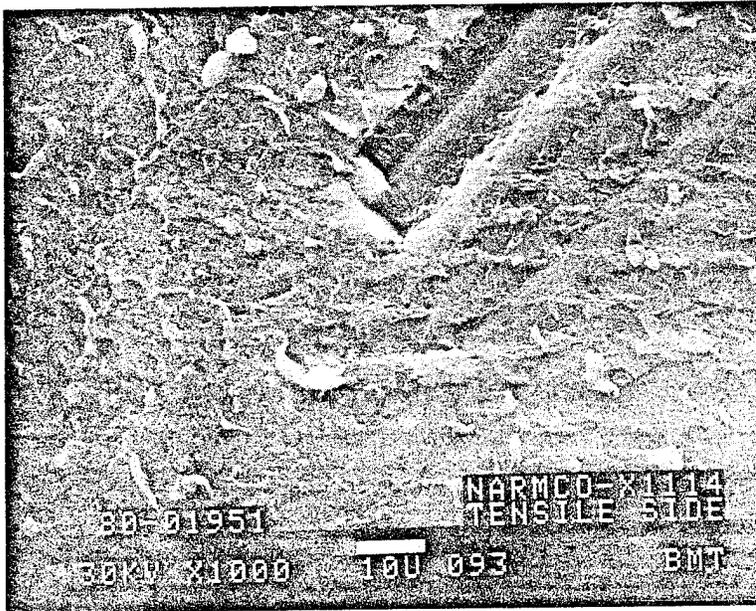
Figure 113. Delamination Face, Narmco X1114 (1000X)

Note lack of propagation of fiber failure.
