DOT/FAA/AR-95/54

Transport Water Impact and Ditching Performance

March 1996

Final Report

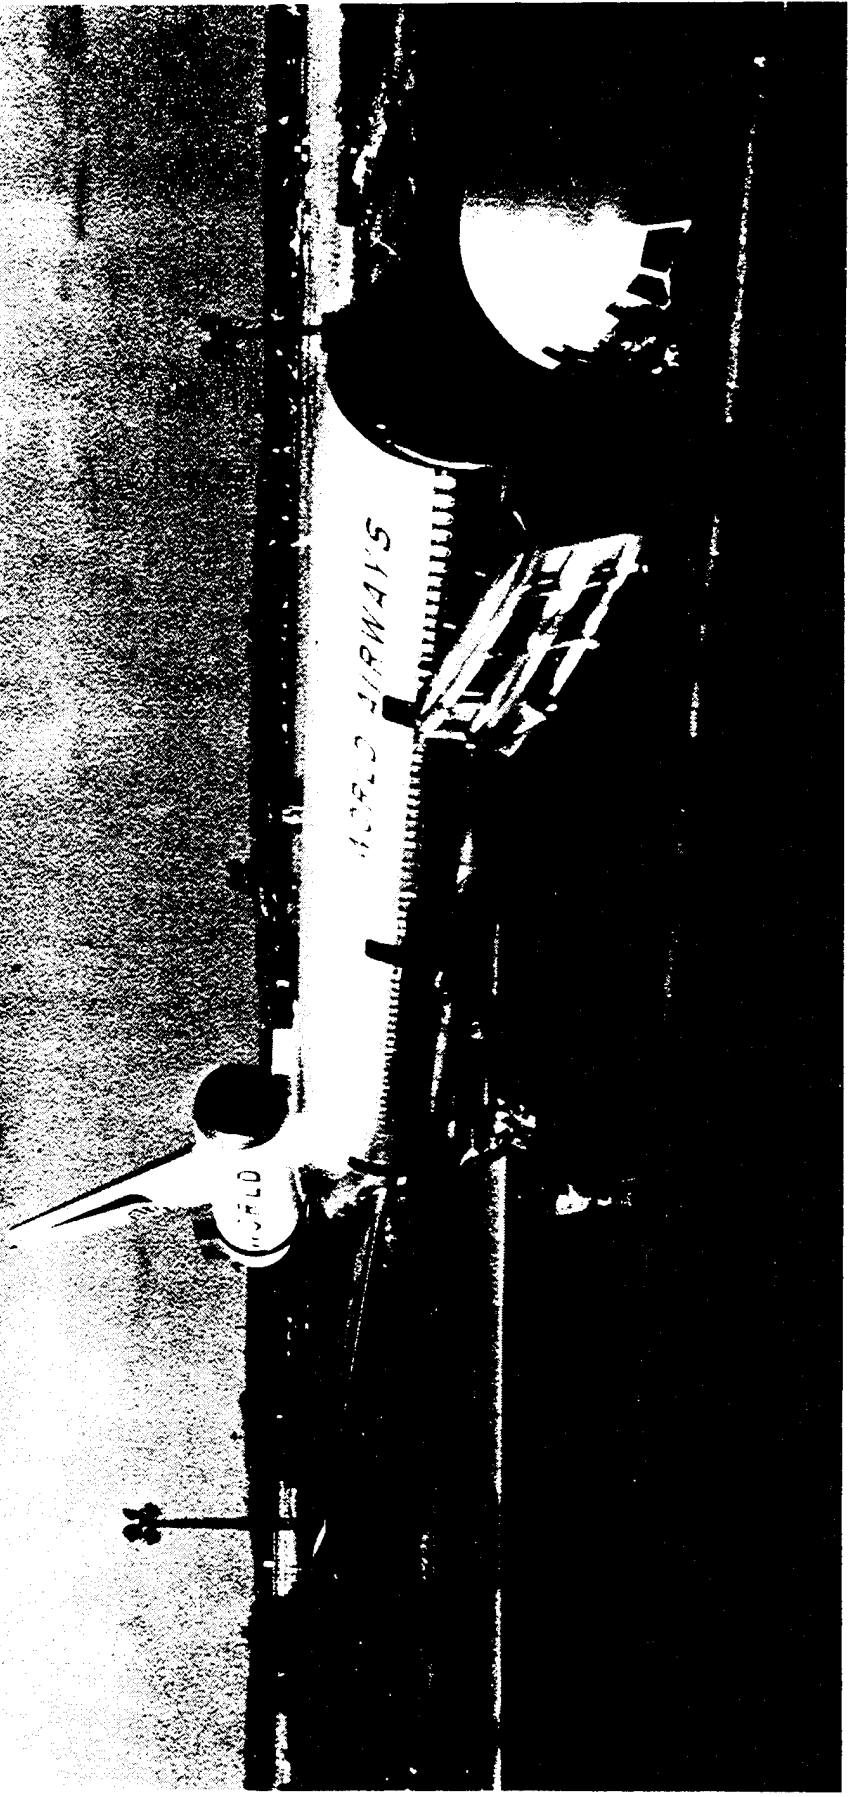
FIGURE 1. WORLD AIRWAYS DC-10 AFTER COMING TO REST IN BOSTON HARBOR

Upon crossing the end of the runway, the airplane came to rest with a slightly nosedown attitude in water which came up to the wings. A section of the nose up to the first row of the cabin seats separated along a fracture line (figure 1) and remained attached to the fuselage only by control cables and electric wire bundles. The pressure bulkhead was crushed along the fuselage bottom centerline, and the main cabin floor beams from fuselage station (FS) 392 to 475 failed due to the downward displacement. The pressure bulkhead at the forward end of the nose gear was crushed as well, leading to the failure of the extended nose gear. The main landing gear were extended and remained undamaged. The airplane's three engines remained attached to their respective pylons, although the No. 3 engine's rear mount was broken. There was no substantial mechanical damage to the engine.

The overall impact forces experienced by the passengers as the aircraft came to rest in the water did not jeopardize occupant survival except in the area of the fuselage separation. The failure of the main cabin floor beams in this area led to floor displacement and subsequent seat track fractures. Three seat modules in the first passenger row, consisting of three left, two center, and three right seats, separated from the floor. This led to the disappearance and presumed death of two of the three passengers seated in this row. The third passenger seated in this row was able to climb back into the main cabin. The cabin aft of the structural separation remained intact.

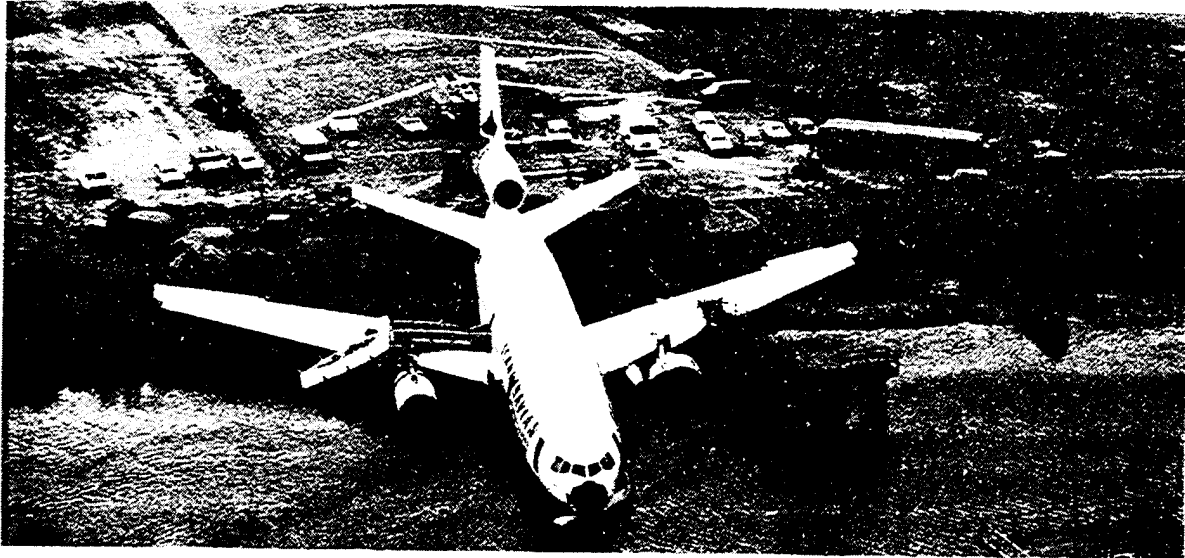
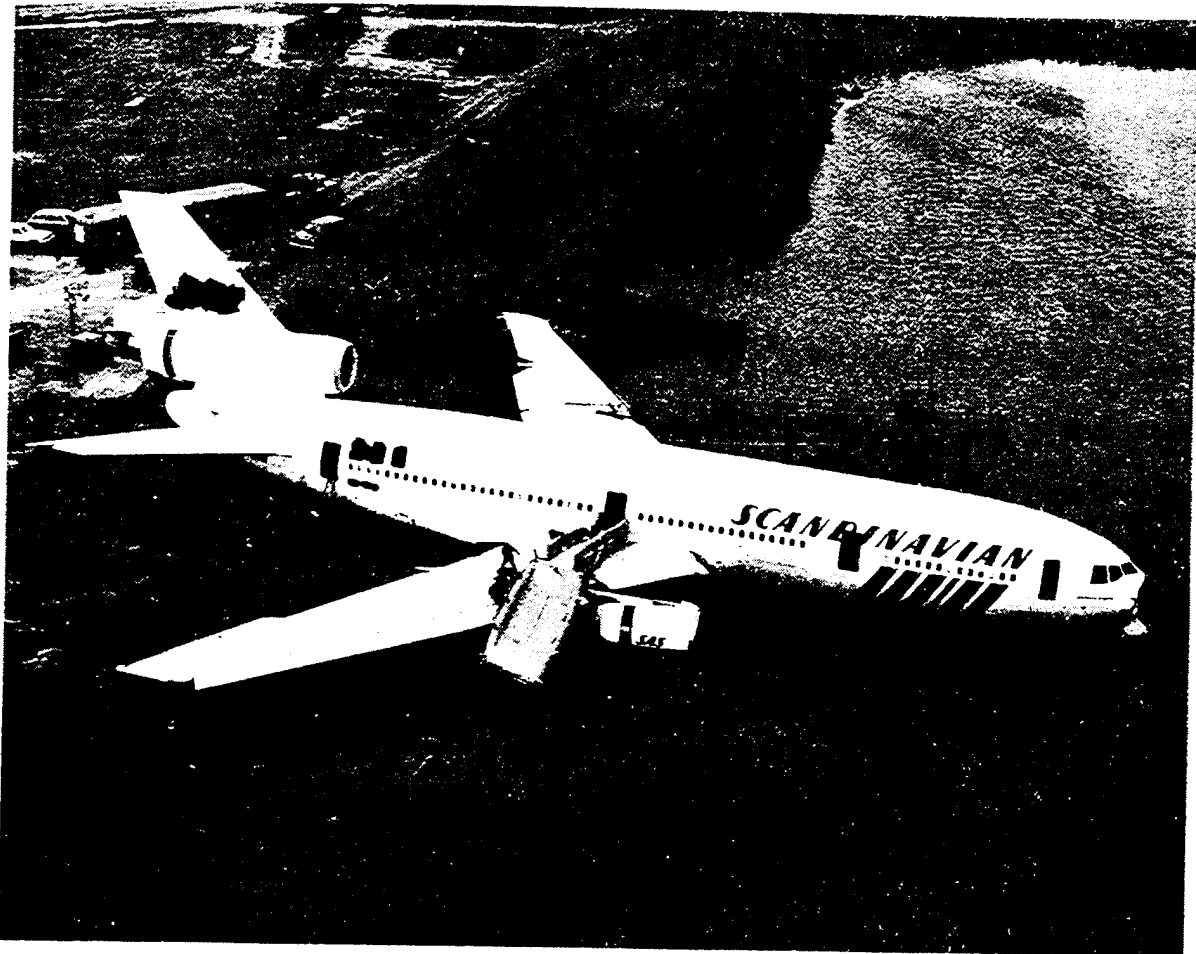
FIGURE 2. JOHN F. KENNEDY AIRPORT RUNWAY GRADUAL SLOPE TO WATER

The nose of the airplane came to rest in the tidal waterway approximately 160 feet from the end of the runway overrun area (figure 2). The leading edge of the left wing was embedded in a wooden pier structure which supported the approach lighting system. The aft section of the airplane remained generally intact, however there was major damage to the lower nose area, to the radome, and to the forward pressure bulkhead at fuselage station (FS) 275. The damage was caused by hydrodynamic pressure generated during impact with the water.

The interior of the forward fuselage area was deformed. The wings, leading edge, and flaps sustained moderate damage from impact with the wooden pier. Several floor beams beneath the galley were fractured. The nose gear collapsed and its drag braces fractured and separated from their attachment fittings. Wing engines Nos. 1 and 3 sustained impact and salt water damage. The No. 1 engine pylon structure was also buckled and twisted. The No. 2 engine sustained no impact damage.

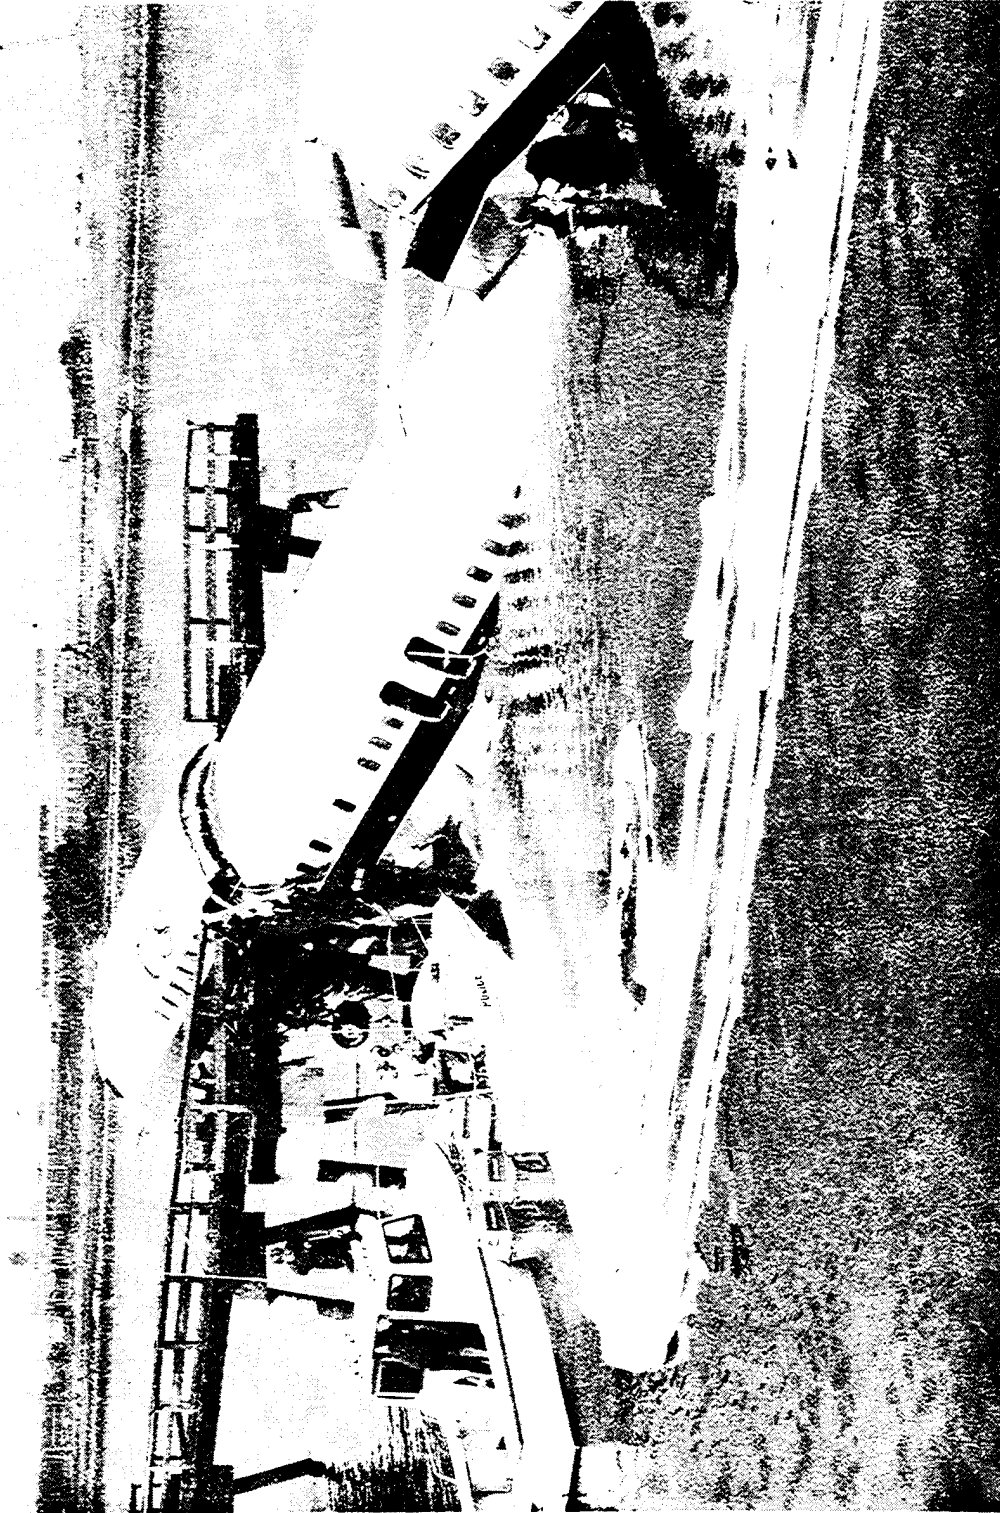
FIGURE 3. US AIR B737-400 AFTER COMING TO REST ON LIGHTING STANCHION IN BOWERY BAY

Decelerative forces were not great enough to cause any seat dislocations or seat belt/shoulder harness separations. The only seat damage was caused by fuselage crush and subsequent floor displacement.

Floor displacement was the primary cause of two fatalities. Timber from the wooden approach light pier structure penetrated the fuselage and forced the floor section and surrounding seats upwards, crushing four passengers against the ceiling. Two passengers in row 21 were killed by asphyxia caused by compression of the chest and two passengers in row 22 sustained serious multiple injuries. A piece of wood also penetrated the forward cockpit bulkhead, but did not produce any seat dislocations and caused only minor injury to the captain. The airplane was equipped with eight exits (figure C-3): the L-1 main boarding door, the L-2 aft entry door, the R-1 forward galley door, the R-2 aft galley door, and four overwing exits. All exit doors, with the exception of the L-1 and L-2, were used during evacuation. The L-1 door could not be opened by the lead flight attendant, and the L-2 door was closed when water began entering the cabin. The R-1 slide was successfully deployed. The flight attendant disarmed the R-2 slide before the door was opened to prevent the slide from blocking the exit area. Both the left and right overwing exits operated successfully during evacuation.

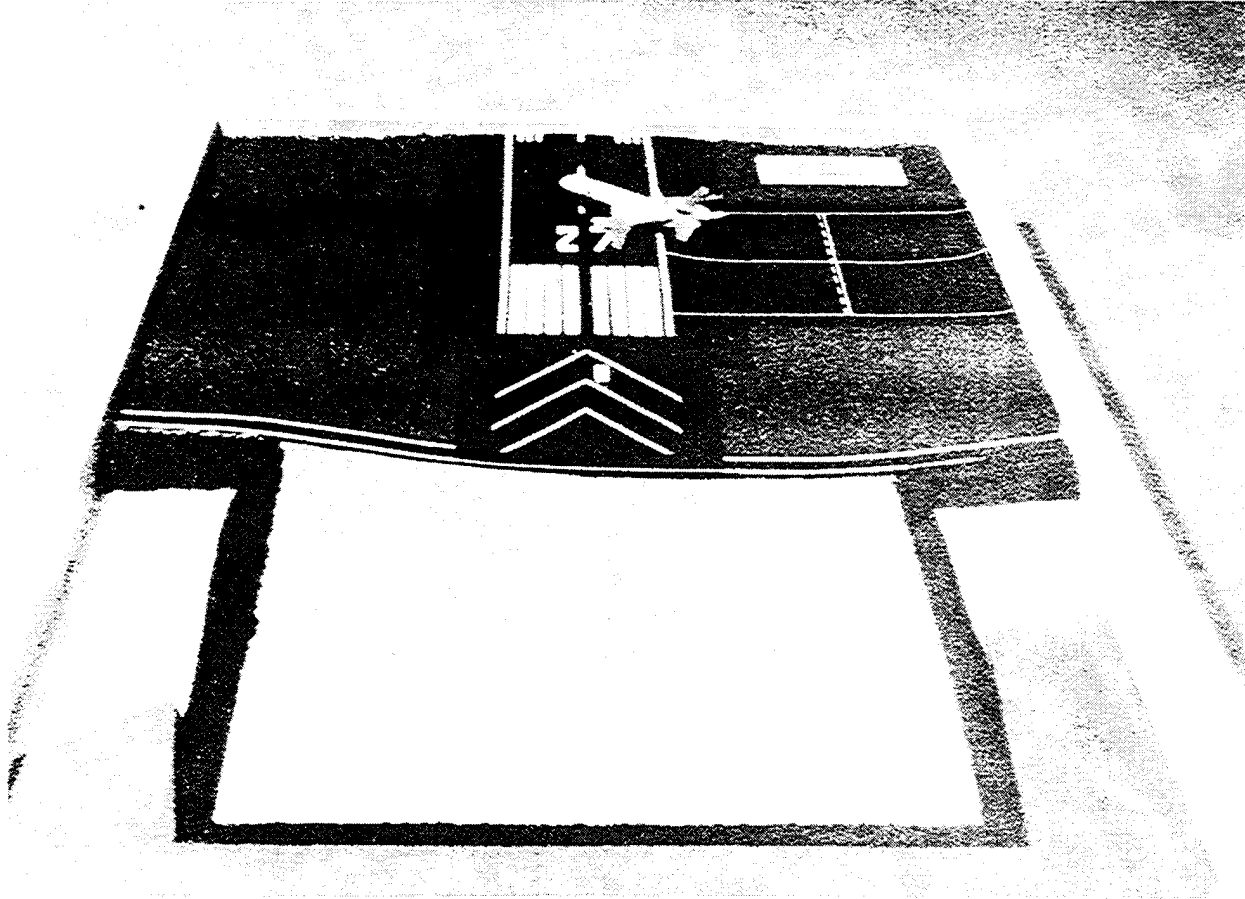
FIGURE 4. INCLINED SAFETY AREA (ISA) MODEL DEVELOPED BY BOSTON-LOGAN AIRPORT ENGINEERS

Allowing the airplane to gradually slide into water, as in the JFK accident, should result in minimal aircraft damage and a successful emergency evacuation of all occupants using the available flotation devices. Runway overrun areas leading into water which avoid sudden drop-offs and allow for a smooth transition into the water can reduce impact forces and prevent fuselage separations. Evidence to support this is provided by both the FAA and airport engineers. As stated in FAR Part 139.307 (a)(1), "No slope from the edge of the full-strength surfaces downward to the existing terrain shall be steeper than 2:1," thus preventing vertical drop-offs. Boston-Logan Airport Engineers have looked into the feasibility of developing sloped runway safety areas that decelerate the aircraft through the use of gravel. The model of such a sloped overrun area, developed by Boston-Logan Airport Engineers, is shown below in figure 4.

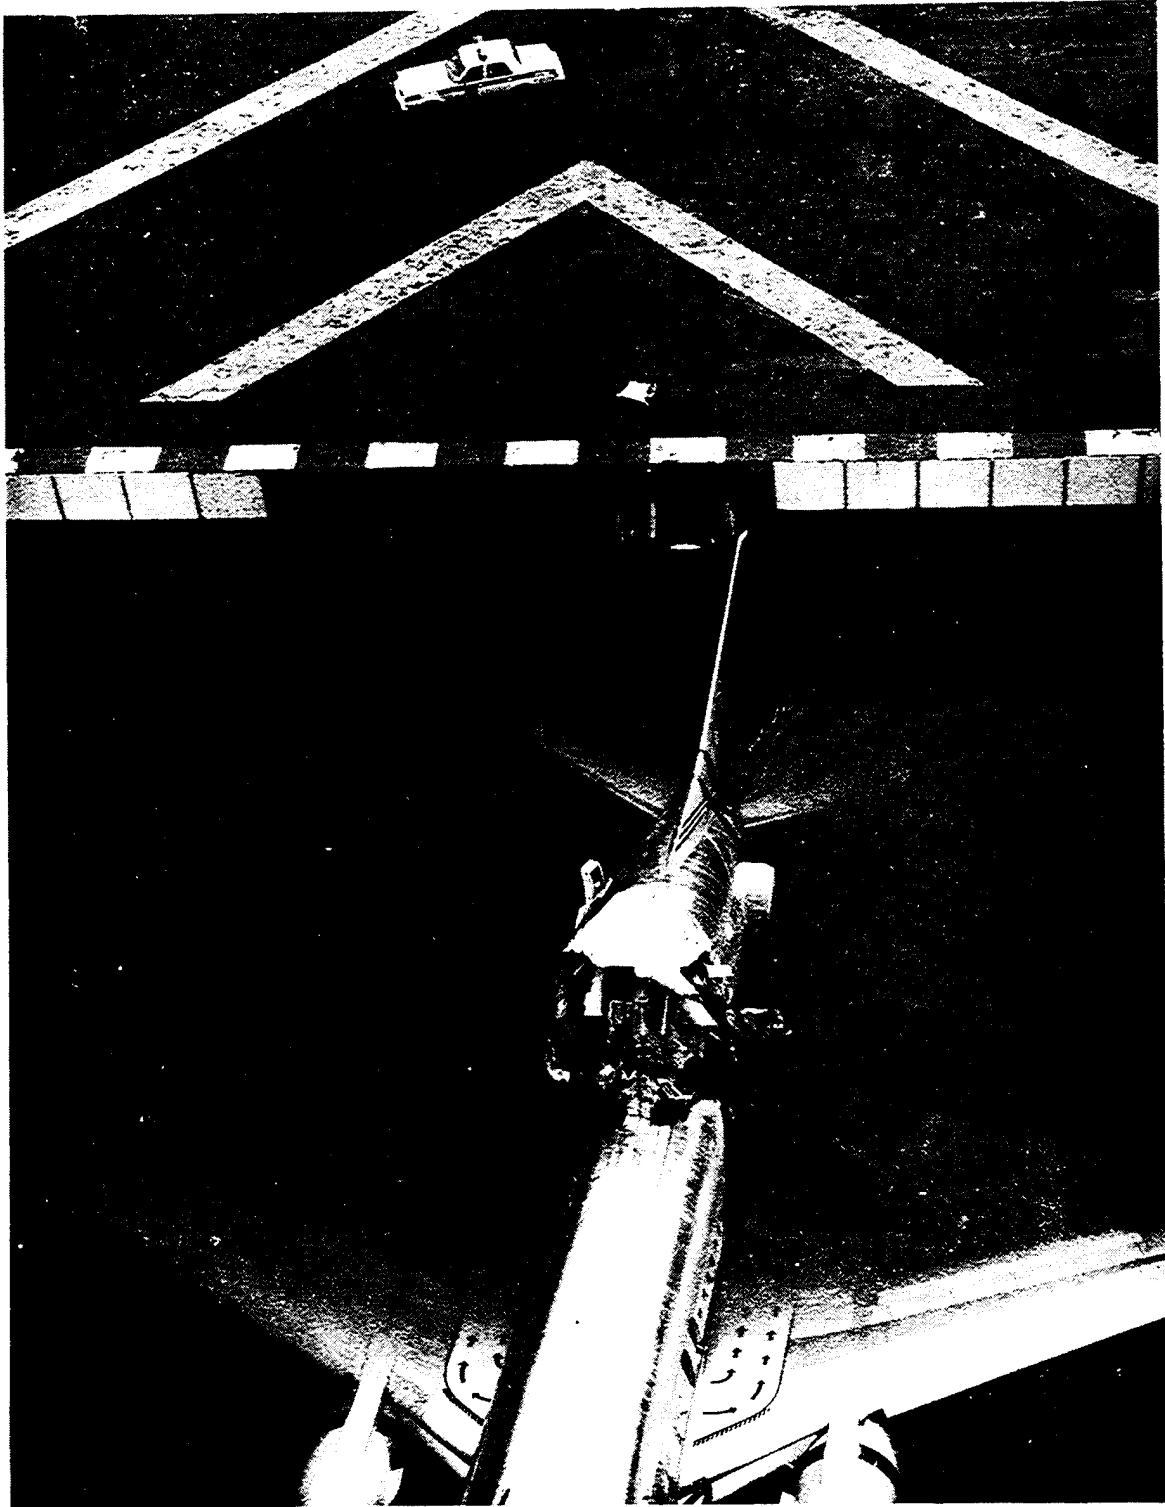
FIGURE 5. LAGUARDIA AIRPORT RUNWAY DROP-OFF TO WATER

The drop into the water and the presence of obstructions immediately beyond the runway increase the potential for excessive impact forces on the airplane. The LaGuardia accident included both of these hazards. Upon crossing the end of the runway, the airplane encountered a drop of approximately 10 feet into the water and a concrete/wooden pier structure positioned within 50 feet of and in line with the end of the runway. The fuselage separated in two locations. In contrast, the JFK accident involved a very gradual slope into the water resulting in no fuselage separations. Although there was an approach lighting pier located directly beyond the runway, the landing gear remained on the ground and the pilot was able to swerve the airplane to avoid it.

NTSB made the following recommendations to the Port Authority of New York and New Jersey. Survey the 1,000 by 500 foot surface area contiguous to the departure ends of the runways at the LaGuardia Airport in order to minimize hazards to airplanes that do not stop on the runways.
