USACERL Technical Report 96/77  
July 1996

# Investigation of Preapproved Underground Heat Distribution Systems

USACERL investigated and evaluated the physical condition and general performance of drainable-dryable heat distribution systems installed since 1981.

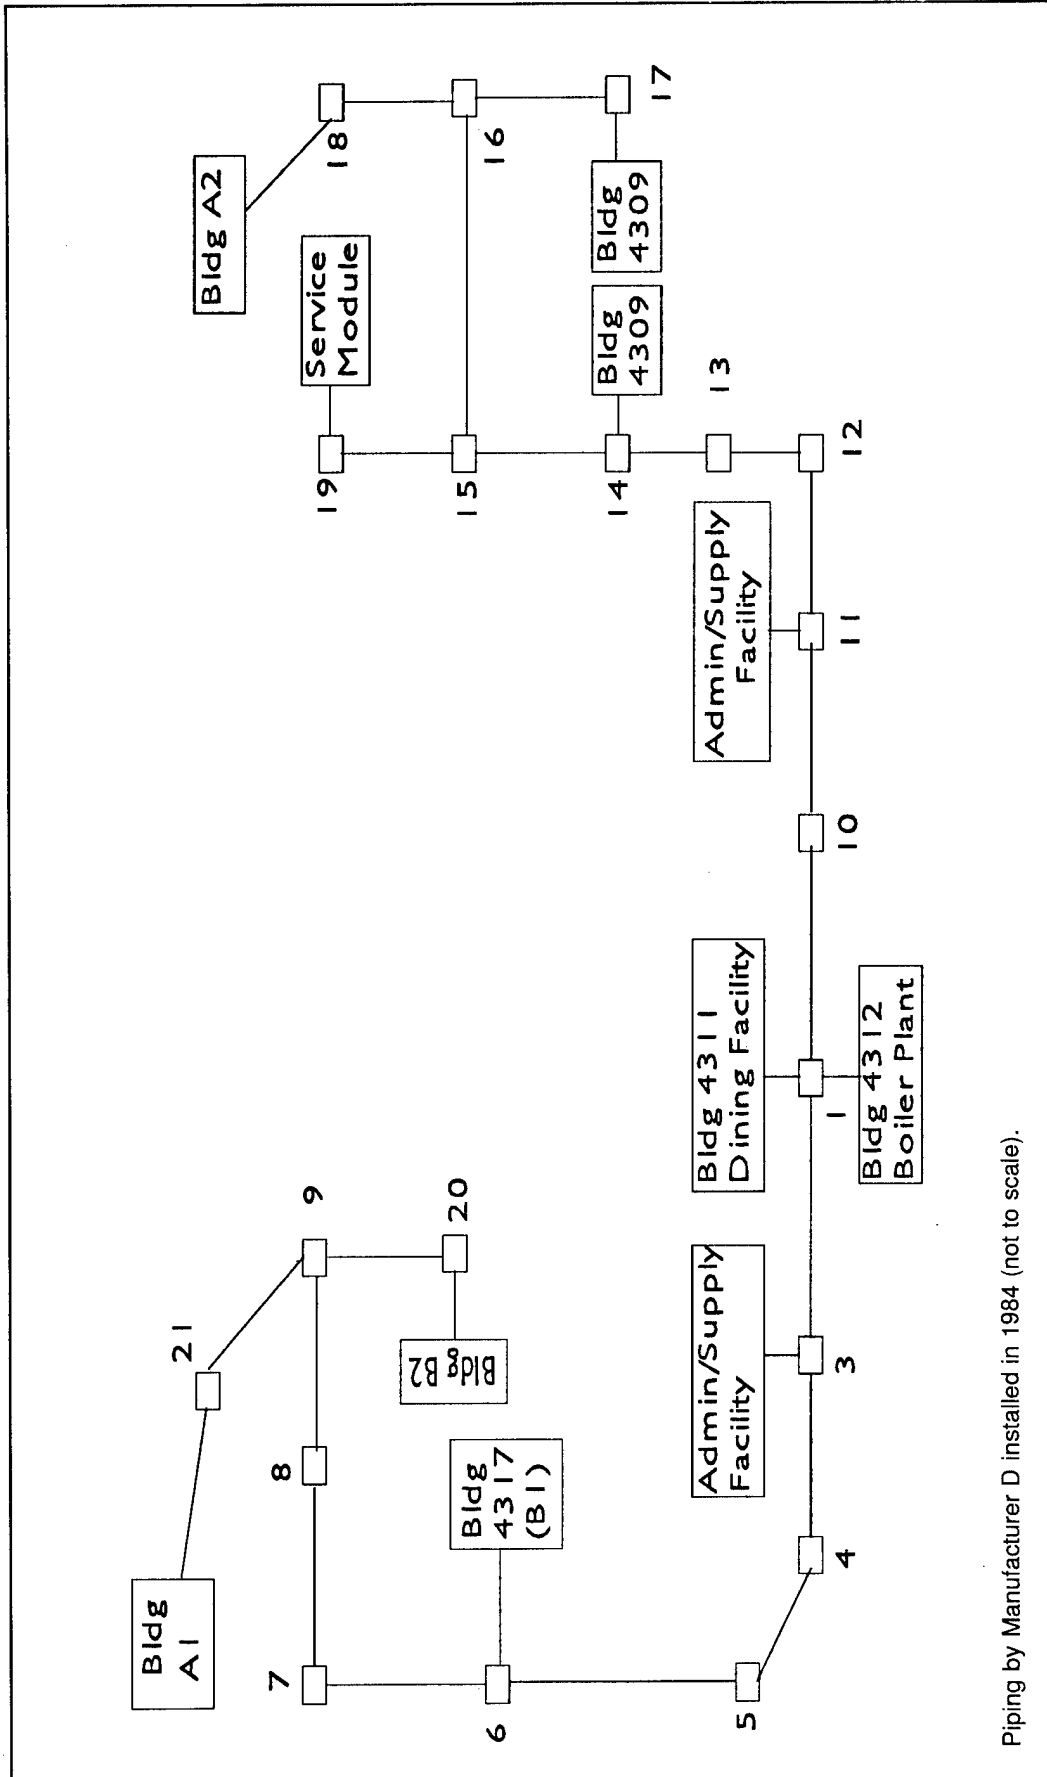
Figure C1. Schematic drawing of System 1 at Aberdeen Proving Grounds, MD.

f. Manhole 6—This manhole serves Building 4317. The sump pump was operational, and the manhole was dry. No steaming was observed at conduit vents. In this manhole, the steam supply and condensate return lines transition from

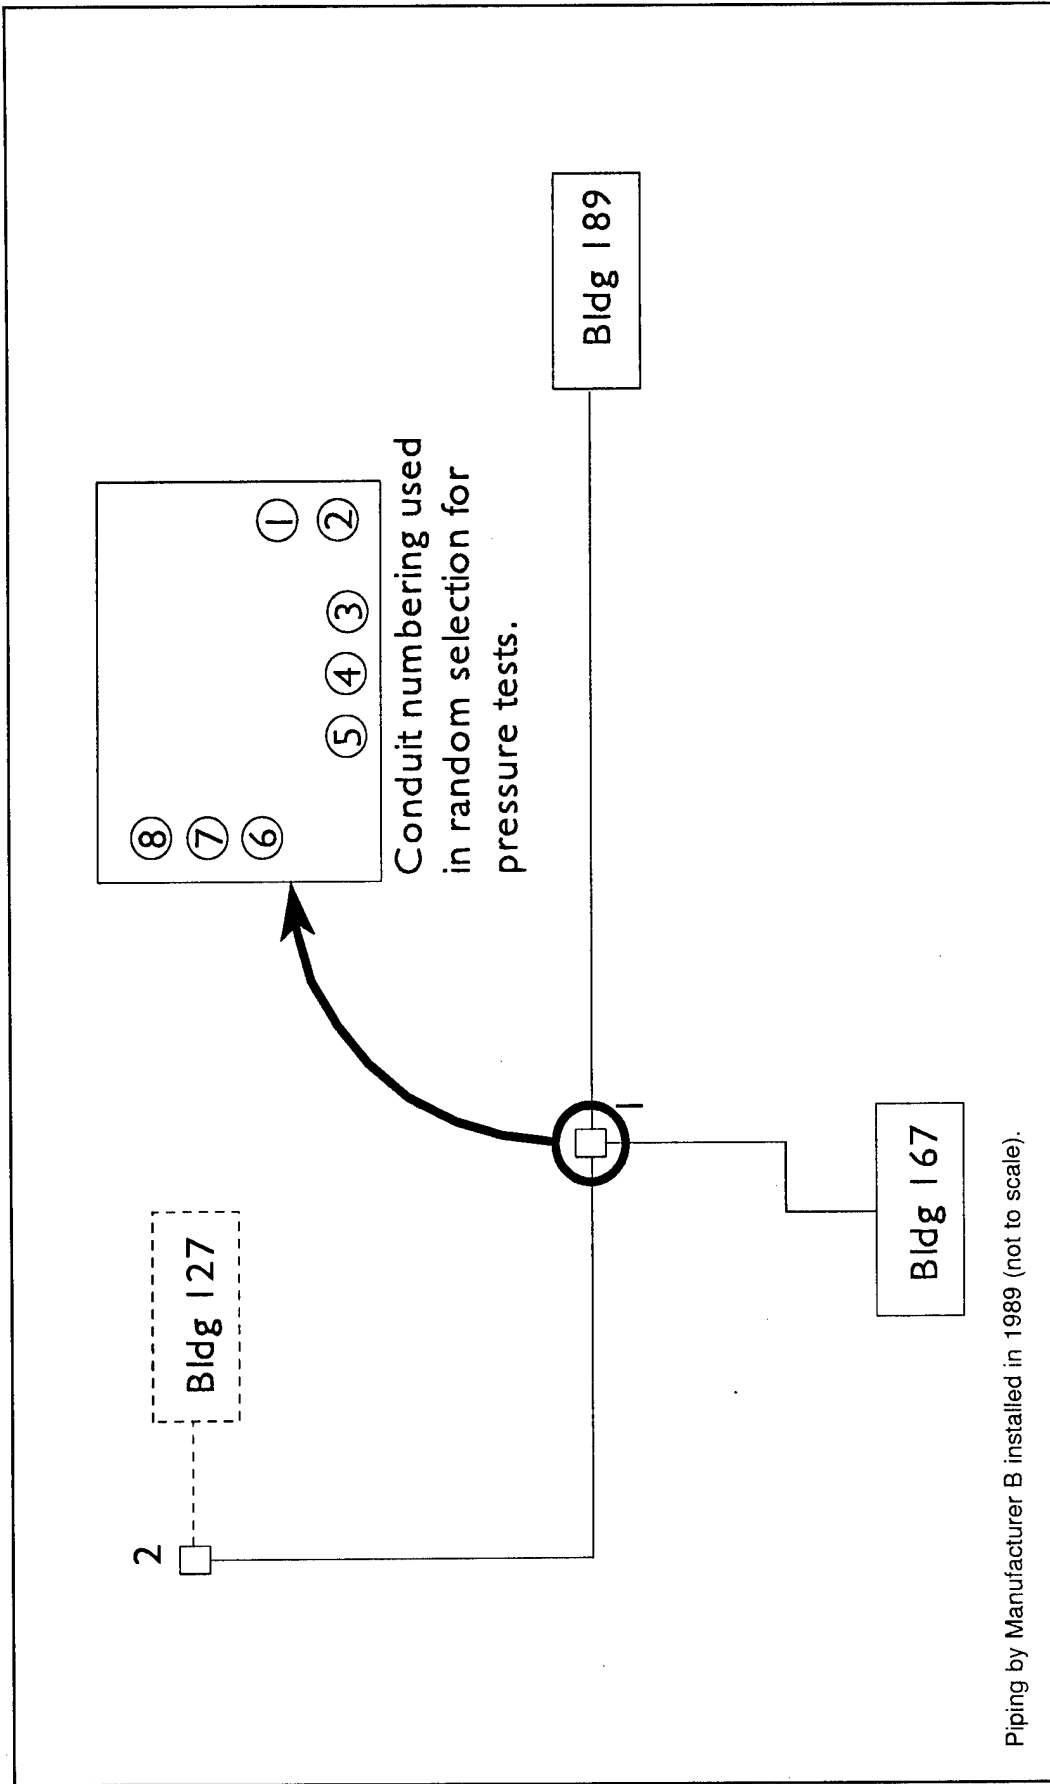
Figure D1. Schematic diagram of System 3 at Wright-Patterson AFB, OH.

- a. Equipment Room - Building 189—Steam and condensate lines were contained in individual conduits. The steam conduit casing did not extend through the wall into

the equipment room as normally required. End plates appeared to be zinc coated and were in excellent condition. Vent and drain openings on both conduits were plugged.

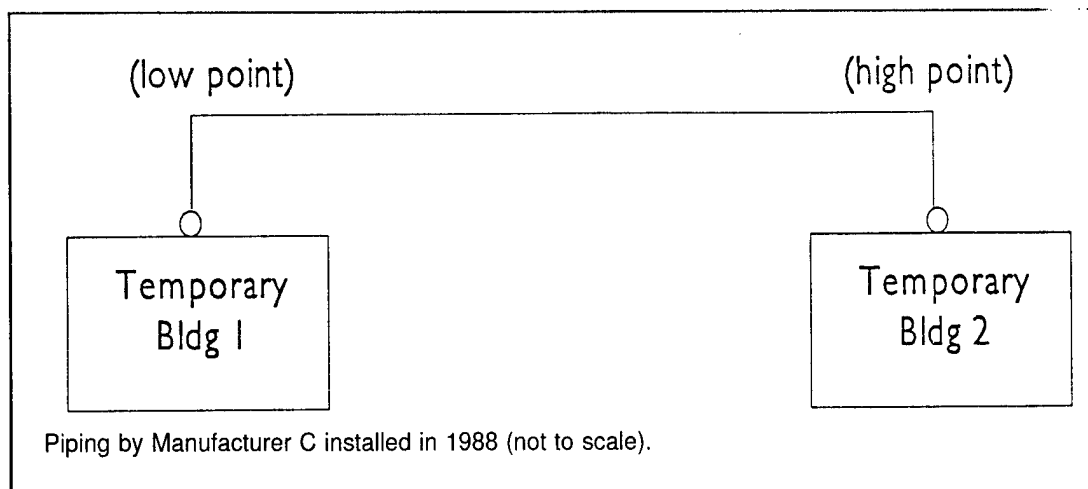
Figure D2. Schematic diagram of System 4 at Wright-Patterson AFB, OH.

This system consists of piping from Manufacturer C and has a steel conduit (Figure D2). It was installed in 1990 under contract No. F33601-89-CW027. The project consists of steam and condensate lines contained in a single conduit. It ties into an

overhead system, feeds two temporary buildings along "L" street and extends approximately 600 ft. On the lower half of the system, the route of the conduit and expansion loops were clearly defined by dried grass over the buried conduit.

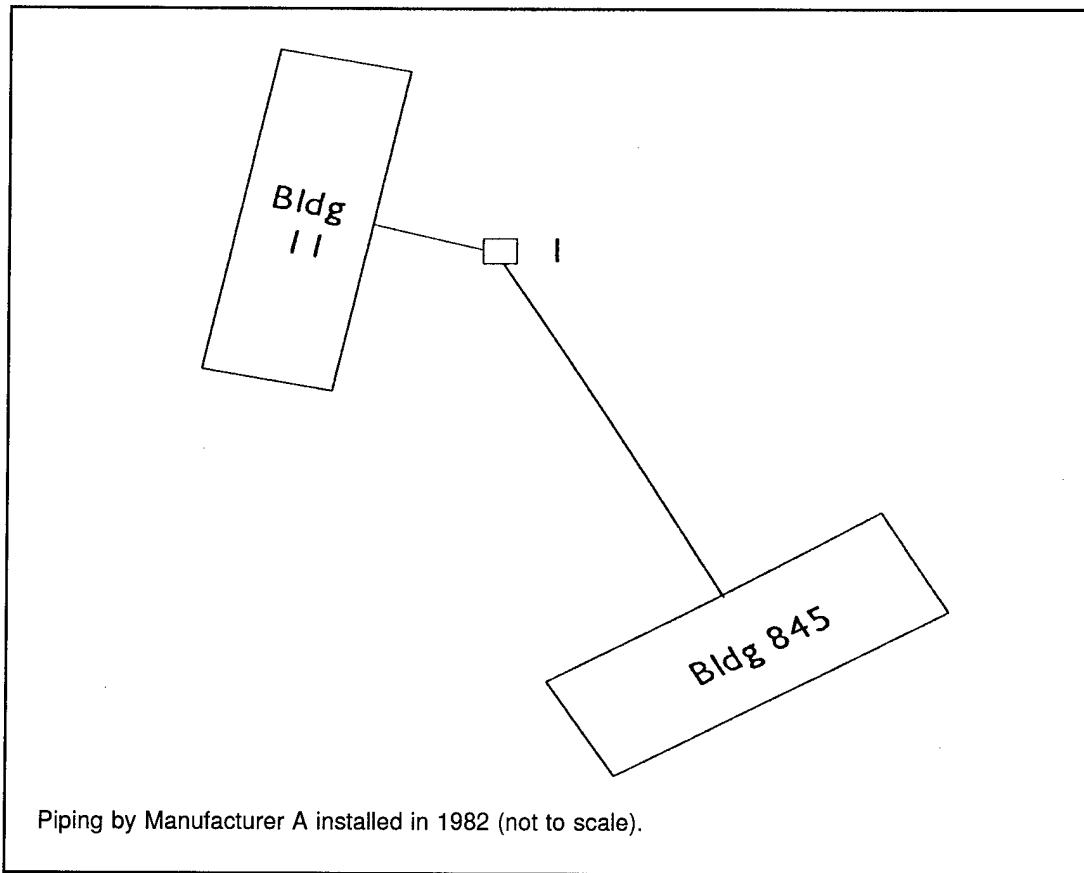
Figure I1. Schematic diagram of System 14 at Jacksonville NAS, FL.

a. Transition Southeast of Building —Two side-by-side manholes are at the point where the above ground system transitions to below ground. Manhole A (7 ft x 7 ft x 5 ft deep) appeared to be part of an older system that was in use prior to 1983. The manhole top was covered with removable steel plates with no manhole vents. The manhole contained no sump pump and was dry. A 6-in. steam line and a 4-in. condensate line exited the manhole through a buried concrete trench. Maintenance personnel indicated that the 4-in. line has been abandoned and that the 6-in. line was being used for condensate return. The temperature of the 6-in. line was 170 °F. There

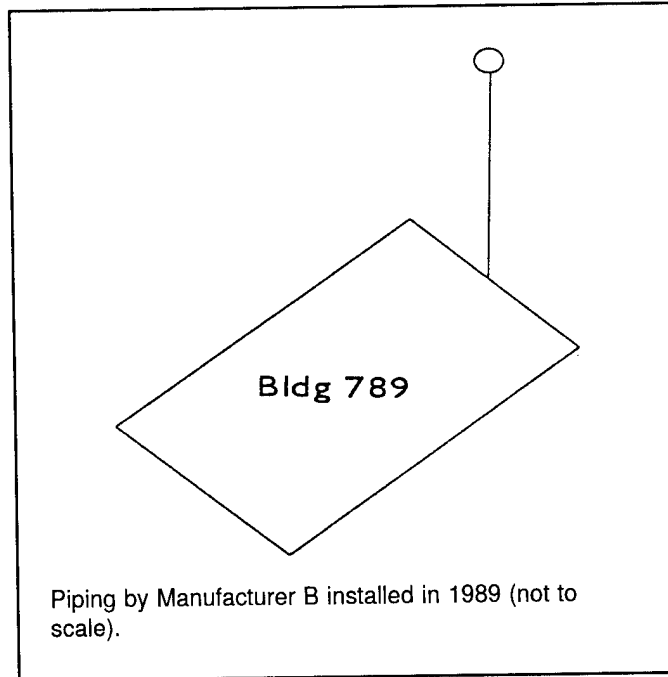
**Figure I6. Schematic diagram of System 19 at Jacksonville NAS, FL.**

This system consists of piping from Manufacturer B and has a steel conduit (Figure I6). It consists of a transition from above ground to below ground without a manhole. A single conduit containing both steam and condensate piping crosses Birmingham street and feeds Building 789. The riser had a loose water shed cap and the "Fostercoat" coating had some minor deterioration. The equipment room pit is 4 ft x 4 ft x 12 ft deep and has an electric sump pump. Gland seals were used at the end plates for both the steam and condensate piping. The single conduit drain was

plugged, but the vent was recessed into the pit wall and was full of concrete. The wall penetration was cemented and caulked, but slight water infiltration was noted. Some water seepage was also evident at an old wall penetration. A pressure test could not be performed because of the rain cap.

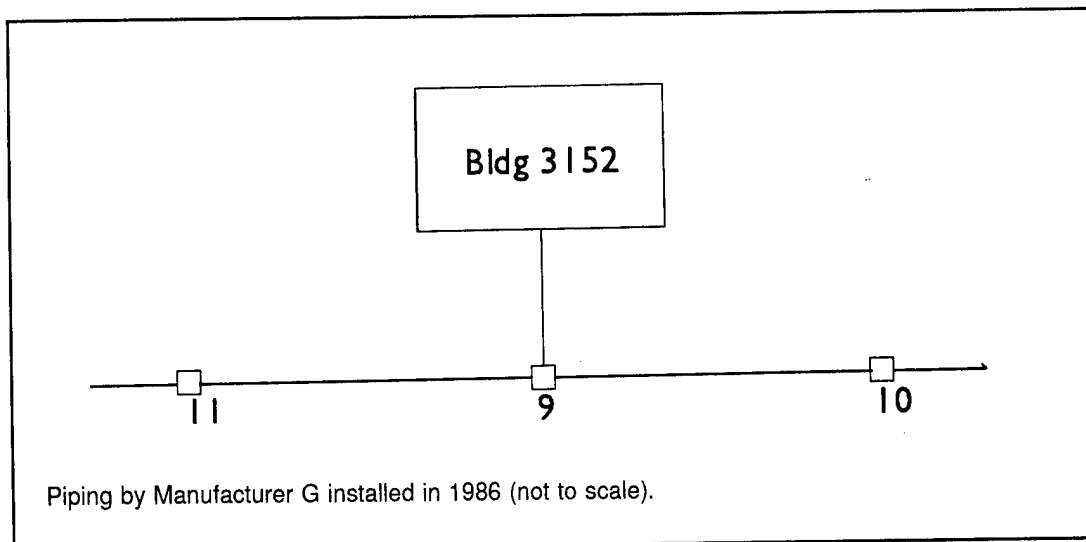
Figure O3. Schematic diagram of System 31 at Fort Lewis, WA.

Base personnel indicated that a major pipe leak was found in this system. The estimated cost for locating and repairing the leak was \$16,814 and the actual documented cost was \$14,234. However, it should be noted that the repair did not involve an "in-kind" replacement of the damaged system. Repair was accomplished by cutting out the failed section of conduit and installing a new carrier pipe covered with cellular glass insulation with a mastic coating. Cellular glass is not considered satisfactory for heat distribution system applications because of its brittleness, lack of shear strength, and its tendency to disintegrate under shock and vibration loads.

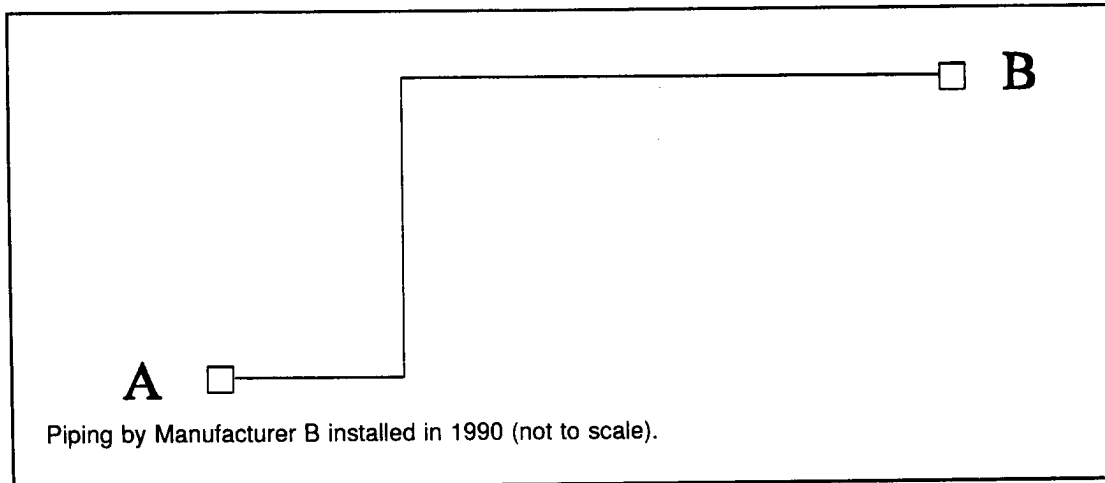
**Figure P2. Schematic diagram of System 35 at San Diego Naval Station, CA.**

Pressure was applied to the casing at 1:25 PM, and it slowly rose to 3 psi but would not rise further. The gland seal and gauge and compressor connections were thoroughly checked for leakage and were found to be sound. The compressor was operated for an additional 50 minutes, but no additional increase in pressure was evident. When the conduit casing was sealed by valving off the compressor, the pressure immediately dropped to zero.
