Investigation of Fatigue Cracking
on LAU-7/A Launcher Housing

D.S. Saunders, M.G. Stimson,
R. Bailey and E. Kowal

DSTO-TR-0229

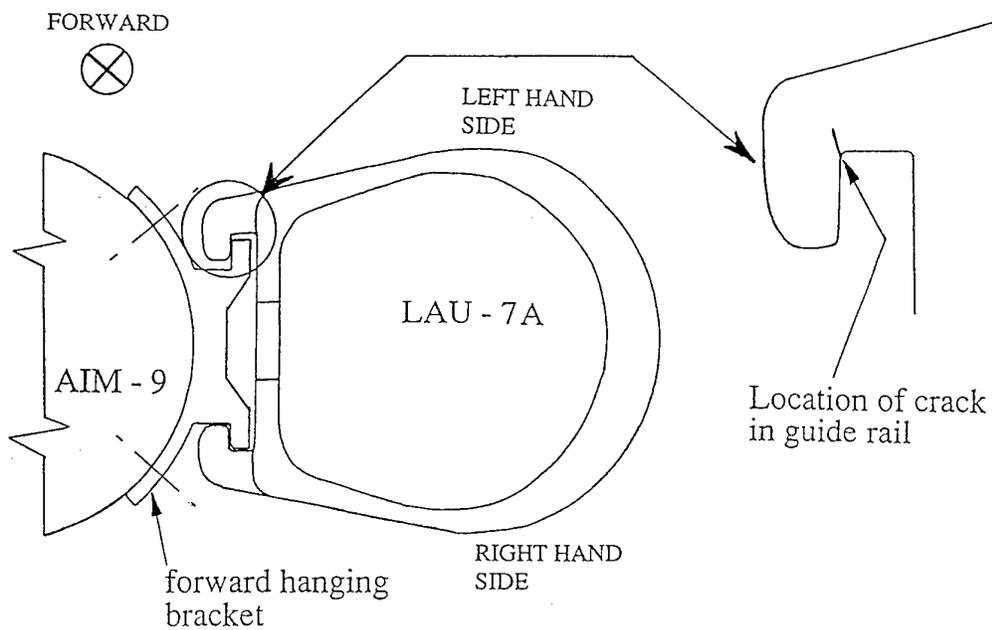
The location of the fatigue crack is shown in Figure 4 and a typical fracture is shown in the inset figure. Left and right-hand sides of the launchers are also defined in Figure 4. At overload failure, when the fatigue cracks have attained critical length, the fatigue cracks are generally of high aspect ratio typically 40 mm along the length of the guide rail and 1 to 3 mm deep. The shallow nature of the cracks creates some considerable difficulty in the inspection of the guide rails. In conjunction with NDISL², No. 481 Wing has developed a new NDI technique which, within the limitations discussed in Section 5.6 of this report, appears satisfactory for the inspection of guide rails. The previous standard technique and the inexperience of operators led to some inaccurate reporting of crack lengths and, possibly, over-estimation of the numbers of launcher guide rails which had cracked in service.

Figure 4. The location of cracking in the LAU-7/A launcher guide rail and typical fatigue crack (inset).

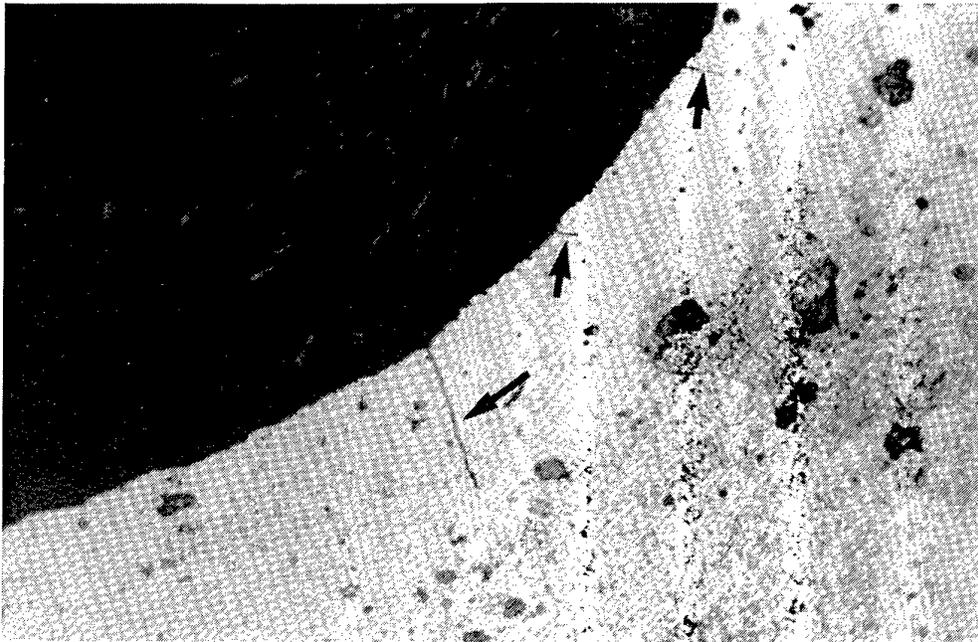
From a metallographic examination of a launcher failed in service, [2] it was apparent that cracking initiated as a result of the stress raising effect of the sharp radius under the lip of the guide rail. This is shown in Figure 5 (after [2]), where it can be seen that initiation of cracking is at a number of sites. The presence of small, intermetallic particles near the surface possibly aided the initiation of cracking. The preliminary scanning electron microscopy has shown that sub-critical crack extension occurred by fatigue. Within this region there was evidence of frequent over loads (causing patches of dimpled rupture) and regions of striation crack growth typical of fatigue. Final fracture by microvoid coalescence (overload) occurred when the crack had grown to a depth of 1 to 3mm, see Figure 6.

Figure 5. *Optical micrograph of the region of cracking in the guide rail of LAU-7/A launcher number 0159, from [2]. 6X*

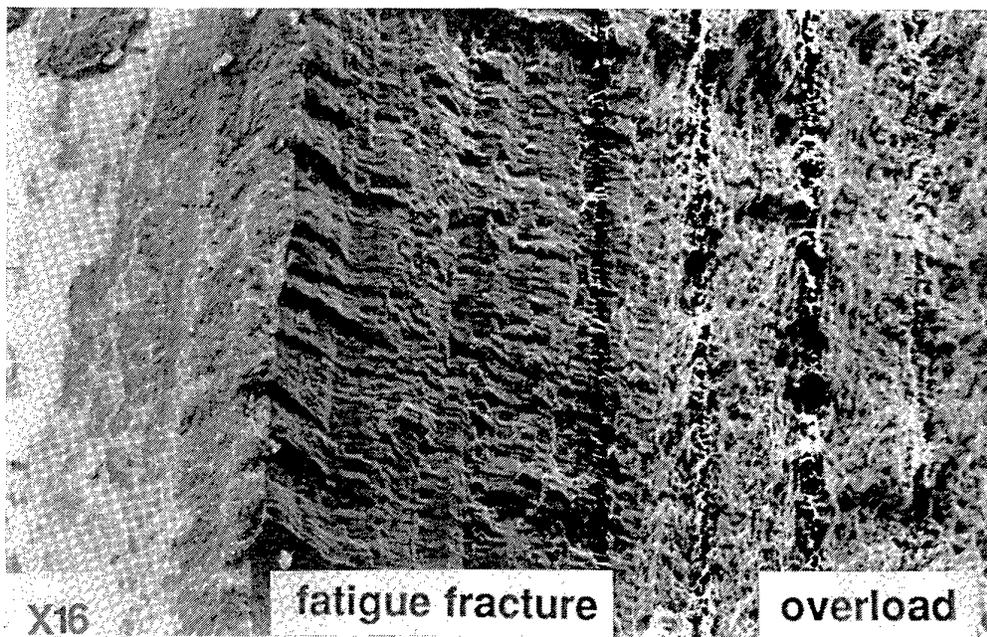
Figure 6. *Scanning electron micrograph of the fracture surface from the guide rail of LAU-7/A launcher number 0159, after [2]. 16X*

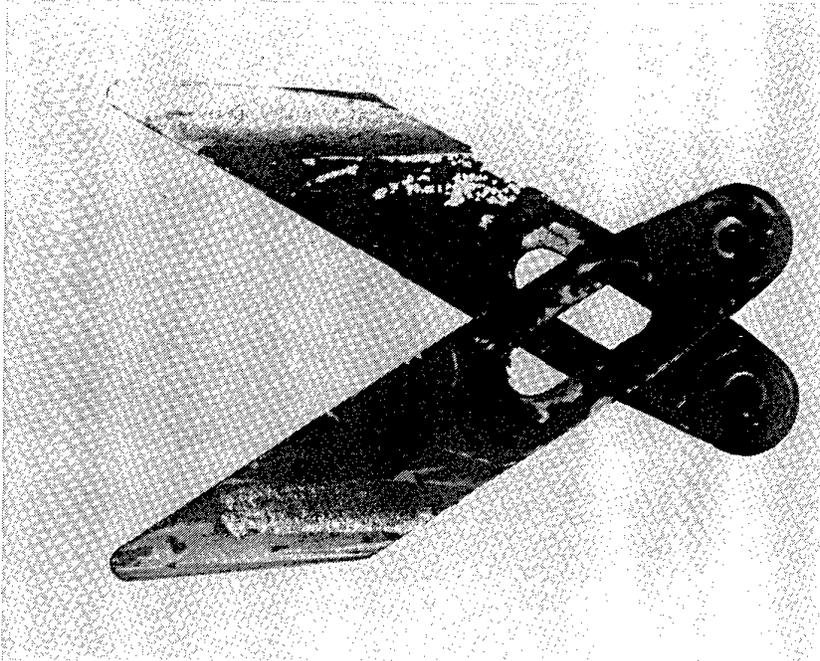
Severe wear to the aft snubbing scissors has been observed, Figure 7, as has the wear to the aft hanging brackets seen in Figure 8. Wear has also typically been reported on the

Figure 7. Worn scissor blades from the aft snubber mechanism. Scissors were painted black prior to cycling to illustrate the wear which reduces snubbing effectiveness

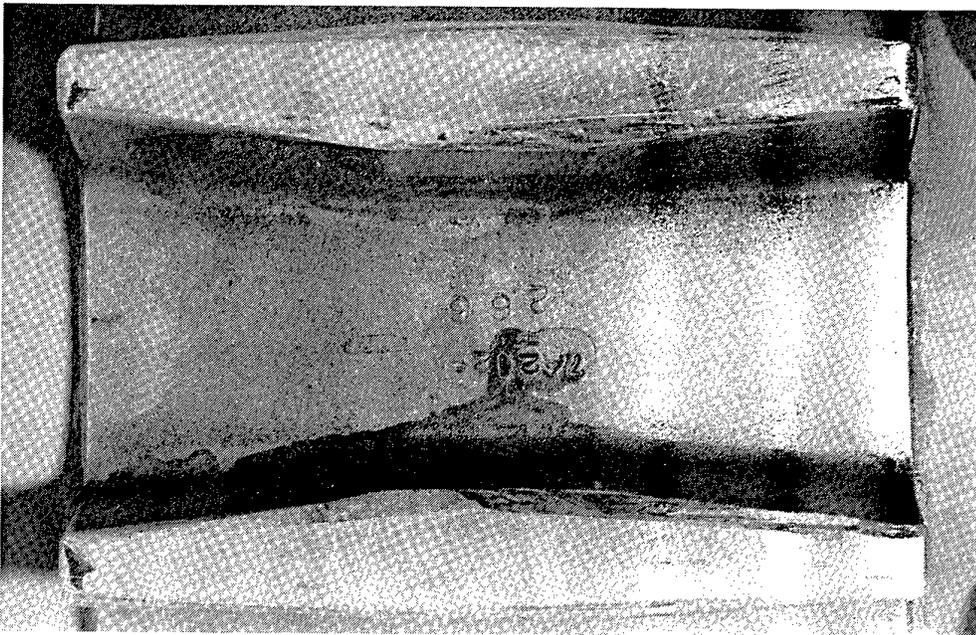
Figure 8. Wear of the inner corners of the aft hanging bracket corresponding to that of the scissors.

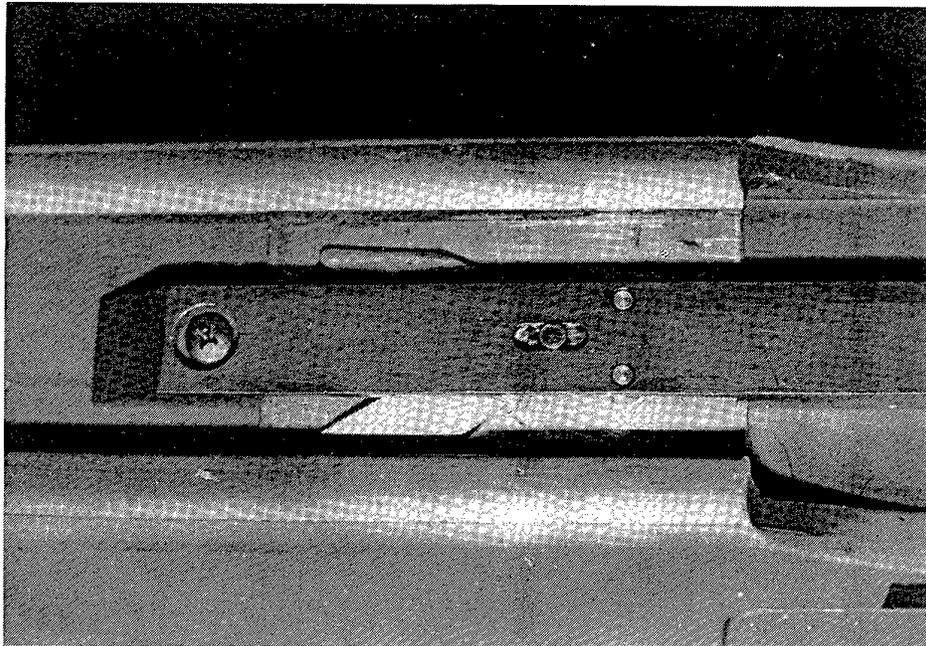
Figure 10. *The RAAF wear plate installed under the aft snubbing mechanism in an attempt to force the missile hanger against the rail and restrict vertical movement.*

In an attempt to overcome the problem of ineffective aft snubbing and presumably decrease load shedding to the region of the forward hanging bracket the RAAF has designed a wearplate which is inserted under the aft snubbers thereby increasing the wedging forces and reducing missile movement, Figure 10. The effect of this plate on the strains at the forward hanger was investigated. Similarly, in an attempt to decrease the loads at the forward hanging bracket, the Canadian Forces have designed sets of teflon cylinders to react aircraft loads directly onto the launcher housing rather than through the guide rails, Figure 11. As an aside in the project this configuration was also investigated in the strain surveys.

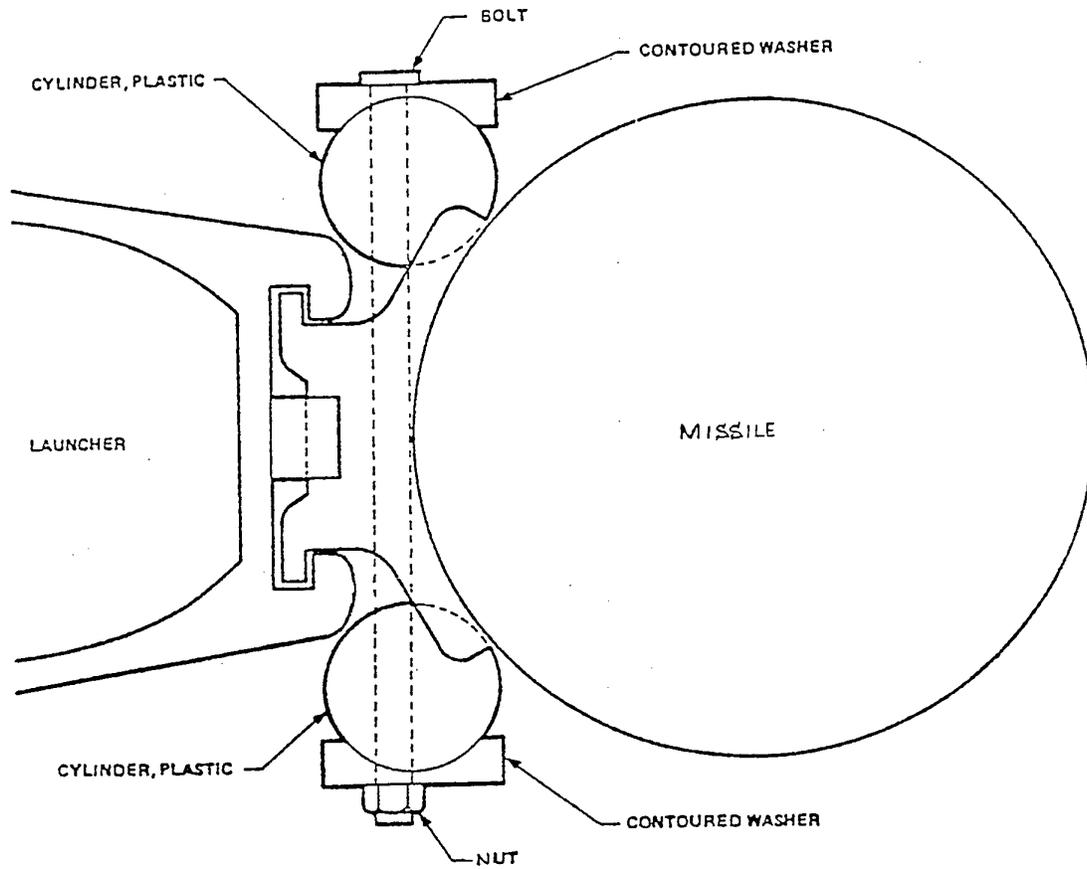
Figure 11. *A cross section of the launcher-missile combination showing the CF design of teflon cylinders to increase snubbing forces. The teflon prevents damage to either part, but soon deforms and loses effectiveness.*

The teflon cylinders introduced by the Canadian Forces were replicated and trialed in just two experiments. The configuration is seen in Figure 11 from [9]. One set of cylinders was adjacent to the forward snubbers and one set attempted to restrict missile vertical movement at the aft snubbers. The recommended torque settings were used, but re-torquing was required after only a few high load cycles as the teflon deformed.

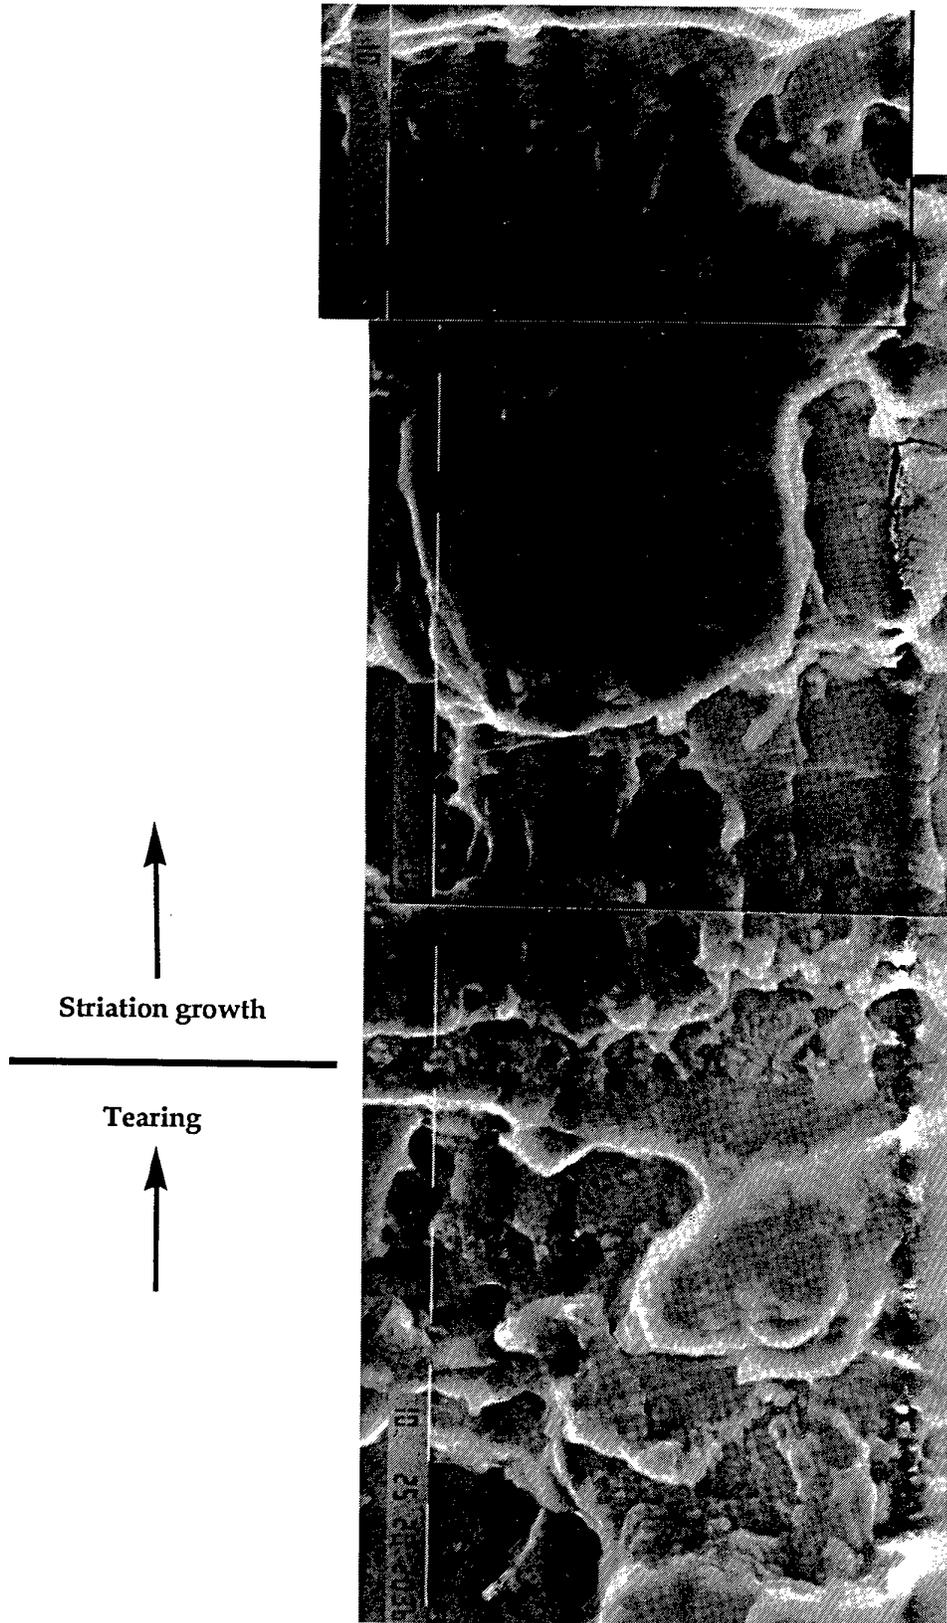
Figure 16. *Fatigue crack growth in the guide rail of launcher NMH 0217 due to service loads. Within the striation bands growth occurs at an average of 900 striations per mm.*

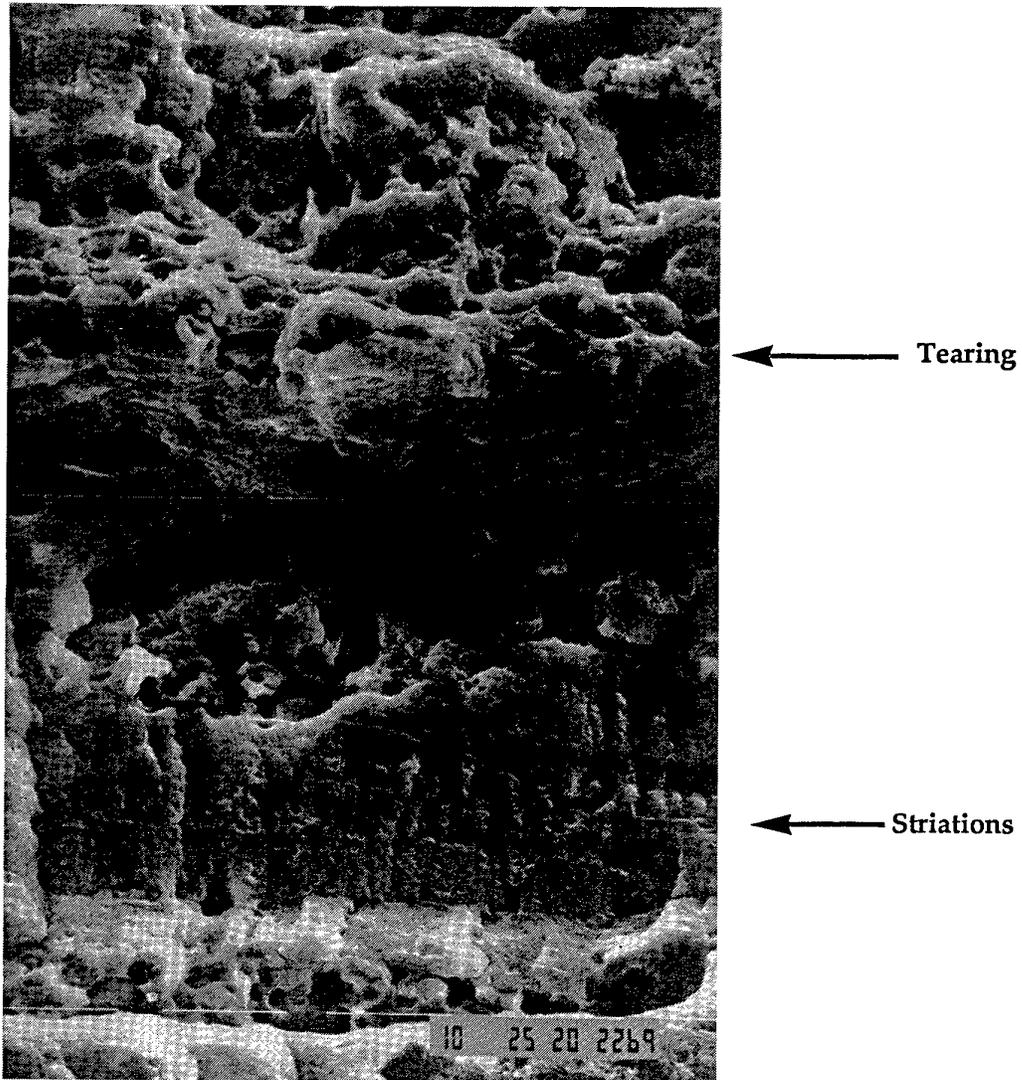
Figure 17. Another example, from a launcher found overloaded in operational service, of fatigue crack growth interspersed with ductile tearing . This scanning electron micrograph is of launcher S/N 0355.

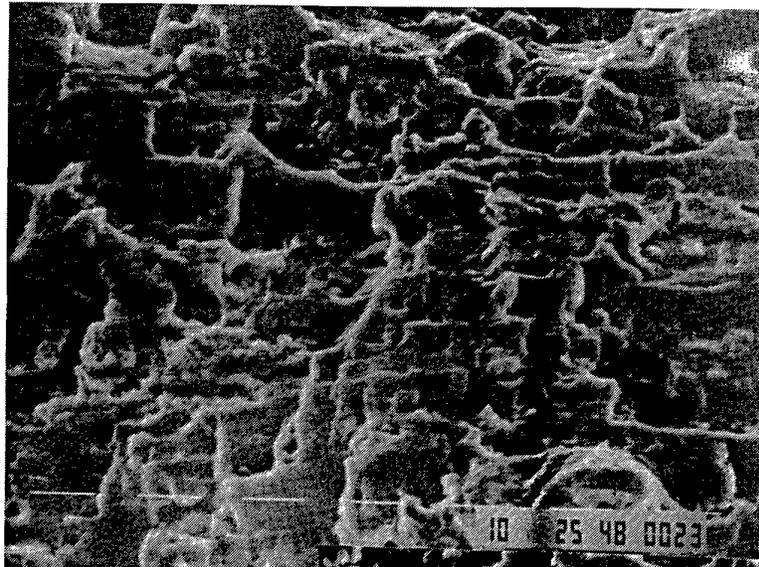
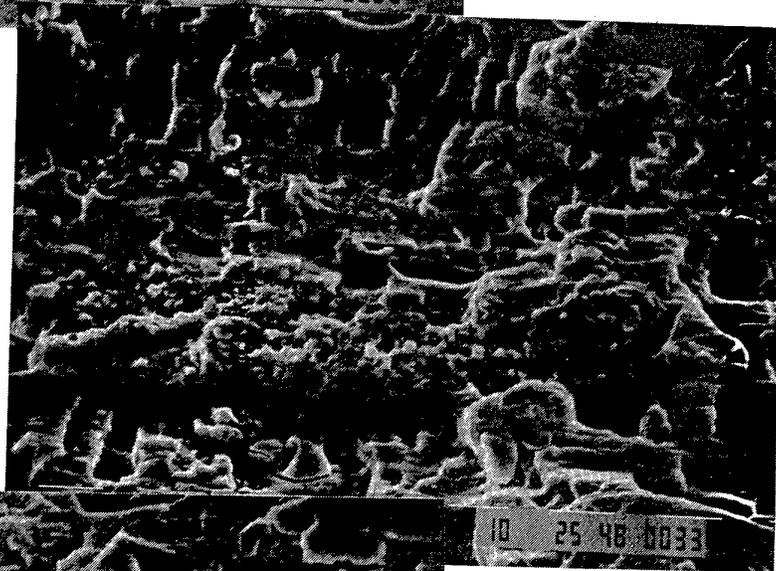
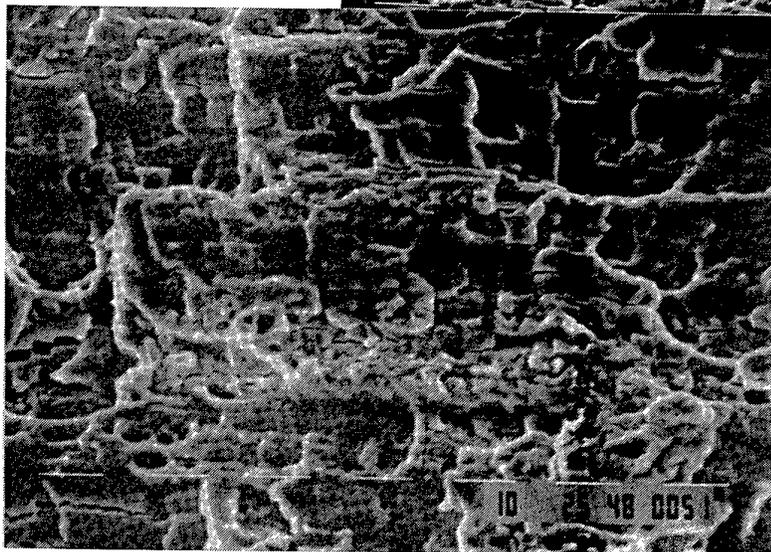
Figure 18. *Fatigue crack growth in guide rails of launcher 71032-012 tested in the laboratory. (a) initial cracking in service, (b) Nz spectrum factored by 3.0, (c) final stages of cracking with spectrum factored by 2.5*

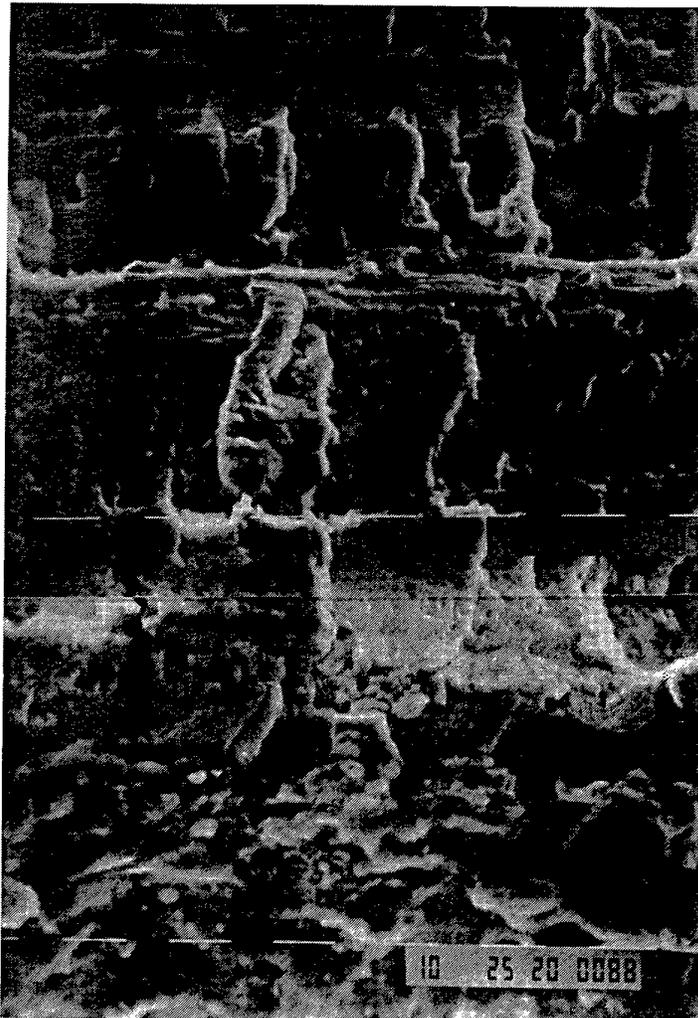
Figure 19. *Fatigue crack growth from an EDM notch in the guide rail (inset) of launcher 0175. The delineation between the melted grains of the notch and the sharp edges of the striation crack growth is difficult to discern.*

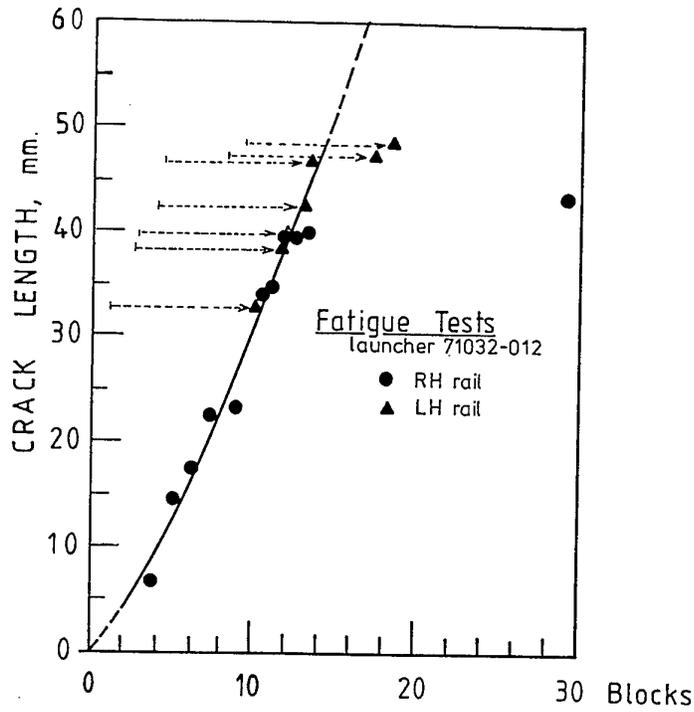
Figure 23. Crack growth in the guide rails of launcher 0148 from laboratory fatigue test.

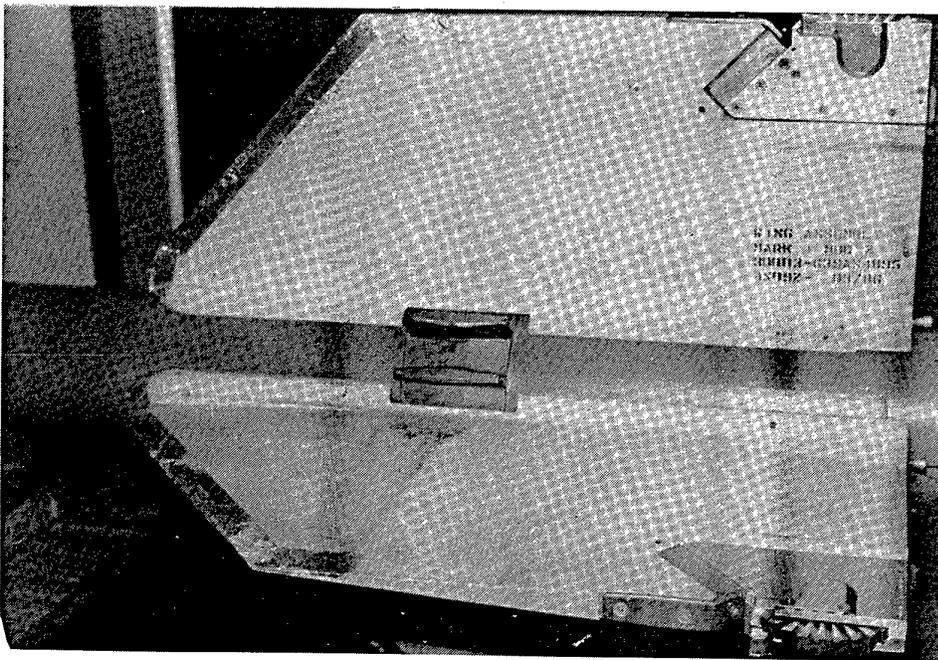
Figure 24. Dark debris particles deposited on the fin as a result of wear at the aft hanging bracket during fatigue testing.
