New Generation Runway Visual Range (RVR) Final Operational Test and Evaluation Report: Volume I

July 1996

DOT/FAA/CT-TN95/32-1

Technical Report Documentation Page

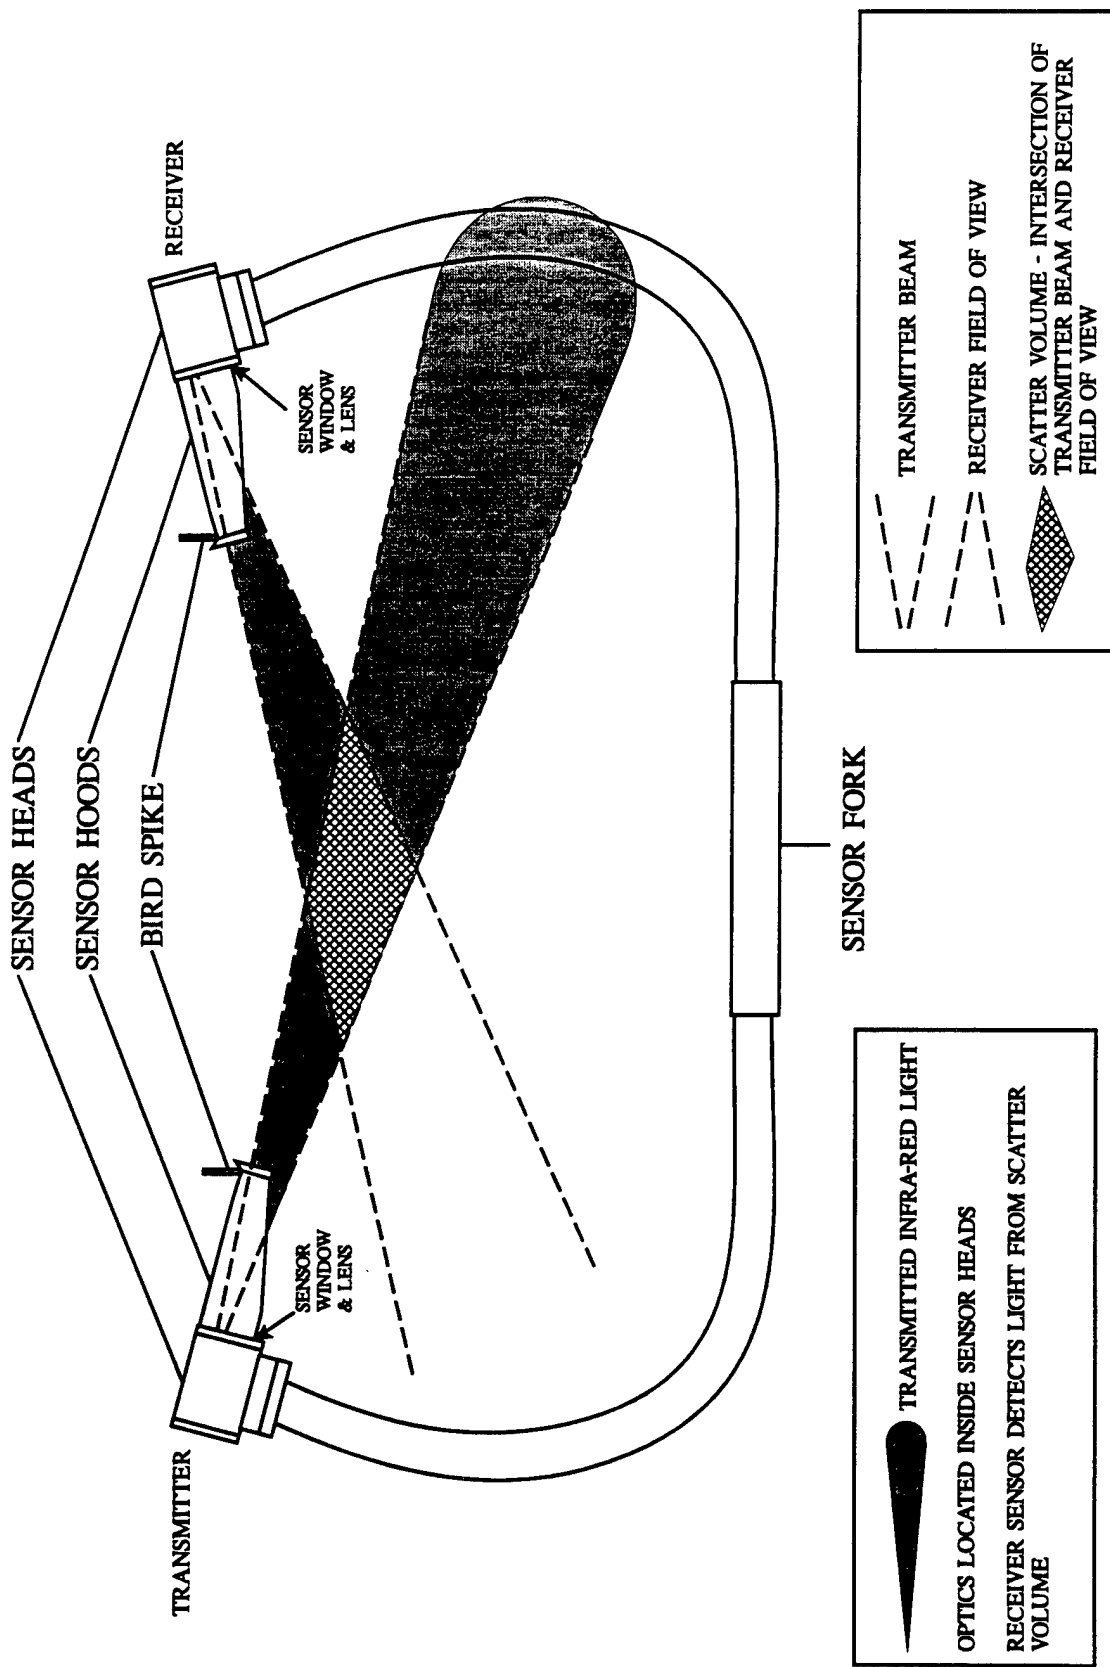
FIGURE 1. LOOK-DOWN VISIBILITY SENSOR COMPONENTS

"Window Signals" originating from the RVR's window contamination detection circuitry were found to be adversely affected by precipitation hitting the lens or "window" (figure 1) of the VS. These signals are actually voltage levels which are proportional to the amount of contamination detected on the sensor lens. Window contamination includes any substance such as snow, water, dirt, etc., that might strike or collect on the sensor window. Effects of precipitation striking the sensor window ranged from errors in extinction coefficients to sensor shutdowns. Because of shutdowns, it was necessary to disable the software modules involved in contamination correction. This effectively eliminated a major functionality of the system.

As mentioned in paragraph 1.3.2.2.1, undetected contaminants blocking the infrared light path to or from the "scatter volume" (figure 1) can cause higher-than-actual RVR readings. This phenomenon was observed during snow events which produced snow "clogs" (figure 2) in the look-across sensor.

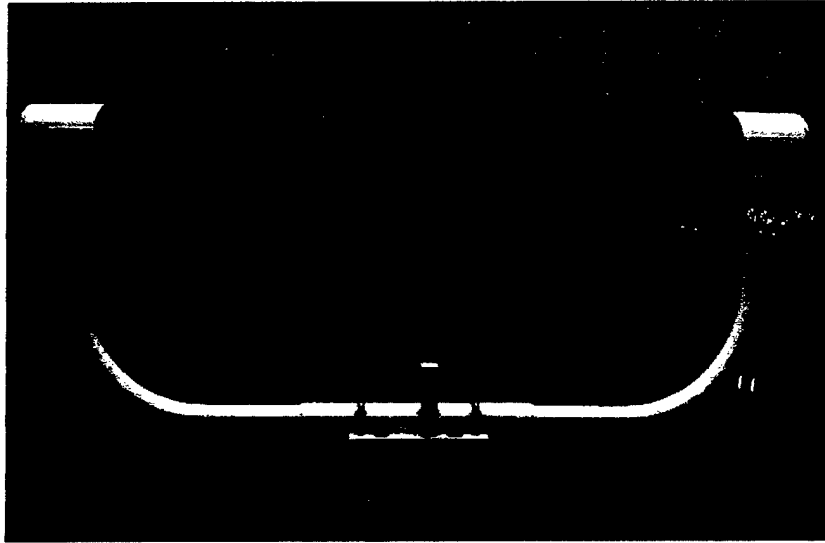
FIGURE 4. LOOK-ACROSS VISIBILITY SENSOR

The original VS utilized sensor heads that were oriented parallel to the ground (figure 4). Because of this orientation, it is referred to as a "Look-Across" or look-out VS. OT&E and Specialized test results indicated that this sensor was susceptible to calibration problems, failures, and questionable RVR readings. The latter two items being particularly prevalent during blowing rain or snow. Problems were attributed to the relative ease with which precipitation could strike the sensor window and to the system's inability to adequately compensate when this occurred.
