FlightFax

REPORT of ARMY AIRCRAFT ACCIDENTS

November 1996 ♦ Vol 25 ♦ No 2

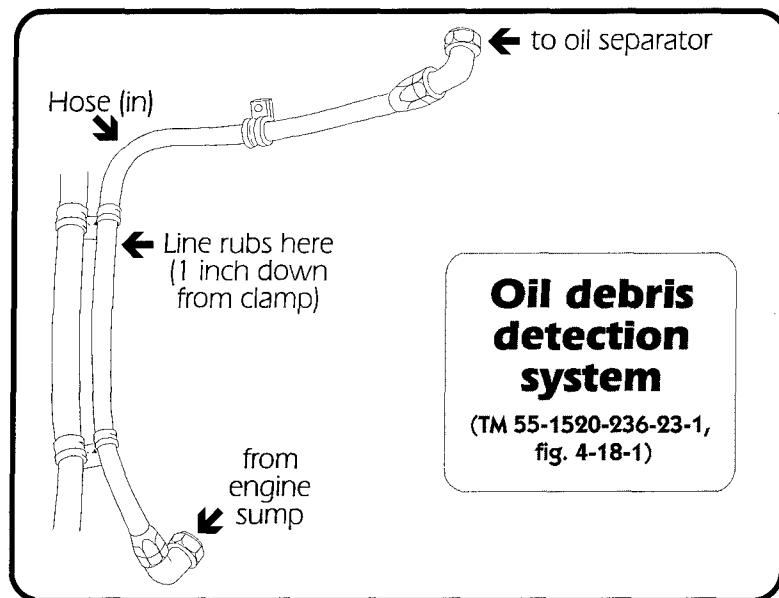
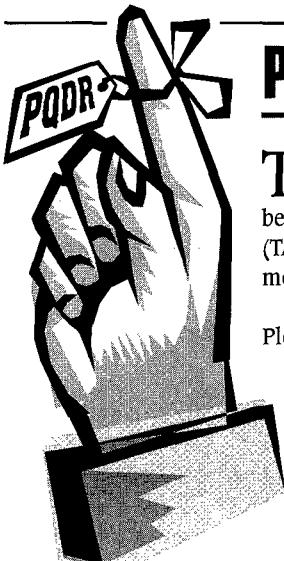
Recently, an oil line from the accessory gearbox to the engine oil debris detection system (ODDS) on an AH-1F ruptured in flight. Luckily, the aircraft, which was on an IFR training mission, was on short final when the line ruptured. Otherwise, this Class E mishap could have been much more serious.

Subsequent maintenance inspection found that the oil line had ruptured due to contact with the sharp edges of the flange on the improved particle separator (IPS) modification. The unit has found three other aircraft with the same problem and has had to replace the oil lines.

It'd be a good idea to inspect *all* AH-1s with the ODDS installed (MWO 55-1520-236-50-30) to ensure that the oil line is not rubbing against the IPS flange.
