**BANK STABILITY ANALYSIS FOR THE UPPER MISSOURI RIVER**

**STEPHEN E DARBY and COLIN R THORNE**

**FINAL REPORT TO**

**AUGUST 1996**

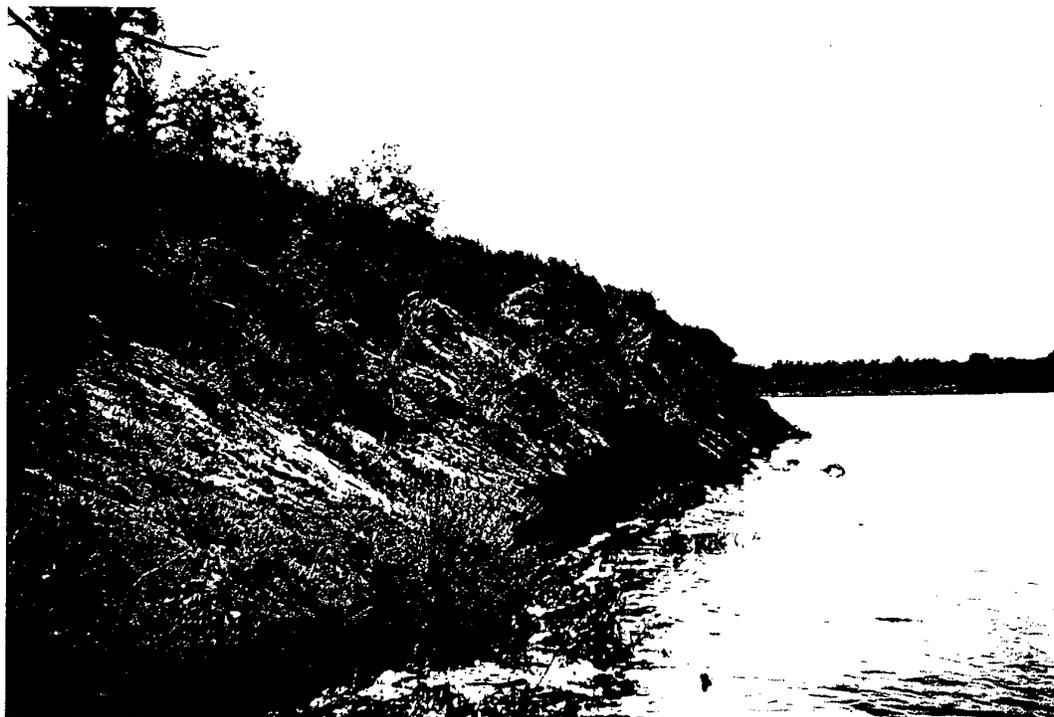
Plate 1d

(4) "Unstable" banks have simulated factors of safety less than 1.1 with failure planes intersecting the lower half of the bank profile (Plate 1d). Bankline retreat occurs through combinations of fluvial erosion and deep-seated mass instability. Rates of bank retreat in this category are commonly severe.
